Advanced Vibration Analysis on Gear Box Train and vibration elimination

**Udayashankar P. Eng., MBA,CMRP
Suncor Energy**

Brief History-7K-20 Gear box

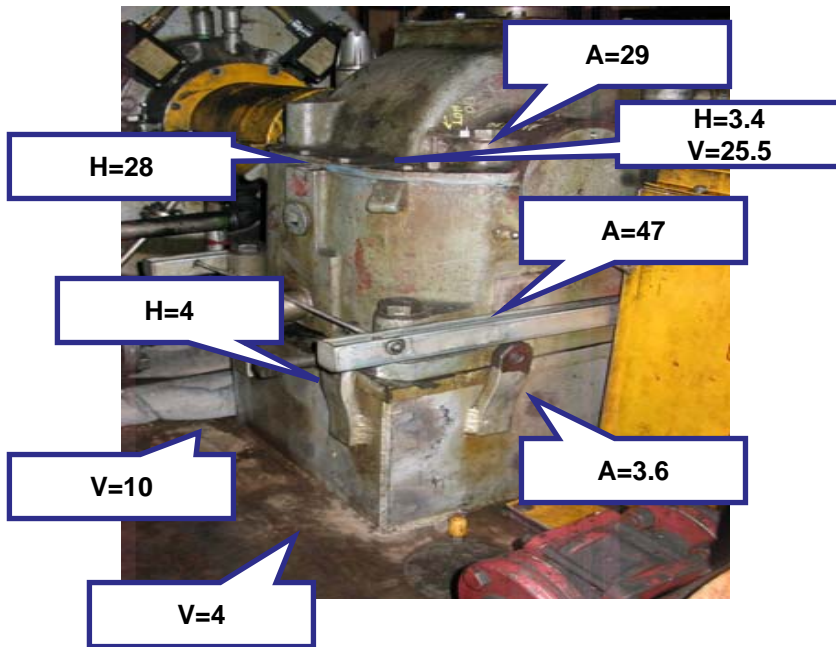
The vibration amplitude (units in g – peak) with stud mounted accelerometers at 3.056 KHz frequency i.e. 15 times run speed frequency of the high speed shaft at 12,224 rpm:

Gear Box Front Right Side
G measured before correction were in the range of 40 g

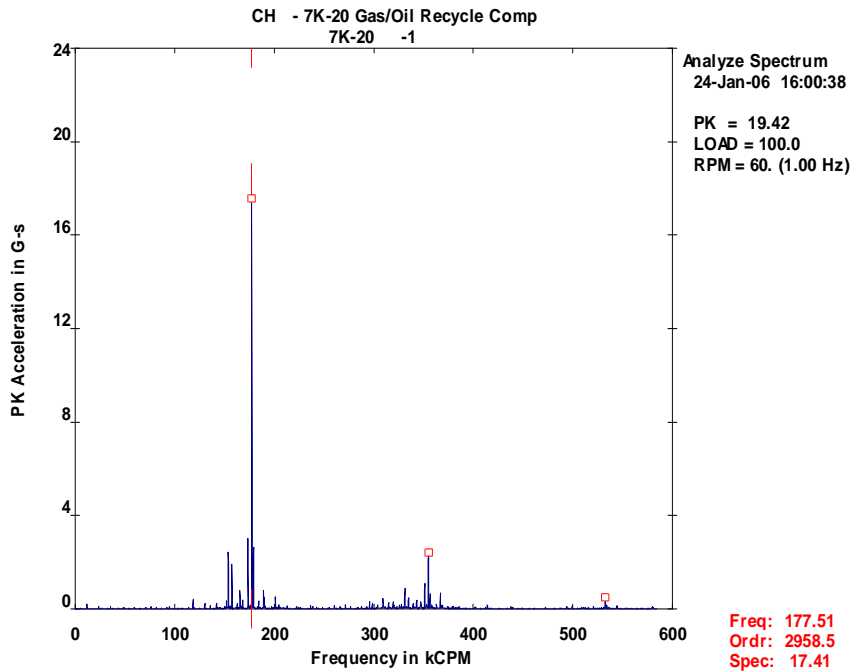
Spectrum on gearbox with high frequency accelerometer showing 2nd & 3rd harmonic of the fundamental frequency- Aug 2005

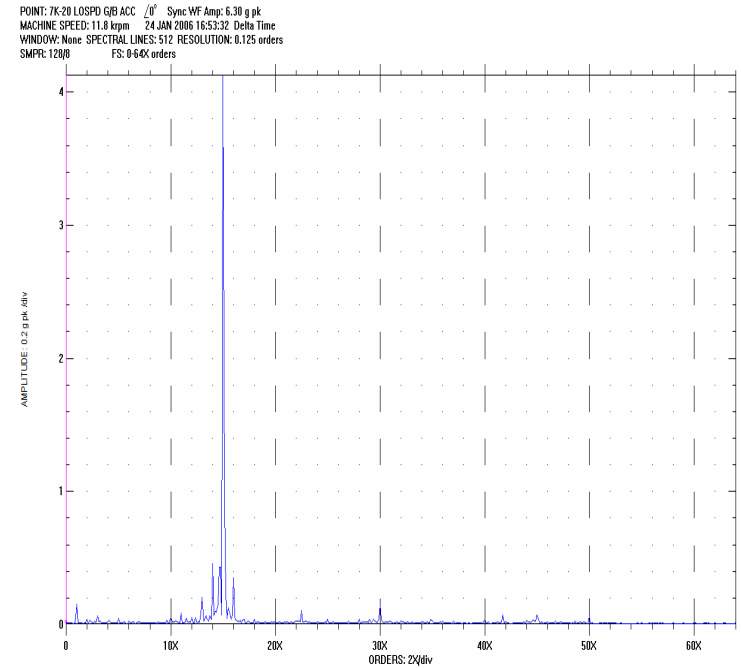
Figure - Spectrum from Data Manager - Spectrum does not show 2nd or 3rd harmonic of frequency- August 2005

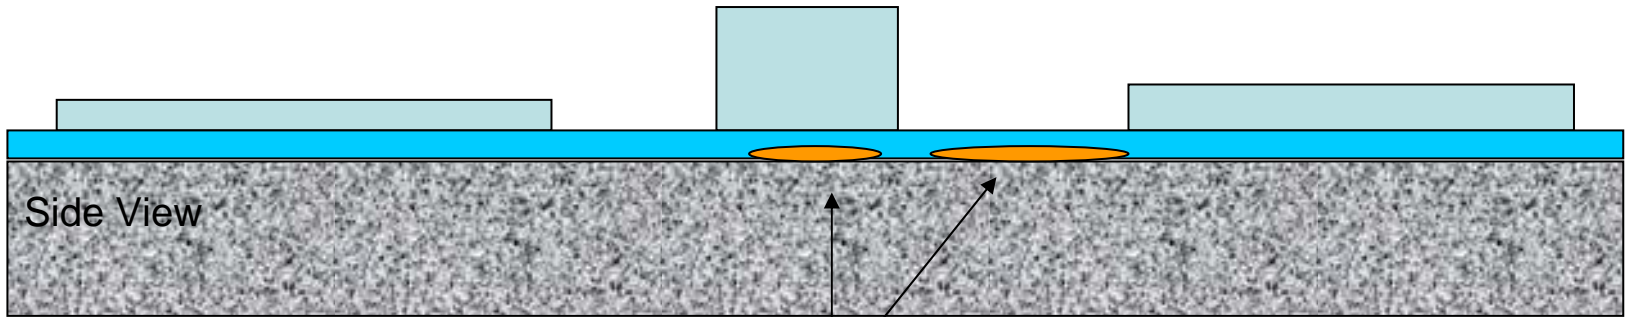
7K-20 Voids In the Gear Box Foundation

- **GB Pedestal is made of two metal plates & two C-Channels welded together**
- **No anchor bolts used to anchor these plates to the concrete**
- **Anchor bolts can also get loose with time**
- **Unit is running over 30 years and Oil spills observed all over the area including foundation, base plate & pedestal**
- **Chances of weak bond between pedestal & concrete, base plate and grout are high**
- **Vibrations at all the test points had a dominant peak at 3.056 KHz. i.e. 15 times running speed of high speed shaft at 12 224 rpm. The gear mesh frequency at 12224 rpm of high speed shaft was 10.187 KHz.**
- **Compressor impeller has 18 vanes and diffuser has 14 vanes.**

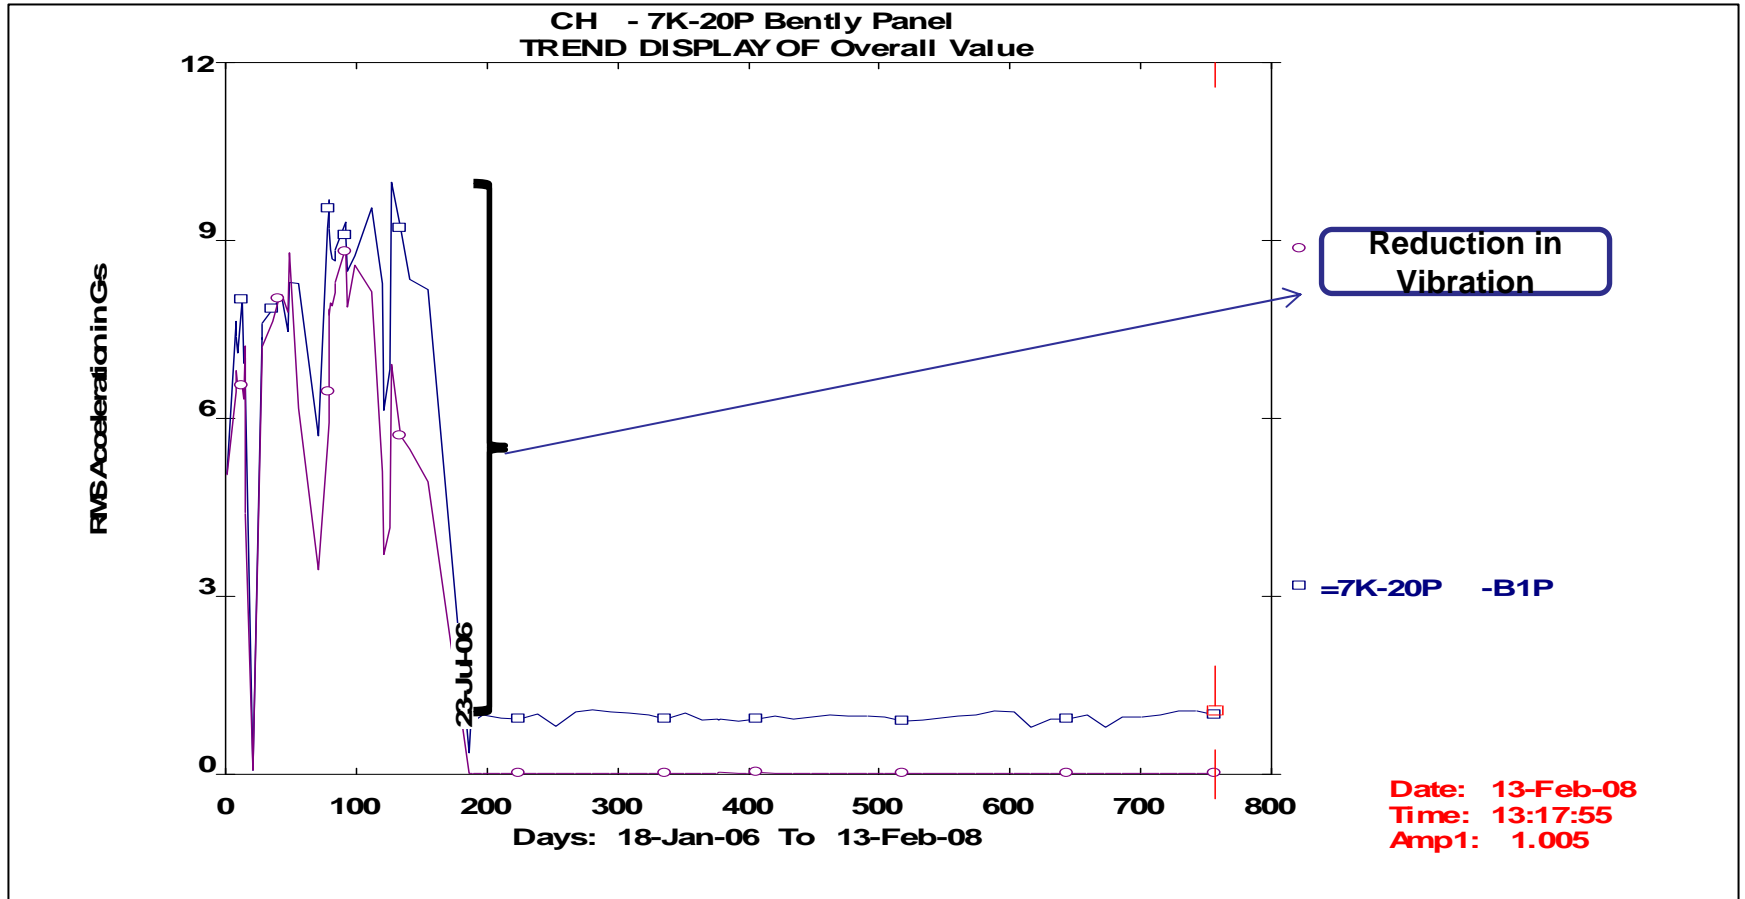
Vibration Trend- Pre and Post Correction cases

- Before: 18g to 22g for 20 years approximately
- Predominant: 15 times RPM
- RPM restricted to Max 5000
- **After: 3 to 3.5g**
- Predominant: 1 x RPM
- RPM: 5650
- Result: Catalyst life increase due to increased run time & higher pressure
- Estimated Annual Benefit: at least \$1 million & one extra outage avoided

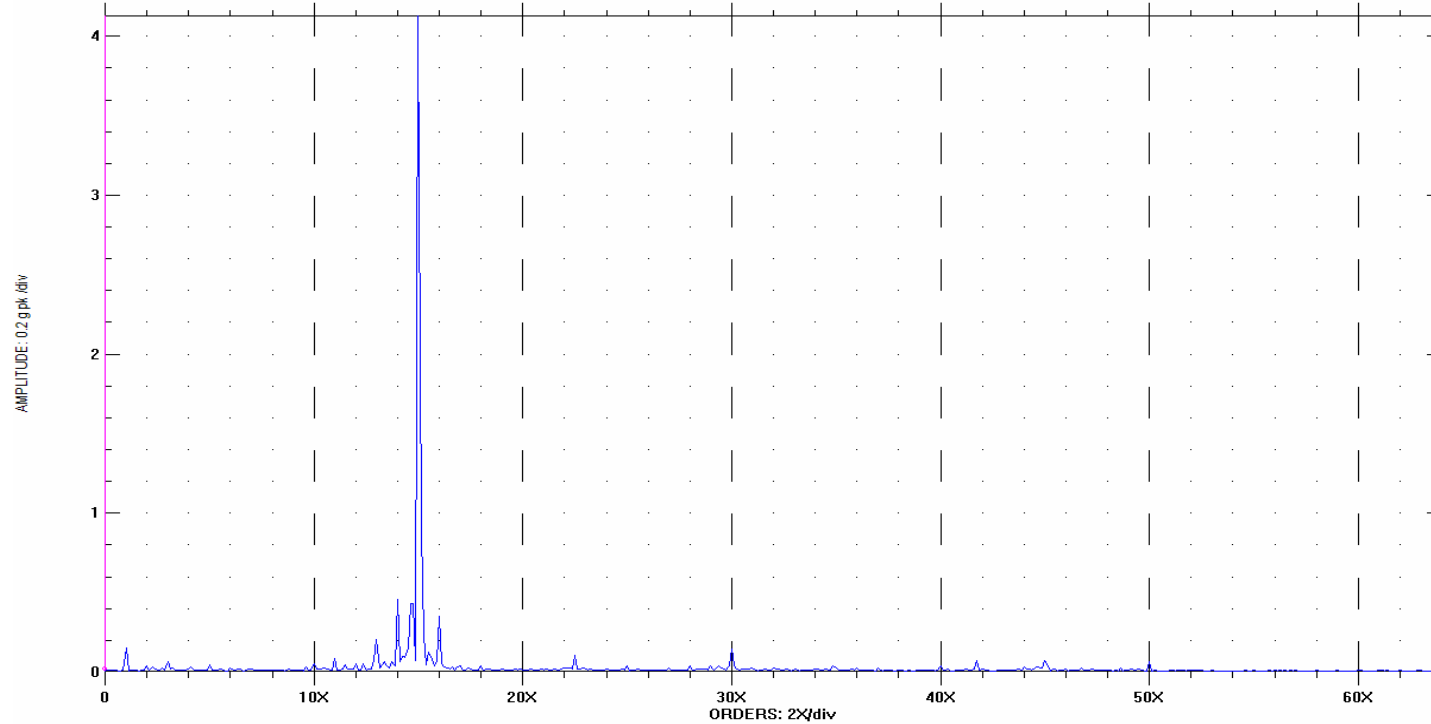
POINT: 7K-20 LOSPD G/B ACC /0° Sync WF Amp: 6.30 g pk
MACHINE SPEED: 11.8 krpm 24 JAN 2006 16:53:32 Delta Time
WINDOW: None SPECTRAL LINES: 512 RESOLUTION: 0.125 orders
SMPR: 128/8 FS: 0-64X orders

Figure - Spectrum from Data Manager - Spectrum does not show 2nd or 3rd harmonic of frequency- August 2005
