Long Term Operating Experience with Corrosion Control in Industrial Axial Flow Compressors

David Linden

D.H.Linden Associates, Inc.

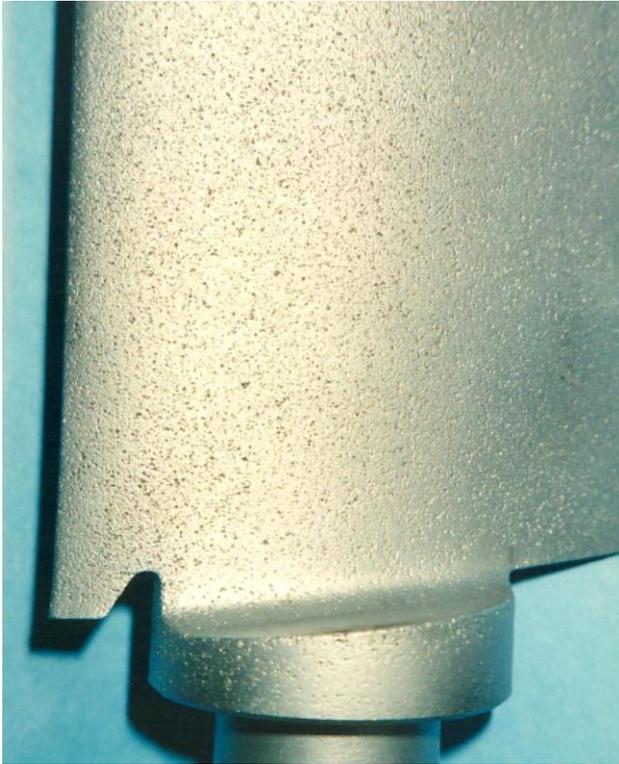
Figure #1 – Corrosion Pitting of 410 SS IGV after 36 months of service

Figures #1 and 2 show how severe the flow path corrosion can be. Figure #1 shows a cleaned Inlet Guide Vane (IGV) after 37 months of service. Heavy pitting can be seen over the entire part. These IGVs were manufactured from 410 Stainless Steel (SS) bar and were uncoated. Figure #2 shows severe rotor blade corrosion (403 Stainless Steel) and rotor disk corrosion (4340 alloy steel) after only 24 months of service. The rotor blades experienced both a generalized corrosive attack as well as corrosion pitting. The pitting on the blades exceeded 0.125" (3.2 mm) in diameter and penetrated into the base material more than 0.030 in (0.8 mm).

- 400 Series Stainless Steel - The 400 Series Stainless Steels typically experienced both a general corrosion and pitting (reference Figures #1&2). The harder/higher strength versions of the alloy experienced much more severe corrosion. At times it was difficult to determine the pitting corrosion rate since the general corrosion removed surface material and caused the pit depths to appear to be less than previous readings. When evaluations were made on a corrosion coupon, the diameter of the coupon was also monitored to determine the general corrosion rate as well as the pitting corrosion rate. Shallow machining marks on the corrosion coupons were beneficial in evaluating the general corrosion rate and locating previously noted pits.

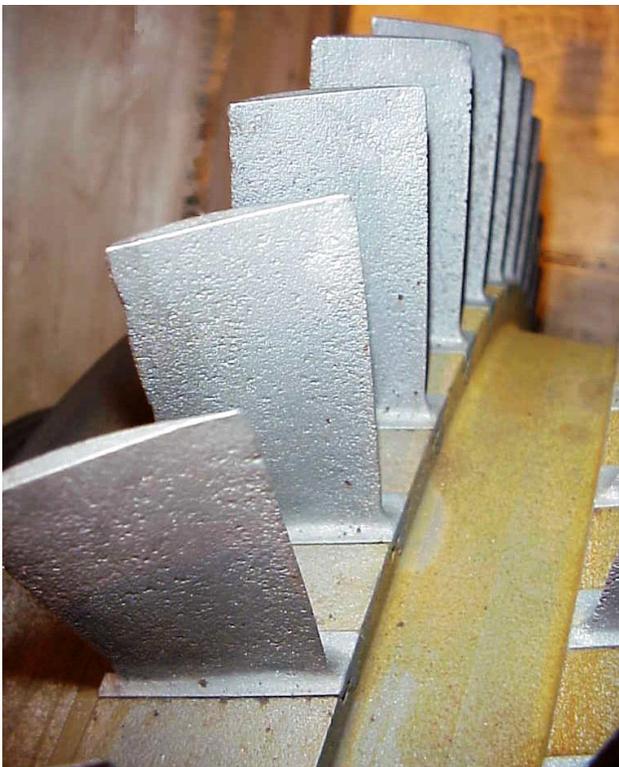
Figure #2 – General and Pitting Corrosion of 403 SS First Stage Rotor Blades after 24 months service

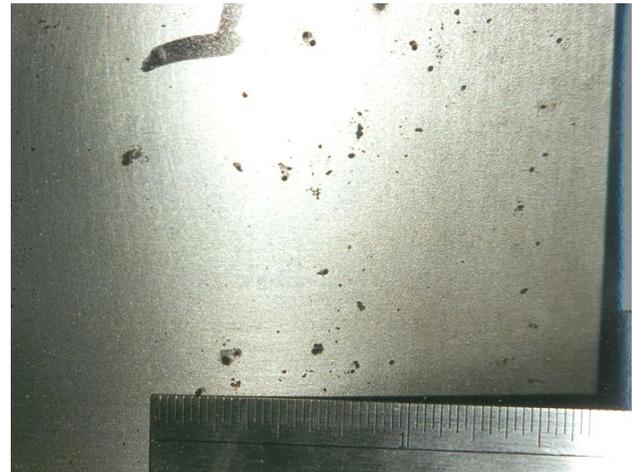
Figure 4 – Bare CC 450 Blading

Note: Surface Pitting after 18 months of operation

- Duplex Stainless Steels - The Duplex Stainless Steels (Custom 450) materials experienced little general surface corrosion, but limited and more aggressive pitting attack (reference Figure #4). The Duplex

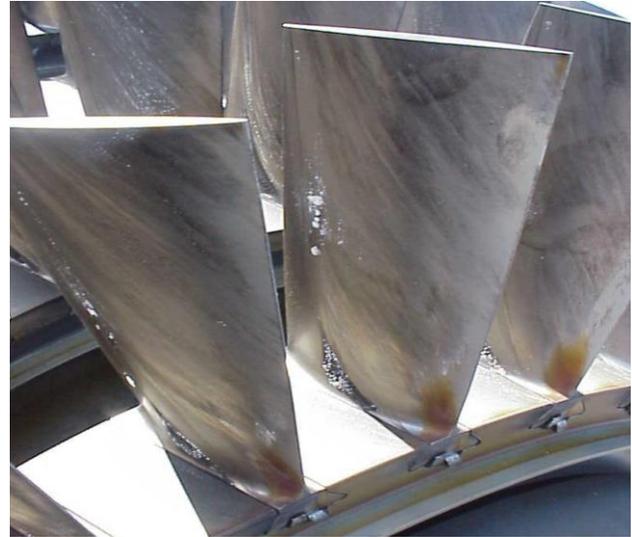
Inlet Stages – Inlet stage flow path deposition is generally found to be a wet oily type deposit. The deposit is often mistakenly identified as oil leakage from the compressor bearing housing since it is wet and oily in appearance. Detailed chemical and compound analysis found that these deposits are almost always Ammonium Sulfate rather than a hydrocarbon. In addition, salt deposits are often present as can be seen as the white colored crystal deposits in Figures #5 thru 7.

Figure #5 - 1st Stage Blade Deposits

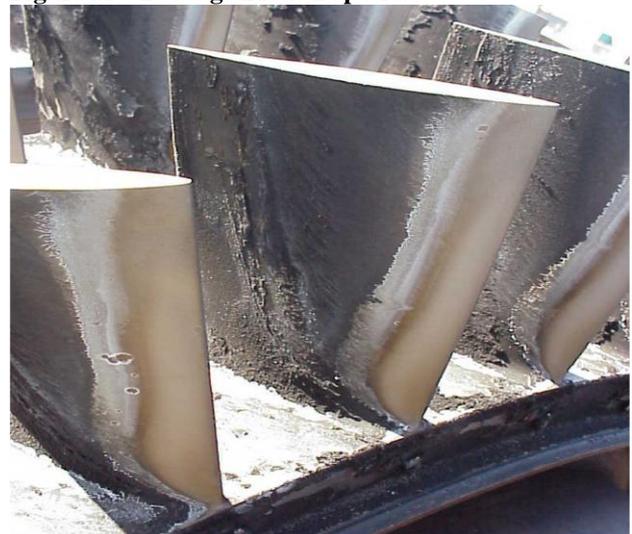
Figure #6 - 8th Stage Deposits

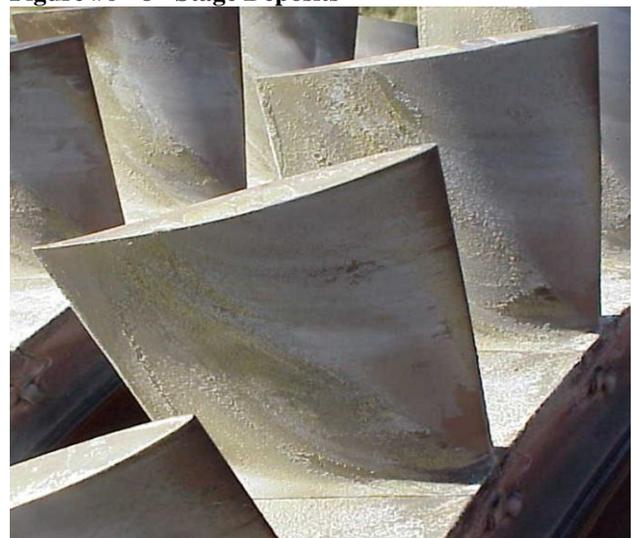
Discharge Stages – The later stages of the compressor generally experience dry powdery deposits as can be seen in Figure #7. While these deposits are of similar chemistries to the earlier stage deposits, they do not cause in-service corrosion of the blade materials due to the stages operating dry.

Figure #7 - 15th Stage Deposits

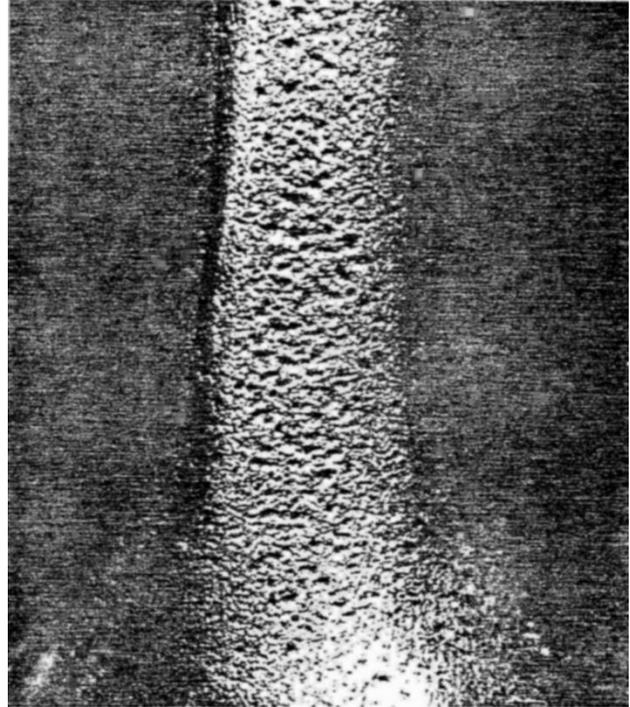
Figure #11 – 403SS Rotor Blade Leading Edge Pitting-8X

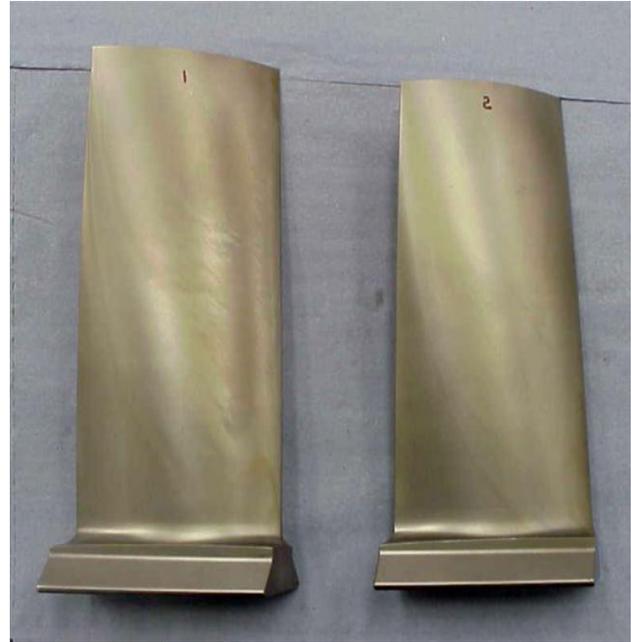
Figure#13- 1st & 2nd Stage Titanium Blades - 48 months

- Titanium - While used in a limited number of compressors, the Titanium blades showed excellent corrosion resistance in all applications including the most severe. Figure #13 shows the condition of first and second stage Titanium blades after 48 months of service. The subject blades were returned to service for another four year operating campaign. The pit depth evaluation of the subject blades showed both very minor general and pitting attack. Titanium compressor blades typically showed a general corrosion attack of less than 1.0 mils (25 microns) in depth and a pitting corrosion attack of less than 3 mils (76 mm). The Titanium attack was found to occur in the first 24 months of service and then had virtually no progression or worsening over the additional operating time. This phenomenon can be seen illustrated in Figure #14. Of all the materials monitored, the Titanium experience the least corrosion damage and appears to be a good choice of material for the more highly corrosive applications.

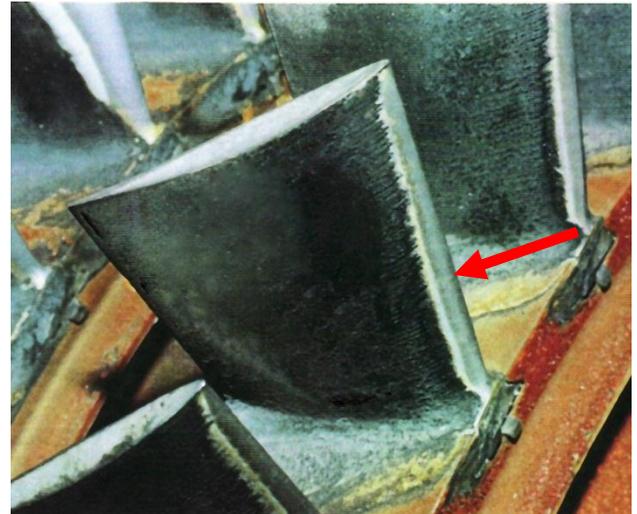
- Many units experienced erosive wear of the airfoil coating. Significant coating loss (both the top and base coats) occurred along the leading edge and just forward of the trailing edge of the airfoils. The erosive wear was experienced mainly in the first two or three stages of the compressor. It appears that the erosive media is centrifugated outward in the flow path and ever decreasing wear patterns occur in the tip region of the subsequent stages. Coating erosive wear was most prevalent in compressors that did not have effective inlet filtration systems.

Figure #15 – Location of Erosive Wear

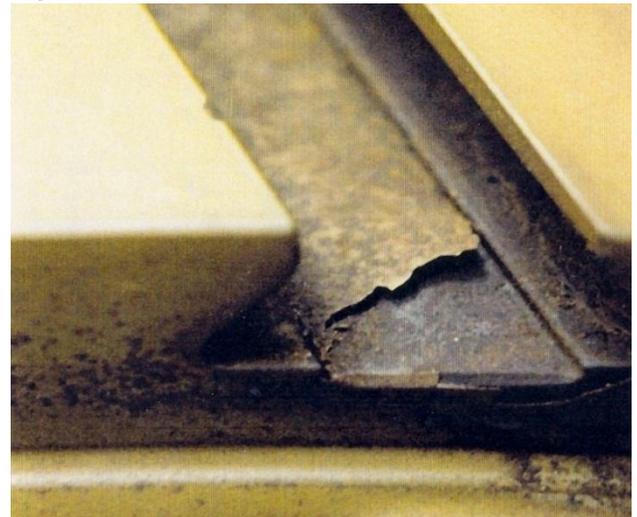
- In the most severe (highly acidic) applications, coating delamination was found in the rotor disks under the blade attachments (See Figure #16). This deterioration was attributed to a very aggressive crevice corrosion in the attachment region.

Figure#16 - Disk Coating Delamination -18 months

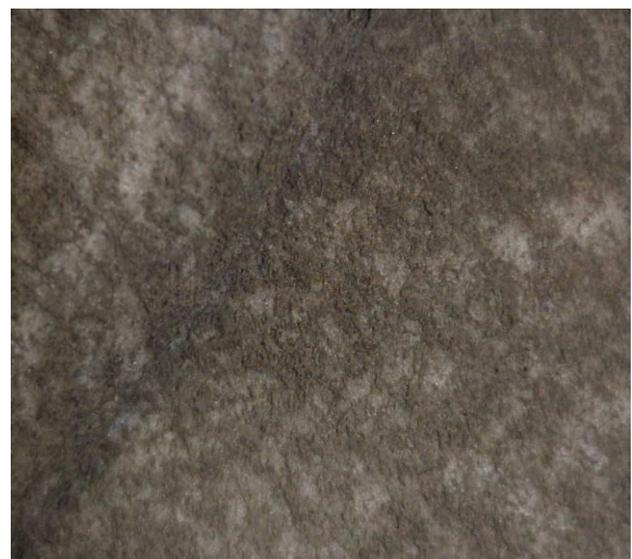
Figure #18 – Filter Element Captured Material – 3X

The filter pad analysis work included macro and microscopic examination of the materials captured in the filter pads (See Figure #18). As expected, the material separated in the filter elements typically included ambient air particulates such as air borne dust, catalyst, sea salts and minerals, gaseous deposits (sulfates), and Iron and Zinc corrosion products.

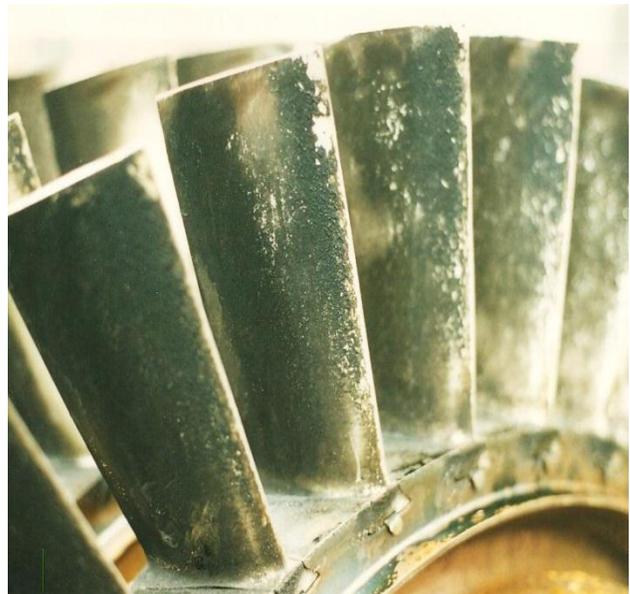
One of the most effect actions that can be taken to reduce compressor flow path corrosion is to keep compressor flow path clean of deposits. Figures #19 and 20 show a fouled compressor flow path after only a few months of operation and a clean flow path after several years of operation. An added benefit of compressor online cleaning is the maintenance of high compressor performance. Several compressor installations have been able to maintain both the compressor capacity and efficiency within 2.5% of the initial startup values, four to five years after the unit start up.

Figure #19 – Typical Inlet Stage Flow Path Deposits

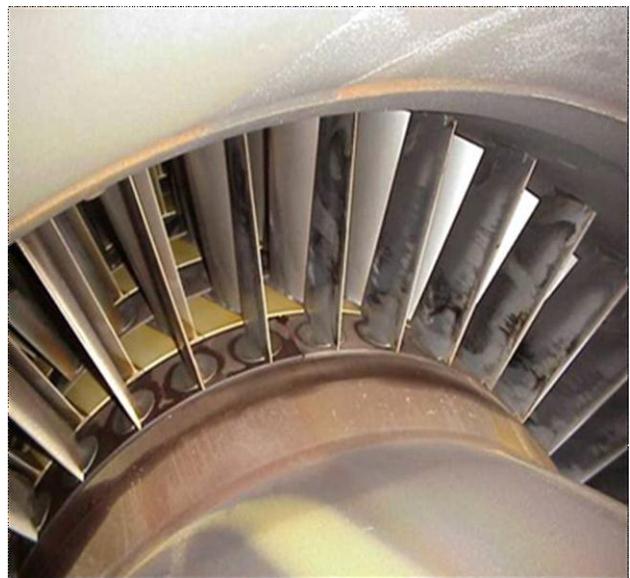
Figure #20 – Cleaned Flow Path from Online Washing
