# APPLICATION OF REPAIRS TO TURBOMACHINERY EQUIPMENT IN OIL REFINERY, CHEMICAL, AND POWER GENERATION PLANTS

**Phillip Dowson**

**David Dowson**

The Elliott Group

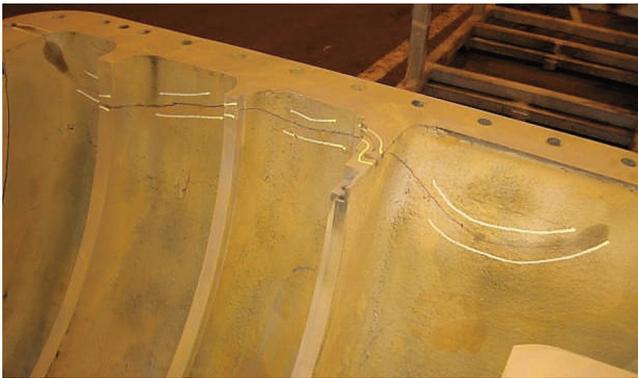
Another technique is called metal stitching. This process has been applied successfully to damaged cast iron compressor casings (Figure 2), steam turbine exhaust casings and stationary components such as bearing housing and diaphragms. Metal Stitching is a cast iron repair process that does not require the use of heat such as in welding. The advantage of no heat being added is it reduces the chances of part distortion. Metal stitching is a mechanical fix that leaves the cast iron physically and metallurgically unaffected.

Figure 2. Shows an Air Compressor Casing That Has Cracked During Service.

Holes are drilled perpendicular to the fracture and milled out in the form of the metal stitching fasteners. The fasteners, which are made of high strength nickel alloys, are inserted until the milled slot is completely filled. Each fastener is preloaded by peening, which increases its tensile strength and ensures proper bonding of the material. Holes are drilled into the fracture itself and metal studs are inserted (Figures 3 and 4). The studs overlap one another, which completely fill the fracture with new material. Finally, the fracture area is machined to a smooth finish (Figure 5).

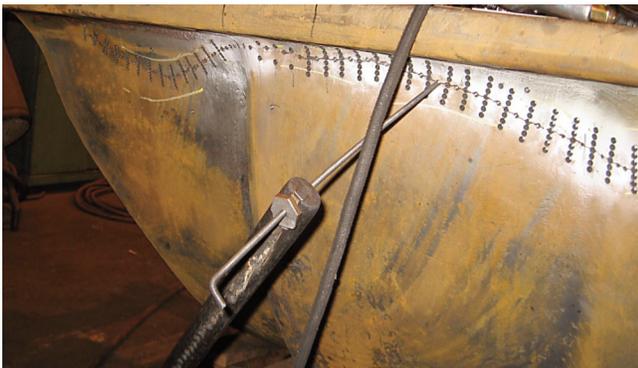
Figure 3. Holes Are Drilled Perpendicular to the Fracture Following a Specific Spacing Pattern.

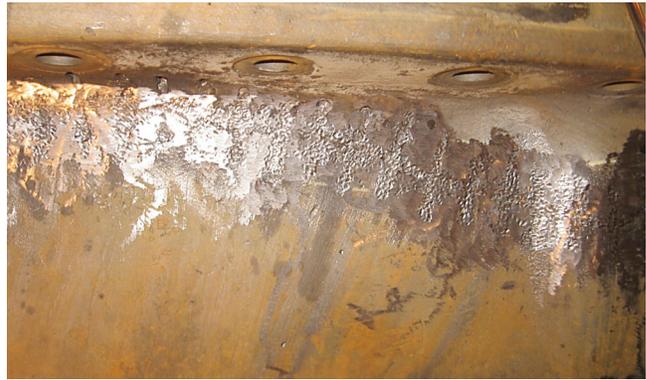
Figure 4. Shows Studs/Dowels Peened and Any Excess Material Is Removed.

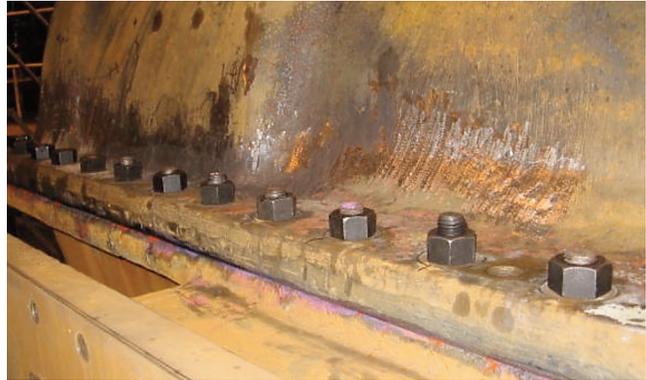
Figure 5. Shows Repaired Casing Ready for Service.

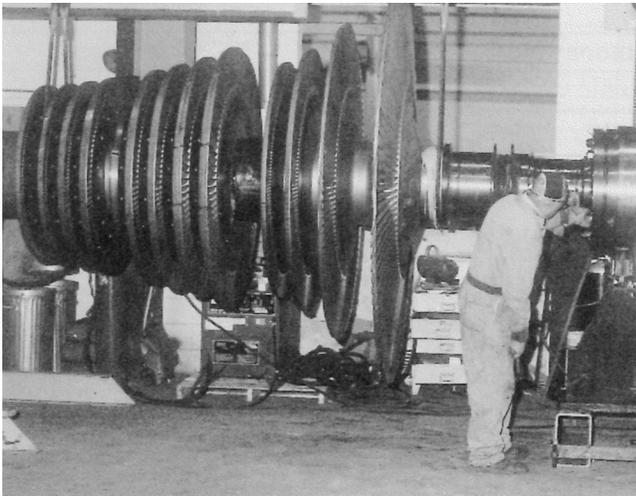
Figure 14. 13-Stage IP/LP Rotor.

Two 13-stage, integrally forged rotors from identical 30 year old turbines, that operated at the conditions shown in Table 4 and located on a western Canadian power plant, were sent to a service shop for repairs (Figure 14). The fifth stage disk rim had cracked at the top pressure land due to high cycle fatigue. It should also be noted that the fifth stage blades also exhibited root cracks and fretting. The root cause of the cracking, as determined by customer consultant, was high vibratory stress due to a second bending mode that was resonant with the nozzle passing frequency. It was recommended that to solve the problem the customer should use a redesigned diaphragm with the number of nozzle openings changed from 62 to 92 to minimize the potential for resonance. To increase the reliability of the disk rim and blades, the blade material was upgraded to 422 SS, the blade root was shot-peened and the blade attachment was reengineered to tighten tolerances and increase fillet radii to reduce stresses and increase the fatigue margin.

With good understanding of the root cause of the cracking and recommended corrective action in place, it was required to repair the disk rim of the fifth stage and assure that the repair would function reliably.

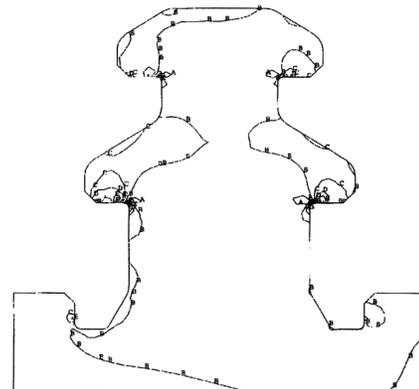
The configuration of the disk rim was a tangential entry male fir tree and the blade root was a female fir tree type. The calculated stresses are shown in Figures 18 and 19 for the blade root and disk, respectively, and were all within the authors' company design criteria when considering both centrifugal and steam bending stresses. Goodman factors also exceeded the criteria for fatigue margin. It should also be noted that the high stress location of the blade root corresponded with the failure location. However, the crack locations on the disk were not at the maximum stress location in the pressure land fillet radii, but rather at the end of the pressure land where fretting was noted. This evidence suggests a fretting fatigue mechanism caused by blade vibration and high contact stresses were the reasons for the disk cracking (Figure 20).

Figure 18. FEA Iso-Stress Profiles of Disk Rim.

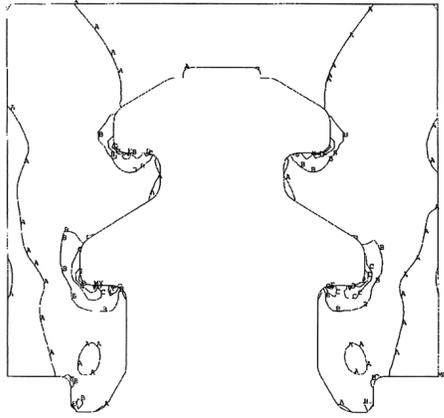
Figure 19. FEA Iso-Stress Profiles of Blade Root.

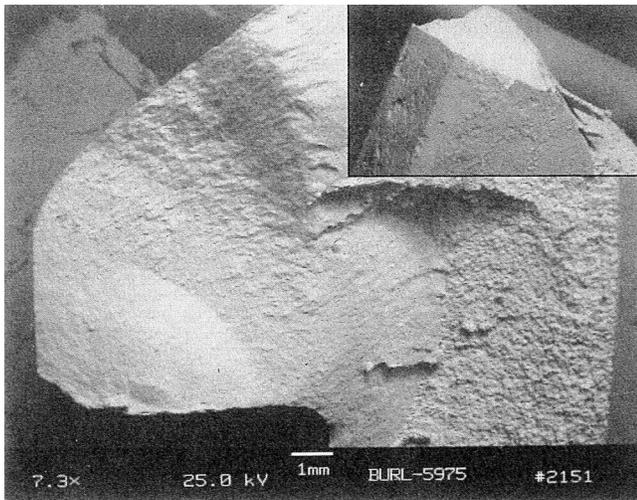
Figure 20. SEM Fractograph Showing Fatigue Fracture (Top) and Heavy Fretting (Top Corner Insert).

The disk cracking was caused by fretting fatigue induced by blade vibration. Mechanical modifications to the upstream diaphragm and blade design (tighter dimensional tolerances), material (422 SS) and processing (shot-peening) changes were adopted to solve the blade and thus the disk cracking problems. Restoration of the fifth stage disks of both units was successful using the mechanized submerged arc welding process and specialized procedures adapted for this application. It should be noted that similar testing and analysis were also completed for the second rotor. However, it was not reported in order to minimize the length of this case study and because these data gathered for the second rotor were similar to the first rotor. In addition, the repair was accomplished in an identical manner. The restored rotors were installed in 1993 and have been operating normally ever since.

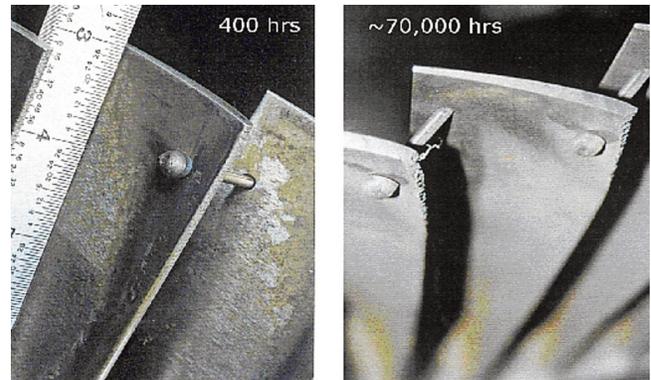
with which the surface of the blade strikes the water droplets. Stresses produced by impact of drops have been calculated by existing theories to be sufficiently high to initiate damage in latter stages of blades in a steam turbine. Turbine experience and laboratory testing have shown that erosion rate is time dependent with three successive zones: a primary zone in which damage is initiated at slip planes with little or no weight loss, a secondary zone where the rate rises to a maximum, and finally a tertiary zone where the rate diminishes to a steady-state value. Moreover, it is this tertiary region that is important to designer and operator alike rather than the initial and secondary zones since it is this region that the turbine erosion shields operate for most of their lives (Figures 21 and 22).

Figure 22. Images Showing Erosion of Blades from the Same Turbine after 400h and 70,000h.

While not strictly coatings, various countermeasures have been utilized by OEM's, including water drainage devices in cylinder wall, flame or induction hardening of the leading edge of the blade, and applying Stellite® or tool steel strips to the leading edge of blade by welding or brazing. All of the above methods show some degree of success, with the Stellite® material providing the better performance in the more stringent water droplet environment (Dowson, et al., 2008).
