PREVENTING UNDETECTED TRAIN TORSIONAL OSCILLATIONS

ABSTRACT

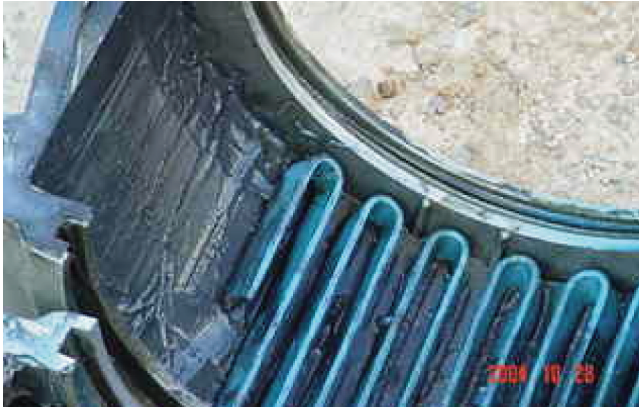
This was done. The first coupling, a grid type design, lasted one hour (Figure 5). Since it was likely the coupling had already been damaged during a few start-up attempts previously, and that is why

it failed so quickly, a second coupling of the same size and type was installed and an attempt to get past the resonance was made. It was done, and this coupling failed.

Figure 5. Case 1 Failed Grid Coupling.

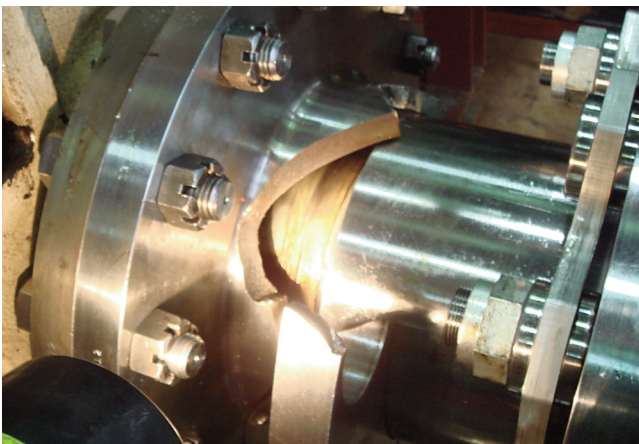
Figure 6. Case 2 Failed Disc Coupling.

The failure of any disc pack adapter flange is uncommon and was caused by torsional vibrations. Under normal continuous unidirectional loading, the adapter is not subjected to high stresses, but in this application there was a high reversing load as evidenced by the pattern of fretting of the disc pack washers on the flange faces (Figures 7 and 8). Beach markings on the fractured surfaces (Figure 9) indicate that initial failure occurred as a result of fatigue, and final fracture was a result of overstress. Metallurgical analysis showed that the material was acceptable per the applicable specifications. The disc packs were not extensively damaged, as they have a high fatigue life, mostly to accommodate misalignment bending loads, but which also helps them take high vibratory torsional loads. There was also extensive damage to the thrust bearing and shaft (Figure 10).

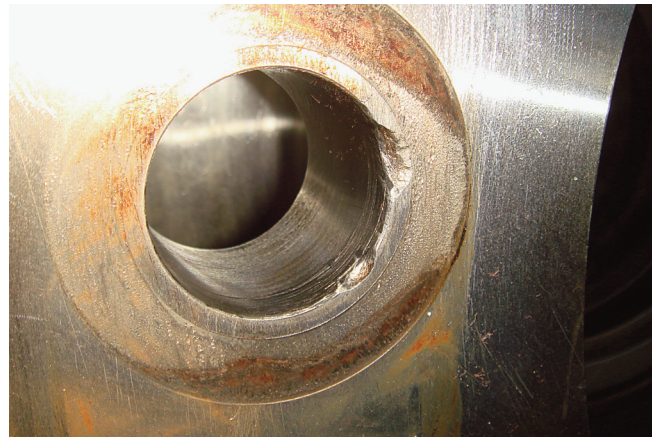
Figure 7. Case 2 Fretting on Disc Pack Flange.

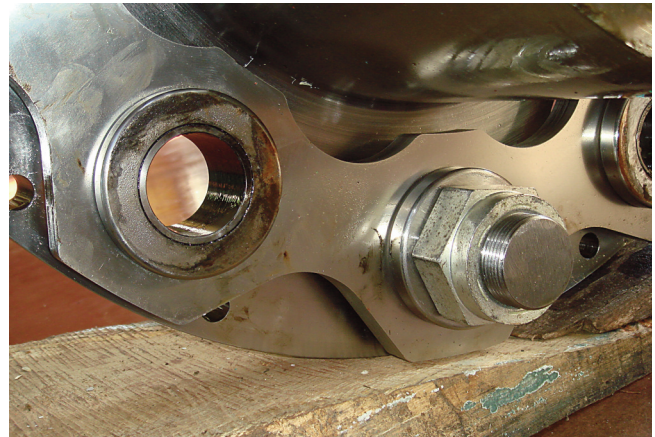
Figure 8. Case 2 Fretting of Disc Pack Washers.

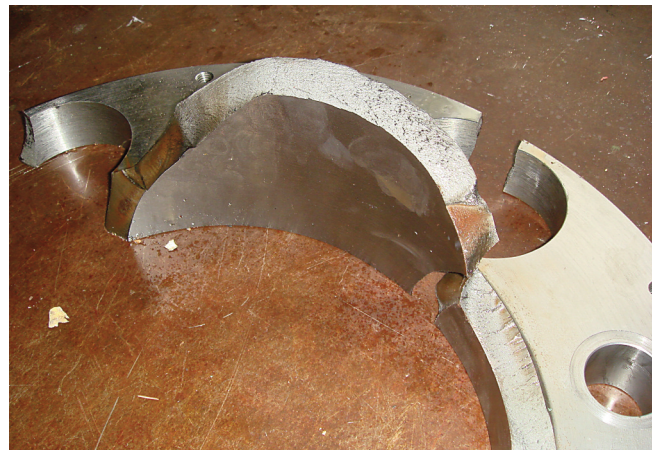
Figure 9. Case 2 Beach Marks at Fracture Site.

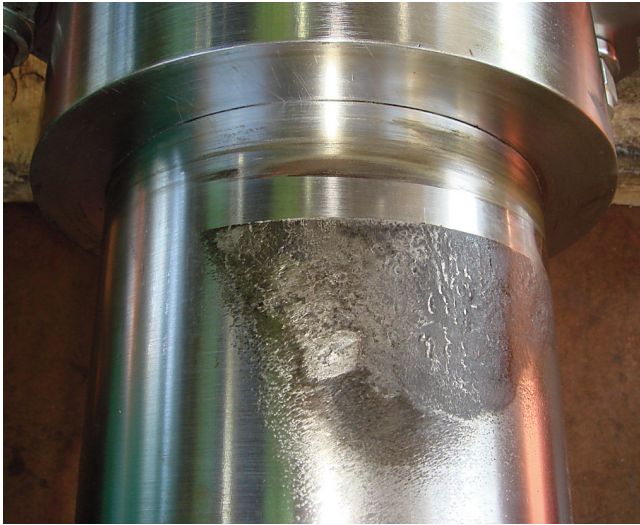
Figure 10. Case 2 Shaft Damage.

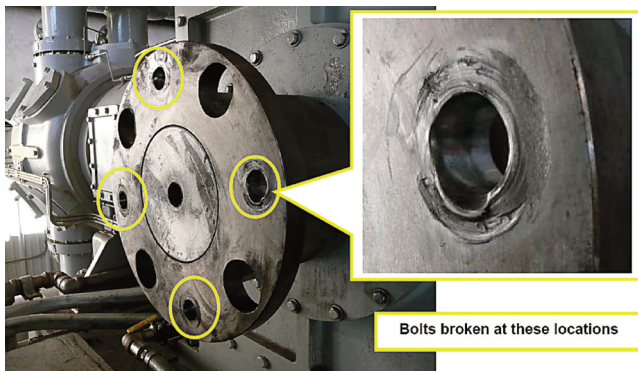
Figure 11. Case 3 Disc Pack Flange Bolt Hole Damage.

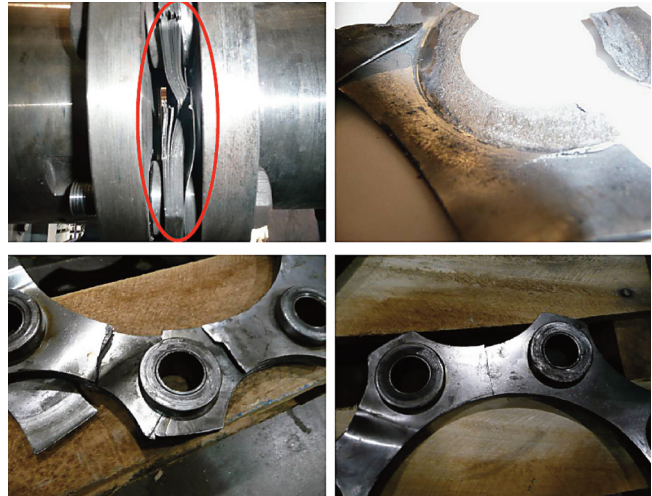
Figure 12. Case 3 Disc Pack Damage.

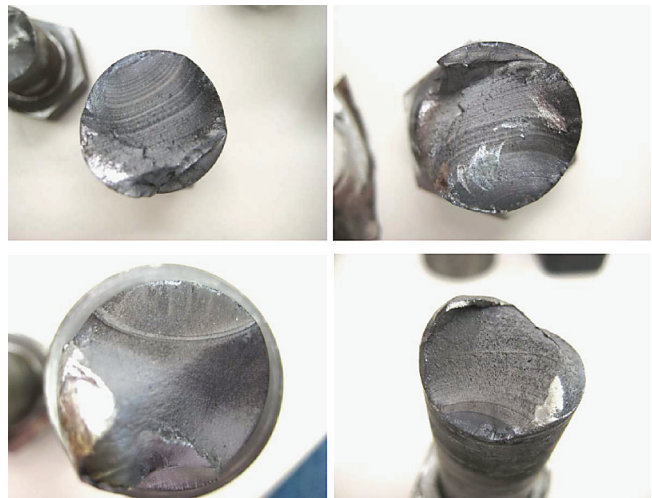
But, this was not a typical loose bolt failure. There was a lot more going on as evidenced by the classic beach marks on the broken bolts (Figure 13) and the two direction (yielded) disc pack holes indicative of reversing torques.

Figure 13. Case 3 Beach Marks on Failed Bolts.

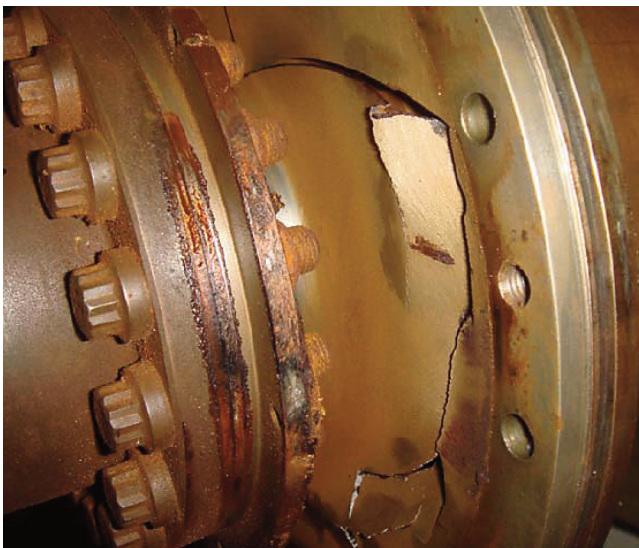
In February of 2007, a diaphragm coupling’s diaphragm failed between a VFD controlled motor (1341 hp at 1040/1559 rpm) and gearbox driving a centrifugal compressor (Figures 15 and 16). The train had been operating on and off since July 2006. The failure was discovered when the train shut down on high lateral vibration. The failed diaphragm was on the gearbox side.

Figure 15. Case 5 Diaphragm Failure.

The diaphragm broken parts were analyzed by the coupling supplier, and the conclusion was that the diaphragm failed in torsional fatigue, as evidenced by the 45 degree crack emanating from the toroidal base (smallest diameter) of this integrally machined (nonwelded) diaphragm, and the condition of the crack surface (Figures 17 and 18). For this particular diaphragm, the base has the lowest resistance to vibratory torque loading, predicted by analysis. An independent test lab confirmed that the failure was from fatigue while also confirming that the material met design specifications. However, the torsional analysis for this train does not predict the loading that would cause this failure.

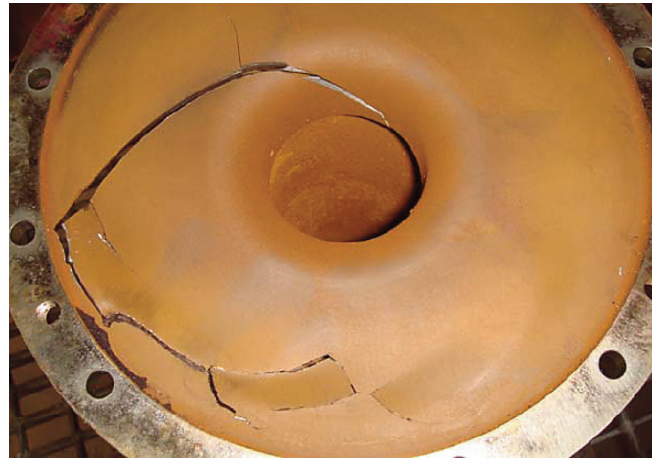
Figure 16. Case 5 Diaphragm Failure Opposite Side.

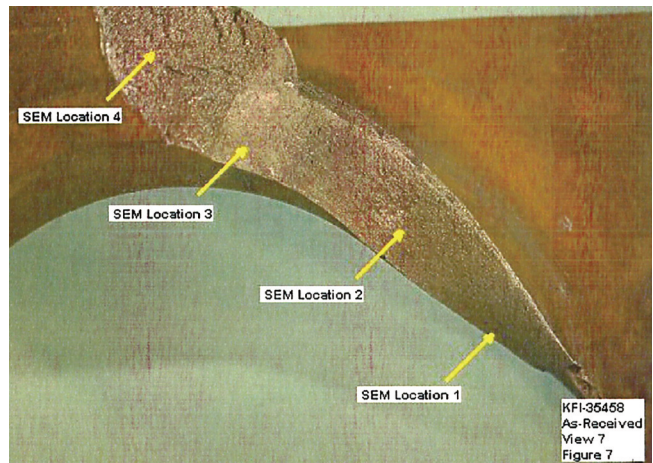
Figure 17. Case 5 Diaphragm Crack Magnified.

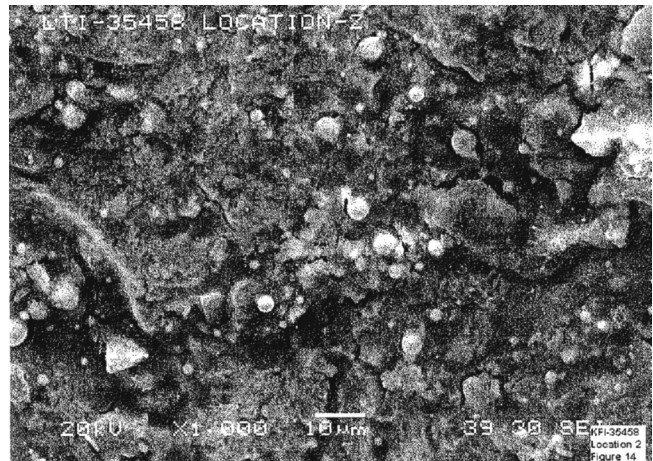
Figure 18. Case 5 SEM Photo of Crack Initiation Surface.

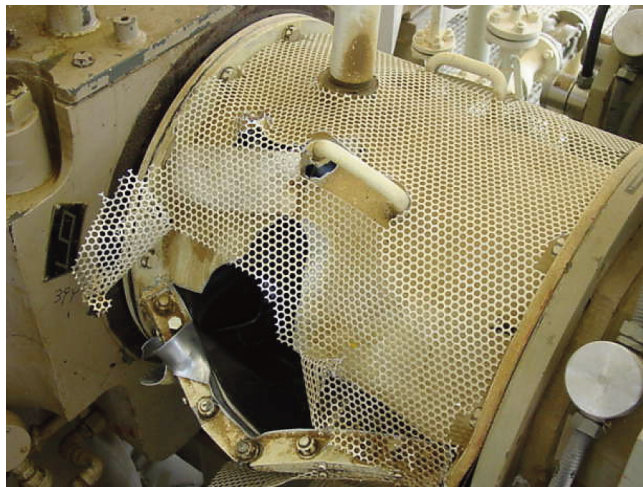
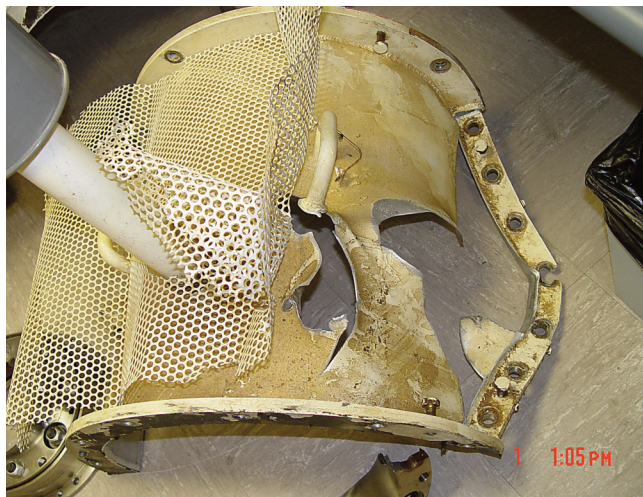
The train consisted of a VFD controlled induction motor (rated at 18305 hp at 1575 rpm) driving low and high pressure recycle gas compressors through a speed increaser. The high performance disc coupling between the gearbox and first (low pressure) compressor running at 6832 rpm failed catastrophically, with parts penetrating the coupling guard, after 2000 hours of service (Figures 19 and 20).

Figure 19. Case 6 Hole in Coupling Guard.

Figure 20. Case 6 Damaged Guard.

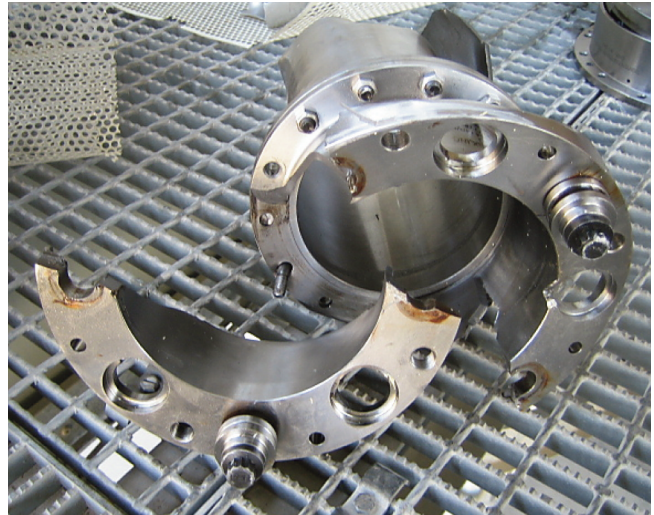
The inspection of the failed parts revealed that this coupling failed in torsional fatigue, as evidenced by the fatigue cracks and severe fretting between the disc pack bushings and washers and the mating flanges (Figures 21 and 22). Examination of the spacer tube revealed a spiral wound crack propagation typical of failures induced by torsional forces (Figure 23).

Figure 21. Case 6 Ejected Parts with Disc Pack Flange Hole Fretting.

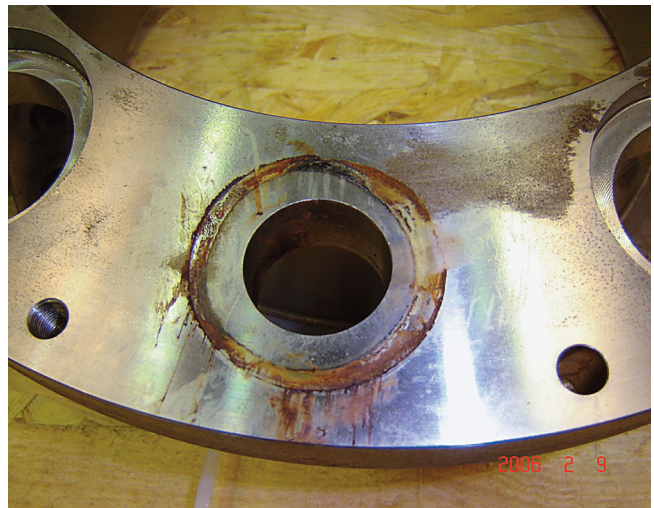
Figure 22. Case 6 Close-up of Disc Pack Flange Hole Fretting.

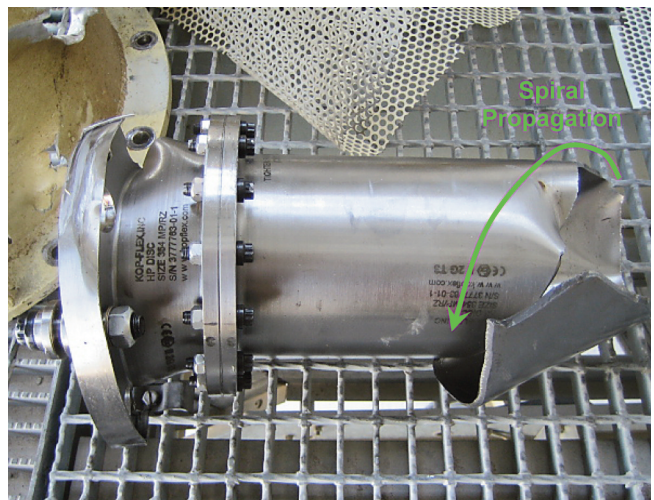
Figure 23. Case 6 Wound Spacer Crack.

In the end, it was decided to just eliminate the odd frequency vibration, by reprogramming the VFD controller. This was done and the train is running now as designed.

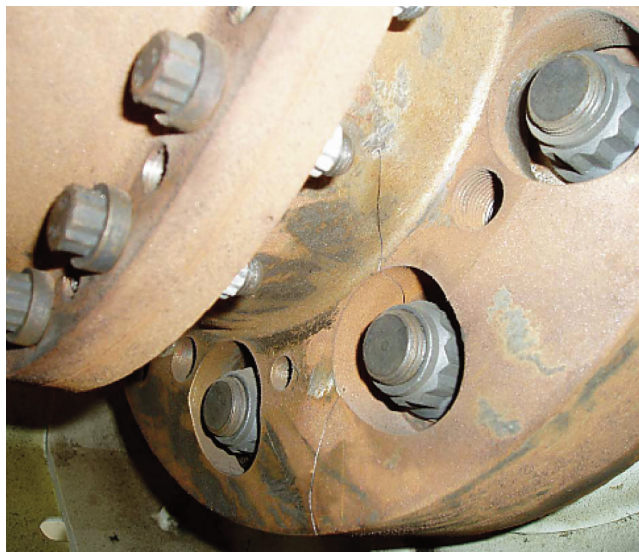
After 1835 service hours and 129 starts, high lateral vibration tripped out a train consisting of a VFD controlled induction motor (3594 hp at 795 to 1590 rpm) to a speed increaser to a high speed compressor (6136 to 12,272 rpm). Maintenance investigation revealed a cracked sleeve in the low speed high performance disc coupling (Figure 25).

Figure 25. Case 7 Cracked High Performance Disc Coupling.

Examination of the failed coupling revealed that the crack measured 10 inches in length and was oriented at an angle of approximately 45 degrees with respect to the coupling axis. No damage to the hub or the disk pack was observed. The crack was opened to expose the fracture surfaces, and detailed examination revealed a crack origin along the inner surface near the sleeve/spacer flange (Figure 26). The fracture features indicated that the crack had propagated through the sleeve wall and along the length of the sleeve. The crack path was predominantly planar. Scanning electron microscope (SEM) examination of the crack origin on the inner surface of the sleeve revealed limited plastic deformation, and the fracture surface displayed a transgranular morphology and crack growth marks (Figure 27). No metallurgical defects or material discrepancies were identified.

Until these pulsations are known, the replacement coupling has been “beefed up” to resist torque pulsation fatigue in the area of crack initiation by increasing the flange/tube junction radius, with minimal change in weight and coupling torsional stiffness. Furthermore, the replacement coupling has been outfitted with a strain gage torque monitoring system that has the capability of measuring the actual torque pulsations. These data will be invaluable in determining the root cause of failure and getting data to verify the torsional analysis.

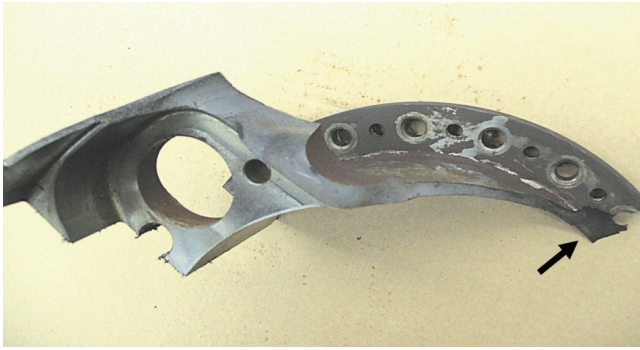
Figure 26. Case 7 Crack Initiation Site in Sleeve.

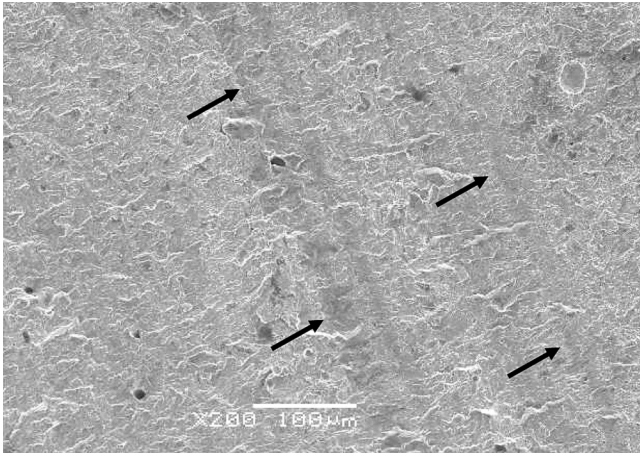
Figure 27. Case 7 SEM of Crack Initiation Site.

The cracking of the subject coupling sleeve was produced by a high cycle fatigue failure mechanism under torsional loading. One of the causes (under investigation) of the subject failure was a high frequency, cyclic loading of the coupling caused by the signal from the variable frequency drive. Another was excessive misalignment that was well above the target tolerances when checked (Figures 28 and 29).
