Case Study

39th Turbomachinery Symposium – Oct. 7, 2010

Is Frame Vibration Enough Protection? Early Detection of a Wrist Pin Failure Using Crosshead Vibration

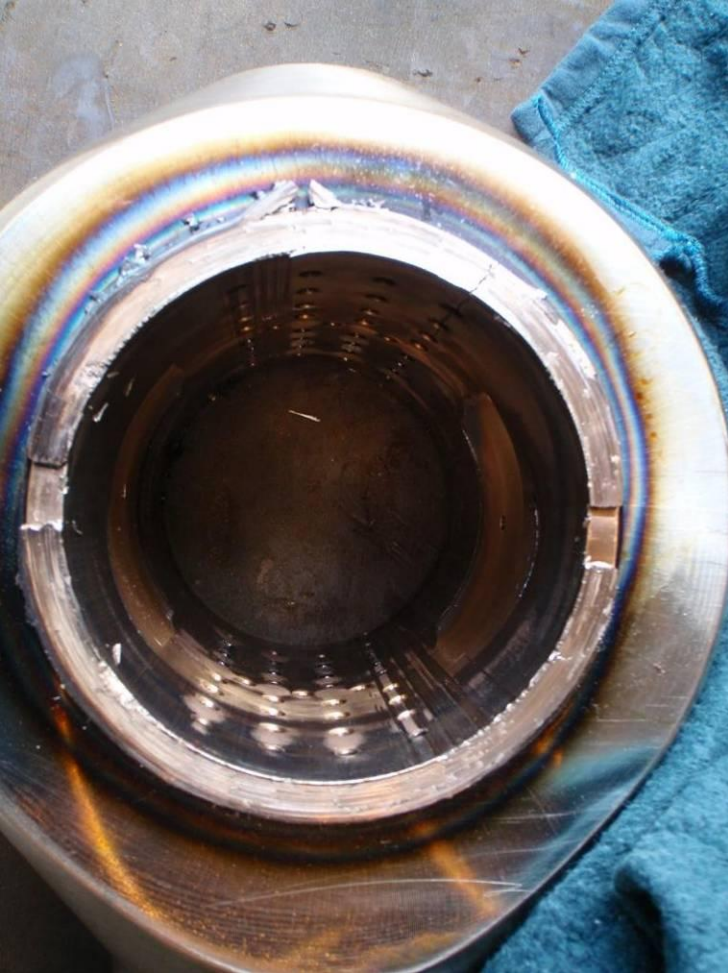
Small end of connecting rod

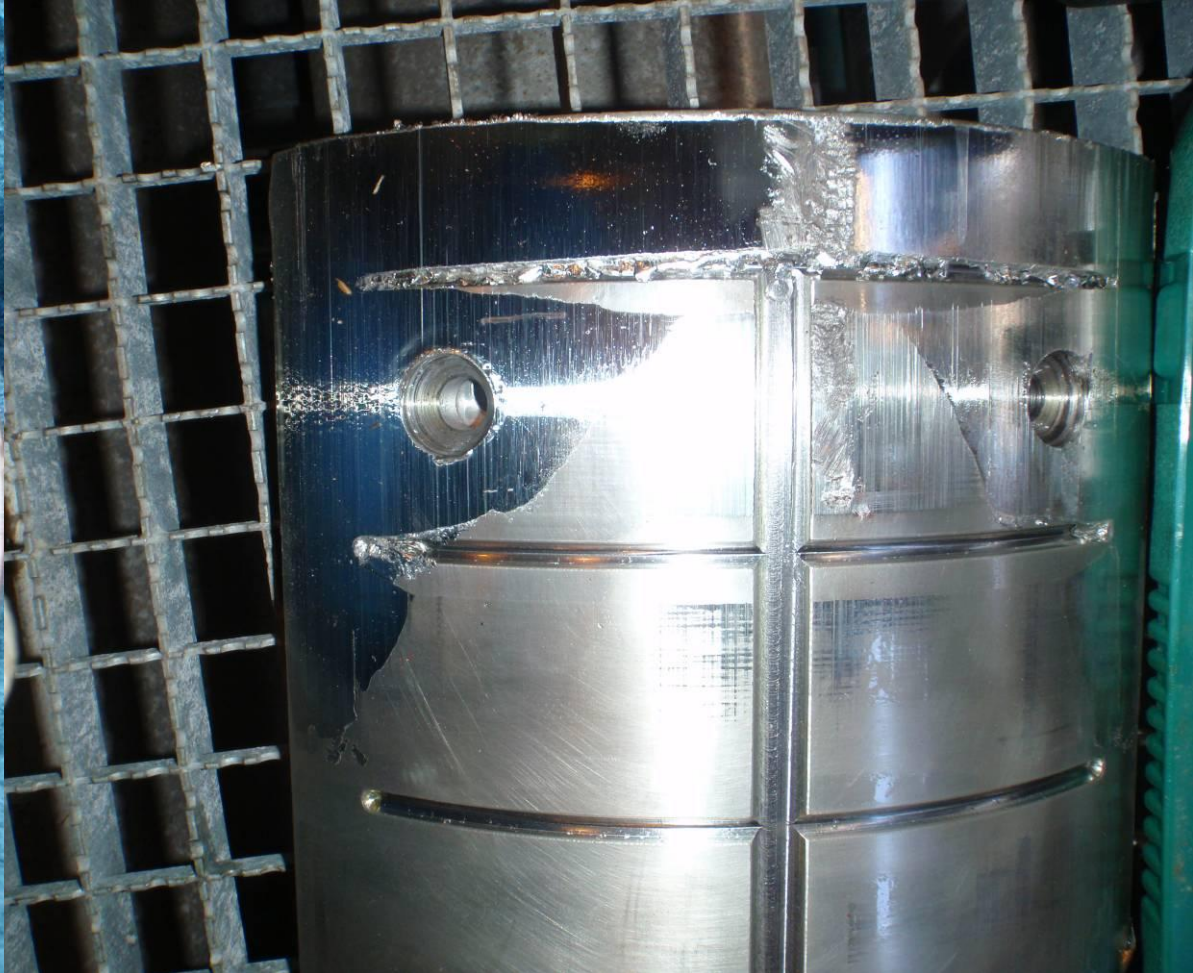
Crosshead slipper

- Due to the resistance at the wrist pin, the crosshead is forced to tilt in the guide. Loss of babbitt at both ends of the slippers confirms the mechanism.
- Piston rod position data clearly shows the movement which occurs due to bending of piston rod and vertical displacement of crosshead

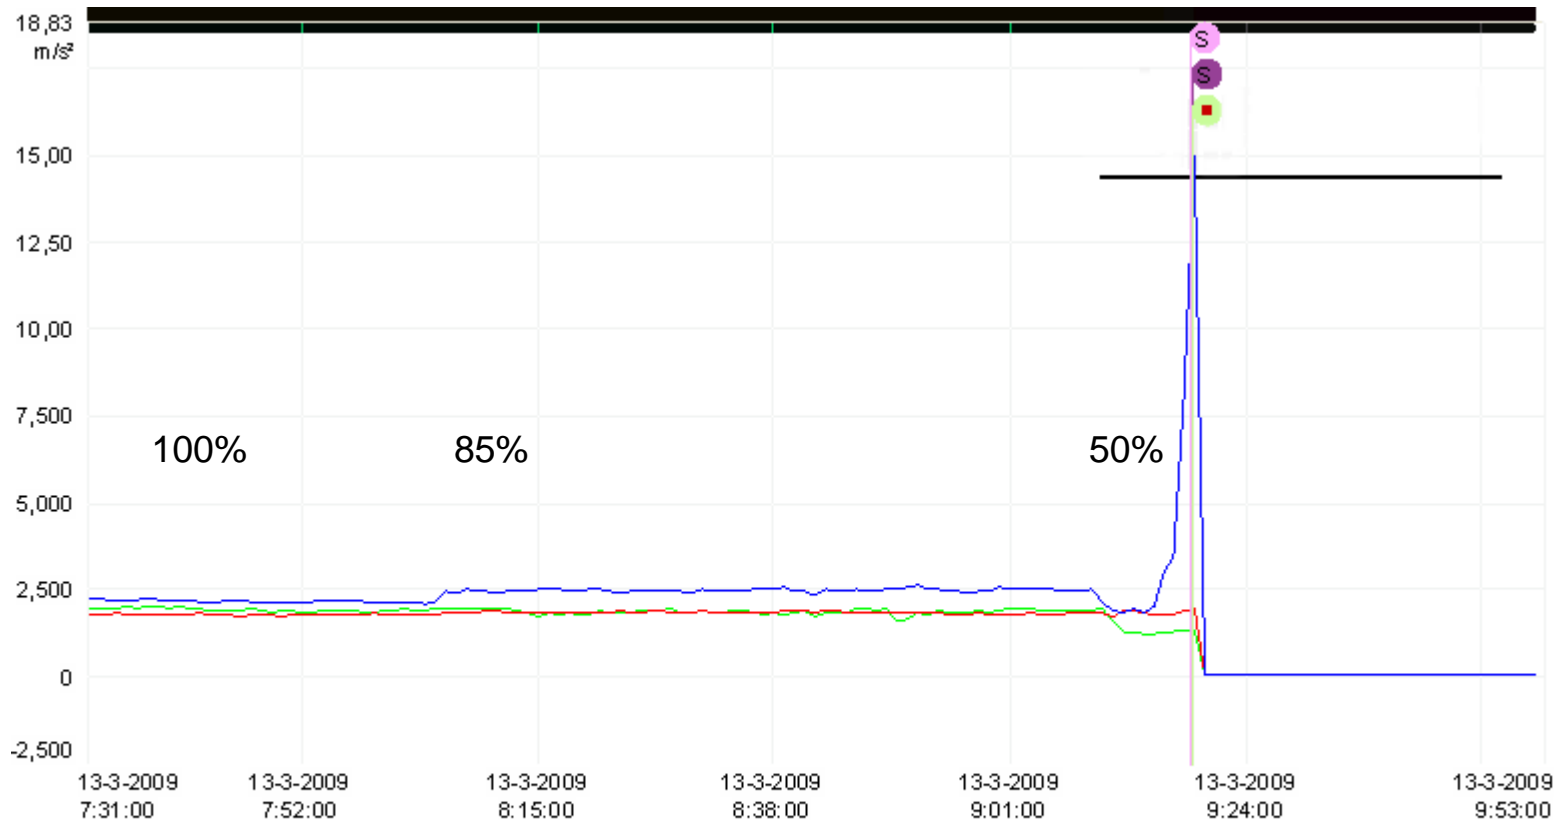
2D Vibration Trend – All Crosshead Sensors

2 Hour Trend of Single Averaged RMS Acceleration – Blue curve is 1st stage

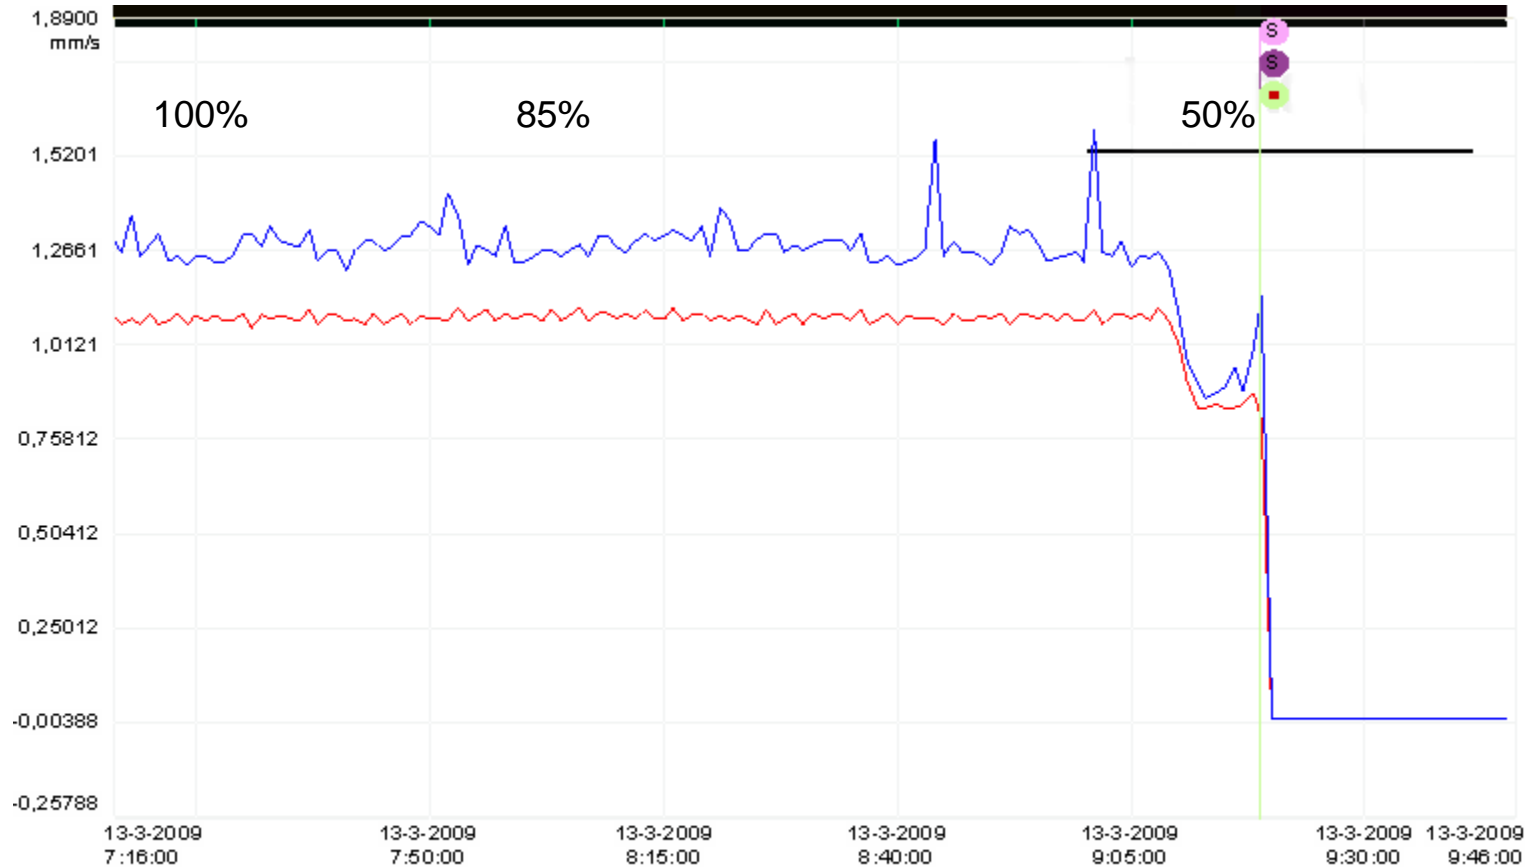
2D Vibration Trend – Both Frame Sensors

2 Hour Trend of Single Averaged RMS Velocity – Blue curve is NDE

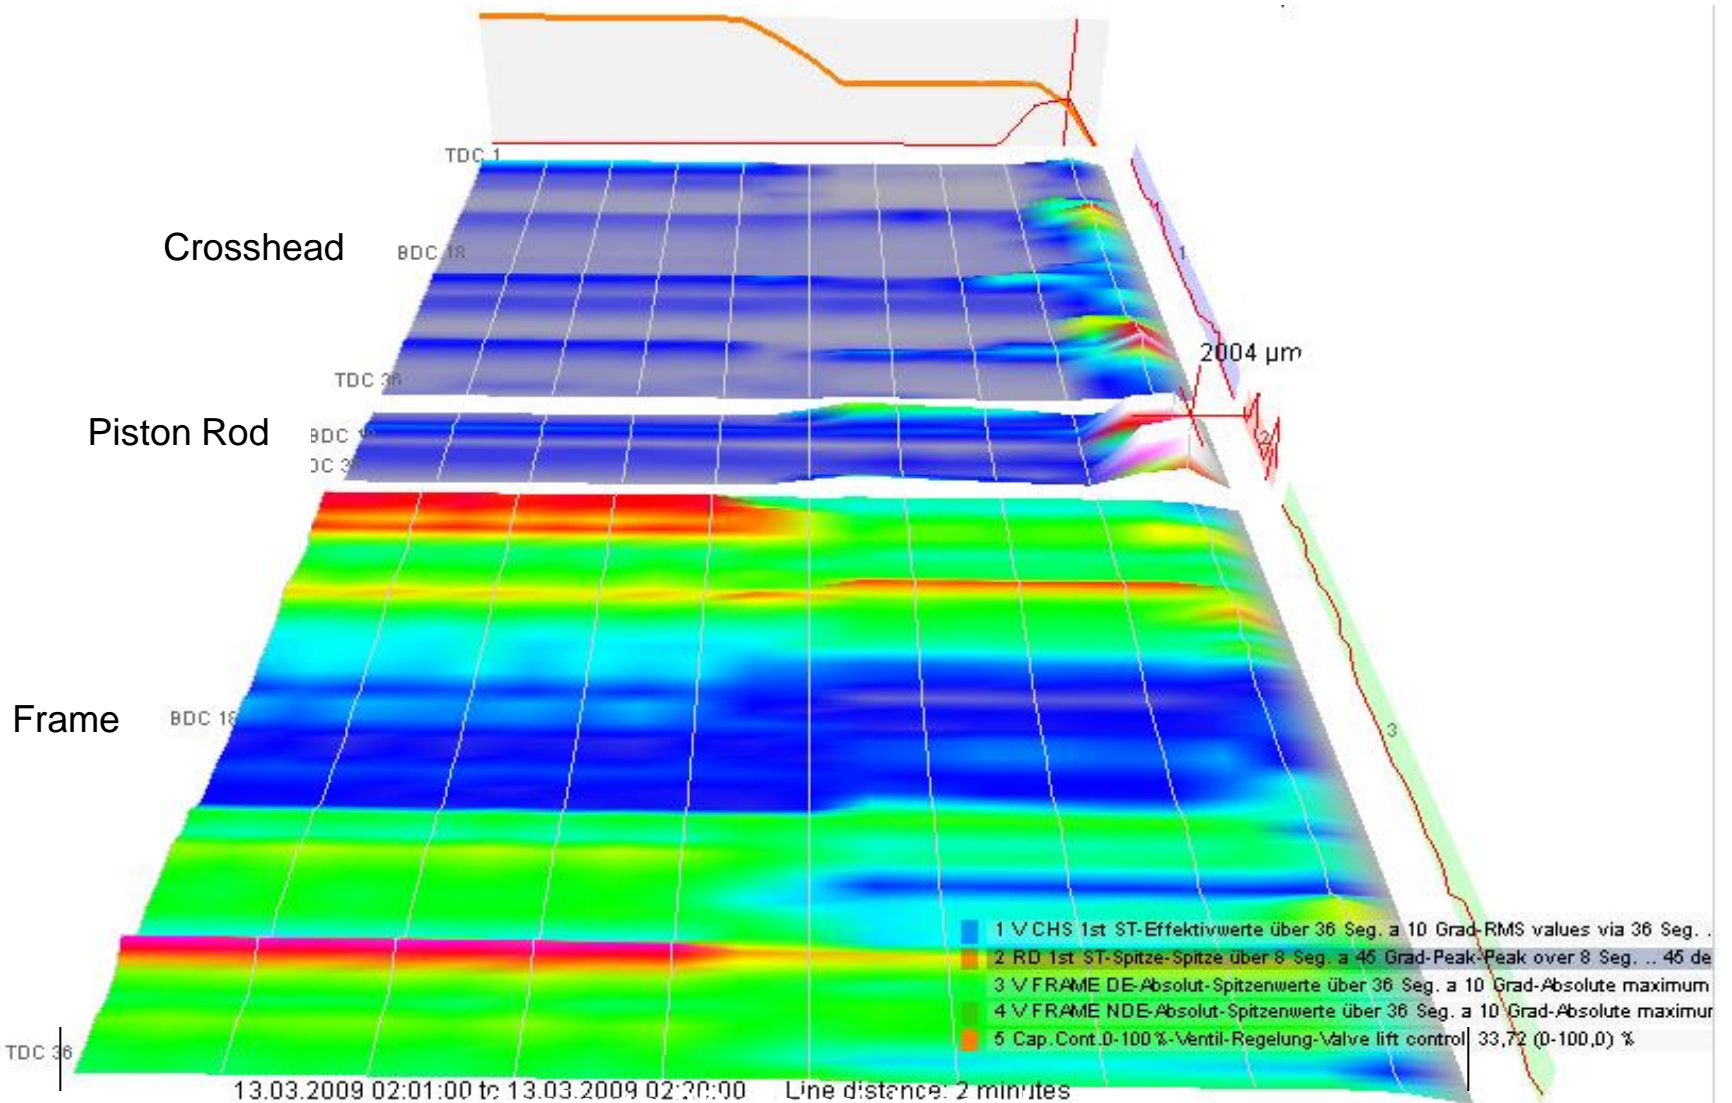
3D Trend of Last 20 min. (Crosshead – Rod Position – Frame)

100% Load 85% Load 50% Load

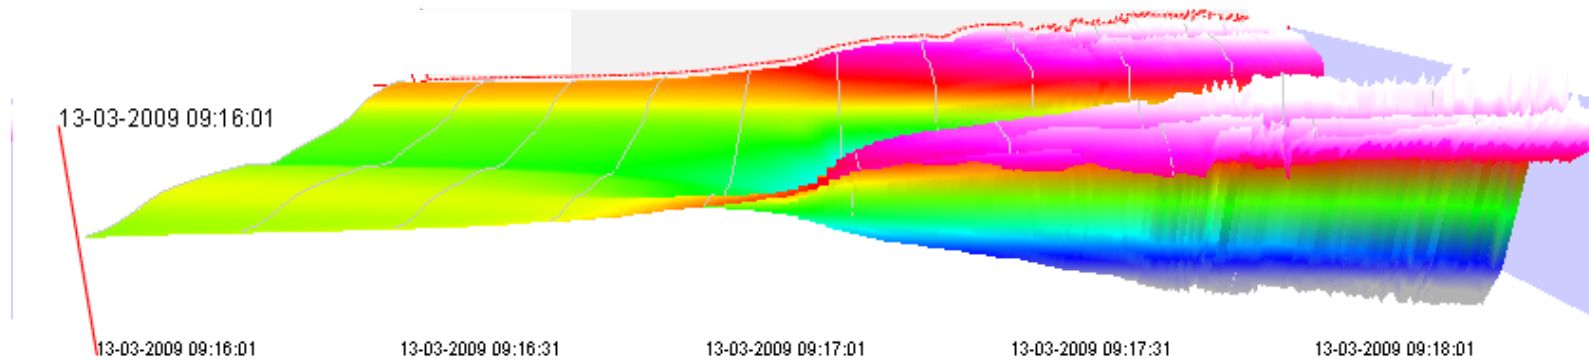
3D Trend of Last 2.5 min. (Rod Position)

Default Trip Limit of 1000 μm (not active) reached approx. 1 min. earlier
