Repeated failures on 2nd stage impeller linked to blade natural frequency excitation.

Problem Statement

- ❑ Three Stage integrally geared air compressor used for process air.
- ❑ Second stage impeller failed after 11 hours of operation.
- ❑ The failure occurred after a rebuild for a different failure and there was no spare impeller.

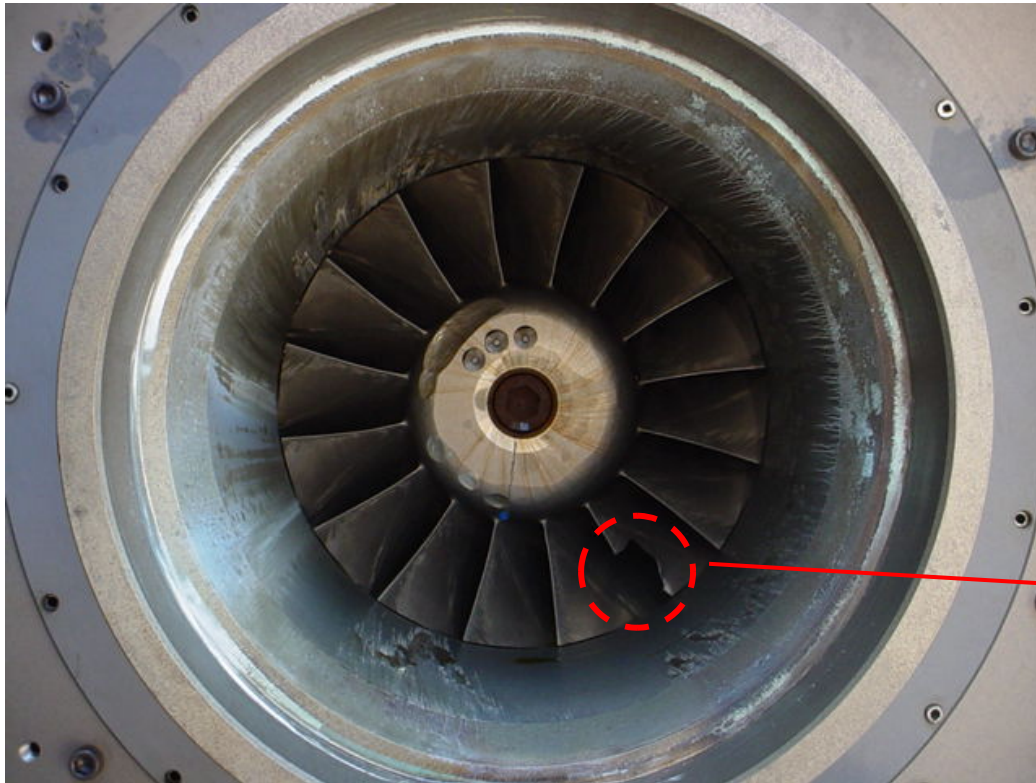
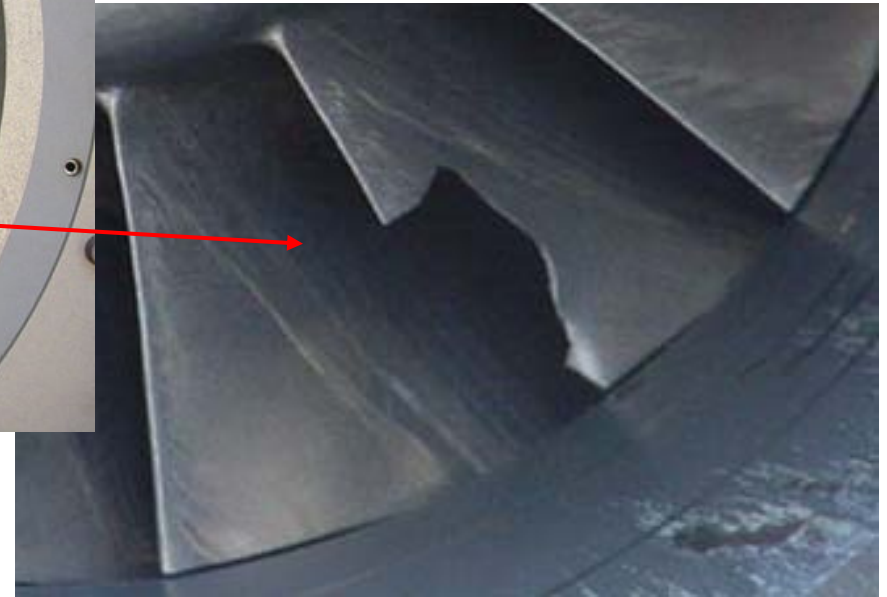
Failed Impeller Still Mounted in the Housing

- Discussions between the Engineering Departments of the Manufacturer and the User decided:
 - Based on the short time of operation before the failure and the type failure. The failure was probably due to **diffuser vane passing frequency** (number of diffuser vanes times stage running speed) **coinciding with impeller blade natural frequency**.
 - Manufacturer would temporarily repair the impeller by cutting the failed blade and the one opposite to maintain balance.
 - Manufacturer also **scarfed the blades to increase the blade natural frequency**.

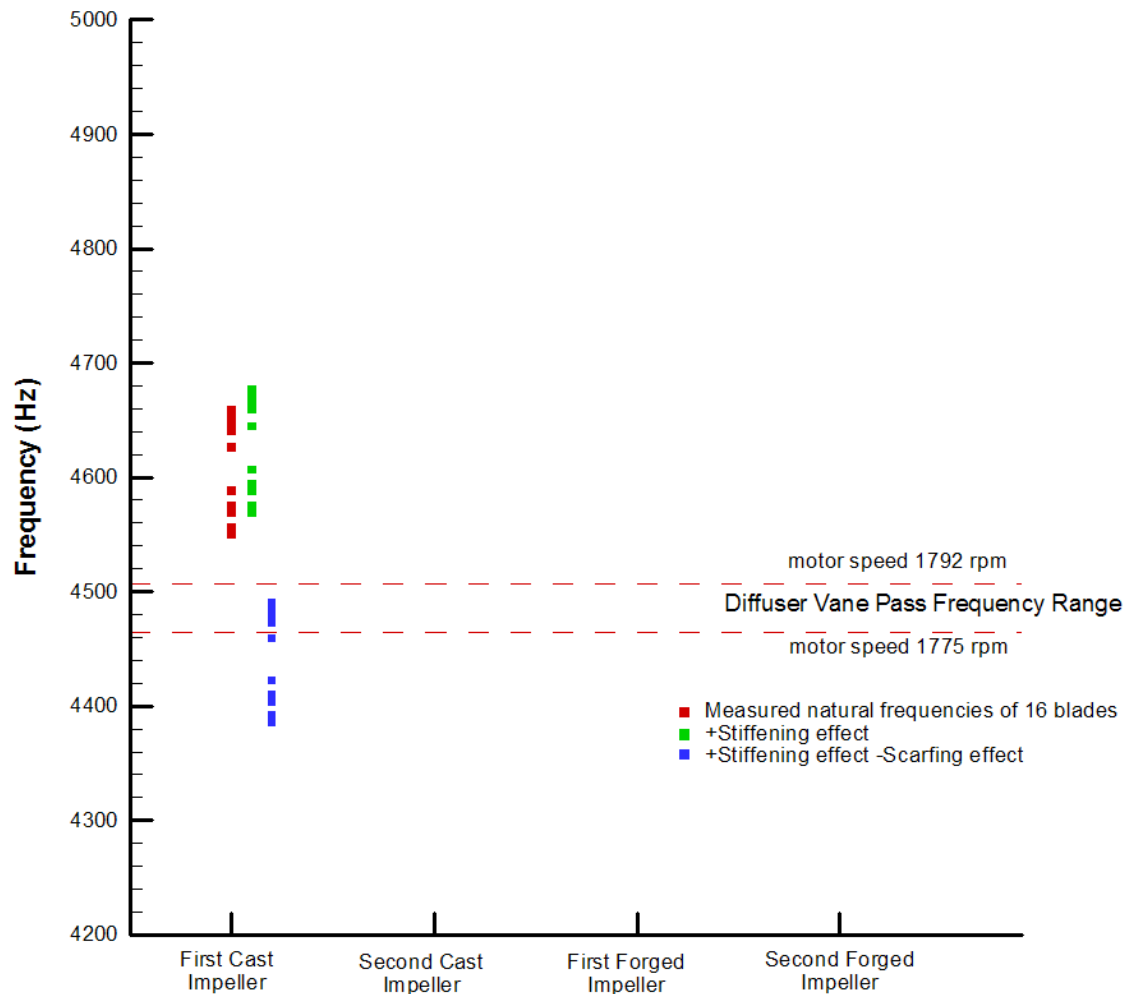
Summary for first cast impeller

- Used the measured frequencies and calculated effects to estimate the original natural frequencies of the blades
- The natural frequencies of the blades were right at blade pass frequency

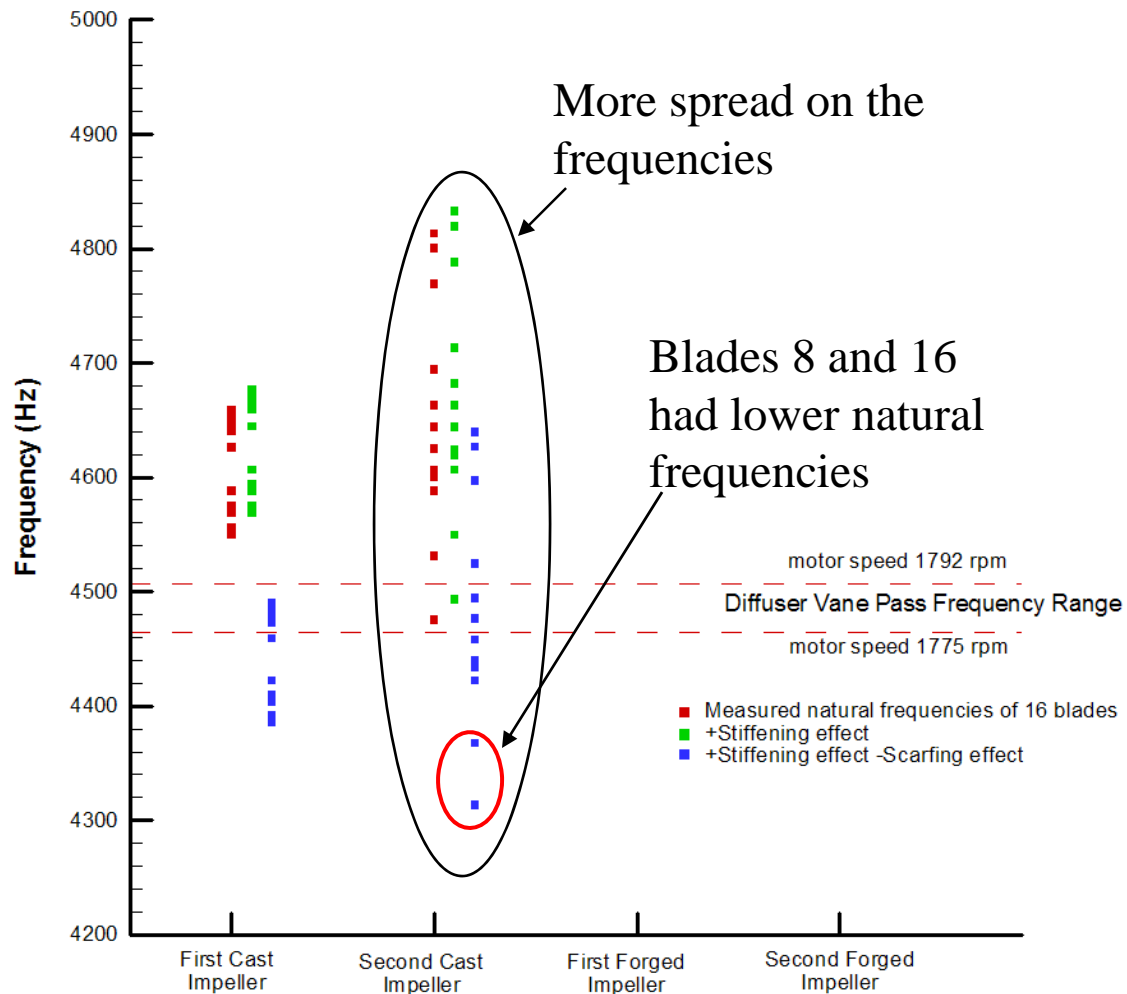
Summary for second cast impeller

- Used the measured frequencies and calculated effects to estimate the original natural frequencies of the blades
- Without the scarf, the blade natural frequencies would have been right at blade pass frequency

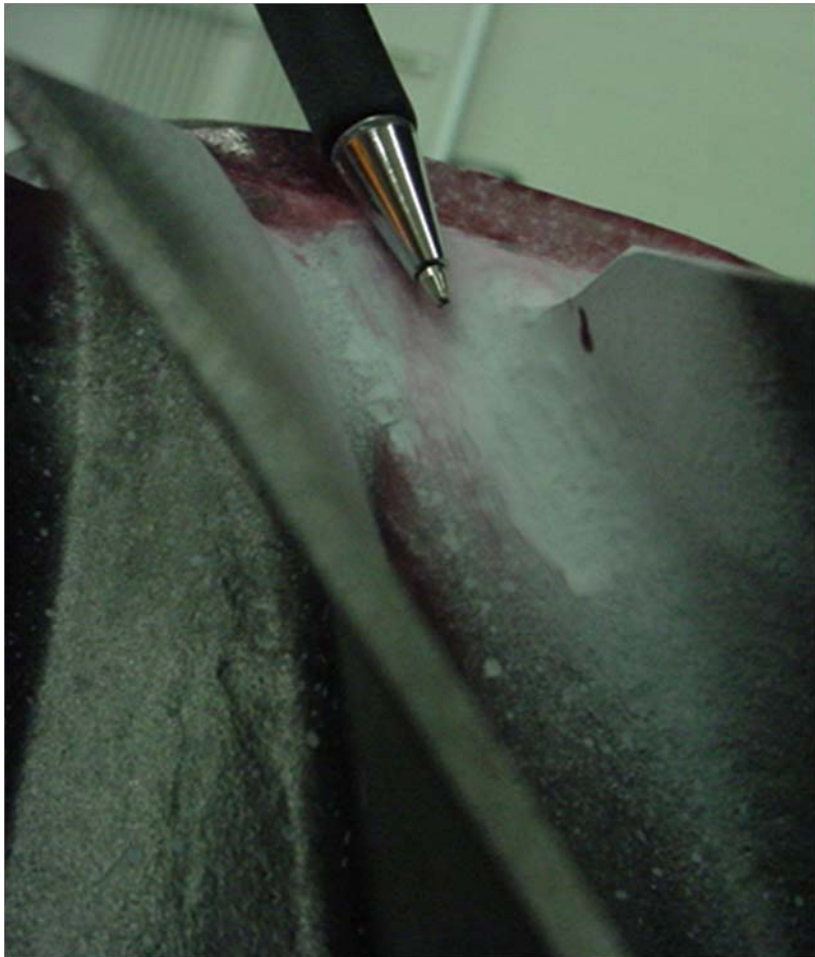
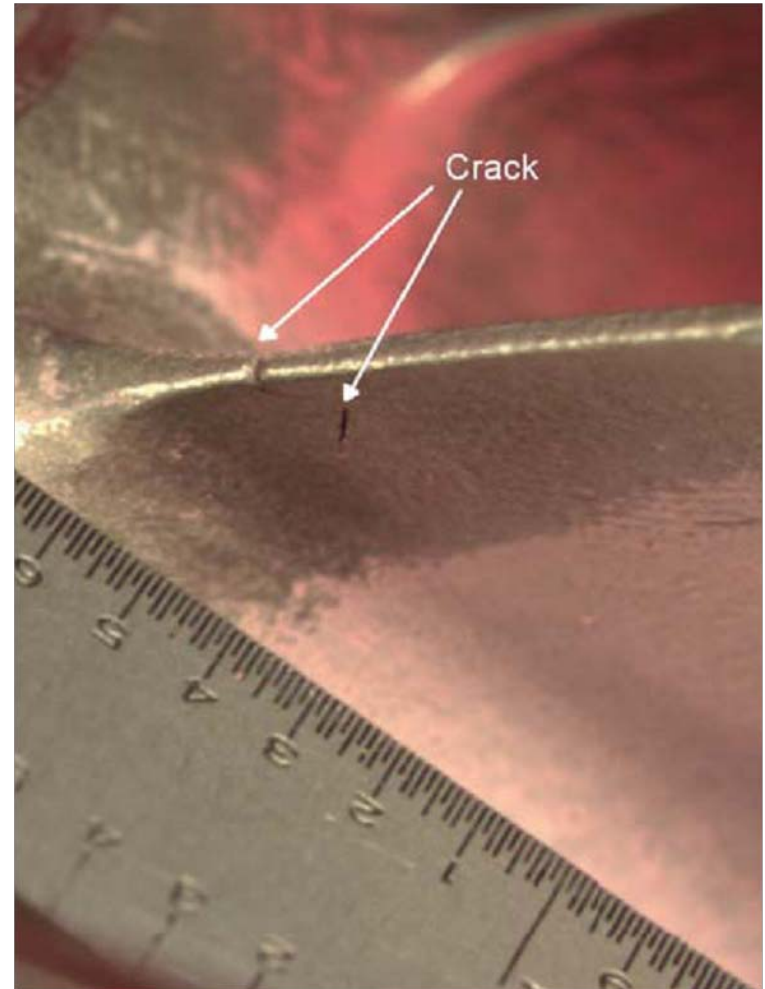
- ❑ Impeller was rejected after inspection based on crack found on blade 16
- ❑ NDT did not identify any obvious defects on blade 8. There was a small surface defect but not enough to account for the difference in frequency.
- ❑ The OEM sent the impeller for analysis. Blades 8 and 16 were cut for inspection and analysis
- ❑ Casting defects were found on both blades giving additional reasoning for going to forged impellers.

Blade 16 of the second cast impeller had a crack

- OEM implemented corrective actions:
 - For this application, the correction was to switch to an impeller machined from a forging.
 - Added a second magnetic particle inspection (after shotpeening) for all impeller castings. Since 2005 the OEM has not experienced a repeat inclusion or failure of an impeller due to inclusions.
 - The impeller foundry identified the skimming procedure of the molten pot as the process needing correction and reinforced this process.

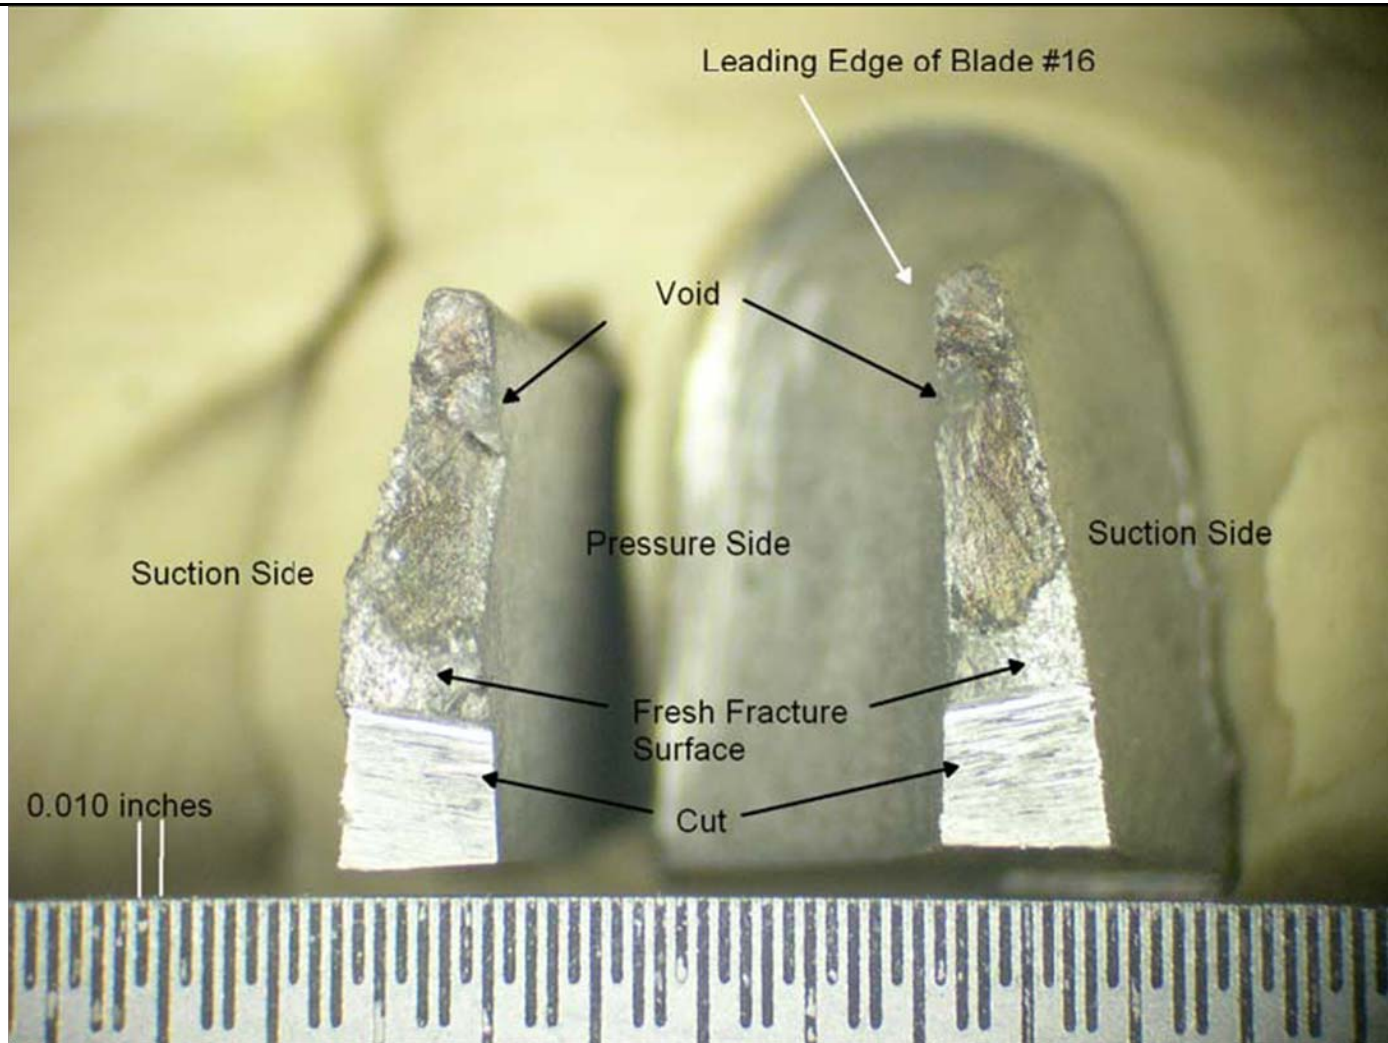
Blade 16 of the second cast impeller had a crack

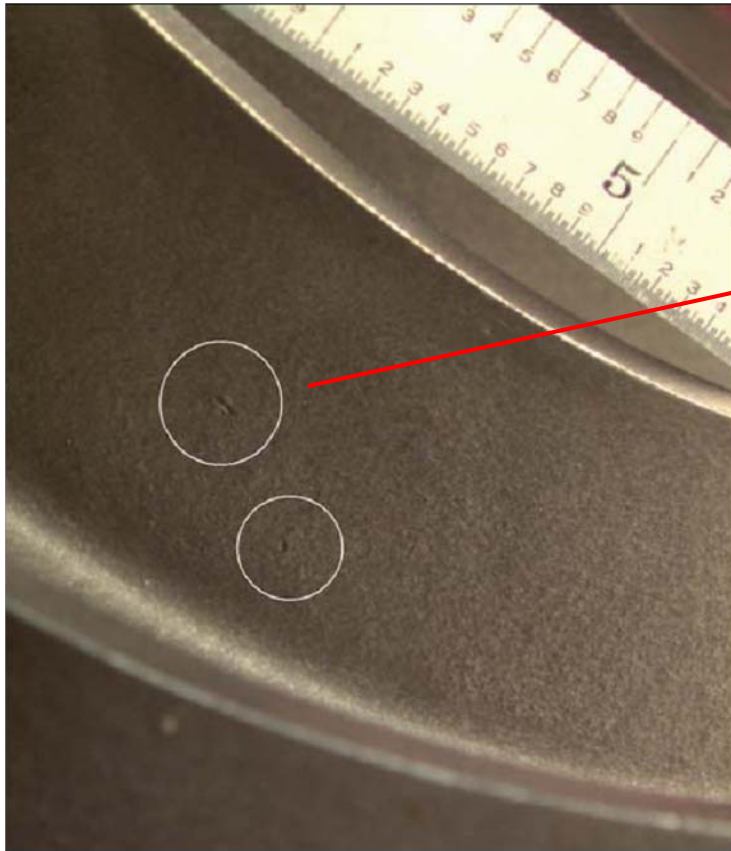
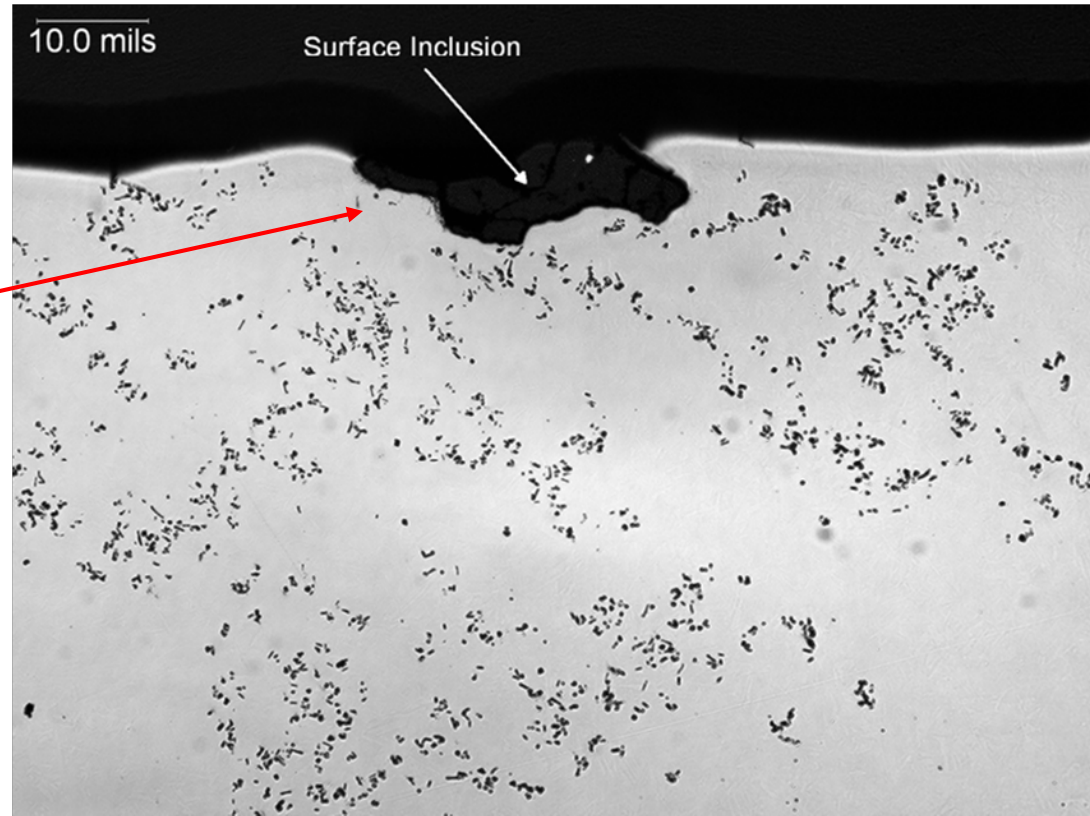
Blade 8 of the second cast impeller had inclusions caused by casting defect

Sub-surface inclusions probably caused by a defect on the casting process
