# **75 MW Turbine-Generator** **Journal-Thrust Bearing Upgrade**

# **ABSTRACT**

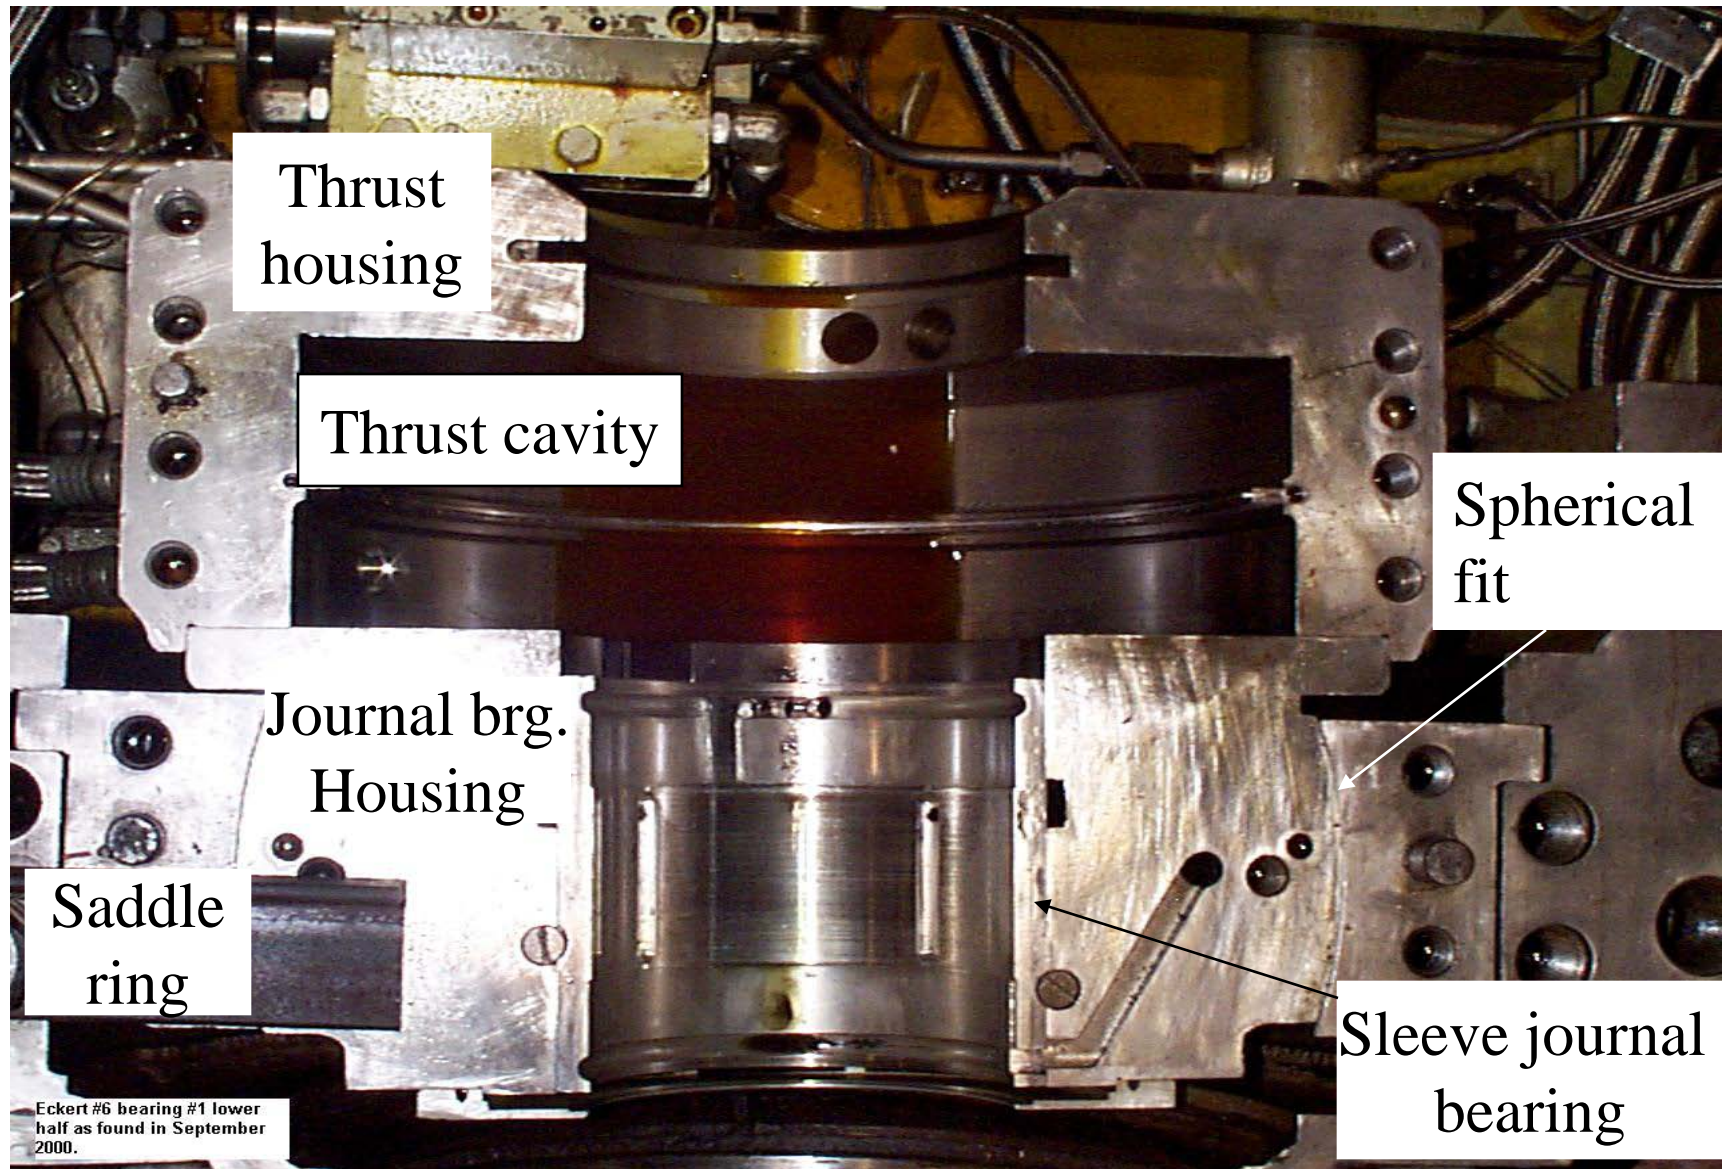
# OEM bearing assembly without the thrust bearings

The spherical fit of the bearing housing assembly did not help with the alignment.

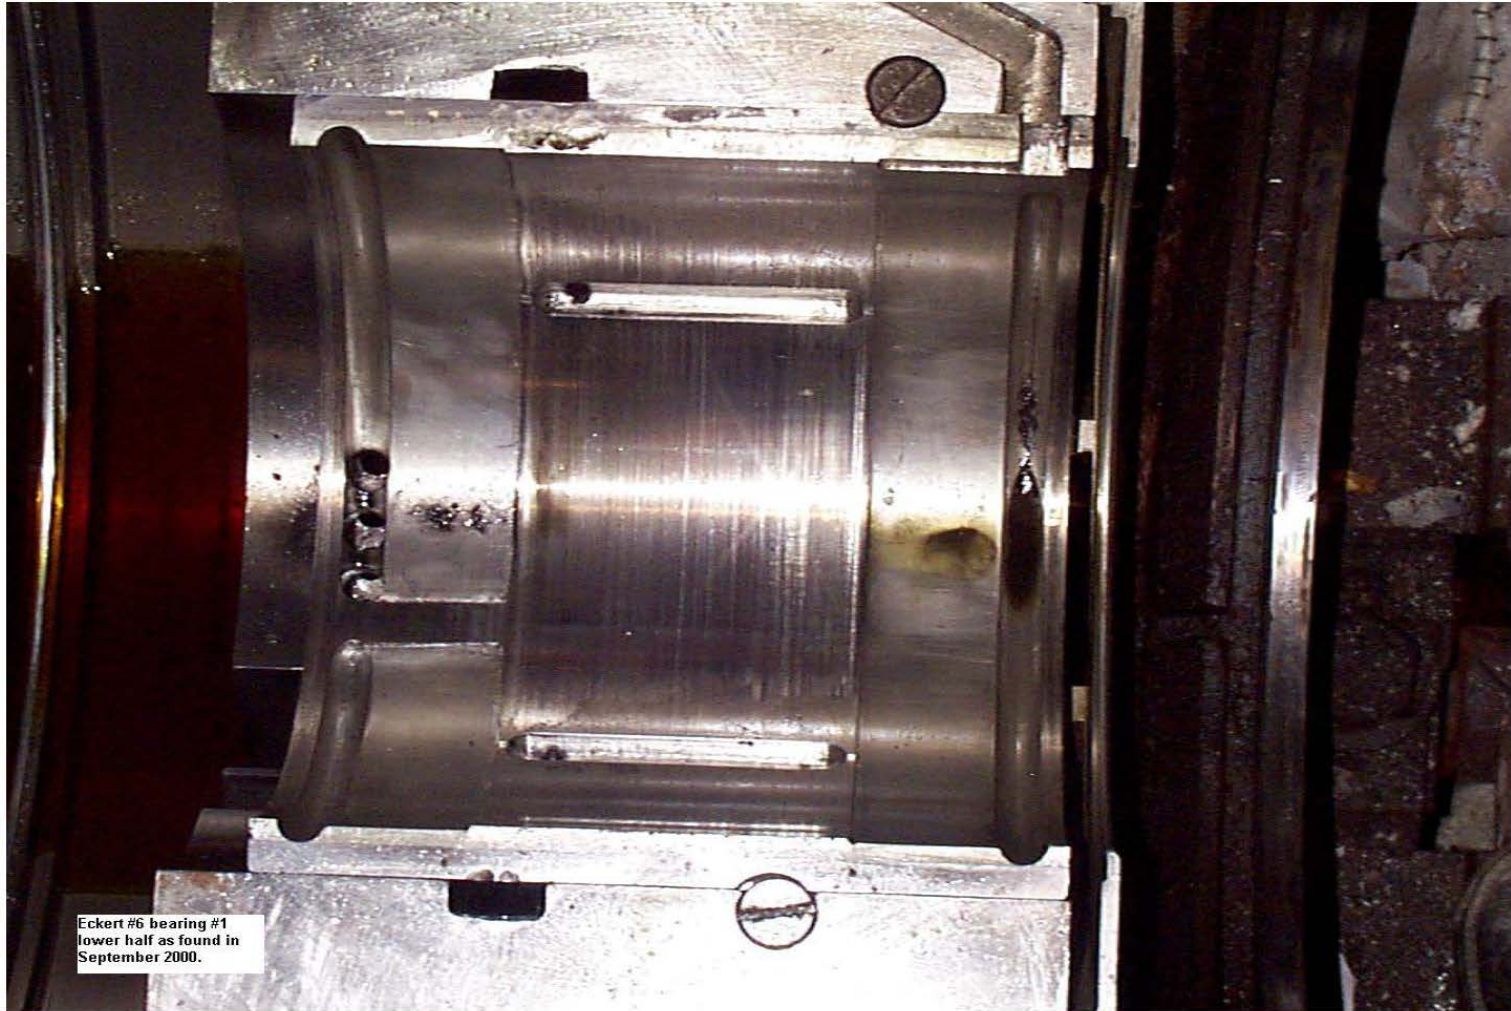
Due to alignment concerns, the journal bearing was set low, so the bearing was lightly loaded which resulted in oil whirl and oil whip, damaging the journal bearing and the shaft.

# Damaged journal bearing

A combination journal-thrust assembly was designed and installed in the front standard of the turbine. This assembly incorporated fully equalized ball & socket 56% offset pivot tilting pad thrust bearings with directed lubrication, a ball & socket tilting pad journal bearing, and a new saddle ring.

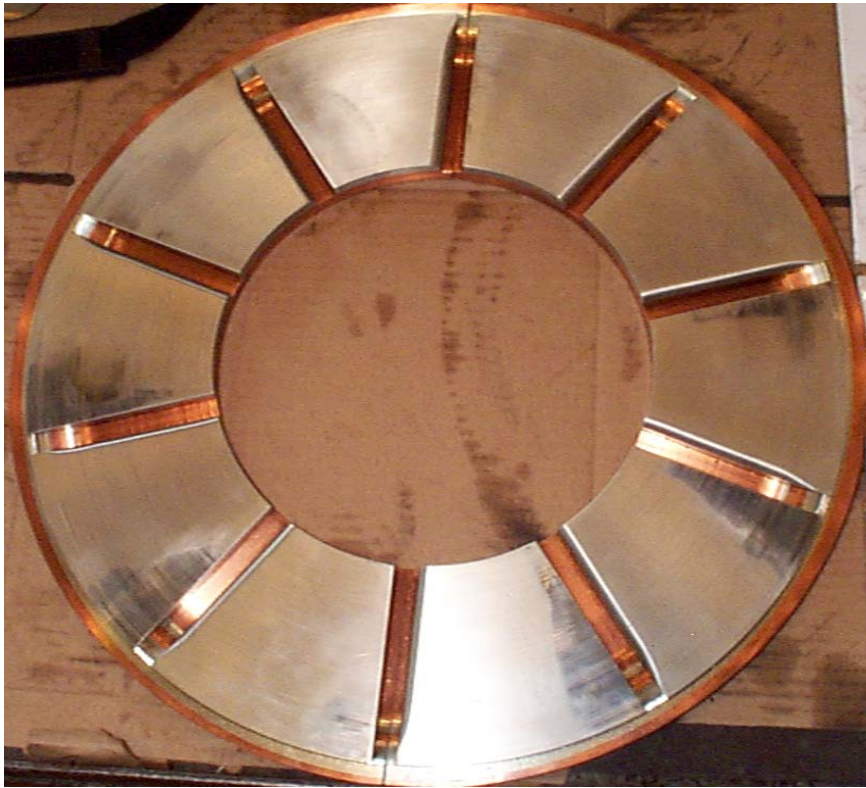
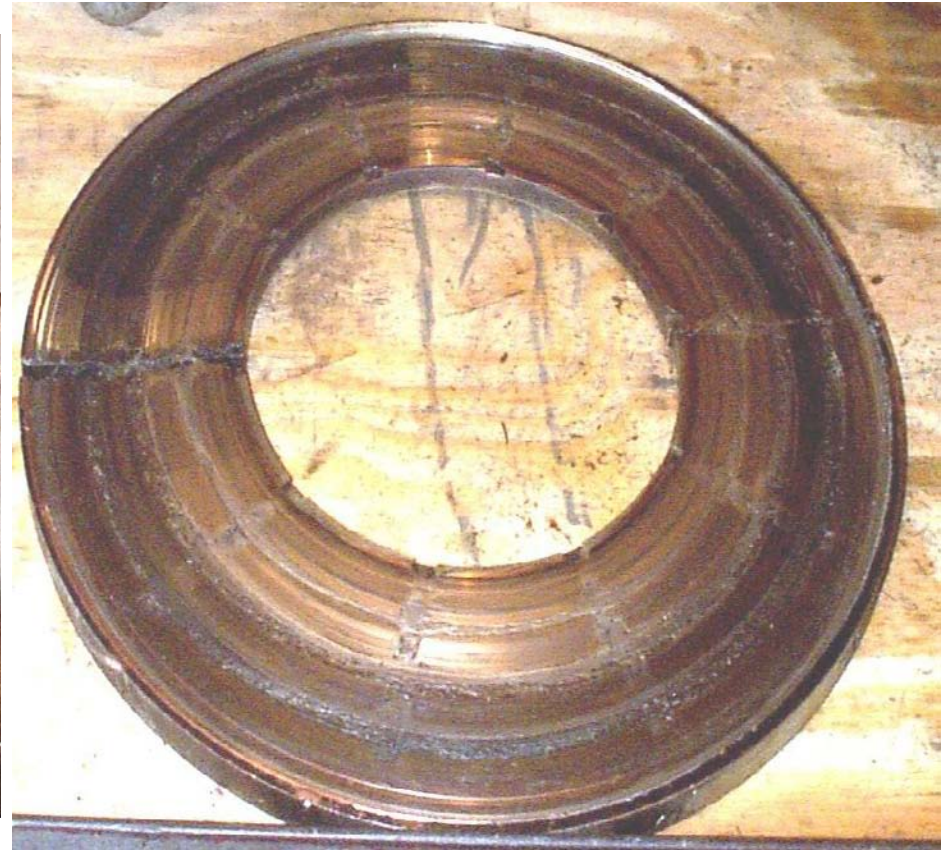
The original bearings had unsatisfactory resistance to the loads, the misalignment, and the lack of effective axial movement of the front standard. Due to erosion of the sliding supports, the supports could not slide and the front standard would not properly align with the shaft. This resulted in numerous failures of the thrust and journal bearings and forced outages.

# Active Thrust Plate with light wear and major failure.

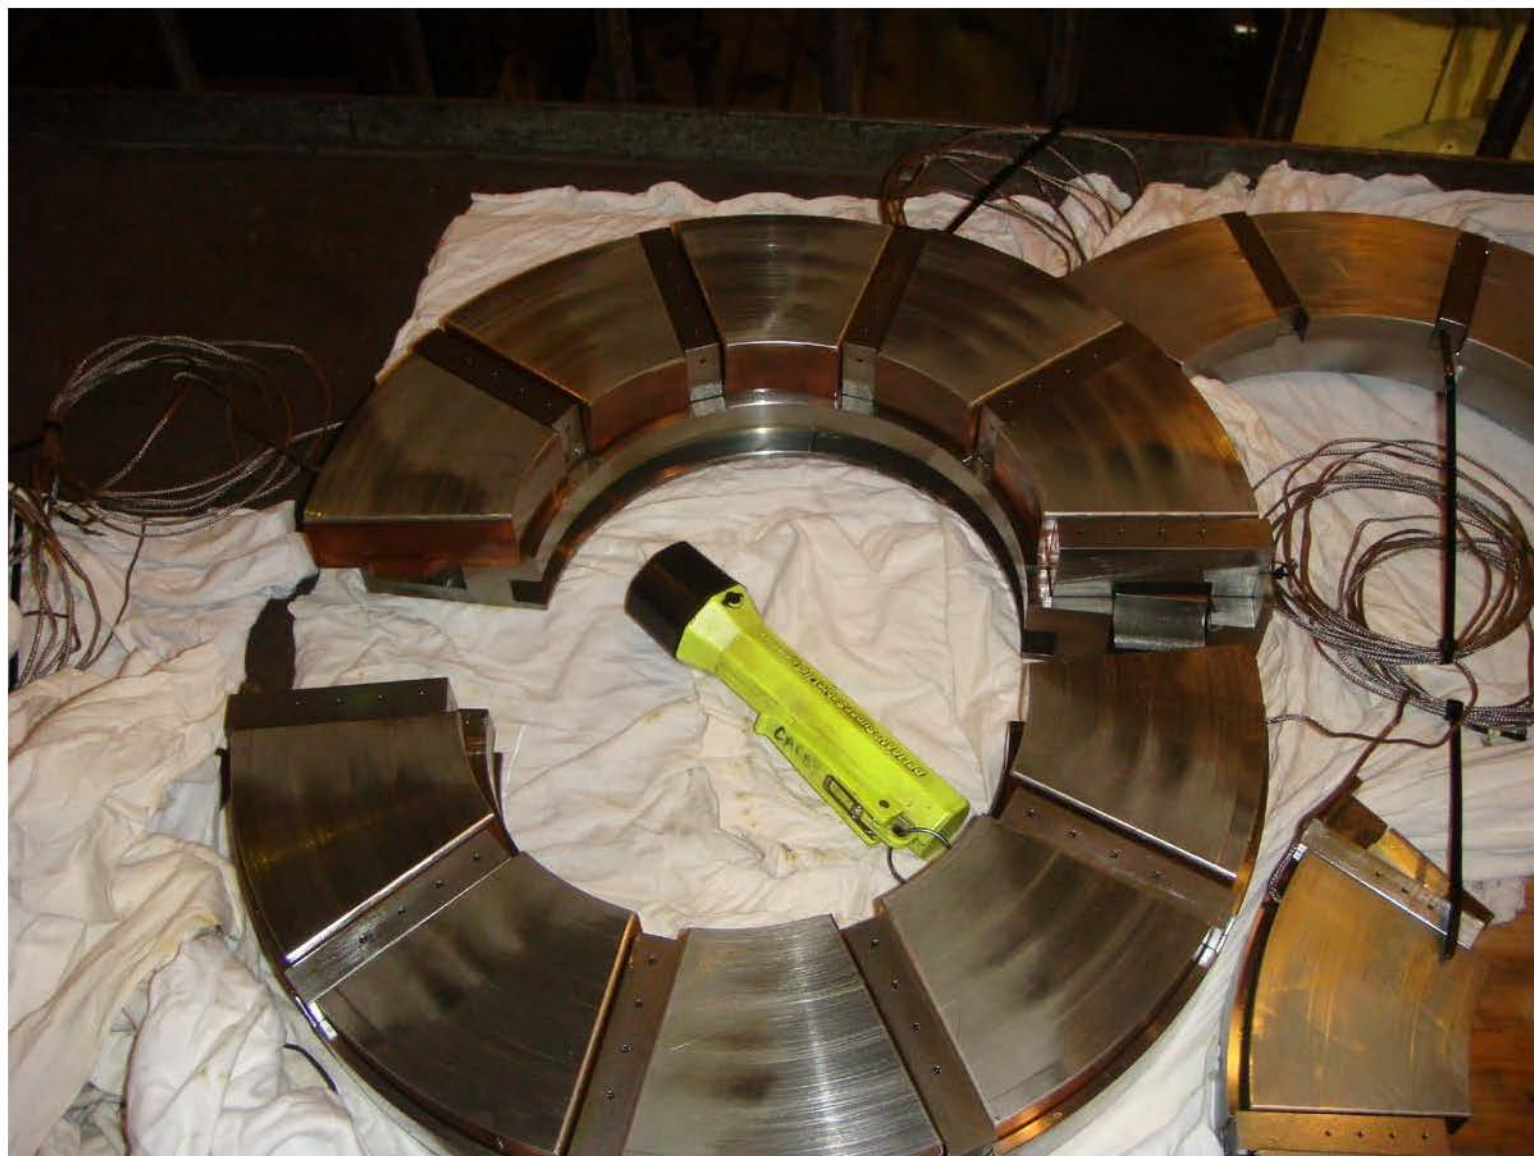
The active thrust bearing after 6 years in service.

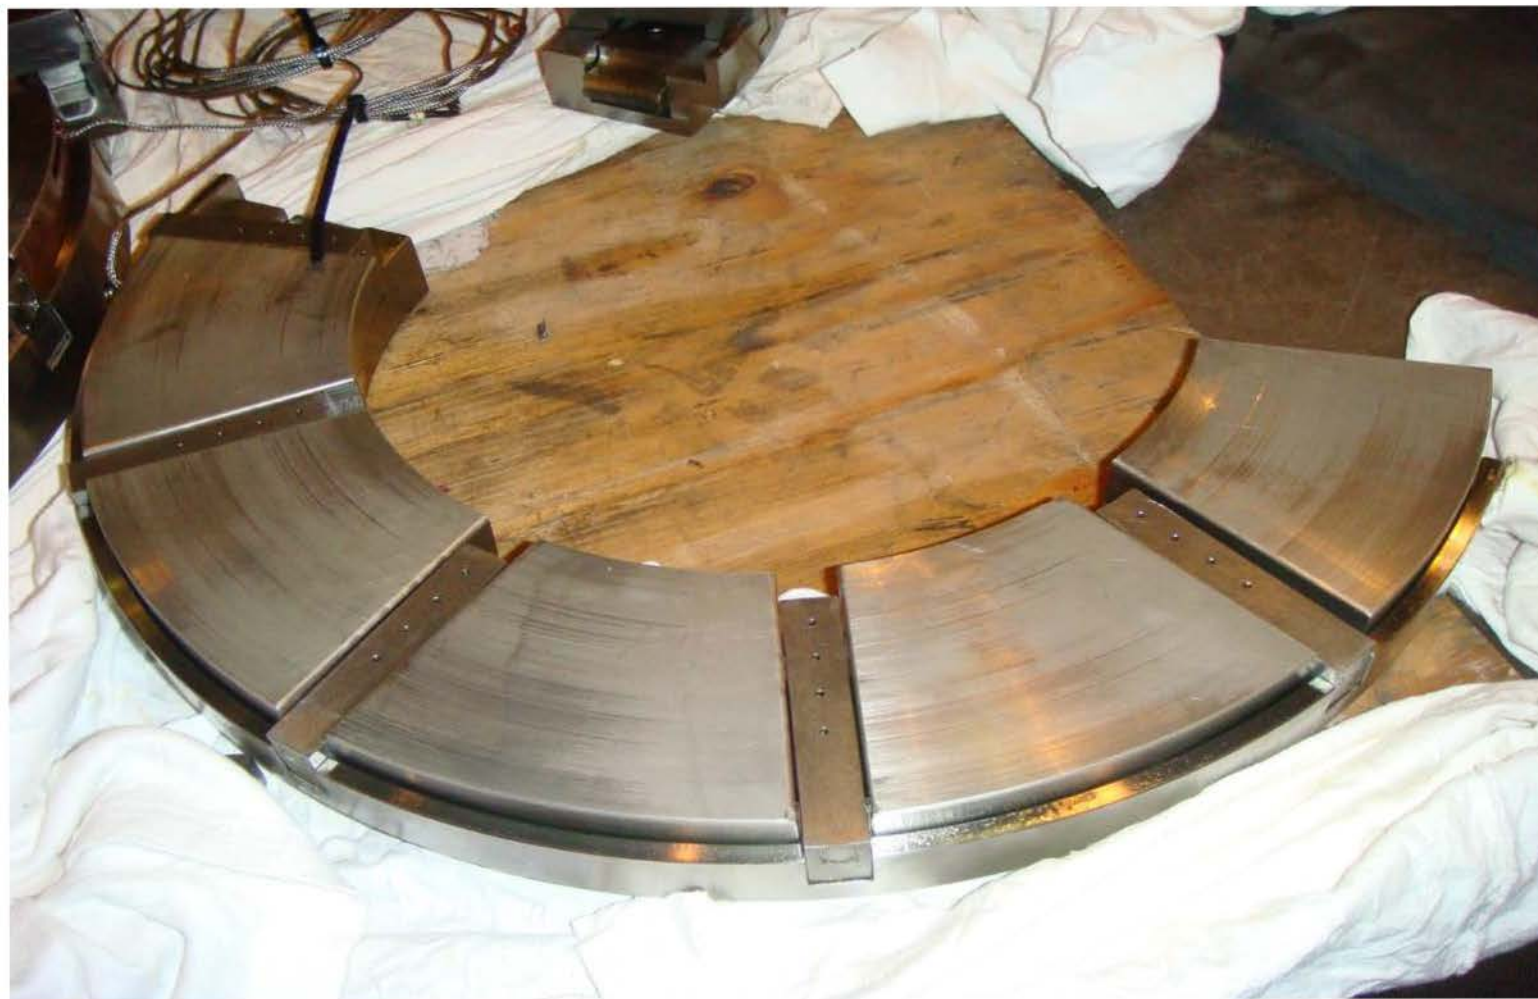
# The inactive thrust bearing after 6 years in service

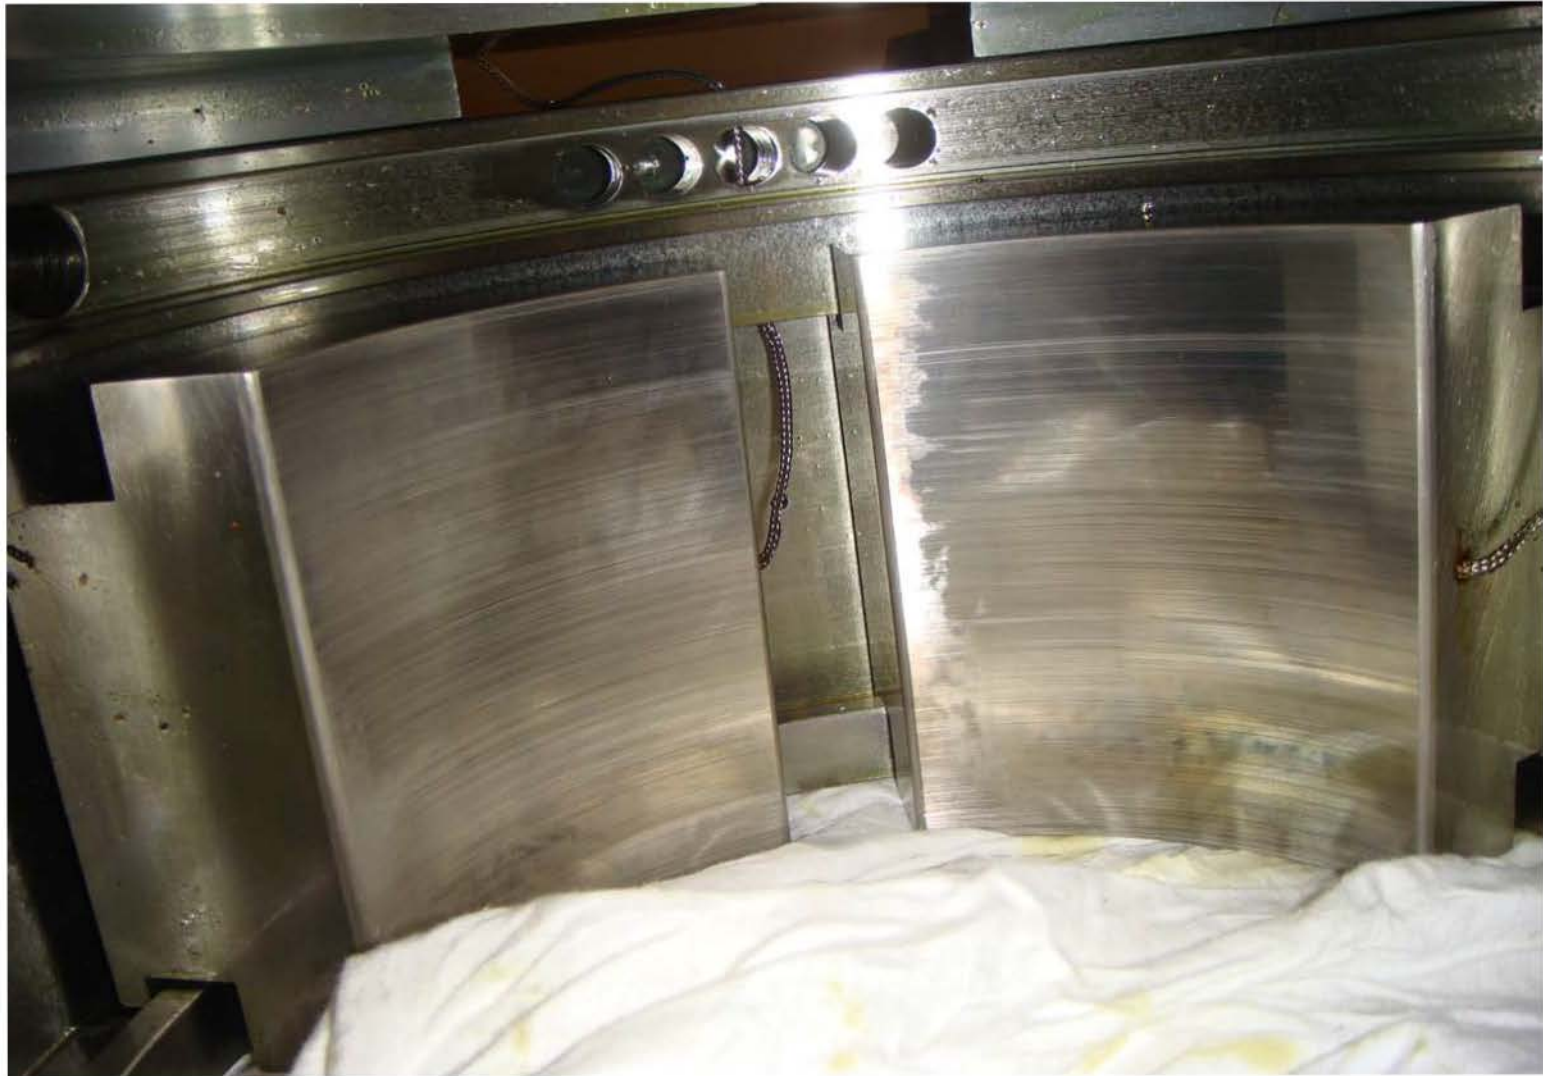
The journal bearing loaded pads, after 6 years in service.
