#### Steam Turbine Pipe Strain Case Study Texas A&M Turbomachinery Symposium

Kevin Yates The Dow Chemical Company September 2008

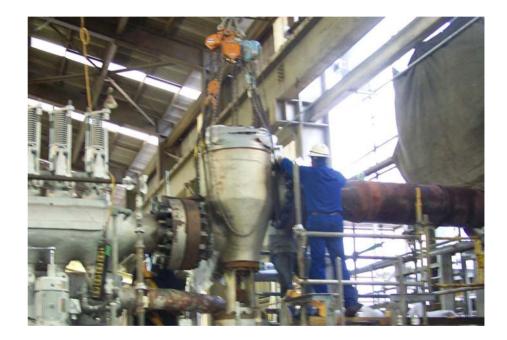
Turbine shutdown due to unrelated maintenance issues
Difficulty in removing inlet flange bolts
Galling and pipe strain after only 6 months of runtime

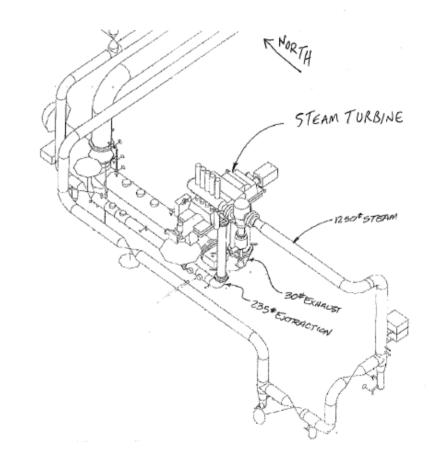
- Significant north to south flange gap / strain observedSignificant flange angularity was
- Significant hange angularity wa also detected
- •As the inlet and exhaust flanges were tightened, the turbine's north feet would lift up with the majority of the movement found on the north east foot
- •The 3 constant load springs on the inlet were found to be in the hot position / sagging with steam system cold
- •Observed that the cold position of the piping was 2-3 inches further north than the original cold constructed position

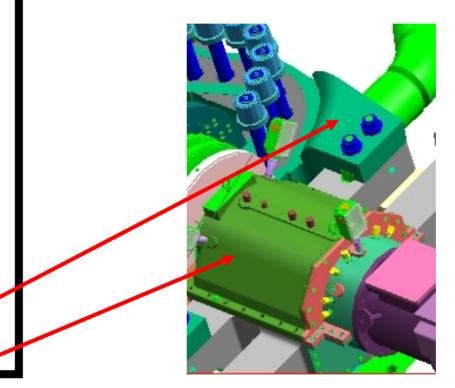
Questioned construction group regarding their initial pipe strain checks •Dial indicators were installed across the coupling hub with no movement observed •This would be acceptable <u>except</u> for the fact that the turbine case is independent of the bearings.

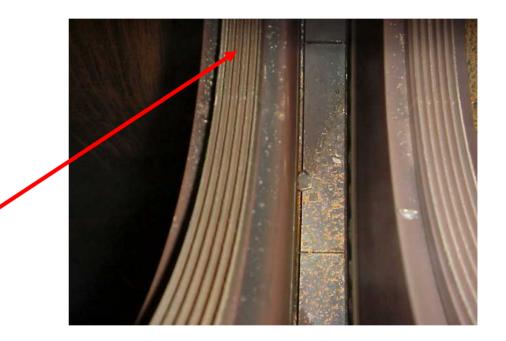
Pipe strain was not detected at the coupling during construction
Pipe strain could be detected if monitoring the casing foot movement during inlet flange installation and tightening
The internal shaft packing was rubbed hard on one side

• The orientation of the rub agreed with the case lifting up on the north side

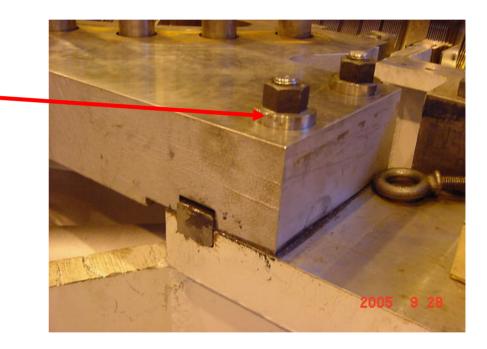
- •The shipping washers allow for thermal expansion of the casing
- •There should have been clearance between the washer and case
- •The pipe strain lifted up the case which eliminated the clearance
- •The turbine case with rotor weight is ~110,000 lbs
