STEAM TURBINE CORROSION AND DEPOSITS PROBLEMS AND SOLUTIONS

by
Otakar Jonas
Consultant
and
Lee Machemer
Senior Engineer
Jonas, Inc.
Wilmington, Delaware

ABSTRACT

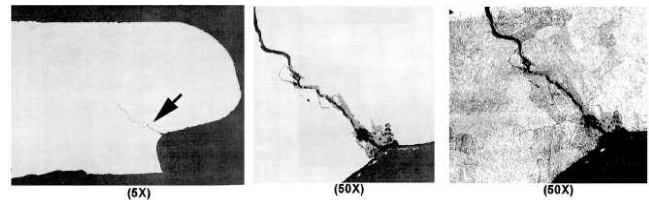
Fractography—SCC cracks of low alloy steels often initiate from pits and propagate intergranularly with branching. The initial part of the crack can be corroded and filled with magnetite. There could be beach marks or stretch marks, caused by overloading the crack during overspeed testing. Another type of beach mark can be caused by changes of the environment or by fatigue. Depending on the ratio of the steady and cyclic stresses, the disc cracks can be a mixture of intergranular and transgranular cracking. Figure 19 shows an SCC crack initiating at the radius of the upper serration of L-1 blade steeples. The intergranular crack initiated from a pit.

Figure 19. SCC Crack in the Upper Steeple Serration-L-1 Blade Attachment.

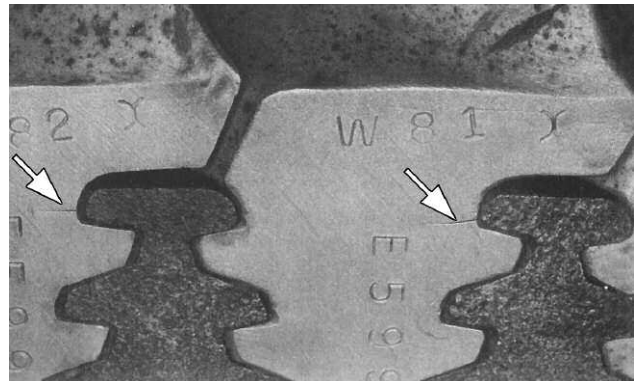
Figures 21 and 22 show corrosion fatigue cracks of L-1 blade root and airfoil, respectively. Figure 23 illustrates pitting in the blade tenon-shroud area, which sometimes initiates corrosion fatigue cracking. Fractography shows that CF blade cracking often initiates from a pit, continuing for 50 to 150 mils (1.3 to 3.8 mm) by intergranular cracking and then proceeding as a flat fatigue fracture with beach marks and striations.

Figure 21. Corrosion Fatigue of L-1 Blade Attachment. (Courtesy of EPRI, 1998a)

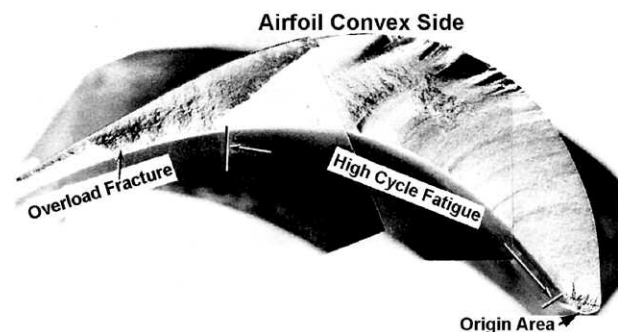
Figure 22. Corrosion Fatigue of L-1 Blade Airfoil. (Courtesy of EPRI, 1981)

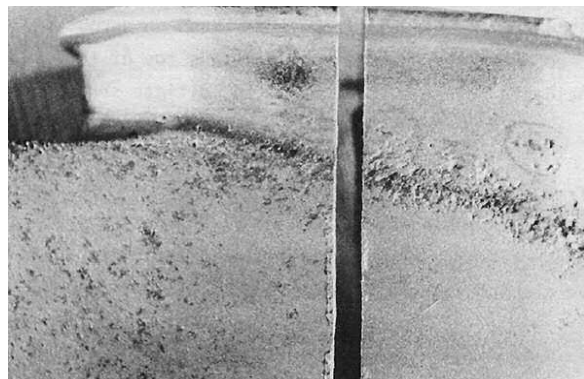
Figure 23. Pitting in the L-1 Blade Tenon-Shroud Area. (Courtesy of EPRI, 1981)

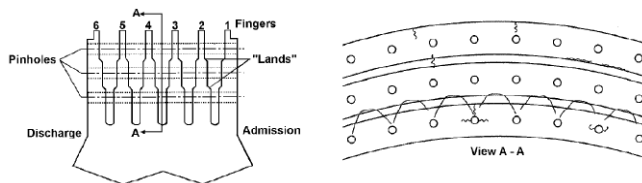
Problem: In 1995, in Unit 1, a blade failed in the L-1 row at a tiewire hole of the leading blade of a four-blade group (Nowak, 1997; Kilroy, et al., 1997). Three damaged groups of blades were removed for replacement. A wet fluorescent magnetic particle examination of the finger-style disc attachments found hundreds of crack-like indications, which were later identified as SCC. Cracks ran both axially and radially, and were deep (Figure 25).

Figure 25. Locations in Finger and Pin Attachments Where SCC Has Been Found. (Courtesy of EPRI, 1997)

Inspection: Inspection procedures and the acceptance criteria that would be applied were developed before the outage. Eventually NDE inspection found some damage in each of the 12 ends of all six rotors. Severe cracking was found in all four-rotor ends in Unit 2 and in Unit 3 on both ends of LPB. Next in severity were both ends of Unit 1 LPB and Unit 3 LPA; with a few indications in Unit 1 LPA. In the heavily cracked rotors, damage was most severe in Fingers 3, 4, and 5 with little or no cracking in Fingers 1 or 6. Cracking was evenly distributed between admission and discharge sides in Fingers 3 and 4 with somewhat more cracking on the admission side in Finger 5.

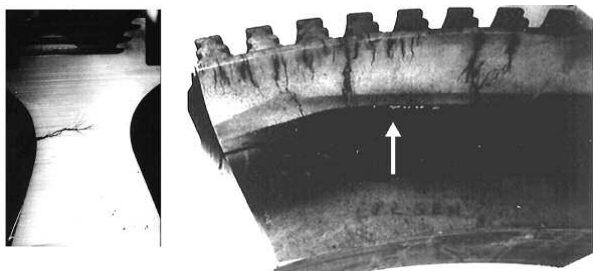
Problem: Stress corrosion cracking of the L-1 stage disc was discovered during routine inspection (Figure 26).

Figure 26. Massive SCC of L-1 Disc Caused by High Concentration of NaOH in Steam.

Root cause: The SCC was caused by poor performance of the condensate polishers that operated in H-OH form through ammonia breakthrough when they released Na⁺. The sodium reacted with water forming NaOH and deposited in the turbine.
