Solving Structural Vibration Problems Using ODS Analysis

37th Turbomachinery Symposium
September 8-11, 2008

Maki M. Onari & Eric J. Olson

Mechanical Solutions, Inc.

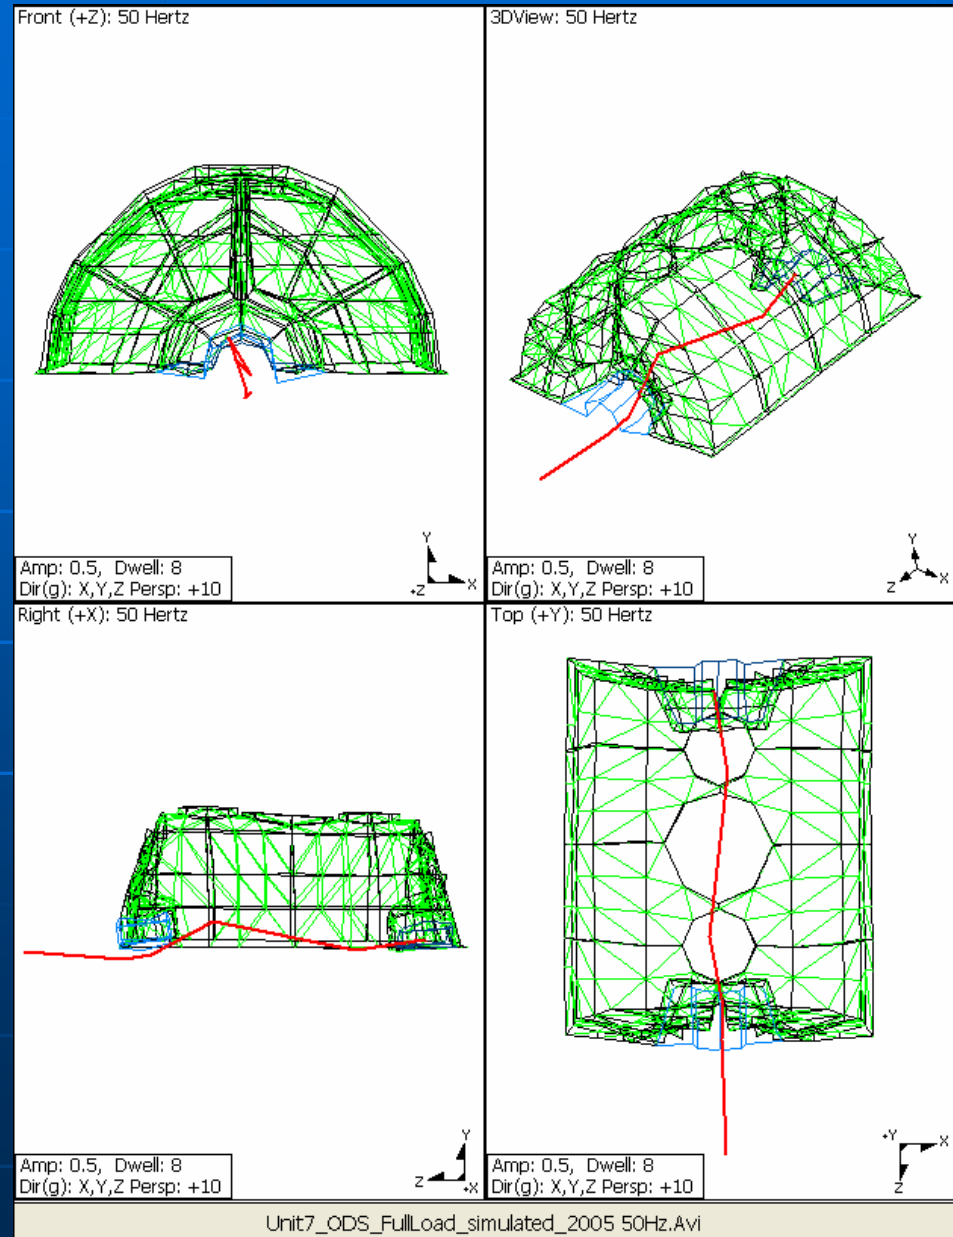
ODS Animation at Running Speed

- LPB section casing of a 660 MW steam turbine in a tandem-compound reheat unit in Indonesia.
- Excessive vibration and occasional cracking of the exhaust hood frame.
- “Identical” units installed in other facilities without vibration and cracking issues (differences in actual structural dimensions).

- Coincident resonance condition between the second bending mode of the rotor system and a sway mode of the casing close to the running speed of the unit at 50 Hz.
- The 2nd bending of the shaft was predicted with a rotordynamic analysis.

- **Structural modification of turbine casing, supported by an FEA analysis and agreed to by the OEM without interfering with the internal flow path of steam.**
- **Bearing and bearing housing stiffness increased**
- **Welded “fish-plating” to stiffen the vicinity where the cracking took place.**

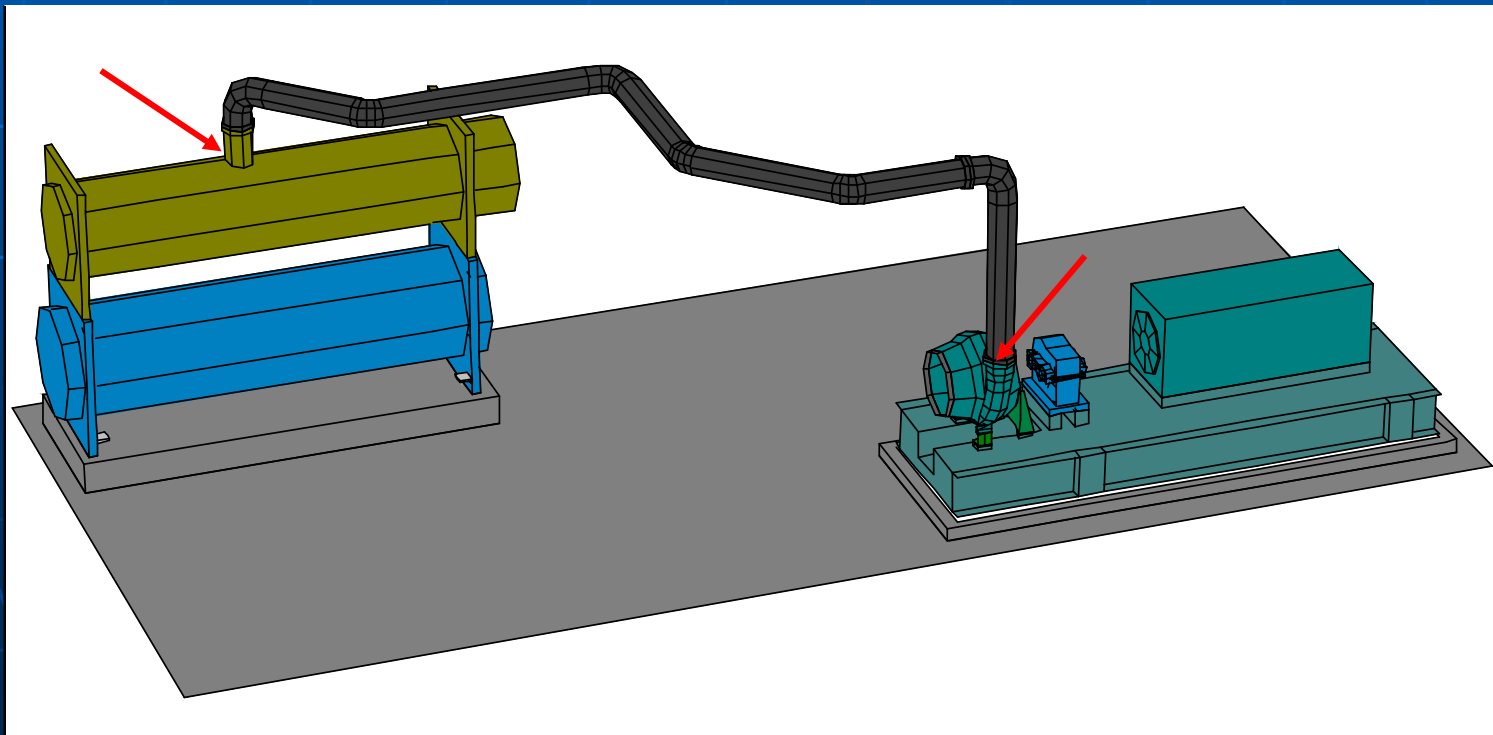
- Repetitive failures (3) of the discharge piping on a single stage refrigeration compressor in a business building refrigeration plant since its installation in 2001.
- Refrigerant leaking due to cracks at the welding location between the pipe and the compressor flange, and between the condenser and the nozzle.

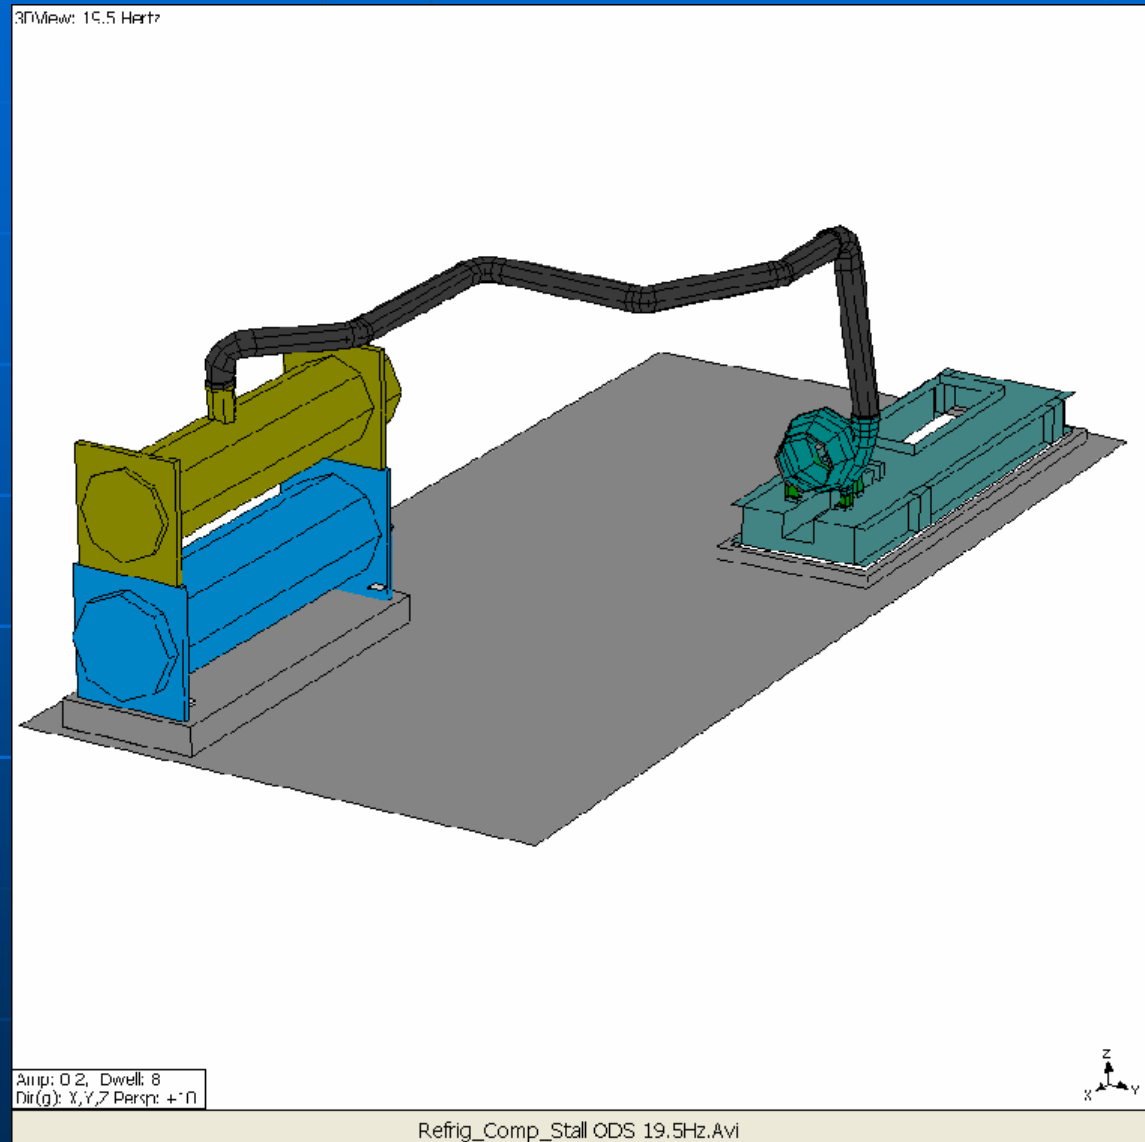
ODS Animation

- Natural frequency excited by a pressure pulsation (rotating stall) from the compressor while the unit operated at 50% of capacity sharing the refrigerating load with the sister unit.
- Bending stresses from strain gage close to endurance limit.

- Addition of specific masses at certain locations of the discharge piping detuned the offending natural frequency from the rotating stall pressure pulsation frequency from 19 Hz to 16 Hz (supported by FEA analysis).

- Piping vibration amplitude was reduced from 1.6 in/s pk to 0.38 in/s pk @ 19 Hz

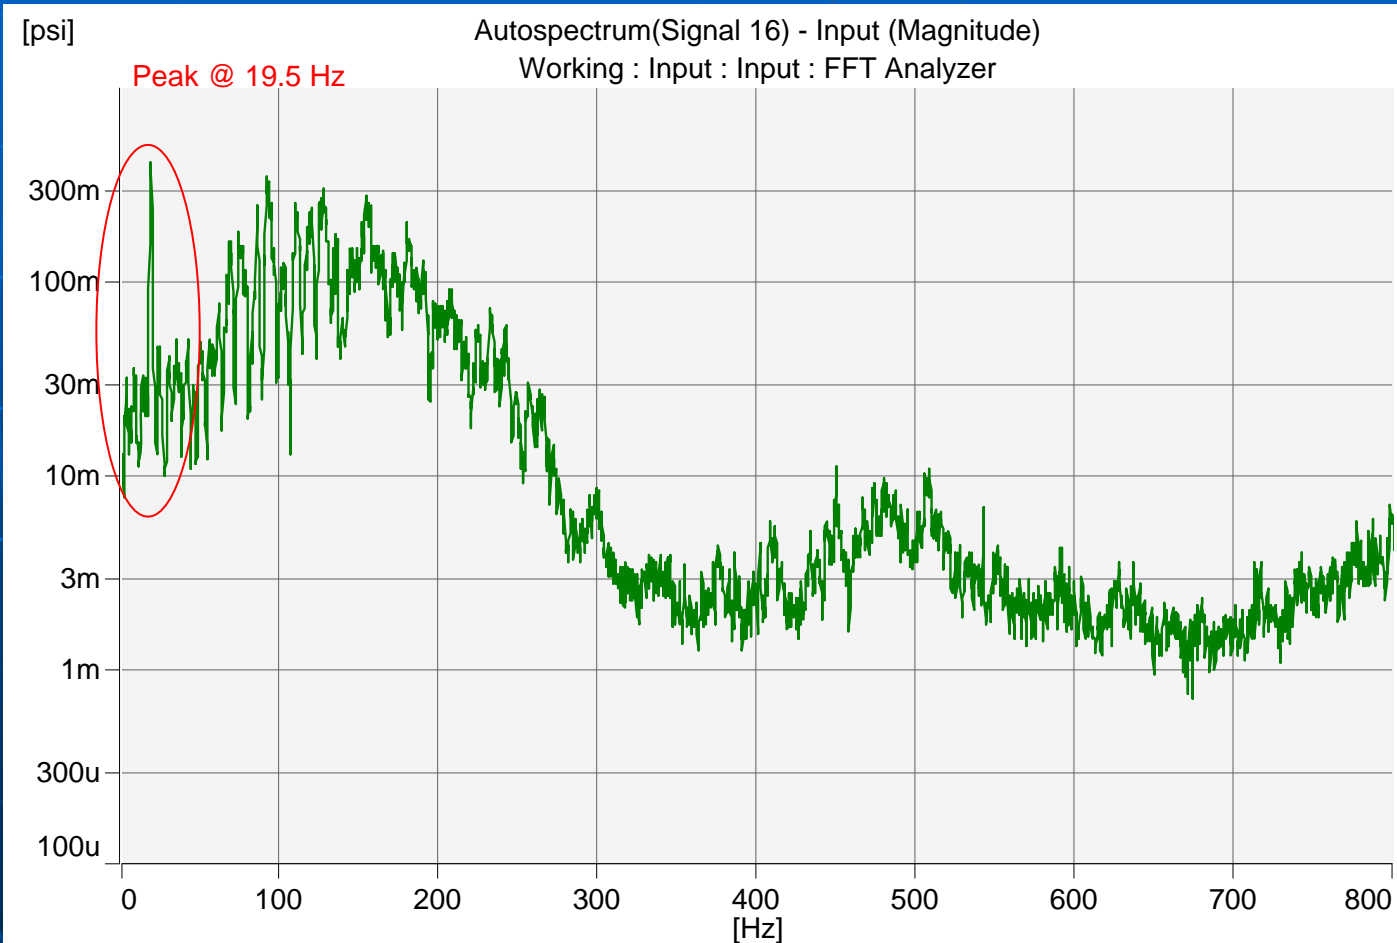
Supporting Information

- Dynamic pressure pulsation spectrum from the discharge of the compressor.

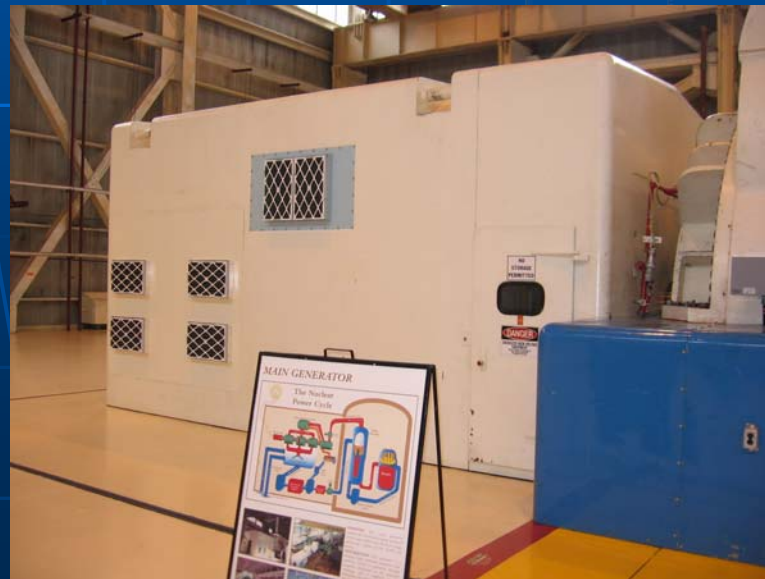
- Excessive vibration on the Exciter's enclosure of a 1300 MW Nuclear Power Generation main unit.
- Nearly 1.0 in/s peak vibration level was detected at the buss-bars' support in the axial direction of the unit at the running speed of 30 Hz (1800 cpm).
- Vibration level was jeopardizing the internal structure that supported the buss-bars.

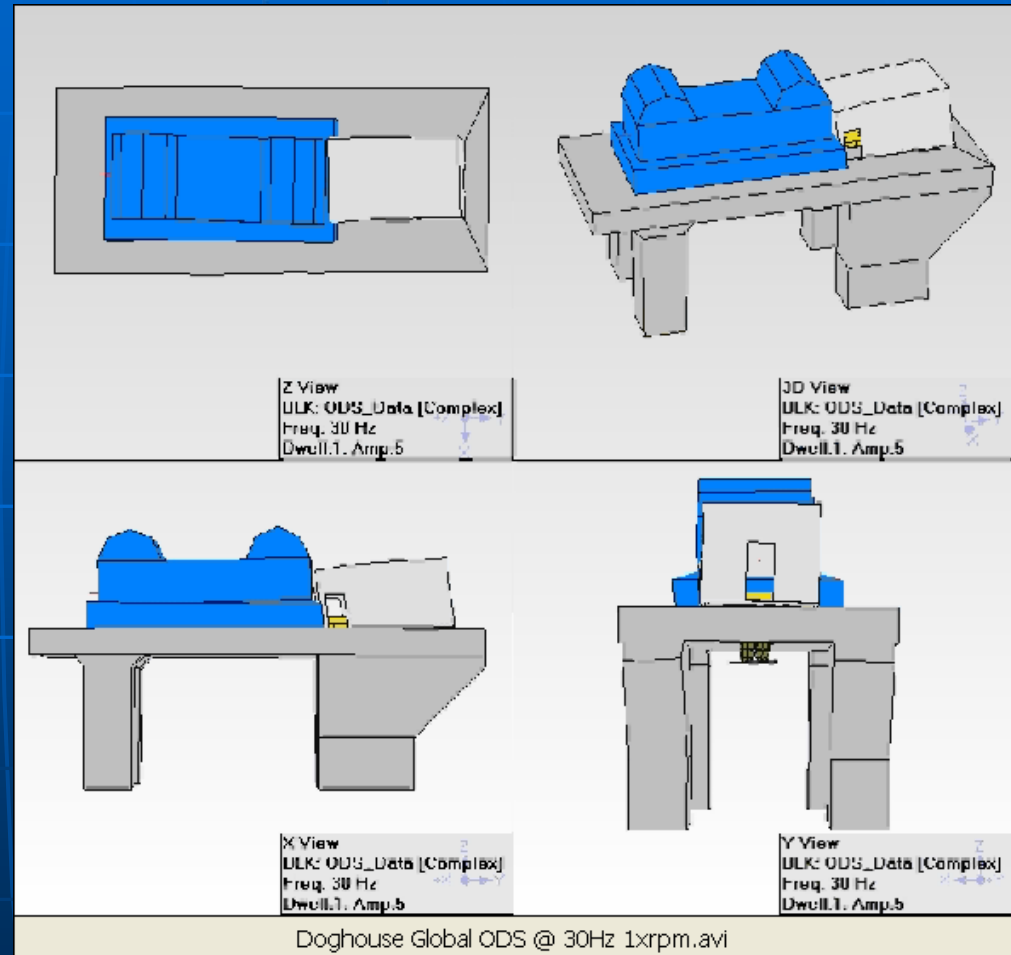
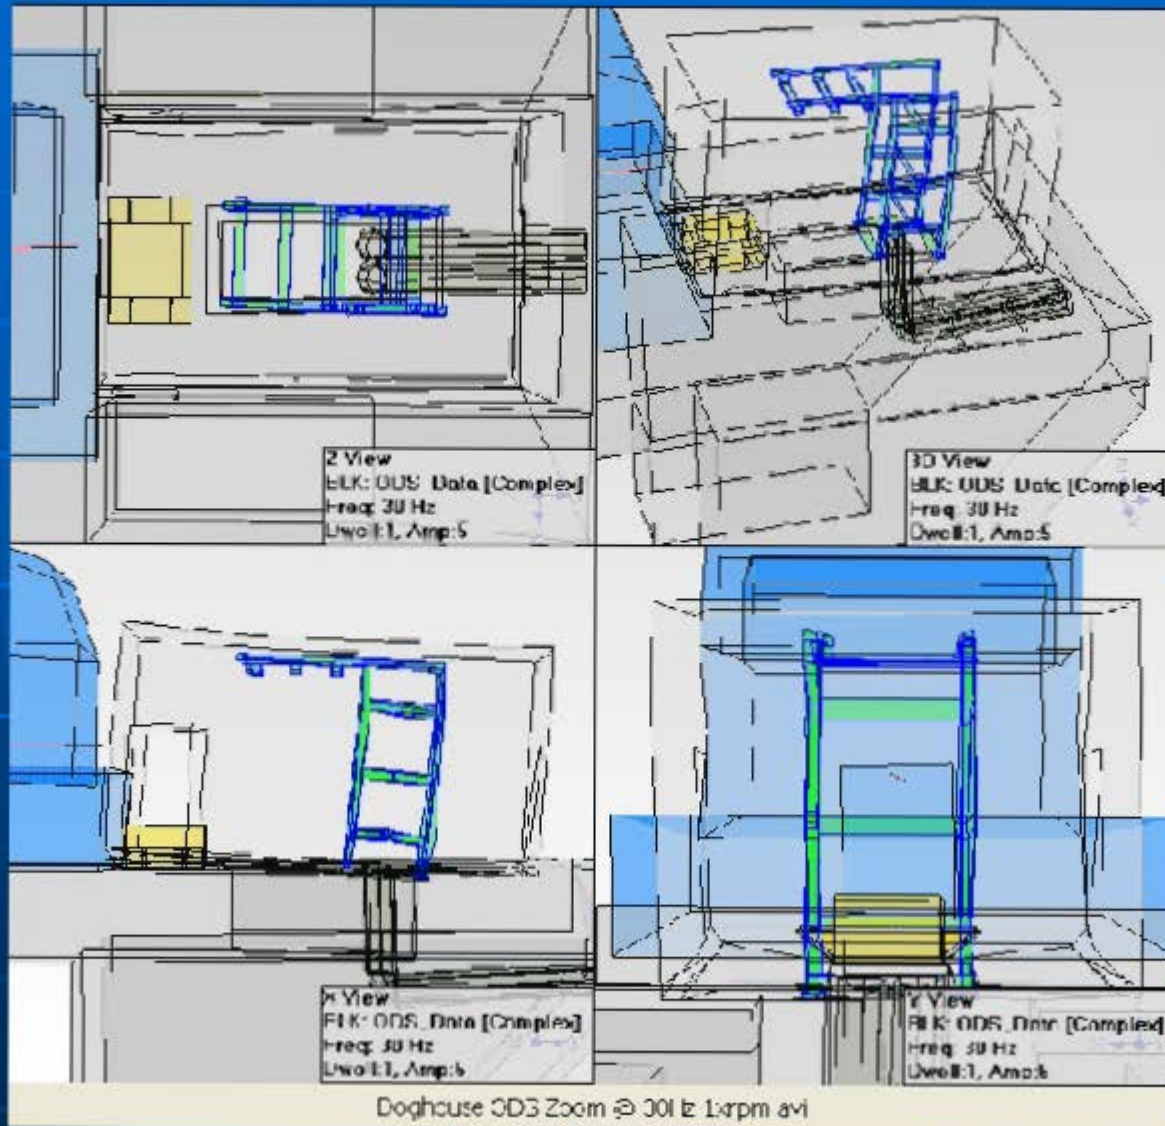
ODS Animations

- Evident looseness of the entire enclosure was detected with the ODS at the running speed of the unit.
- A natural frequency of the enclosure was tuned-in with the 1x running speed of the unit as a consequence of looseness of the enclosure relative to the foundation floor.

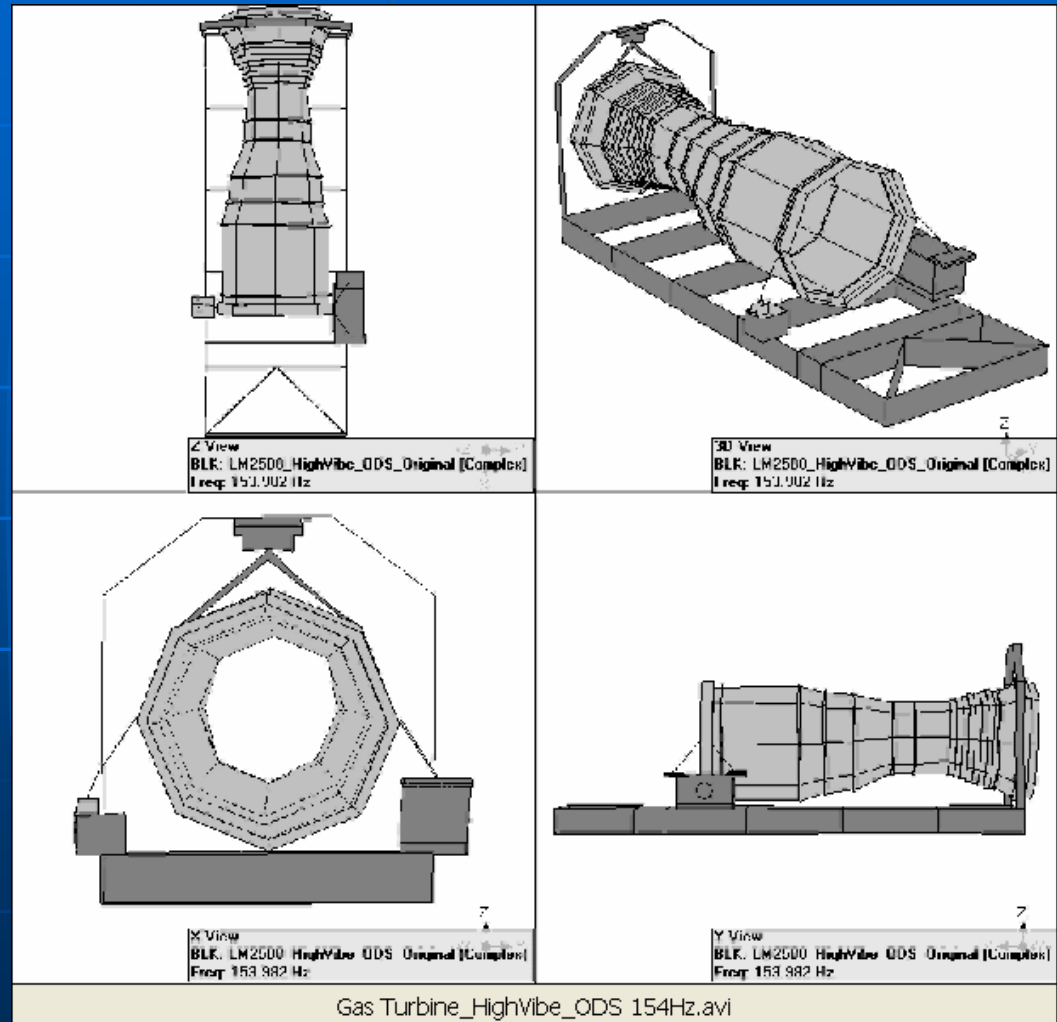
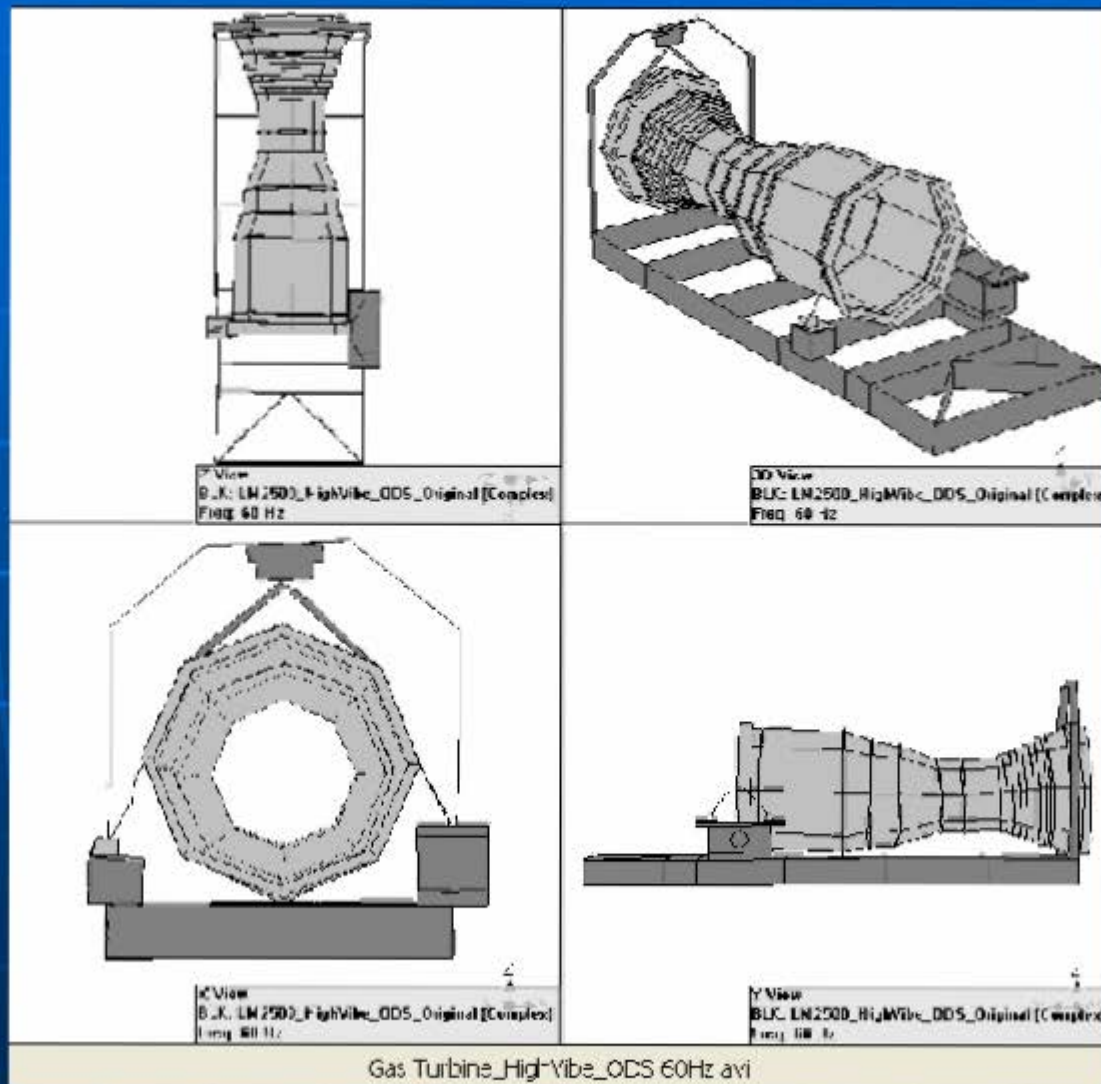
ODS Animations

- **Relatively high vibration was reported on a gas turbine engine rated at 22 MW at a pharmaceutical power generation plant.**
- **Vibration amplitude of 6.0 mils pk-pk of was detected at the compressor section of the engine at the gas generator rotor speed of 154 Hz (9240 rpm).**

- ODS test analysis indicated a mechanic or aerodynamic imbalance of the gas generator rotor.
- The ODS also revealed potential looseness of the baseplate and excessive flexibility of one of the engine's supports.

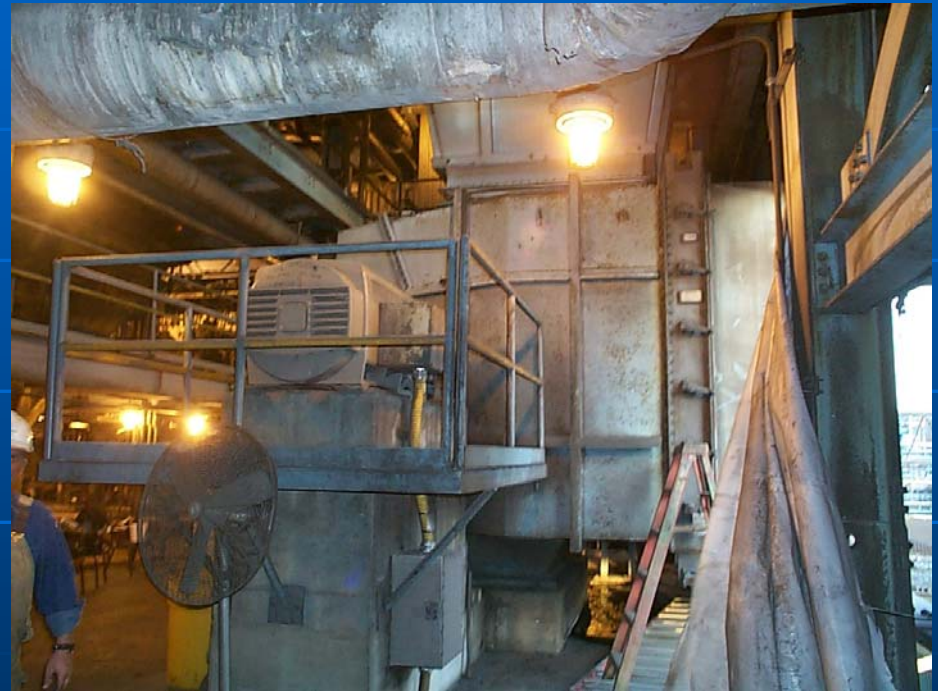
- The vibration of a FD Fan in a Paper Mill facility was reported to be very sensitive to the balancing of the rotor with frequent on-site balancing performed by the End User.
- Vibration levels were measured to be low during the test due to recent major maintenance of the unit.

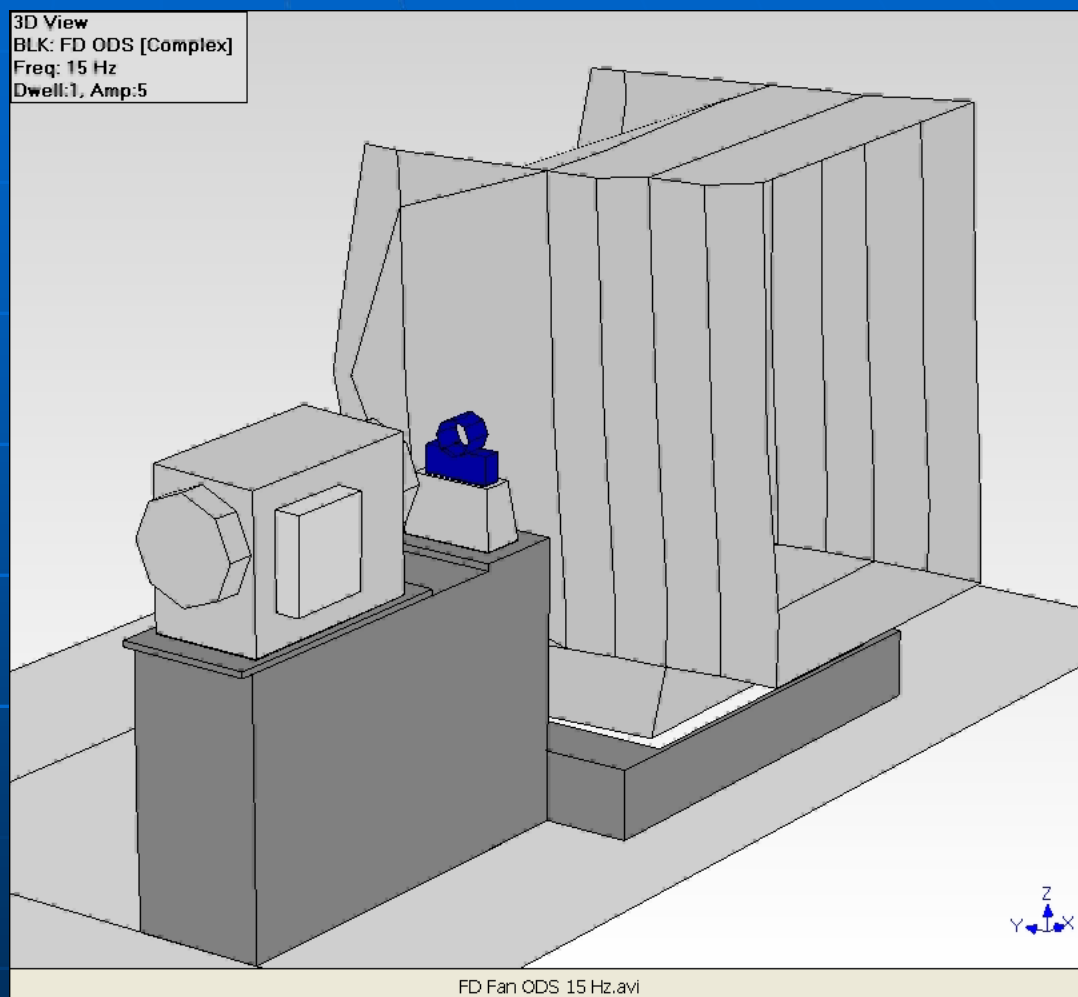
ODS Animation at the Running Speed

- Excessive looseness of the entire fan housing detected with the ODS at the running speed of the unit.

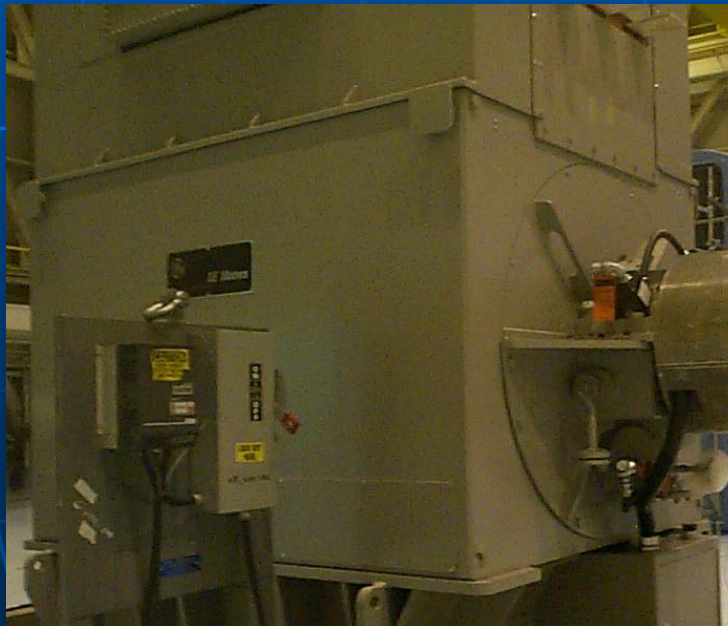
- A 1200 MW Steam Turbine-Generator Exciter presented high vibration level at the running speed (1800 RPM).
- At 1x RPM, the highest vibration at the inboard bearing housing was above 0.40 in/s in the horizontal direction.
- Vibration level incremented gradually after major outage in 2002.

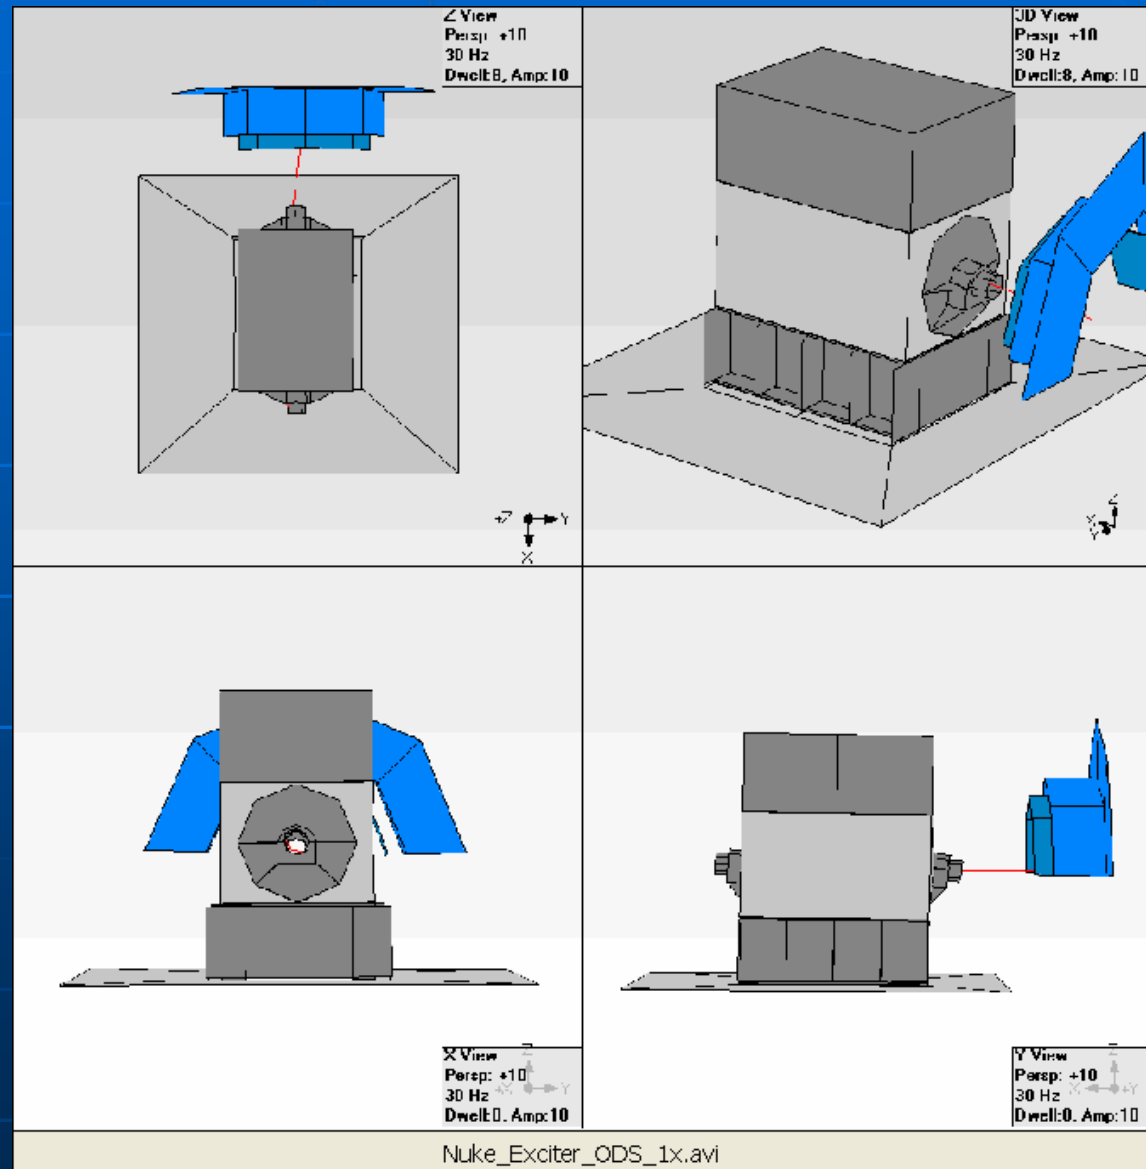
ODS Animation at the Running Speed

- Significant soft-foot condition detected in the opposite south-west and north-east corners between the exciter casing and its base-plate.

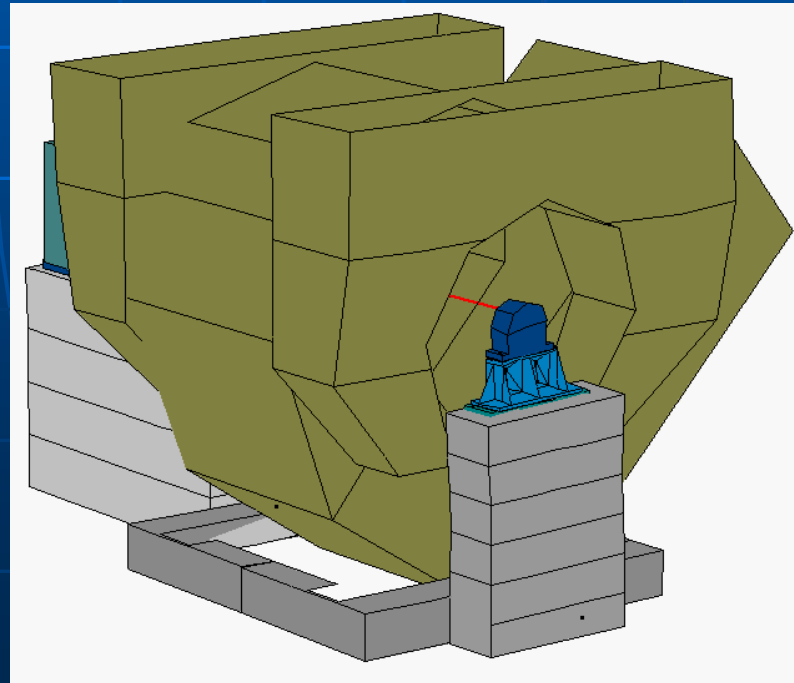
- High vibration on two newly installed double suction ID Fans, rated 7000 HP, in a fossil power plant (450 MW) driven by constant speed electric motors at 895 RPM (14.9 Hz).
- The largest vibration amplitude measured was 0.46 in/s peak measured at the running speed in the horizontal direction of the OB bearing housing.

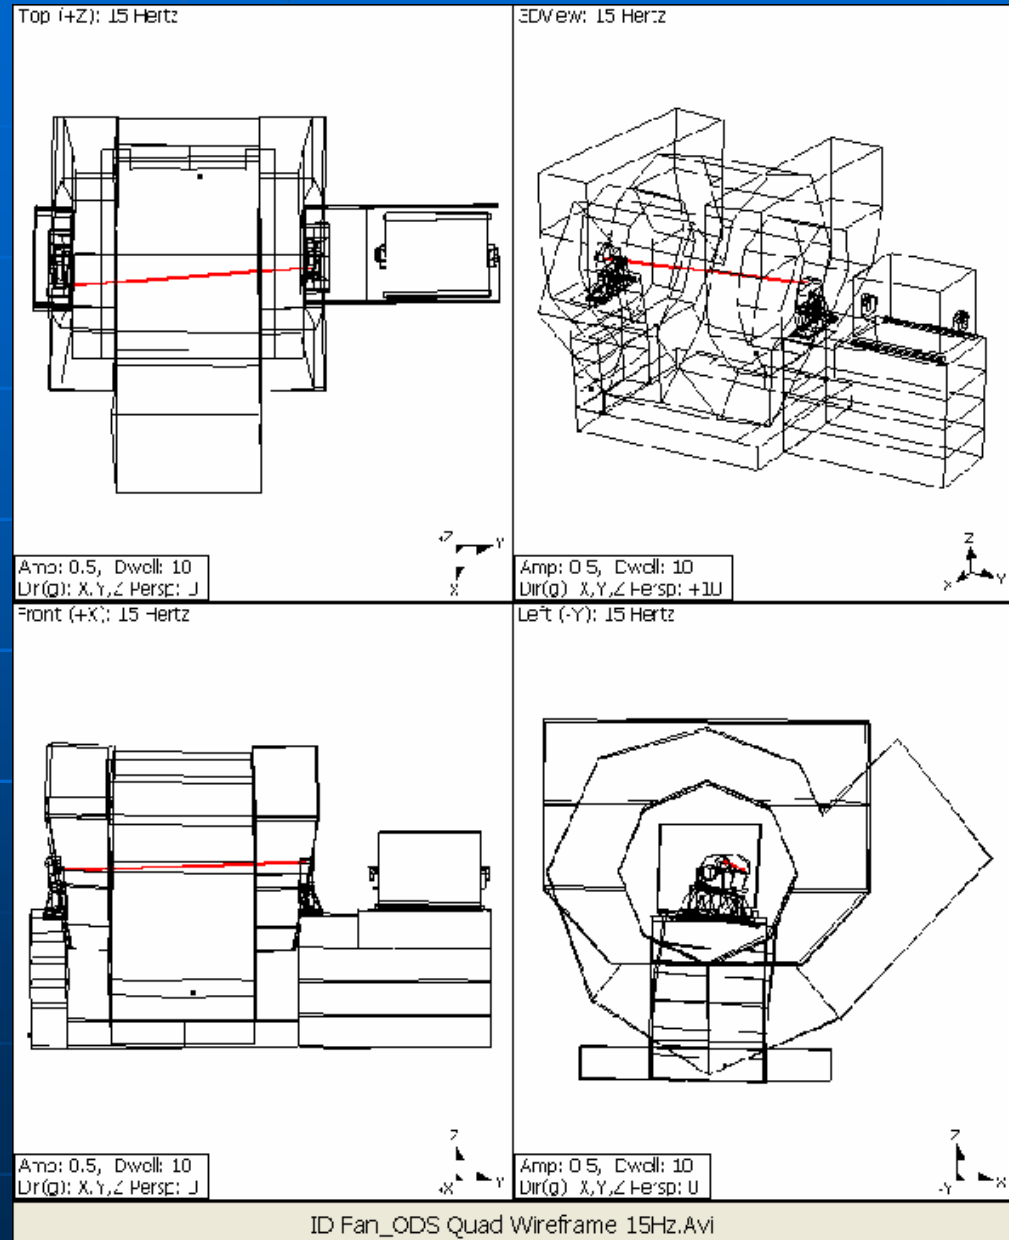
ODS Animation at the Running Speed

- Rocking motion of the outboard concrete pedestal as a rigid body at the running speed.
- Looseness of the bearing assembly and bearing support and its soleplate.

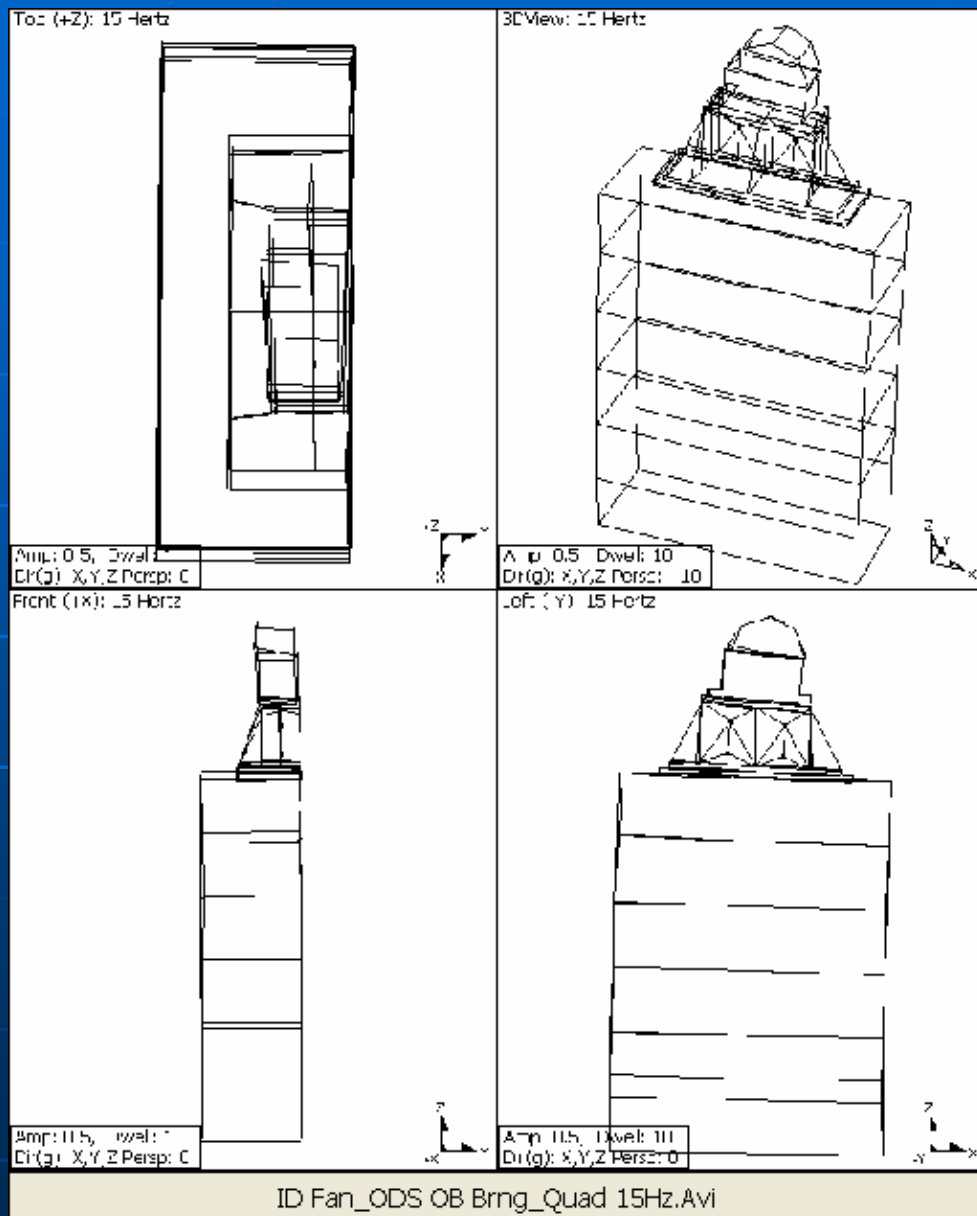
ODS Animation at the Running Speed

- Looseness of the bearing assembly and bearing support and its soleplate.
