**Case Study:
Charge Compressor Turbine Vibration – Diagnostics/Risk Assessment**

Reducing downtime and sustaining high production rates are essential for companies to remain competitive. A 36MHP steam turbine experienced sudden high vibration. Through use of vibration analysis, selective external case cooling, and altering of specific operating conditions, continued safe production was provided for eight months until an overhaul opportunity became available.

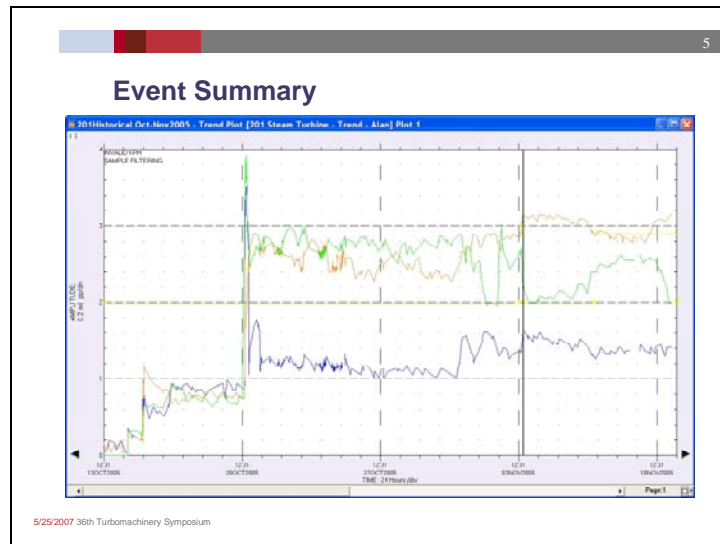
Slide 5

- Overall sequence of events...
- Plant startup was completed the second week in October following Hurricane Rita, within a week after startup, the charge compressor turbine experienced a sudden increase in vibration, the highest amplitude observed at the OB bearing/exhaust end of turbine.
- Speed was decreased on the machine, and a review of the available vibration data was performed, as well as a determination of the machine's sensitivity to speed changes, e.g. imbalance, rub, and change in vibration levels.

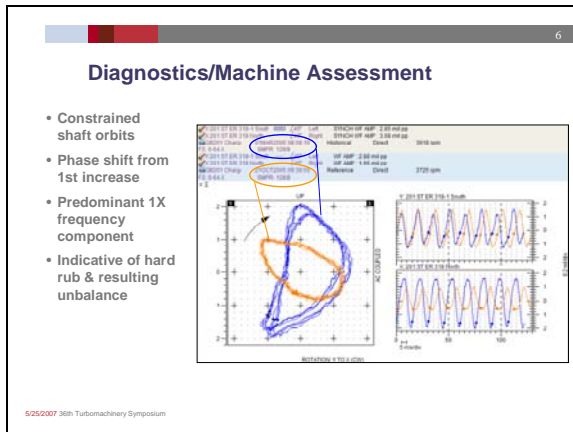
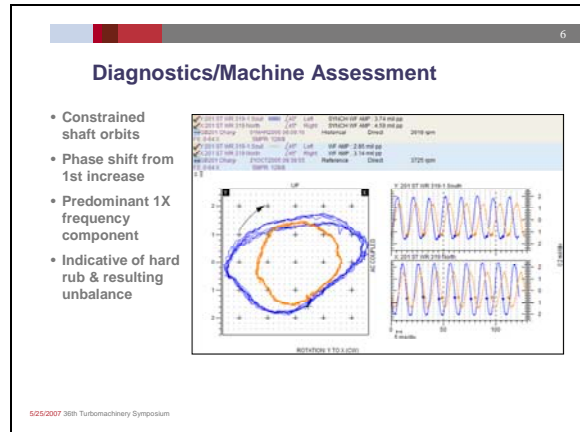
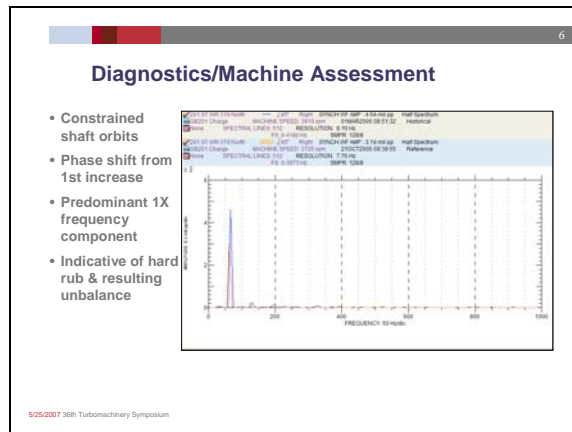
Slide 6

- Review of the Bentley System 1[®] vibration data produced the following observations:
- Constrained orbits (both ends of machine)
- Higher amplitudes at exhaust end of rotor
- Predominantly 1X component
- Most likely a mechanical issue, broken component (shroud band, etc.) and possibly lodged, creating a rub and thermal bow in shaft

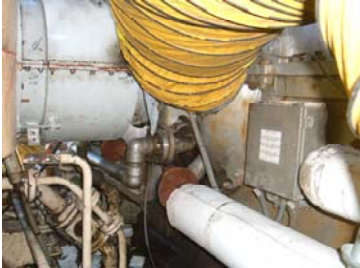
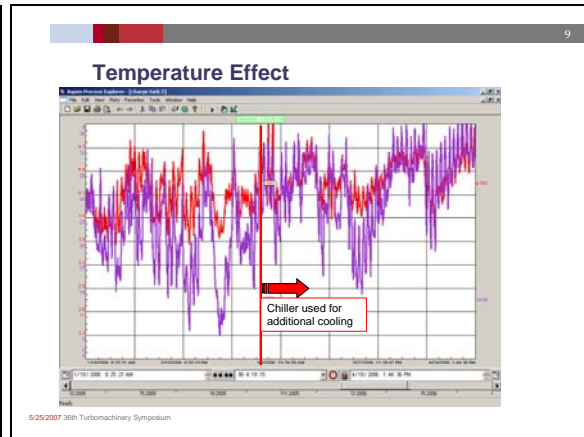
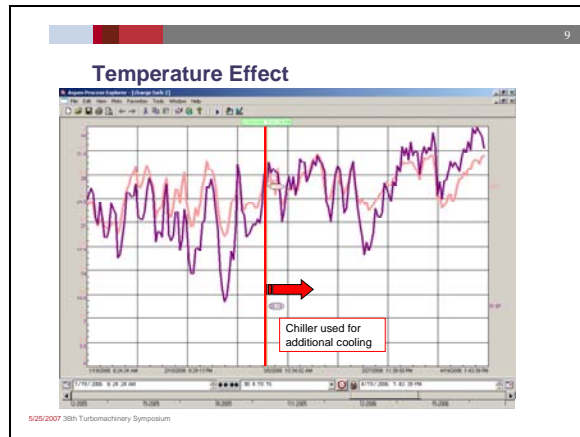
Slide 9

- Used refrigerated air to attenuate vibration amplitude
- Air ducts directed at bearing housings
- Reduction of over 1 mil

- Noticed trend relationship of vibration and ambient temperature—lower ambient temperature, lower amplitude.
- Provided Refrigerated air at both bearings at specific locations; result “racked” case/bearing enough to reduce rub contact and thermal bow associated with rub.
- Installed chiller for lower temperatures as summer/hotter temperatures approached.

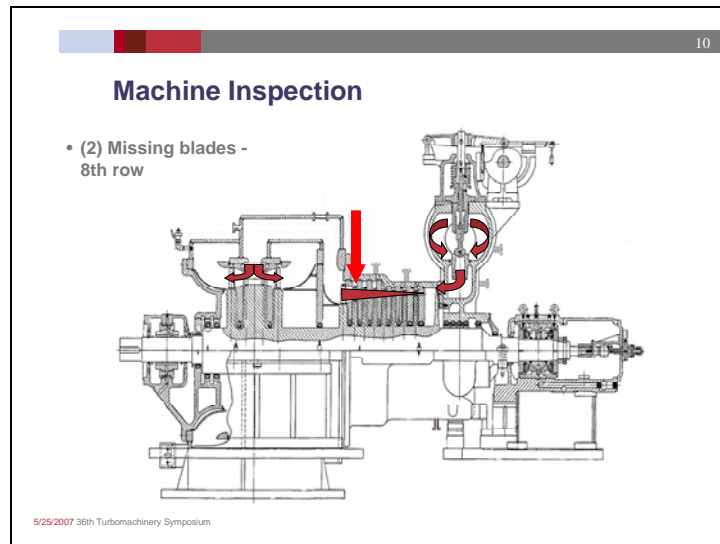
Slide 10

- Discovered (2) blades missing in the 8th row, broken at the root; roughly 40 degrees apart

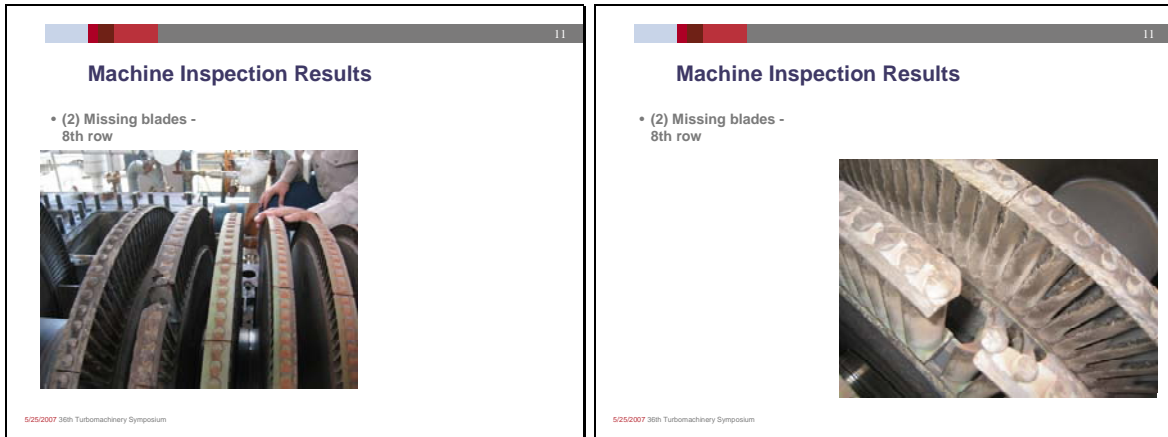
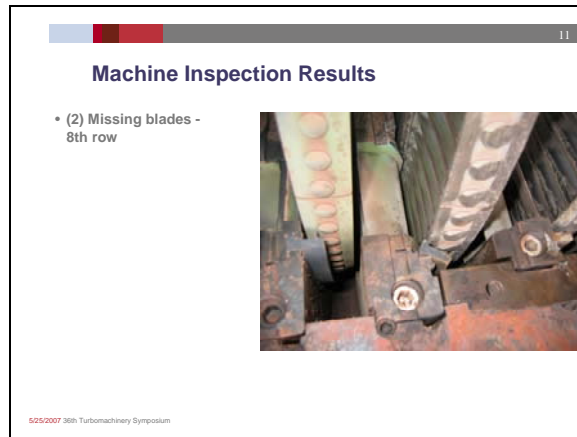
Slide 11

- Heavy rub marks on shroud; damaged tip seal, diaphragms where FOD passed through remaining steam path.
- Largest piece of missing blading discovered (wedged against diaphragm) was roughly the size/volume/shape of a level teaspoon of material.

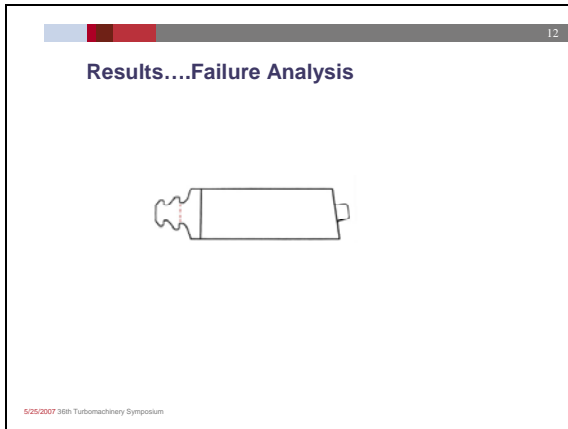
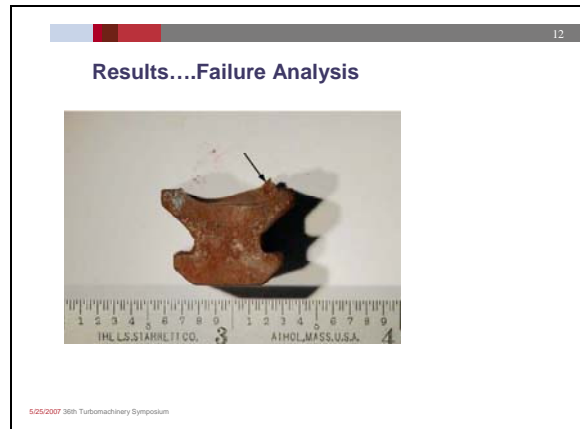
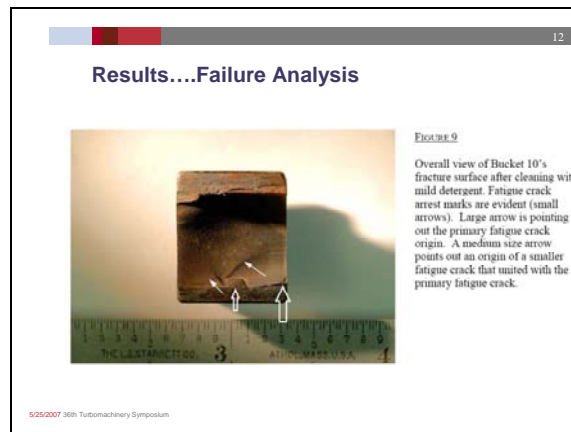
Slide 12

- Photographs from failure analysis report from Dresser showing origin of initiating crack

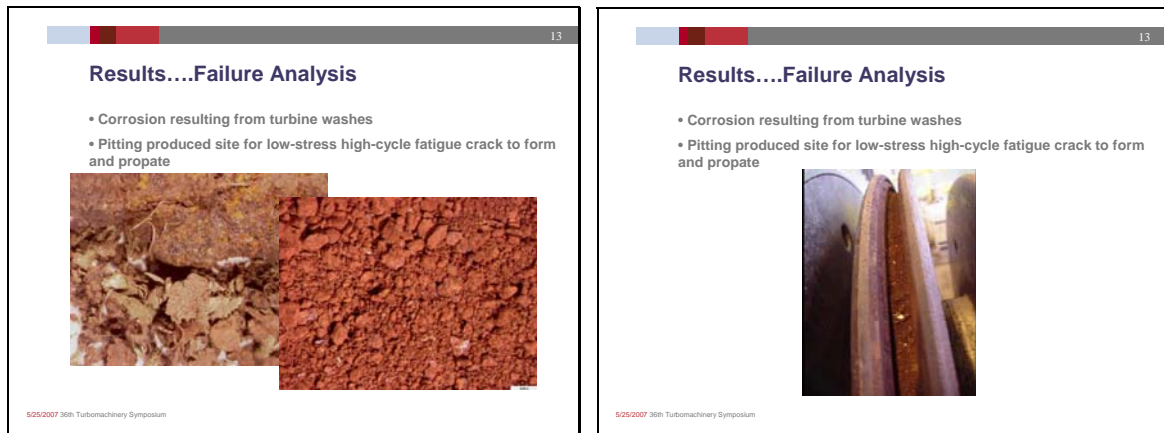
Slide 13

- Had performed monthly turbine washes 2/02 thru 5/03 to re-establish efficiency; corrosion/corrosion products the result of these washes. Washes were necessitated by poor water quality caused by excessive condenser leaks. Condenser has been replaced.
- In removing the blading from the 8th and 9th rows, the corrosion deposits were prevalent in the 8th stage.

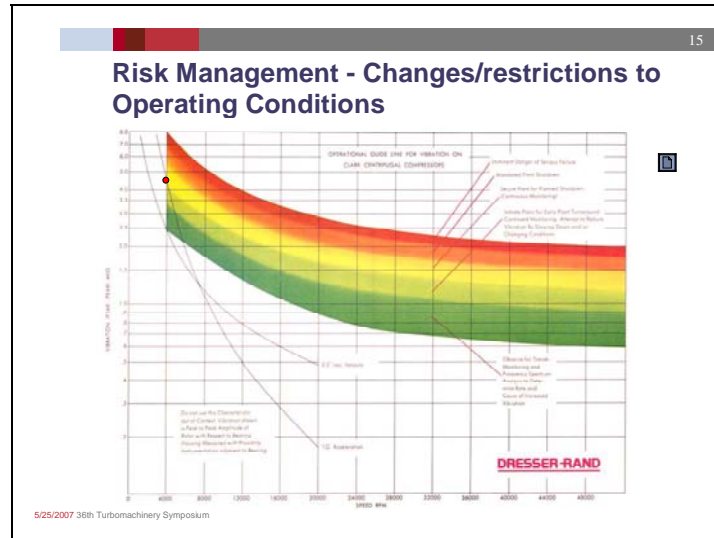
Slide 15 (Supporting Info for Slide 7)

- Rotor showed 4.5 mils direct amplitude
- Interlock scheme set at 2 for alert (1 vote in), danger at 6.5; 1 alert vote + 1 danger vote on same bearing needed for interlock
- Considered potential failure modes of system and hazards associated with possible failures:
- Turbine protected from excessive damage by interlock; moved danger from 6.5-10 mils (based on severity chart); 10 mils within bearing clearances, provide margin for potential spike.
- Concerned with peripheral systems and potential hazards; governor oil/fire, stainless instrument tubing failure, etc.
- Decided to operate machine on speed control--typically operated on suction pressure control—to reduce likelihood of “moving/shifting” the rub, possibly worsening or interlocking the machine and not being able to bring back up through criticals.
