FORENSIC ENGINEERING ANALYSIS OF A COMBUSTION TURBINE COMPRESSOR BLADE FAILURE

Teodoro Leon-Salamanca, Ph.D.
Reinhart & Associates, Inc.
Austin, TX

PROBLEM STATEMENT

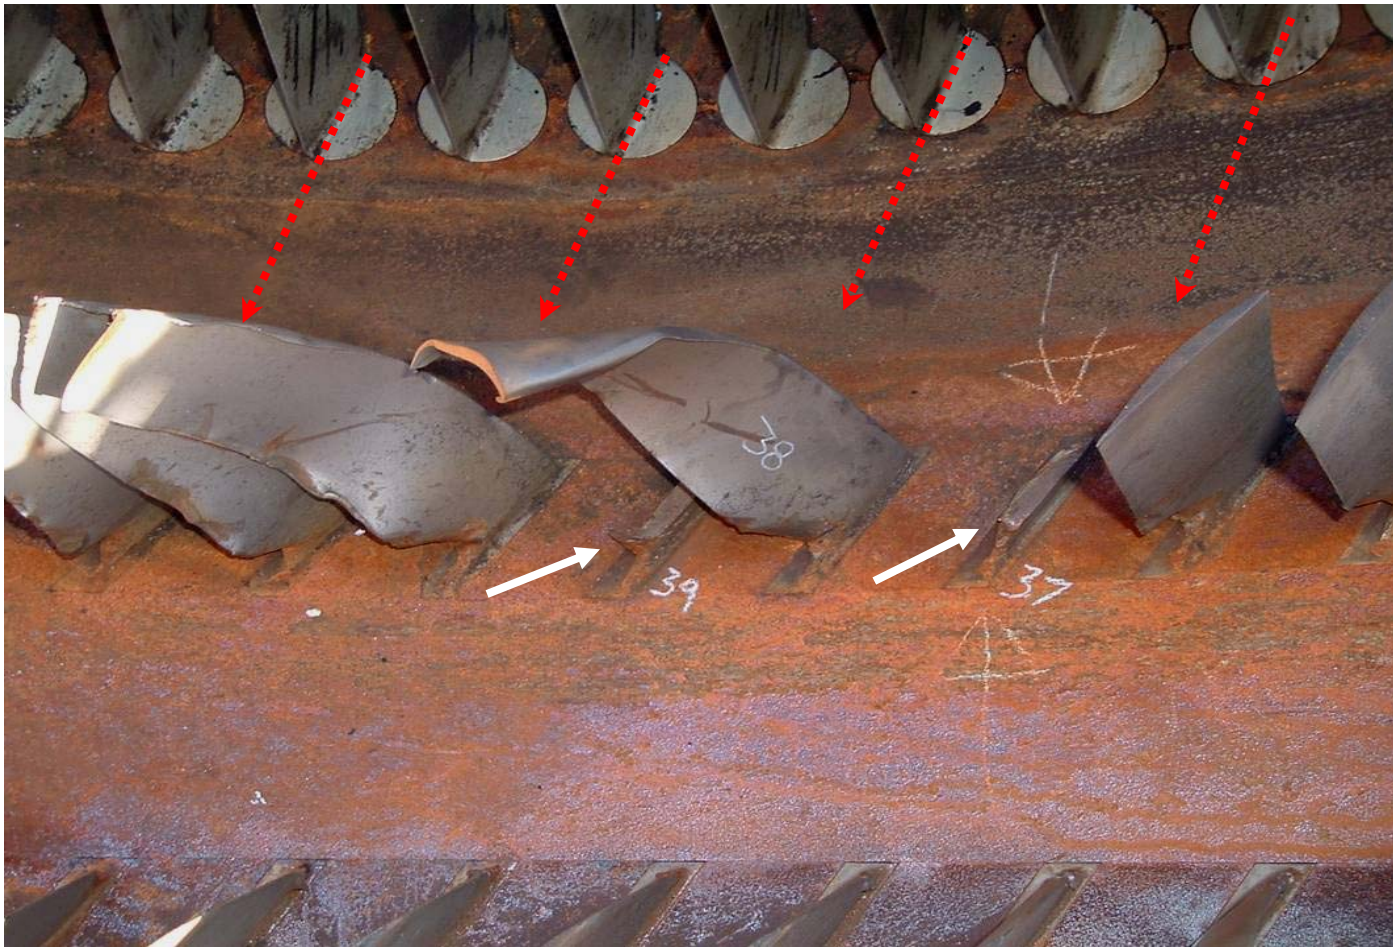
Two stationary blades from the first stage had failed and came apart at the blade root. These two failed blades were pushed through all the compressor blade stages down stream inducing severe damage on all the stationary and rotary blades of the compressor.

Photo of the compressor stationary first stage failed blades. White arrows point at two out of five failed blades. Red dotted arrows show air inlet flow direction

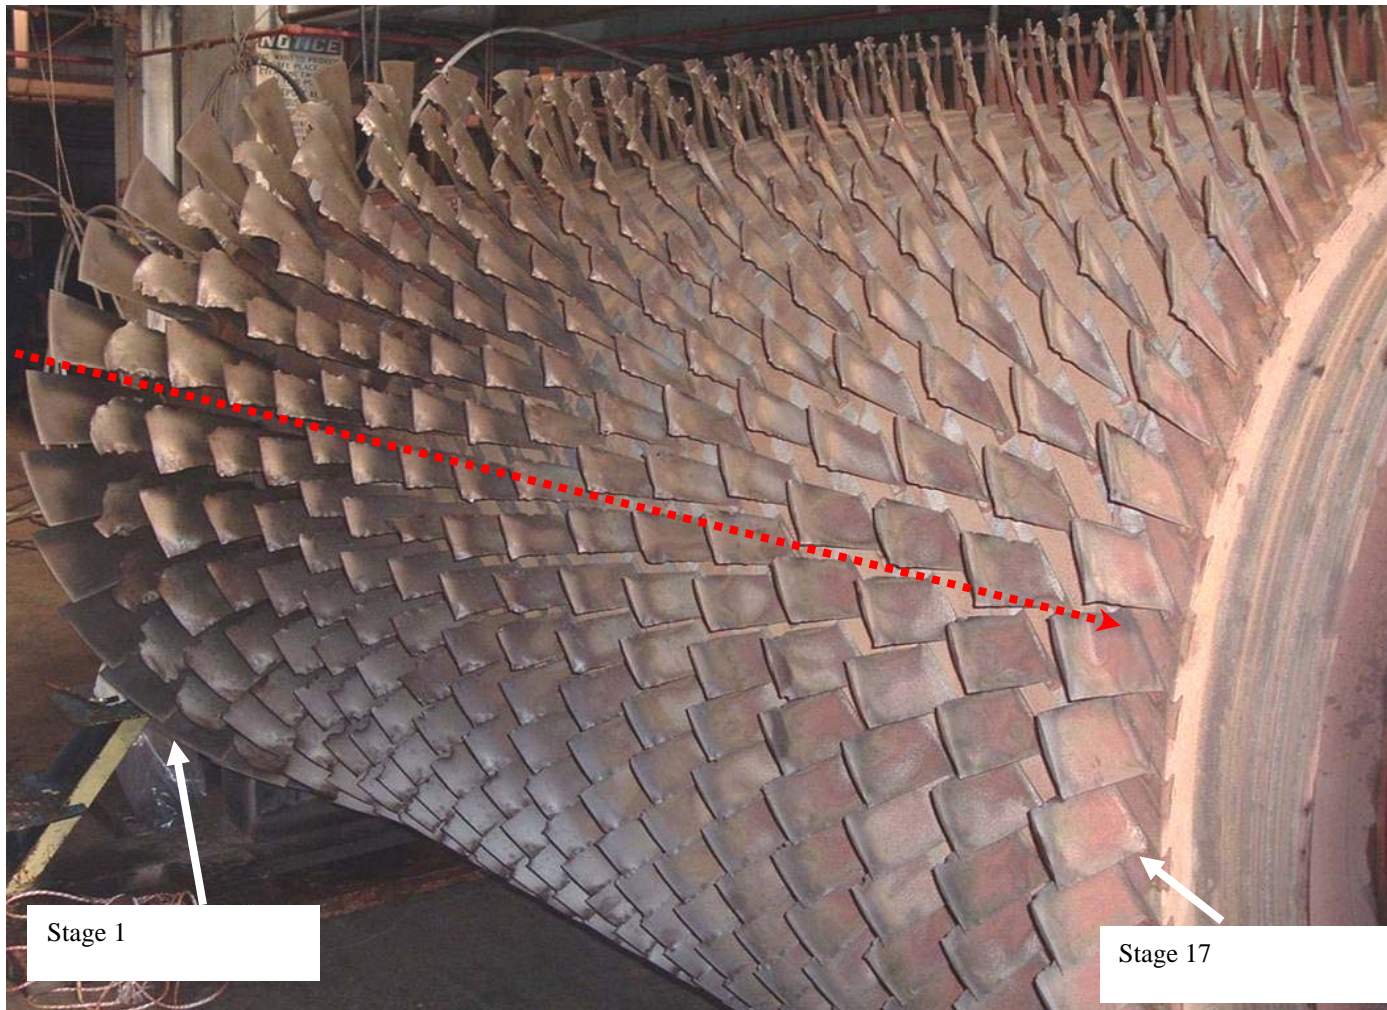
Severe mechanical damage observed on the compressor rotor blading caused by the stationary failed blades. Red dotted arrow shows air inlet flow direction from stage 1 toward stage 17.

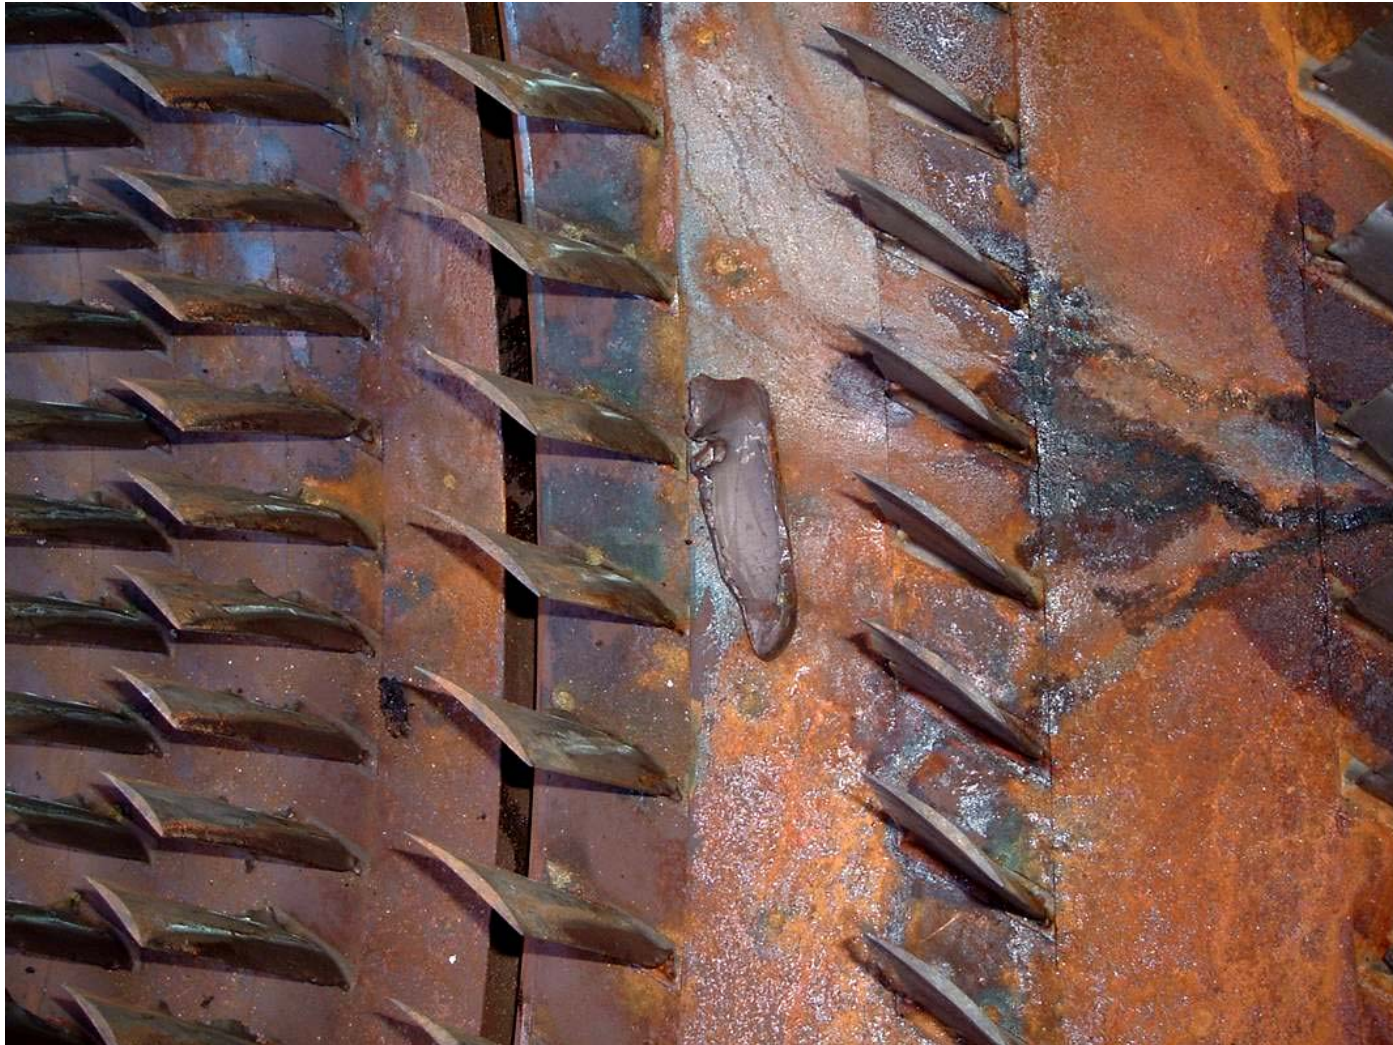
Photo of compressor stationary blading (lower half) showing a piece of a blade severed from the first stage failed blades

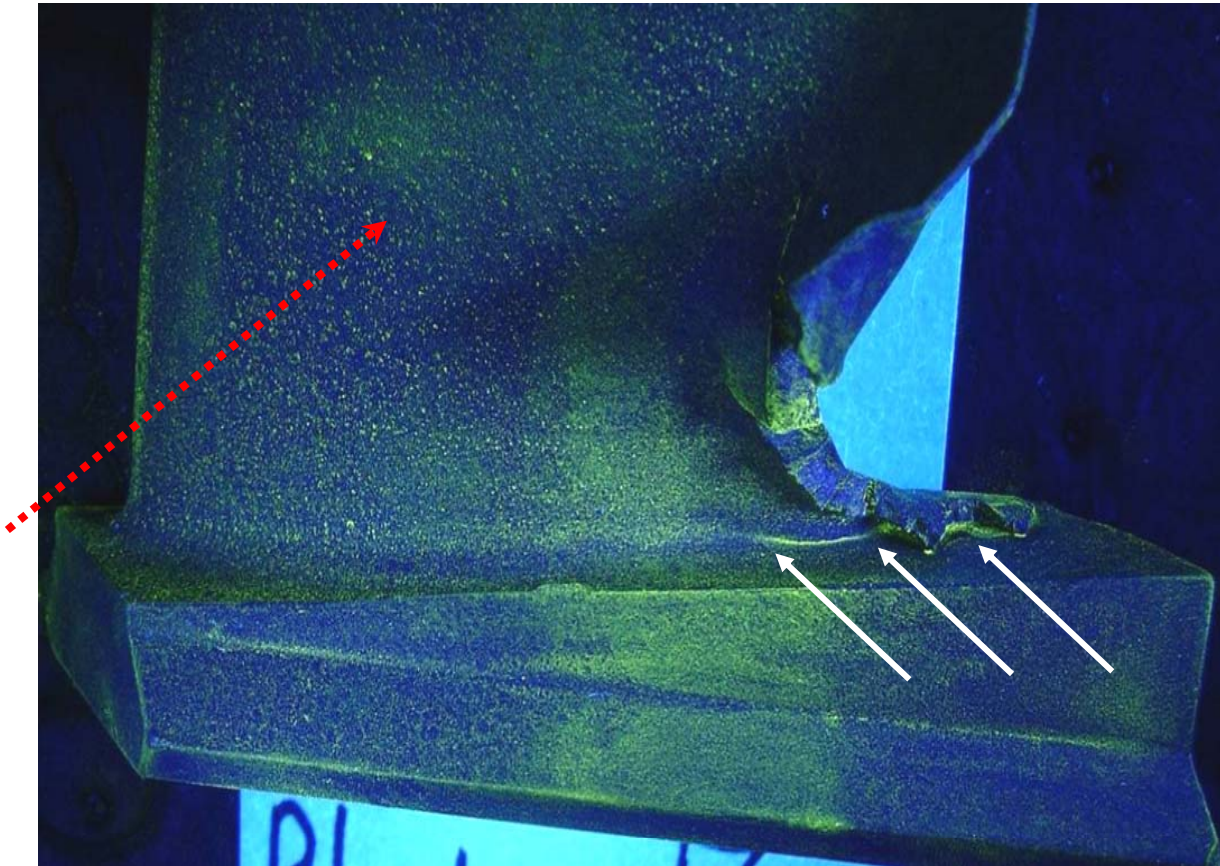
Wet fluorescent magnetic particle testing (WFMT) linear indications were detected in several other blades in stage one of the compressor stationary blading. These indications were located away from the mechanical damage caused by the failed blades.

WFMT linear indication located near the root of a compressor stationary blade as shown by the white arrows (red dotted arrow shows air inlet flow direction). This type of linear indication is located away from the mechanical damage caused by the failed blades and it was observed on several of the compressor stationary blades removed for analysis

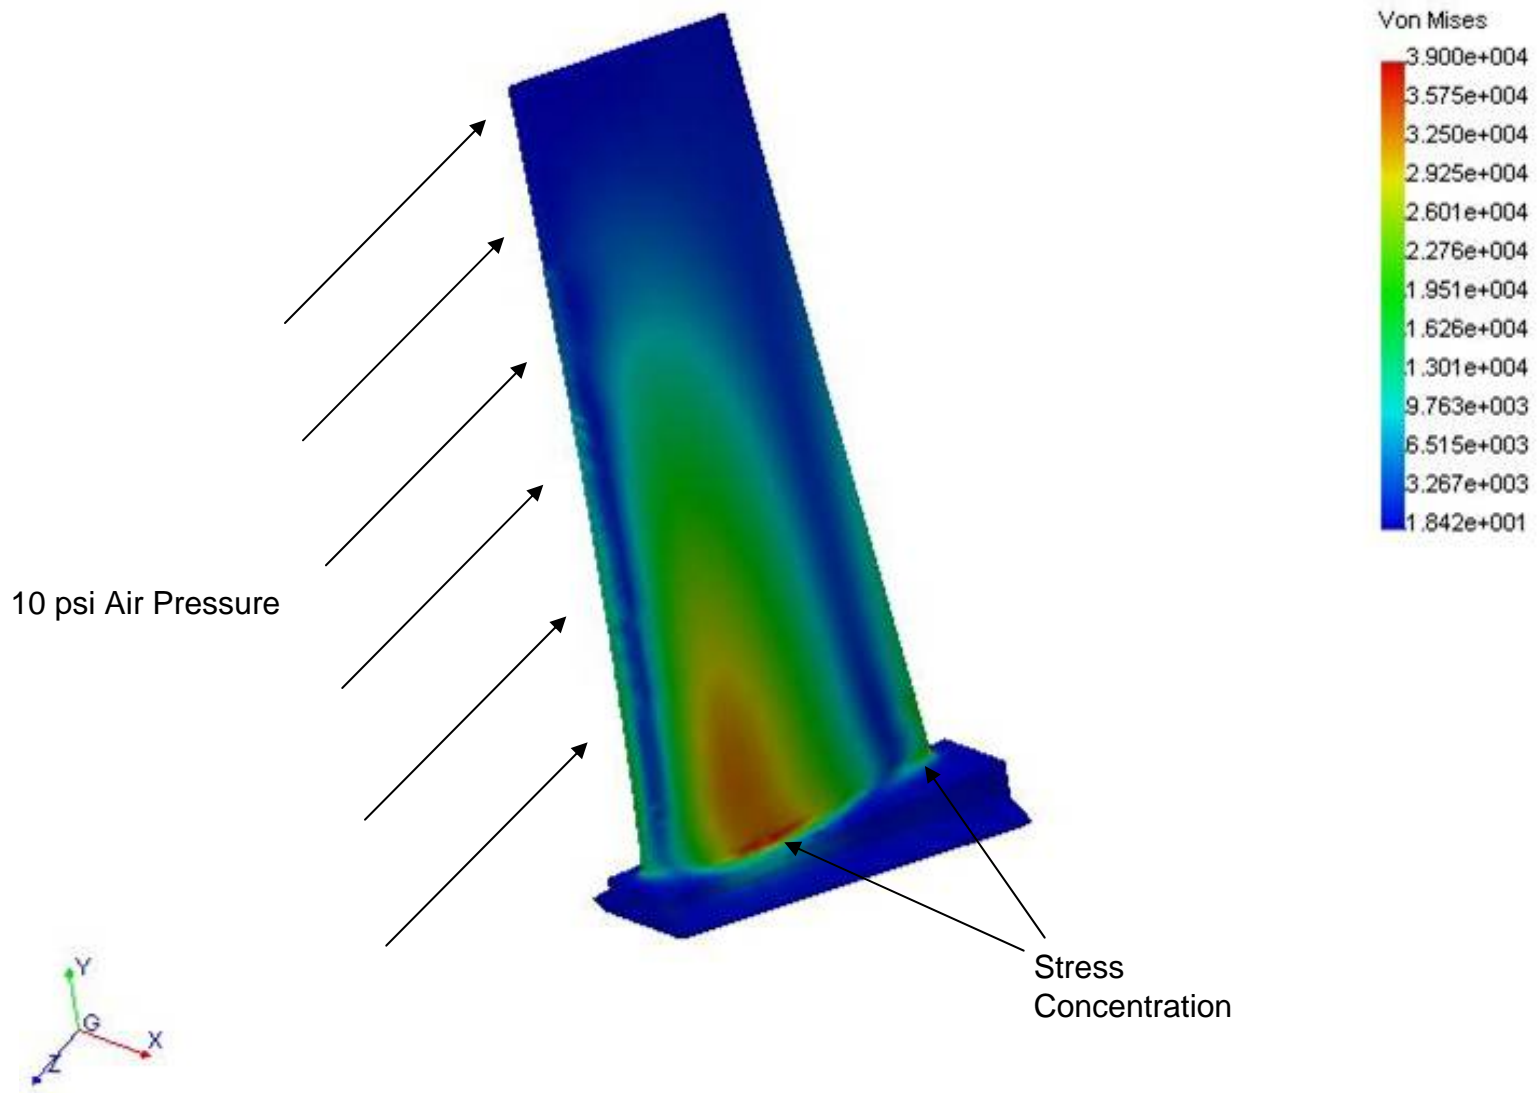
Finite element stress analysis plot of stationary compressor blade subjected to a 10 psi air pressure.

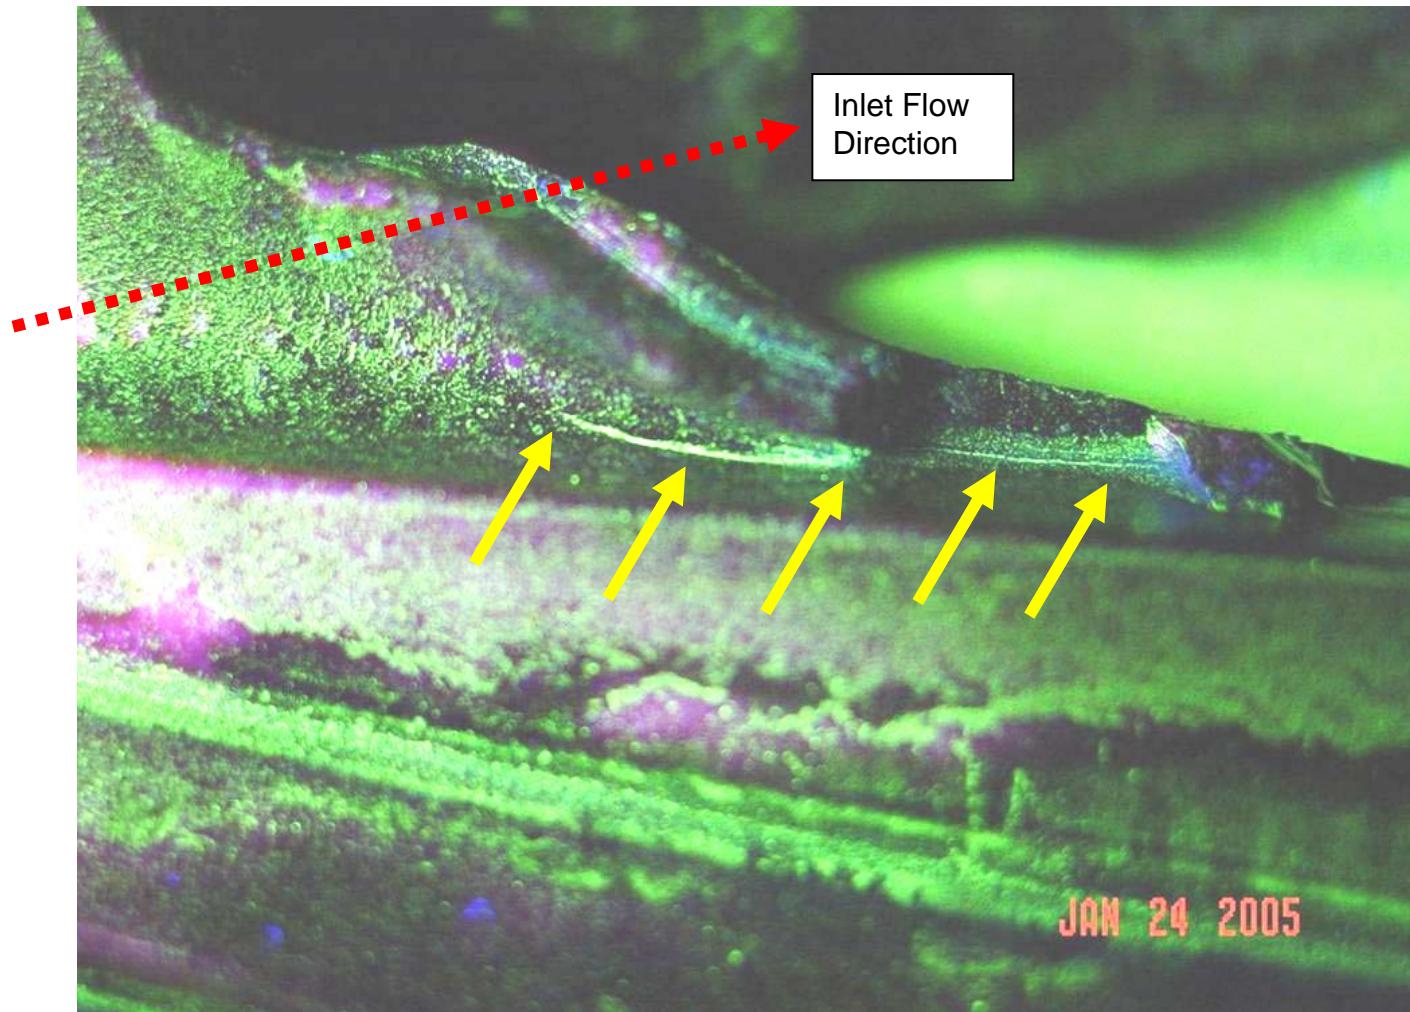
WFMT linear indication located at the root of a blade as indicated by arrows. Flaw located under mechanical damage

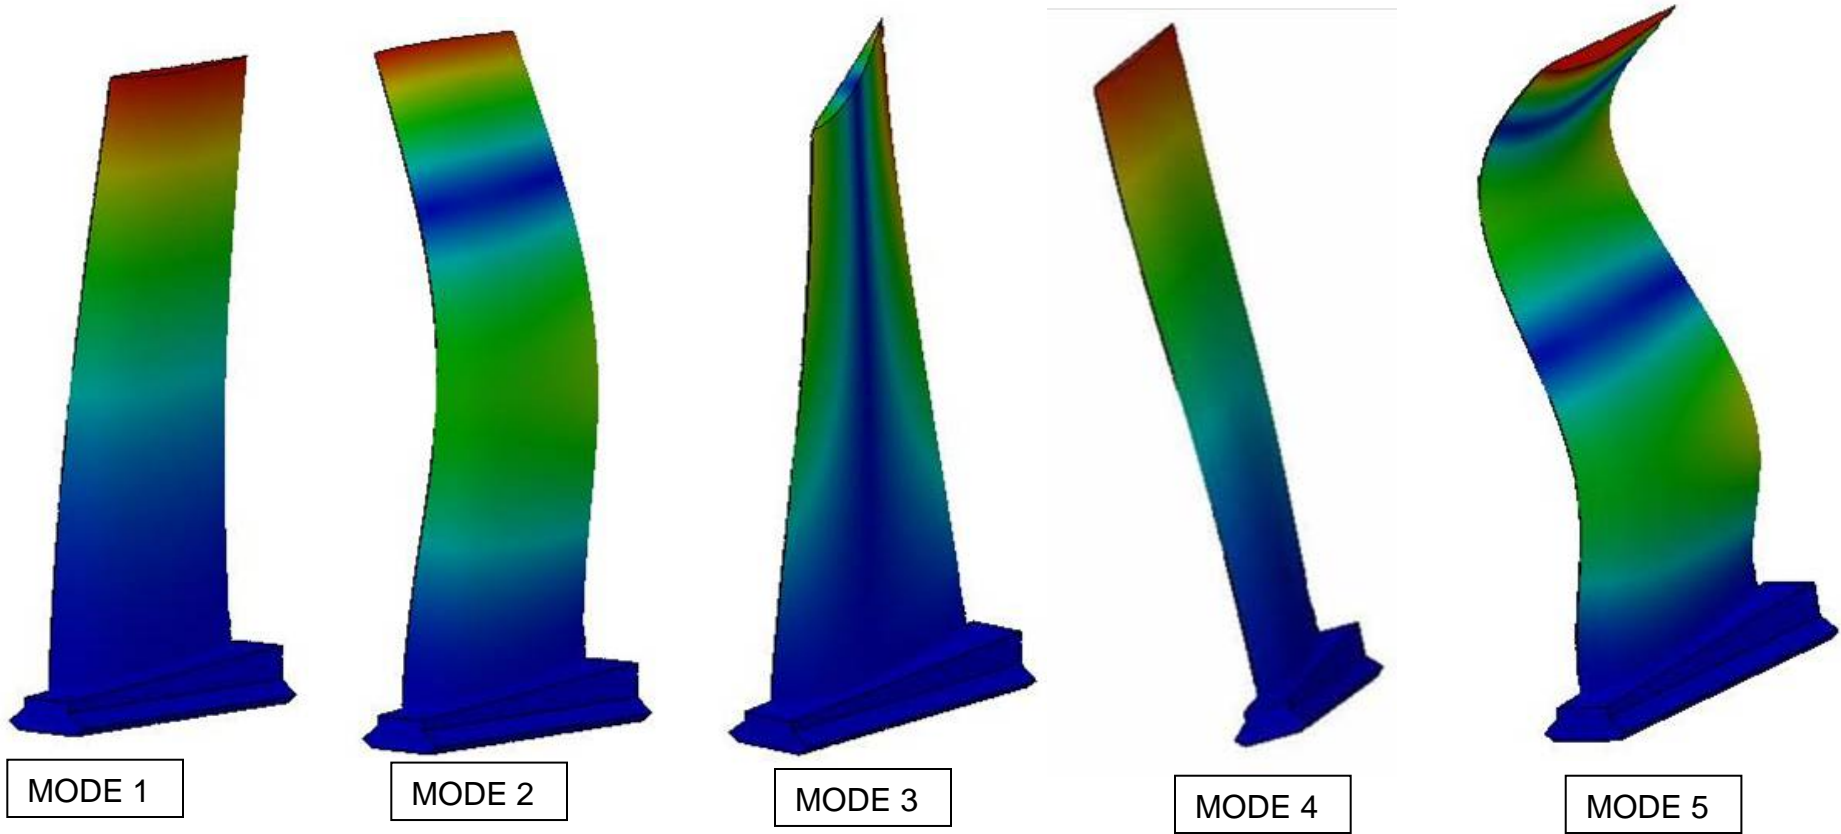
Compressor stationary blade five modes of vibration. The red color indicates the areas of maximum displacement

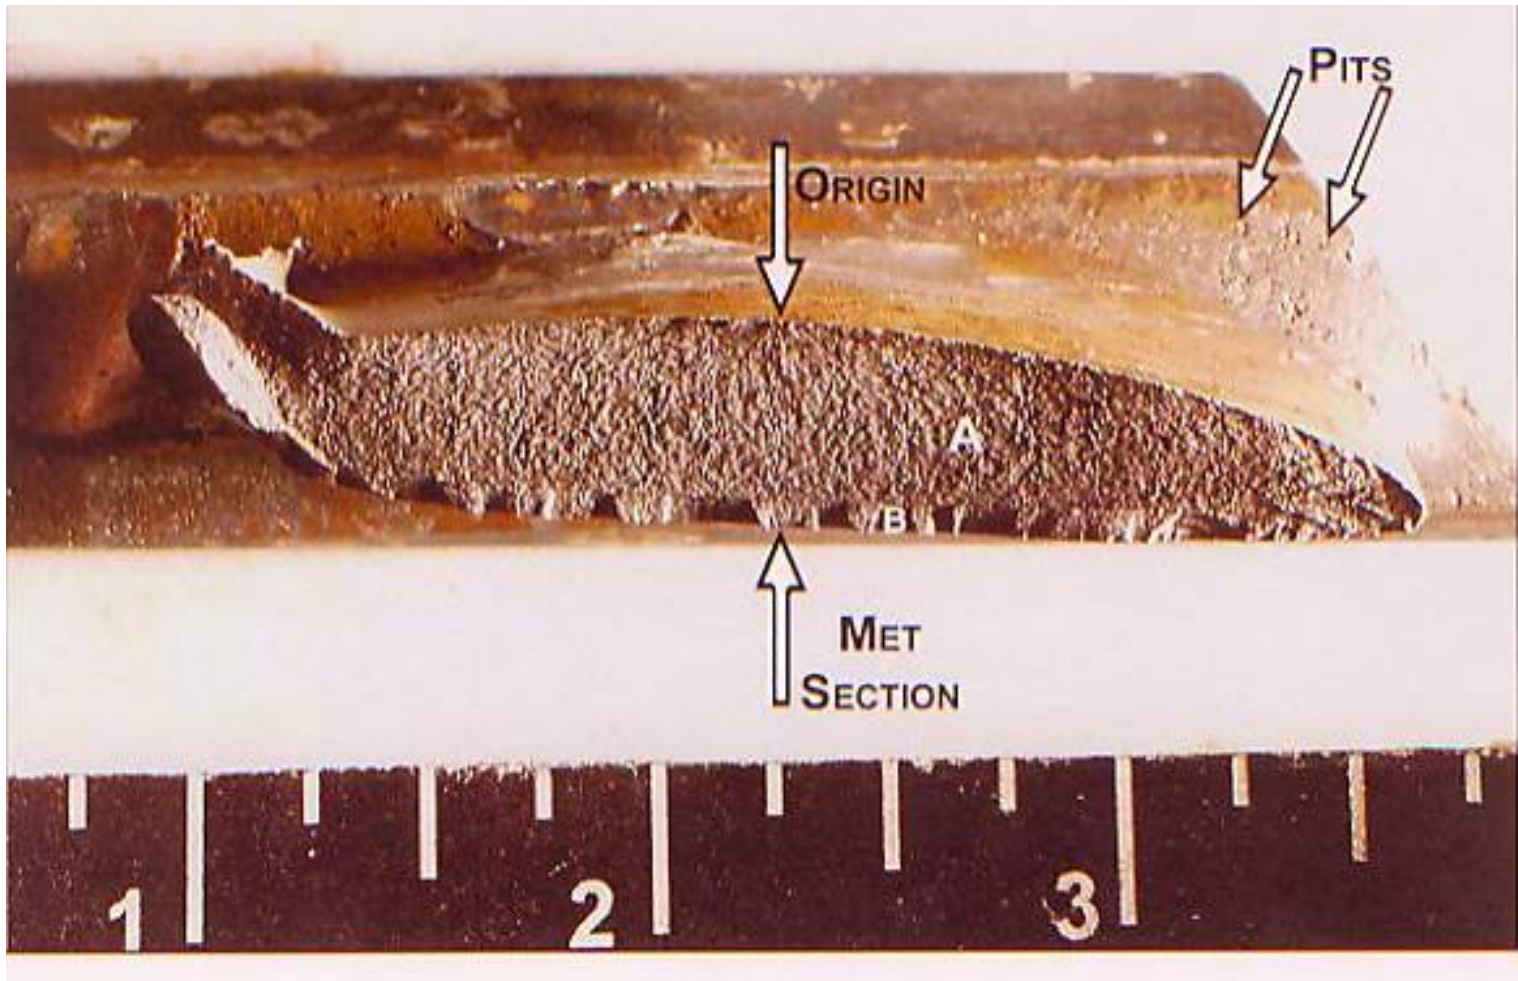
Fracture face of failed blade after solvent cleaning showing areas A and B, origin at curved face of the blade and external pits (Magnification 1.8X)

Based on all the results from the three main tasks described above, it was found that the combustion turbine compressor stationary blade failure was caused by stress corrosion cracking which is a combination of three main factors, repetitive tensile stress, corrosive environment, and material susceptibility to corrosion.

It was recommended that one or more of these factors be controlled to minimize the reoccurrence of stress corrosion cracking. The utility changed the material for one that is not susceptible to corrosion in this case from 410 SS to 403 SS turbine quality steel with protective coating. Also, the utility installed a system at the intake of the compressor to control the humidity when the unit is not in service.

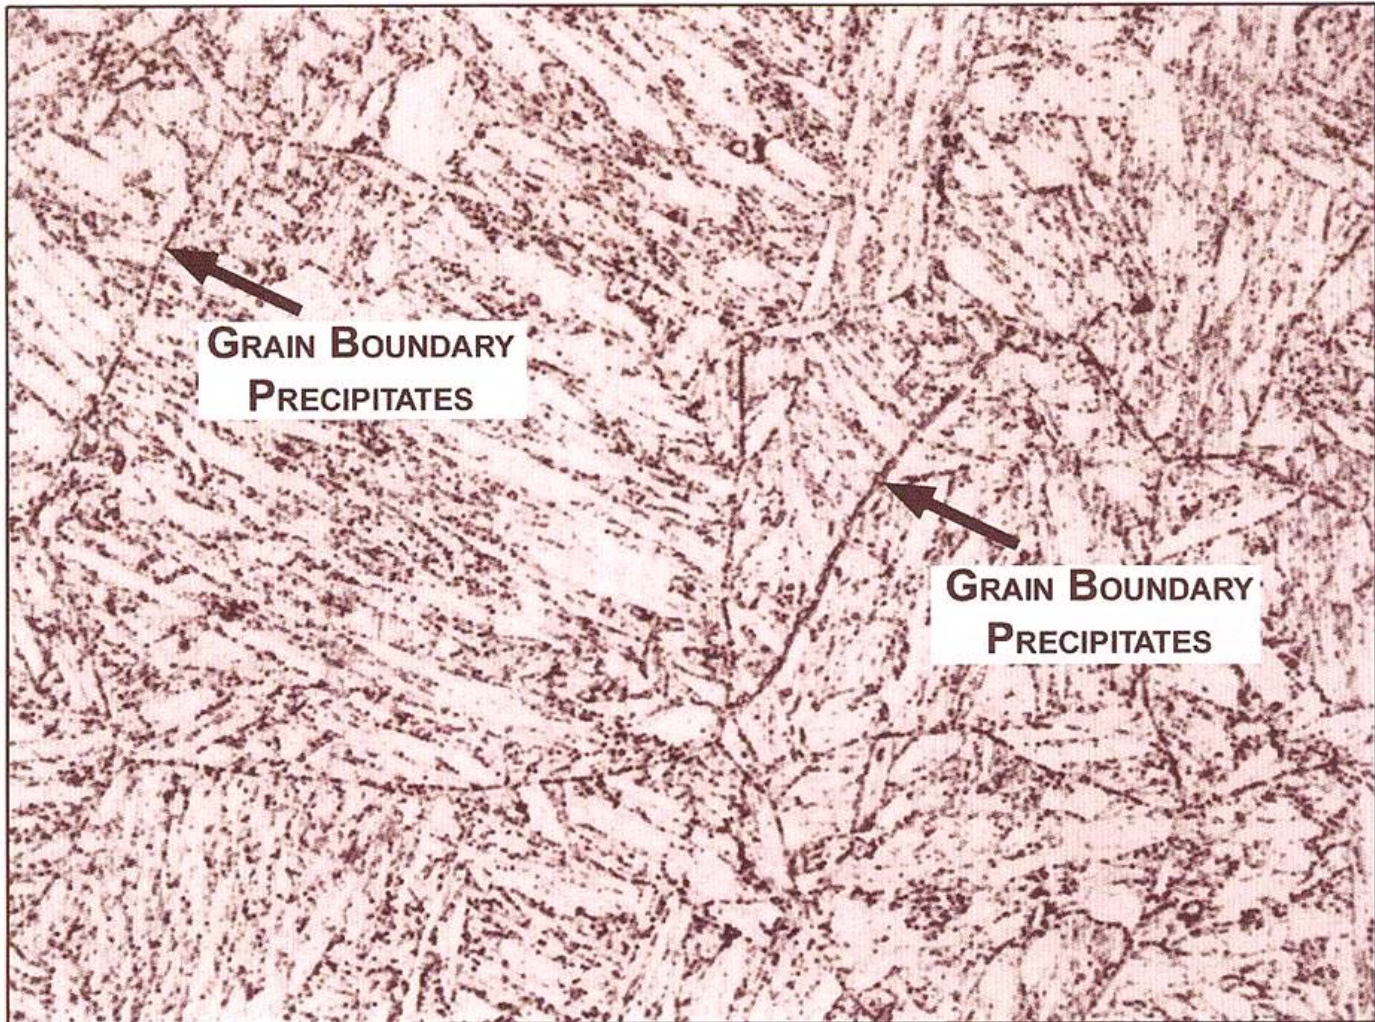
Typical microstructure of 410 SS blade material showing tempered martensite and grain boundary precipitates (Magnification 1300X)

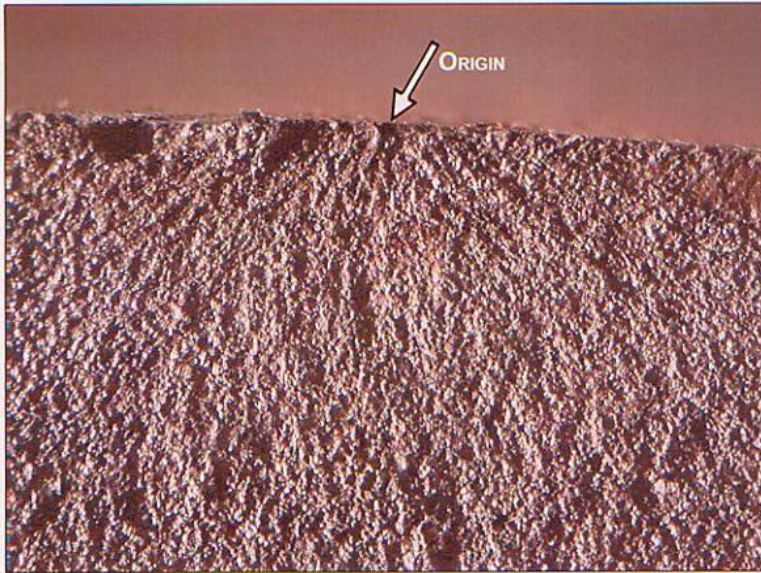
Origin area showing a corrosion pit on the fracture surface area (Magnification 16X)

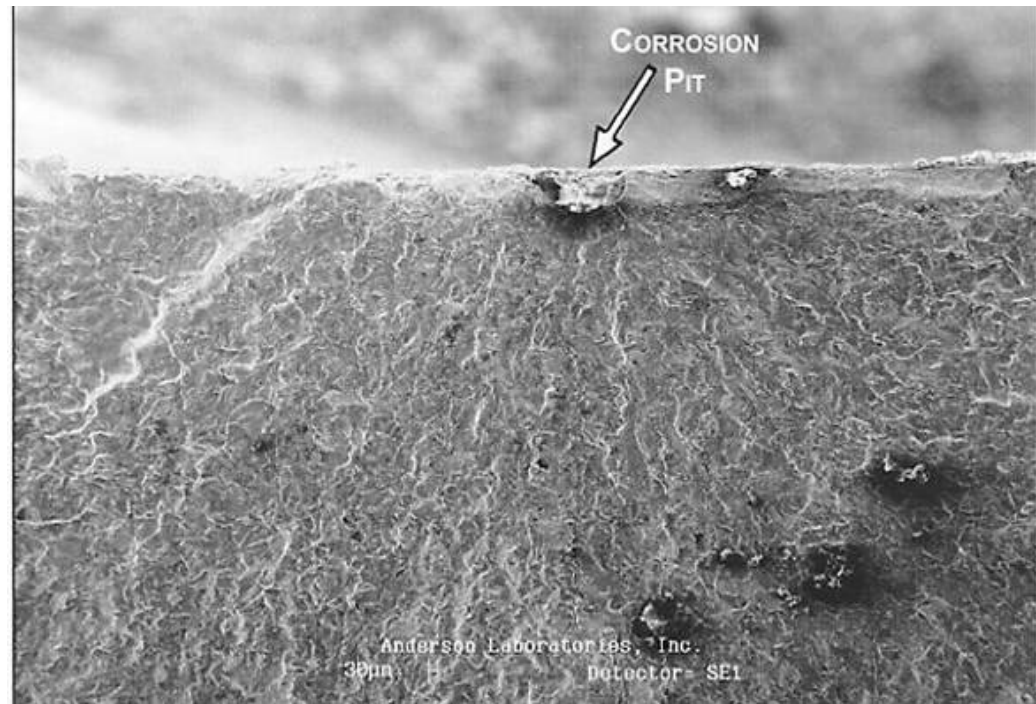
Scanning Electron Microscope (SEM) image of the pit at the fracture surface area A at 50X magnification. Corrosion and mechanical damage are also observed

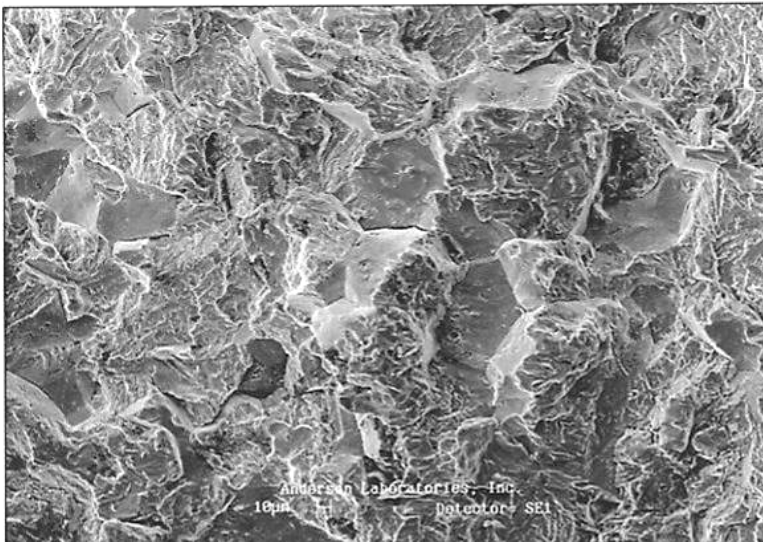
SEM image at 270X of fracture surface area A showing typical failure mode containing significant intergranular separation

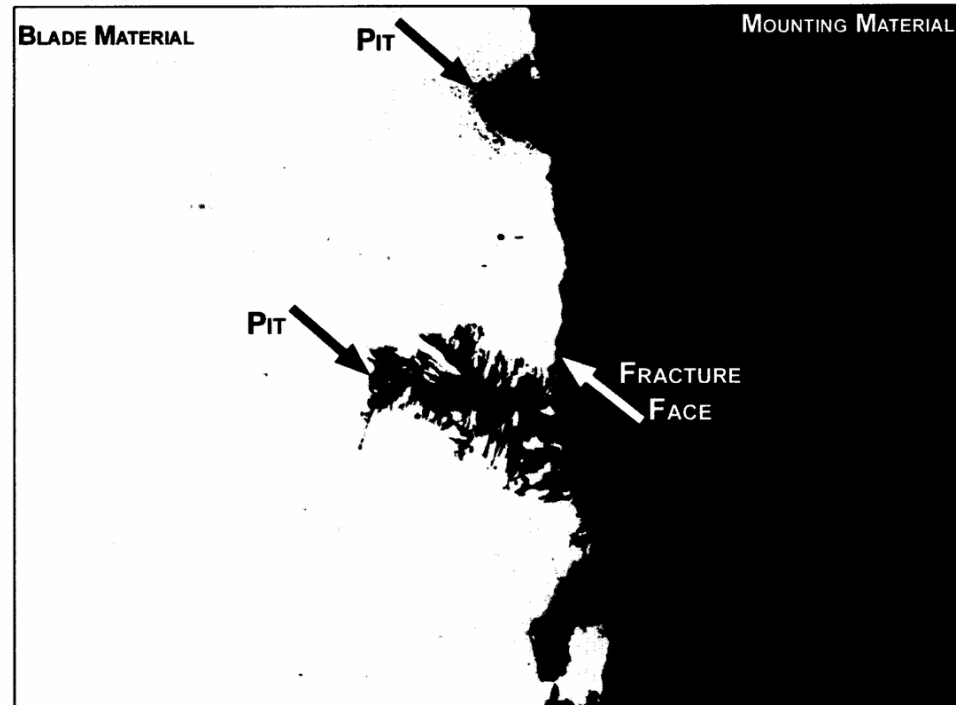
Fracture face of the blade showing pits at 650X

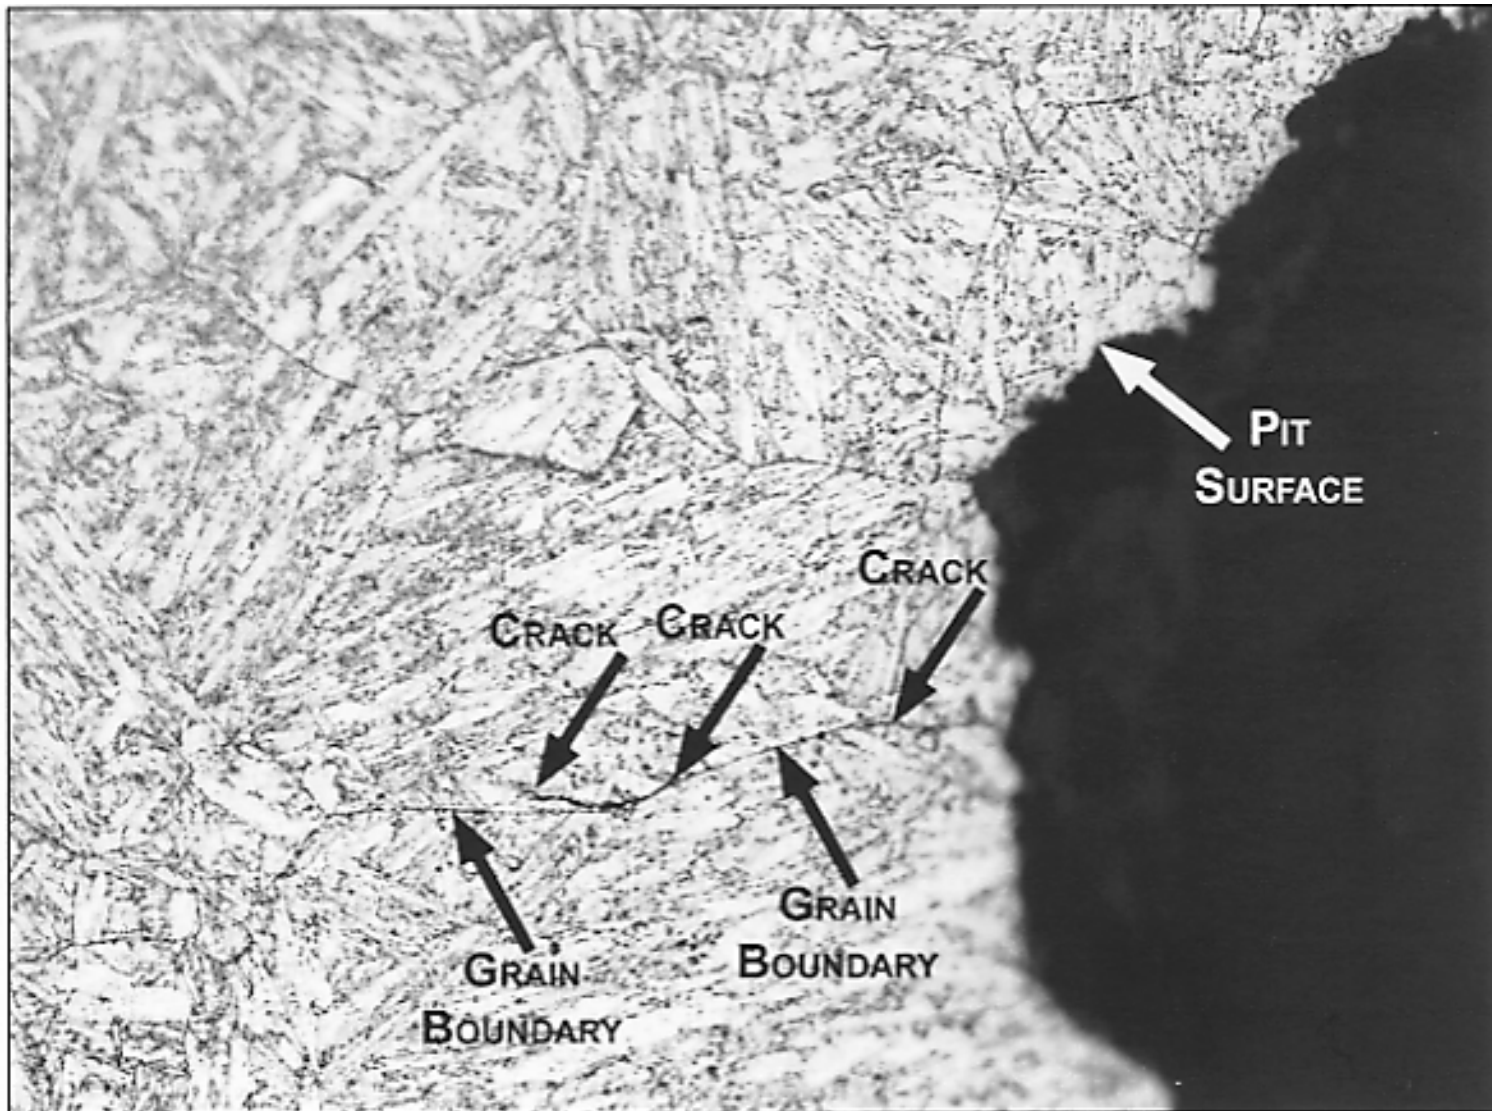
Image at 250X of the fracture surface of the blade showing a pit and a small crack along a grain boundary extending from the bottom of a pit
