A Sub-Synchronous Vibration Problem:

Trapped Fluid in Compressor Coupling Spacer

Diagnosis and Resolution

John E Sutton
Chevron Energy Technology Company Pty Ltd
Perth, Western Australia
john.sutton@chevron.com

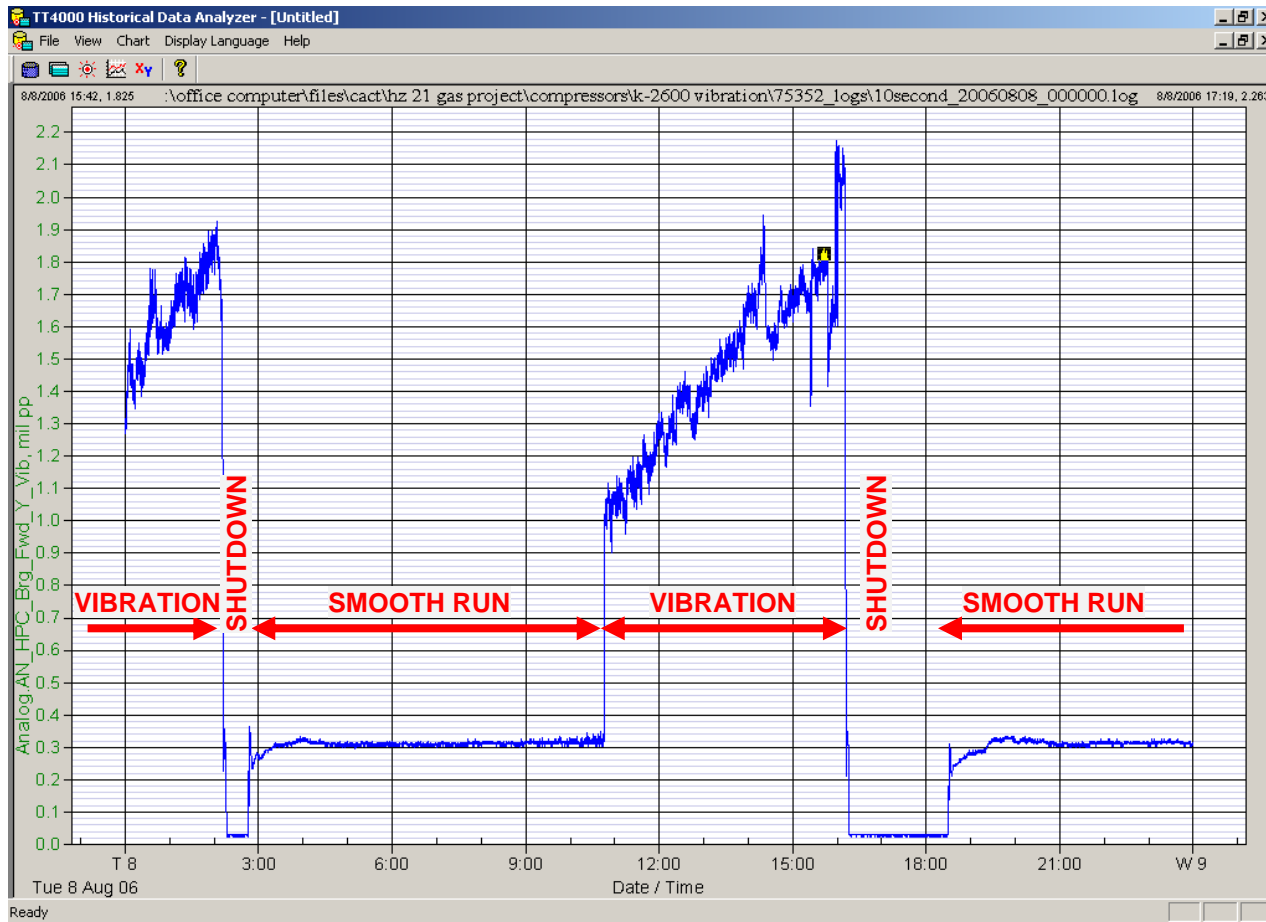
Characteristic Vibration Curve

After the vibration started, it would gradually increase over the next several hours until reaching the limit to cause compressor shutdown. After a short shutdown (~ 1 hr), the compressor would be restarted and the cycle repeated.

- Vibration was in compressor driven end only, not non-driven end.
- Turbine driver is not fitted with vibration probes.

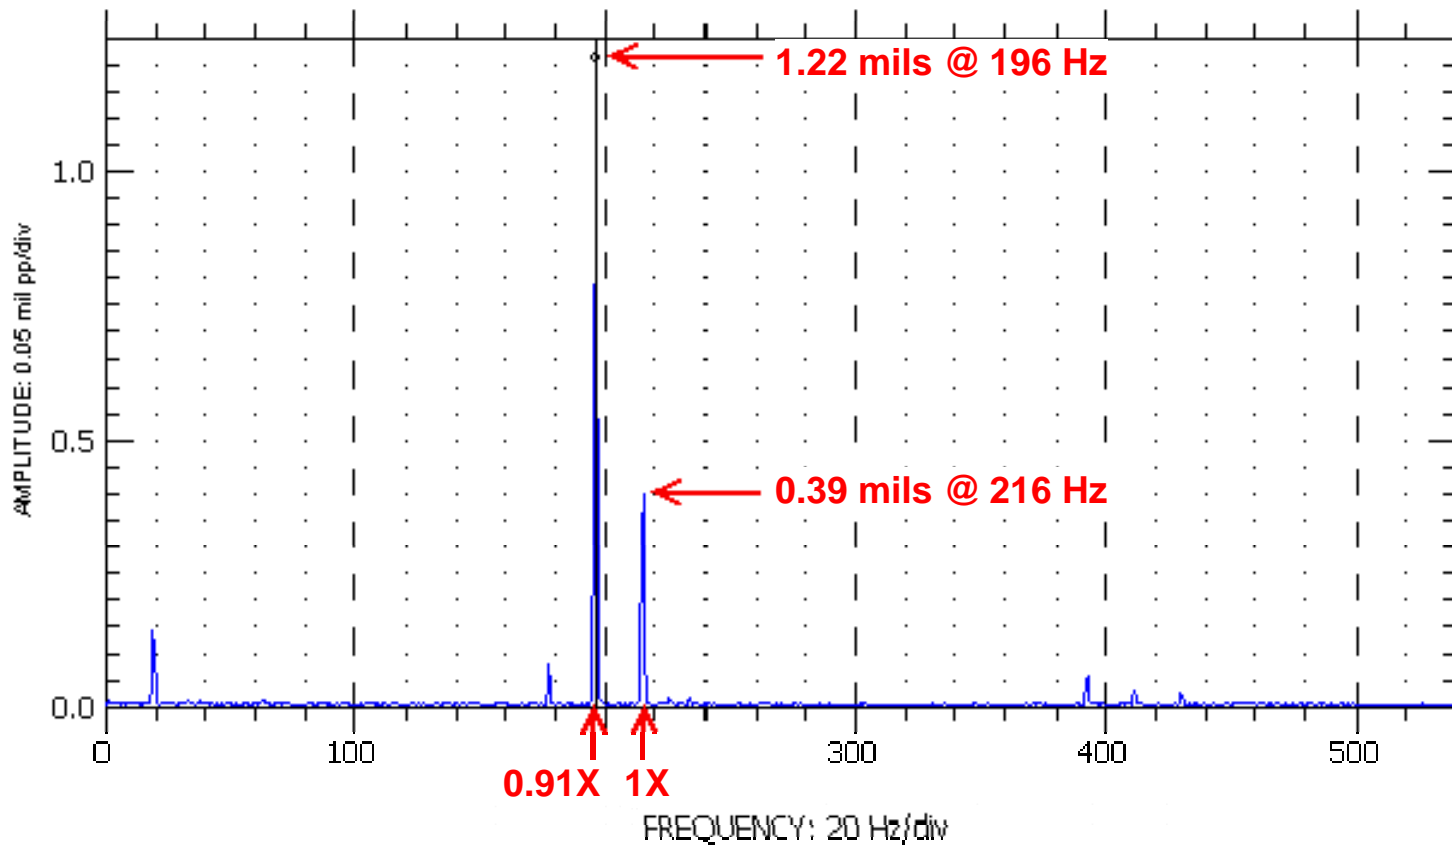
Vibration Spectrum

The vibration was sub-synchronous, with a vibration frequency at 93% of compressor operating speed.

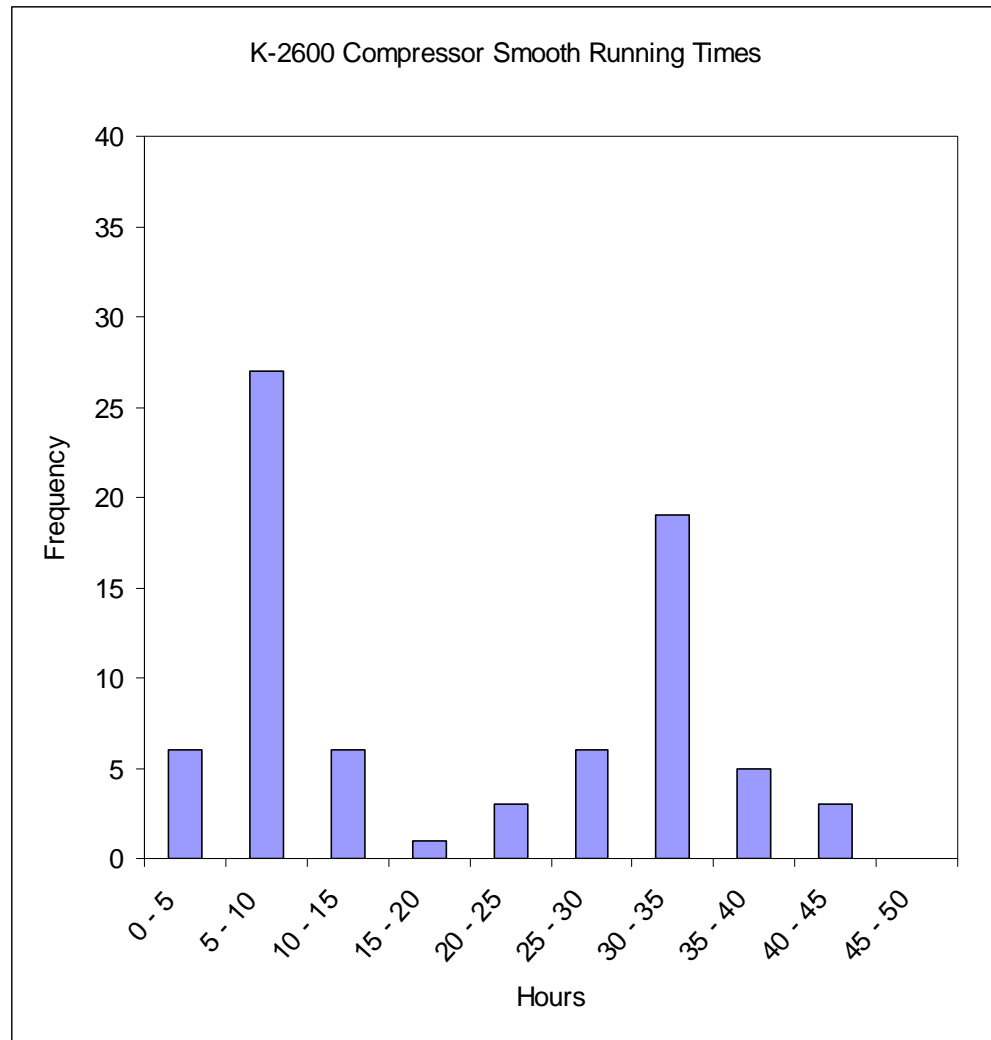
Smooth Run Times

The compressor would usually run smoothly either about 10 hours or 30 hours before onset of vibration.

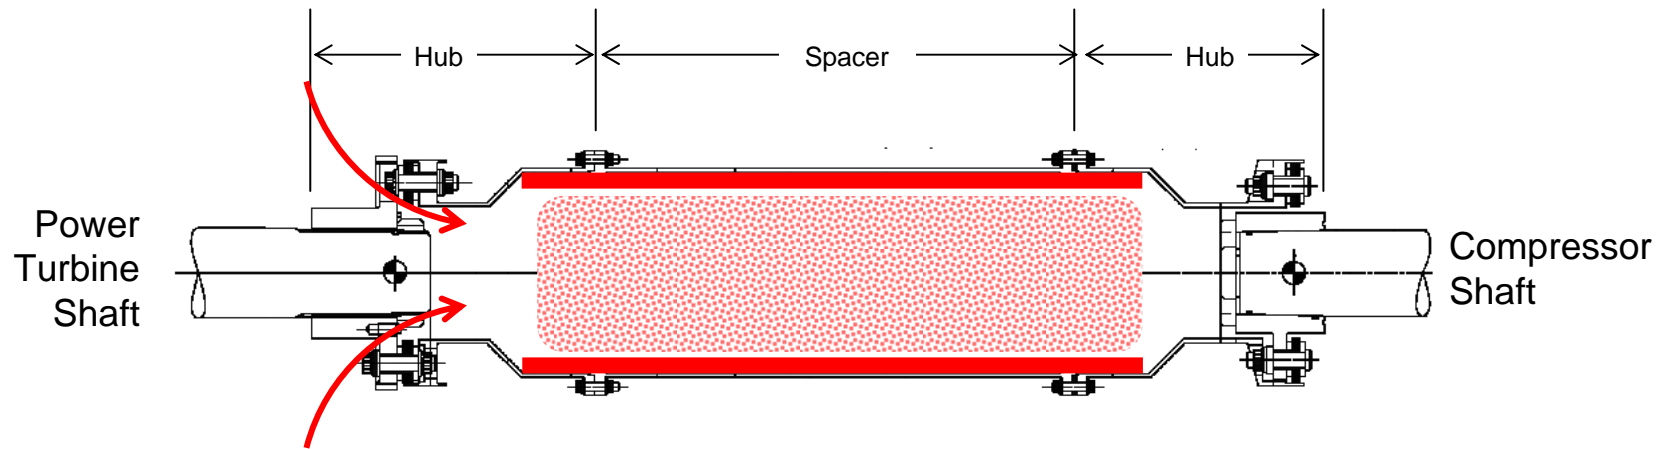
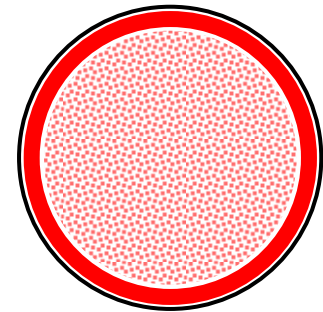
Compressor Coupling

Lube oil is drawn into the spacer. As it rotates, the oil is trapped against the wall of the spacer. Spacer design has internal lip which prevented oil reaching existing weep holes in the end hubs.

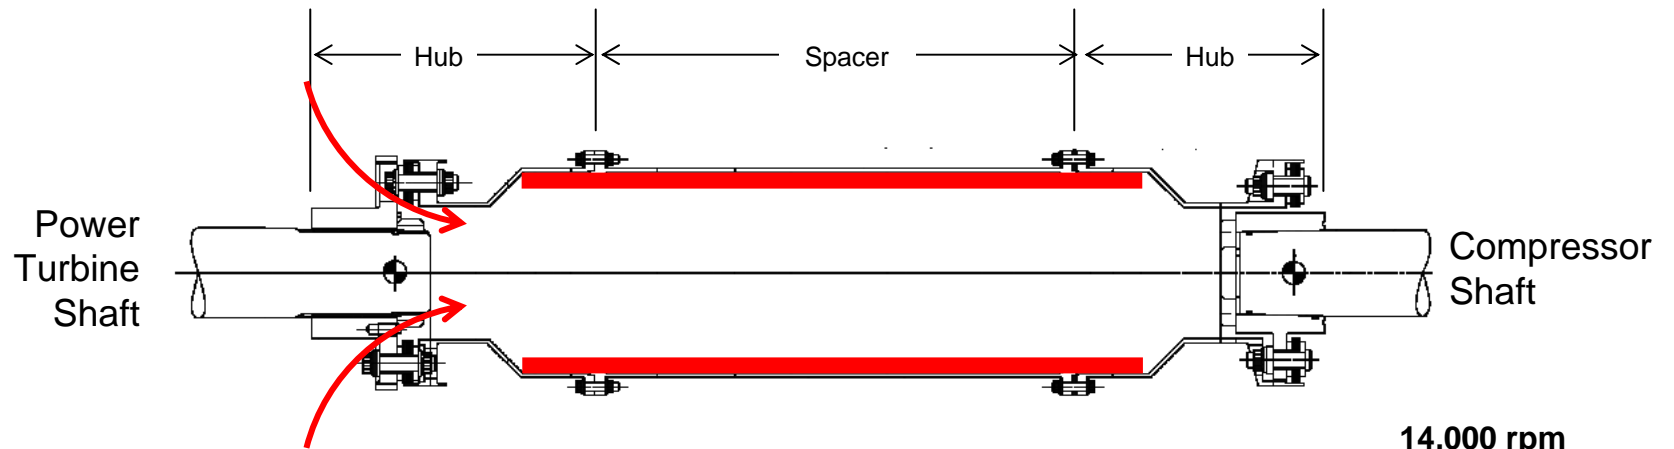
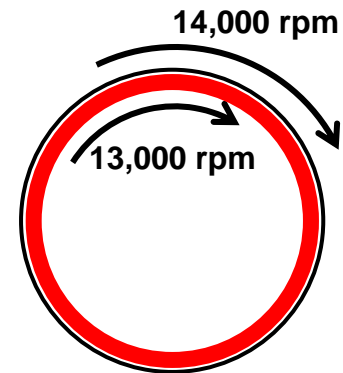
Compressor Coupling

Because of viscous drag, the oil layer spins at a speed slightly less than the coupling speed (93% of compressor operating speed).

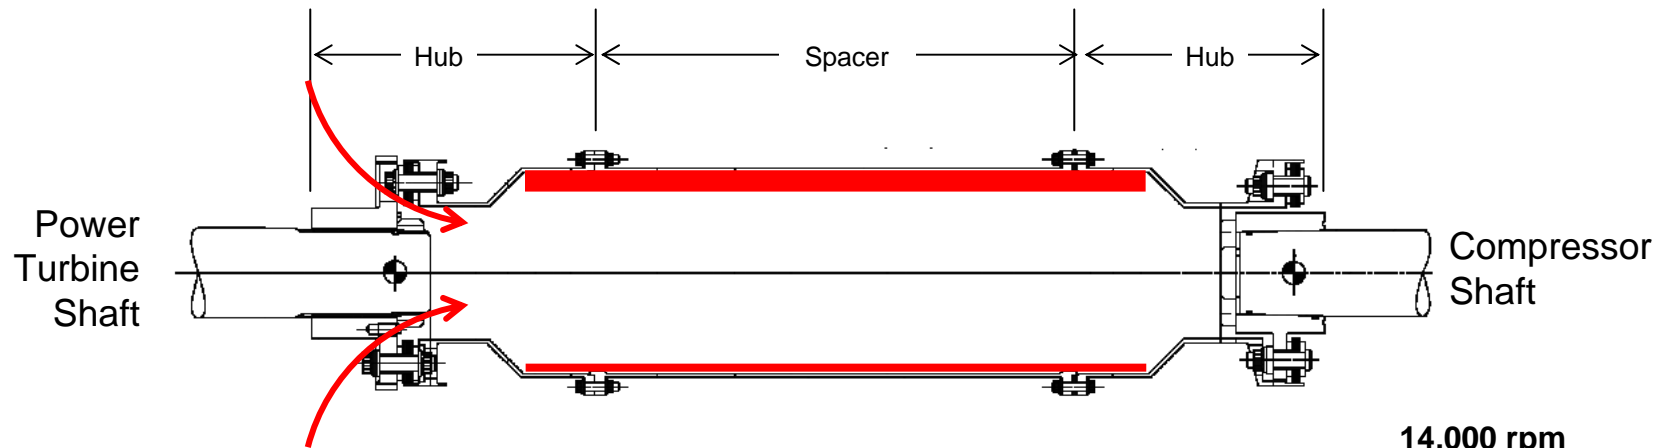
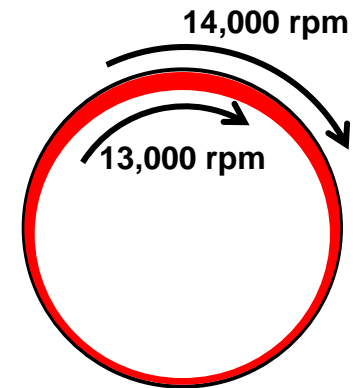
Compressor Coupling

When the trapped oil layer builds up, the fluid distribution is unbalanced and vibration starts. As more oil enters, the distribution becomes more unbalanced and the vibration increases in magnitude, causing the “ramp up” feature of the vibration curve. The vibration is at 93% of compressor operating speed.

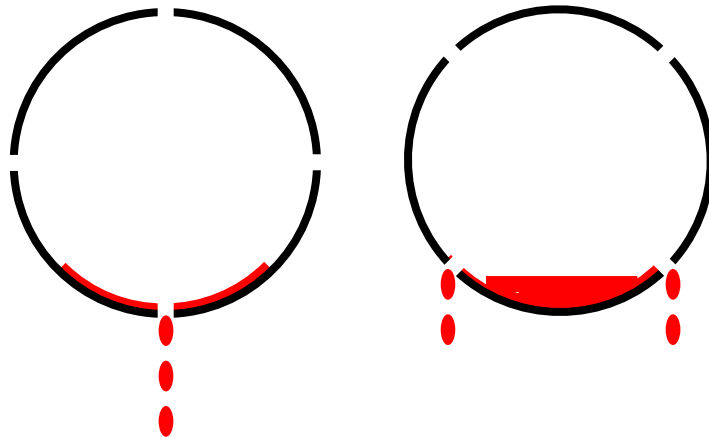
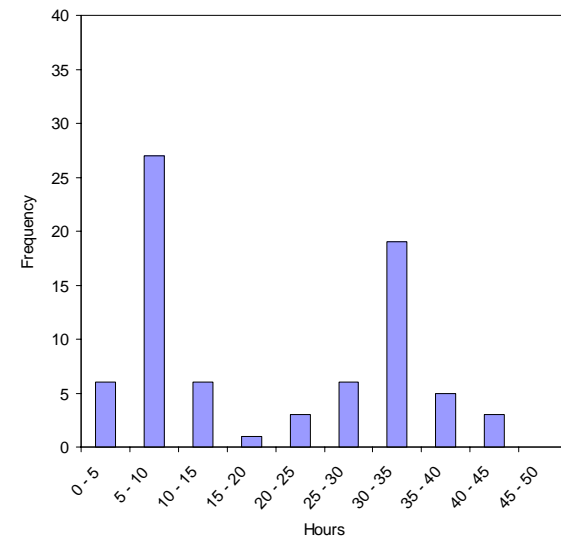
- There were existing weep holes in the coupling hubs, spaced at offset angles. If one of the holes was at or near the bottom of the coupling when it stopped, the oil would drain to the maximum extent possible, and the unit would subsequently run for about 30 hours. However, if none of the holes was at the bottom of the coupling when it stopped, the oil would only partially drain and the unit would subsequently run for only about 10 hours.
