# REPAIR TECHNOLOGIES OF MECHANICAL DRIVE STEAM TURBINES FOR CATASTROPHIC DAMAGE

Mitsubishi Heavy Industries, Ltd.

## ABSTRACT

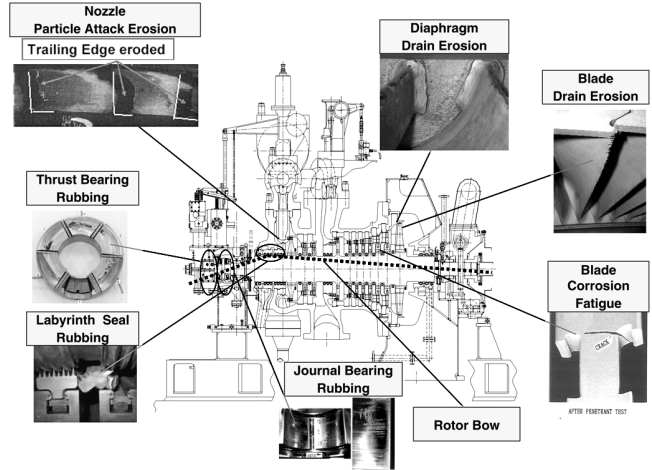
Figure 1. Failure Damage Map.

In Figure 1, a typical damage condition is shown in the steam turbine cross section. The first stage nozzle profiles are eroded at the trailing edges, due to contact with hard solid particles. The flow path of the diaphragm and blade profiles at the leading edges in the low-pressure (LP) high moisture section are eroded by water droplets. In some cases, the welded zone of the nozzles are affected by a combination of erosion and corrosion. Corrosion fatigue failure will occur in the blades of the LP section at the wet and dry enrichment zone under corrosive conditions, if proper water treatment is not performed during steady and transient operation, or if a corrosive chemical leakage occurs at a heat exchanger. Excessive contact friction at the rotor thrust collar will induce melting damage of thrust bearing pads, due to excessive thrust force from drain invasion. In other cases, lubricant oil additives may generate oil sludge contaminants on pad lubricating surfaces, and this will reduce bearing durability. If lubricant oil is not selected properly, in the worst case the rotor will rub against the bearings.

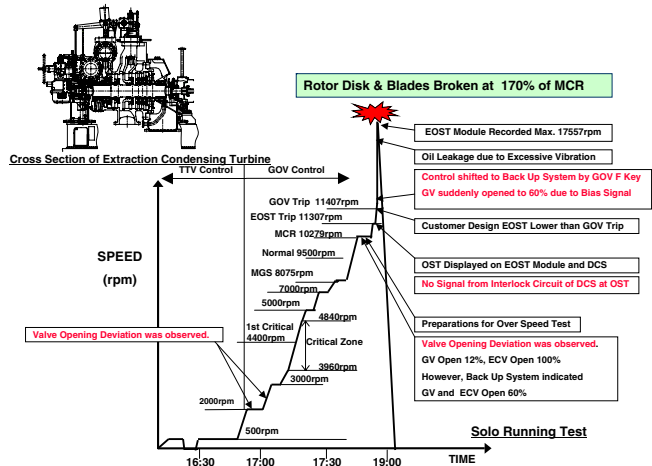
Figure 2. Typical Failure Experience (Overspeed Burst).

Figure 2 shows trends in rotation speed and key events from start to excess speed rotor damage, during the site-based solo running test. This extraction condensing turbine for driving a charge gas compressor is equipped with a position control backup system. The turbine was coasted up smoothly to a maximum continuous speed of maximum continuous rate (MCR) 10,279 rpm. Rotating speed was increased for a moment to electric overspeed trip speed (EOST); however, the trip interlock did not activate and speed

continued to increase, exceeding EOST speed. After the operating governor function key and the turbine control were shifted to the backup system, the governing valve suddenly opened from 12 percent to 60 percent in a no load condition and the turbine rotor was accelerated to 170 percent of MCR. Eventually, the turbine rotor disks and blades became damaged, resulting in oil leakage.

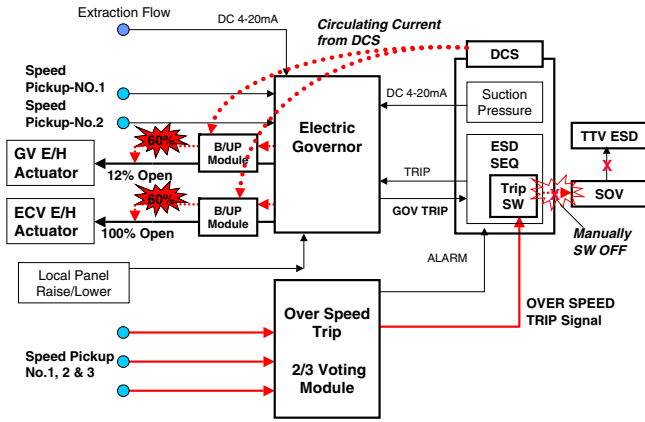
Figure 3. Overspeed Burst and Back Up System Error.

The control system for this turbine is shown in Figure 3. The control system has backup modules operating by position control, and this position control is used to supply the actuator output signal instead of the electric governor in the case of a governor failure. The backup system monitors the actuator output signals from the governor and controls two signals to switch the actuator signal source from governor to position control. Two backup modules are utilized for governing and extraction control valve actuators.

As a result of detailed investigation of the system and signals, it was found that circulating current from the distributed control system (DCS) into the signal system of the backup modules caused the supply signal to the actuator to increase, thereby opening the valve. This caused a large amount of steam flow leading to the abnormal increase in rpm, and the interlock that should have performed an emergency valve close did not operate properly.

Circulating current causes a 12 percent to 60 percent deviation of signals between the governor and governor backup module.

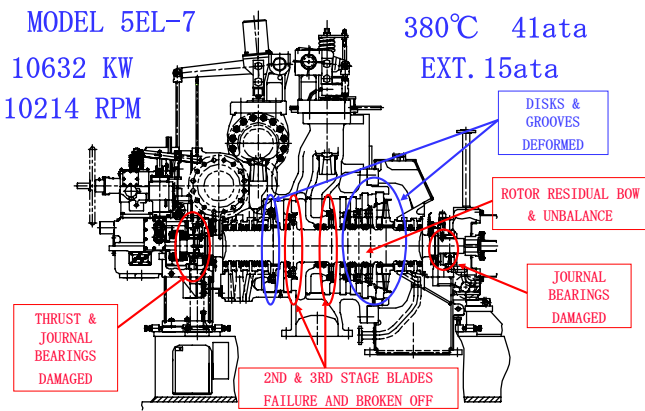
Figure 4. Damaged Condition of Turbine.

The actual damage conditions are shown in Figure 4 and Figure 5. The second (high-pressure section) and third stage blades (low-pressure section) have broken off from the rotor grooves, and the disks and grooves are deformed at the first stage and other stages

of the low-pressure section. The rotor is bowed from a large amount of friction and contact due to a seriously unbalanced condition. The journal and thrust bearings are damaged and their Babbitt metal pad has melted due to a huge friction loss heating resulting from the excessive overspeed and high loads. Rotor shaft at bearing location had no damage and was protected by Babbitt metal melting promptly. As explained in Figure 5, damage of the rotor was catastrophic.

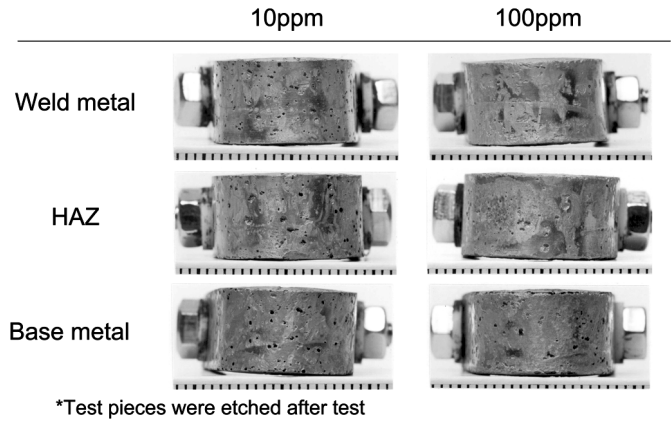
Figure 12. Surface of Specimens after 1000 Hours in NaCl Solution.

Figure 12 indicates the appearance of the HAZ specimen after the 1000 hour test. Although the surface became rough by corrosion, cracks did not occur.

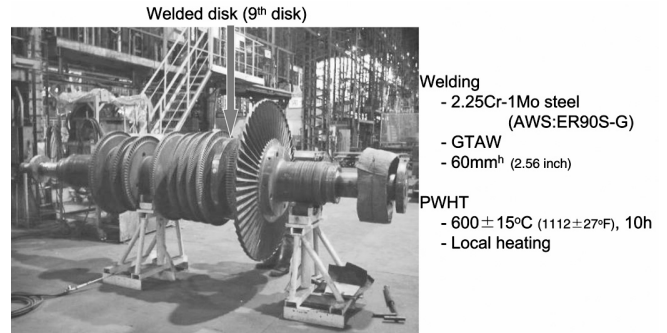
Figure 13. Welded Disk on Real Scale Test.

An actual rotor was welded and heat treated for a real scale test. Figure 13 shows the appearance of a welded disk. 2.25Cr-1Mo was welded 60 mm (2.36 inches) in height by GTAW. Welding speed was kept constant to prevent bowing of the rotor shaft.

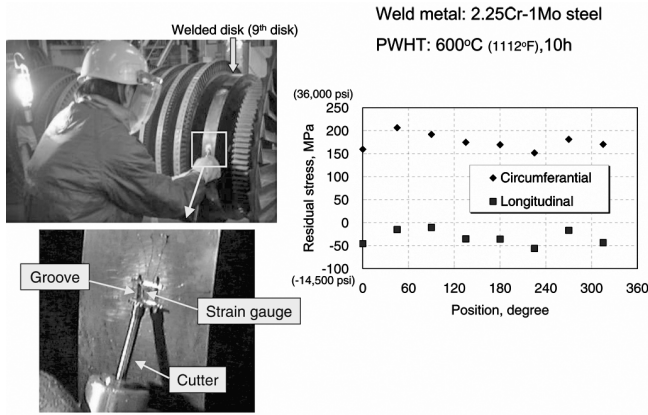
Figure 15. Residual Stress Measurement for Repaired Disk.

Figure 15 shows the appearance of the residual stress measurement. A strain gauge was attached to a square weld metal area, and a groove of 1 mm (.04 inch) in depth was cut around this area.

Measured strain after cutting was translated into the released residual stress. Measured residual stress was around 200 MPa (tension) in a circumferential direction. This corresponds to the target value required to prevent SCC and the value estimated through the finite element analysis.

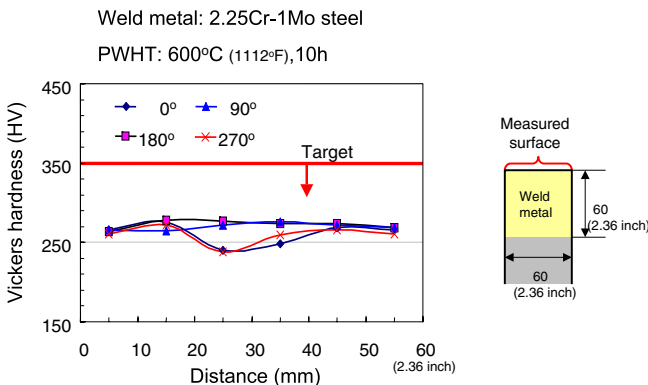
Figure 16. Hardness Distribution on Real Scale Disk.

Hardness on the surface of the weld metal was measured. Figure 16 indicates the measured hardness. The measured hardness of 240 to 270 HV is almost the same as that of the final bead on the laboratory test piece heated at 600°C (1112°F) as shown in Figure 10. Therefore, it can be estimated that the hardness of HAZ was also reduced within 350 HV.

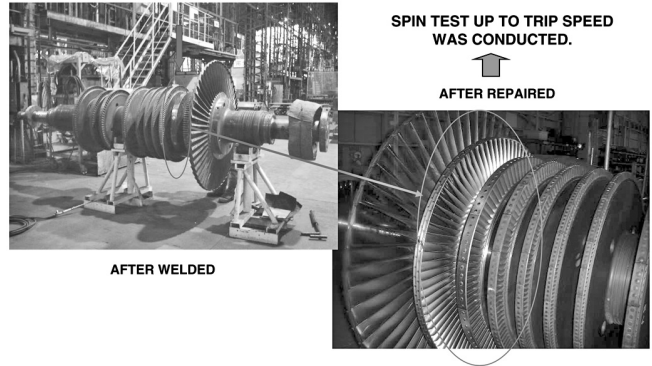
Figure 21. Welding of the Rotor Disk.

First, Figure 21 shows the case for a large rotor in a charge gas compressor drive steam turbine at an ethylene plant. The ninth stage disk of this turbine had heavy frictional contact with the diaphragm, and the blades and one side of the disk were damaged. The damaged portion was cut off and repaired successfully based on the results of the above laboratory test and analysis. Figure 22 shows hardness check results in the repair process used to confirm that the welding conditions are the same as in the test results.

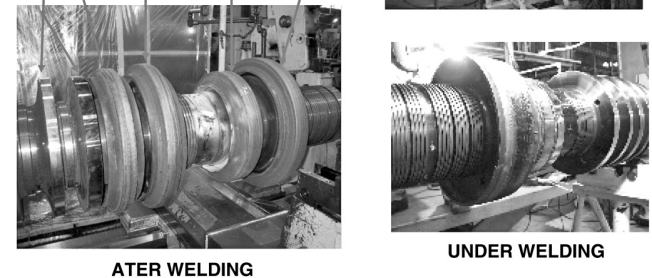
Figure 23. Welding Repair of Rotor Disks.

repair all stages. However, it was also necessary to start the plant very quickly, and the time for repair was limited. In discussion with the customer regarding minimum required power in the plant, turbine performance and blade strengths of each stage were decided upon with the customer, and as a result, the number of stages were reduced and heat drop distribution was changed for the LP section. Figure 23 shows the condition of welding repair on the rotor disks. Figure 24 shows rotor residual warpage check after welding and final machining were within the criteria of 0.005 mm (.0002 inch), and the blades for each stage were assembled as shown in Figure 25.

BLADES AND DISKS CUT OFF BY MACHINING

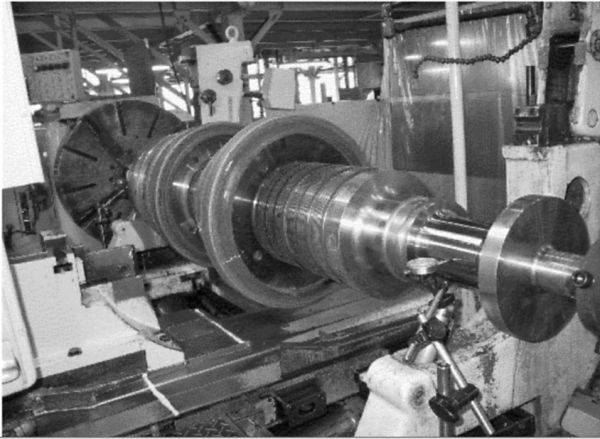
Figure 24. Rotor Residual Warpage Check.

Rotor Residual Bending after Welding and Final Machining was within Criteria 0.005mm.

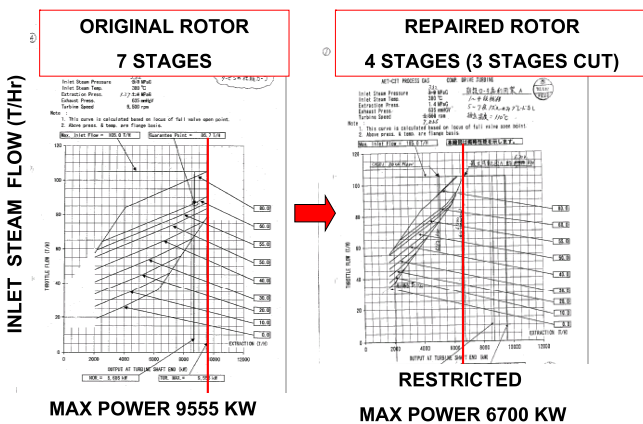
Figure 26. Actual Operation of Repaired Rotor.

Figure 26 shows the comparison between the turbine performance curves at the original 9555 kW and after repairs at 6700 kW, with the number of stages reduced by cutting off the last fifth,

sixth, and seventh stages. Blades and diaphragm strengths were checked and exhaust vacuum pressure was limited. This repaired and revived the rotor of the extraction condensing turbine, and it was actually placed back into the casing and operated successfully at a condition with low vibration and full load for three months until the new rotor was prepared.
