# DETERMINING THE ROOT CAUSES OF SUBSYNCHRONOUS INSTABILITY PROBLEMS IN TWO CENTRIFUGAL COMPRESSORS

## ABSTRACT

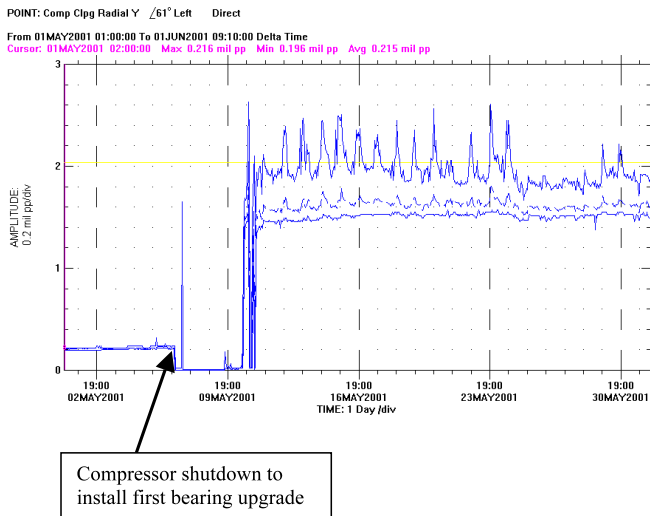
Figure 5. Compressor Inboard Radial Vibration before and after First Bearing Upgrade.

expected (Figure 5). A spectrum of the vibration revealed that the largest portion was a subsynchronous component, at approximately 4100 cpm (Figure 6). This subsynchronous component would begin increasing around noon, reaching a maximum around 7:00 p.m. (refer to overall and subsynchronous components in Figures 7 and 8). This frequency corresponded to the first lateral mode, which was confirmed from the transient data recorded on startup, as well as the rotordynamics study (Figures 2 and 9). As expected, the first critical speed had shifted down approximately 500 to 700 cpm after the bearing modification, in comparison to that seen during the coastdown with the original bearings (i.e., the new bearings with higher clearance and reduced stiffness lowered the critical speed). Also, note the rapid increase in synchronous amplitude at running speed (i.e., the far right-hand side of Figure 9). This appears to be a result of the compressor operating so close to its second critical speed (Figure 10).

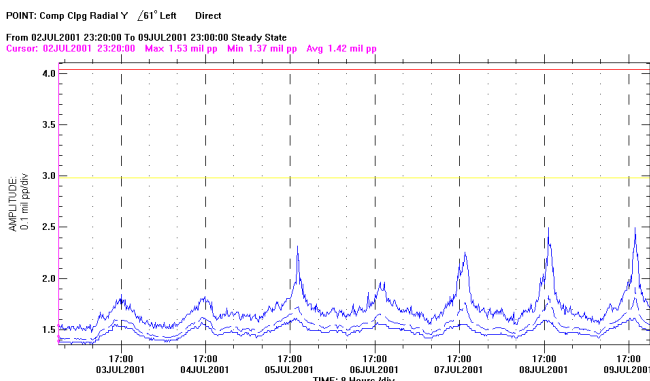
Figure 7. Erratic Nature of Compressor Inboard Radial Vibration, Overall.

No correlations between process or lube oil conditions could be found that explained the erratic change in vibration. The compressor was not operating close to a surge condition in either section. Likewise, the compressor flows, temperatures, and pressures did not change with the vibration. The only correlation with the vibration that peaked at approximately 7:00 p.m. was sunshine on the compressor/gearbox/baseplate. Several observations determined that the sun would set behind several distillation towers at approximately this time of the day and shade the compressor. It was concluded that this might be slightly affecting the alignment and/or oil temperature. Obviously, the possible changes in alignment were not drastic because there were no indications in the shaft orbit or fast Fourier transform (FFT) that would indicate misalignment. Likewise, the supply oil temperature varied by less than 5 degrees. However, it did indicate that the compressor was very sensitive to small changes (i.e., marginally stable). Furthermore, to determine if the unstable

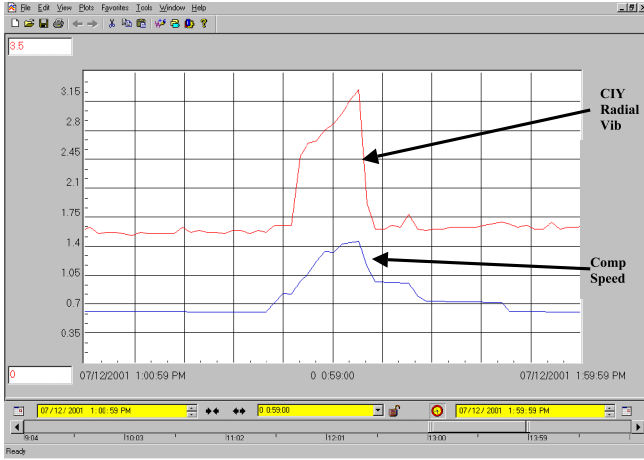
Figure 11. Compressor Inboard Radial Vibration During Speed Increase on 7/12/01.

condition of the compressor could be attributed to load (i.e., horsepower), on 7/12/01, the speed of the compressor was increased from 11,000 to 12,200 (Figure 11). The radial vibration jumped from an overall value of 1.6 to 3.3 mils, most of which was the subynchronous component. The drive end shaft orbits before and during the speed increase are shown in Figures 12 and 13. As can be seen, the internal loops are representative of a large subynchronous vibration at  $1/3$  of shaft speed. The speed was lowered back to 11,000 rpm, and the vibration dropped back down to its previous level. This further confirmed that the problem was indeed stability related.

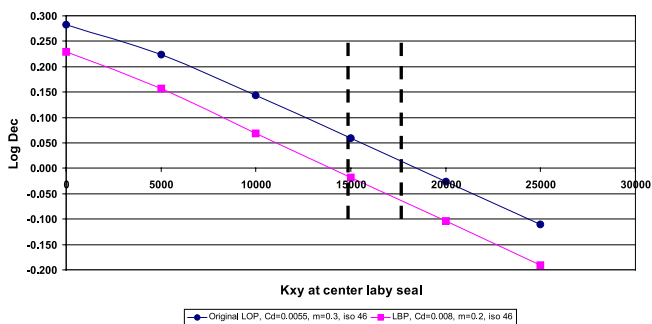
Figure 21. Compressor Stability Map for Prior LOP and Current LBP Bearings.

A stability map of the compressor with the old LOP bearings and the new LBP bearing is shown in Figure 21. Based on these calculations, it seems reasonable that the stiffness coefficients used for the center labyrinth seals are too large, since there were no stability problems prior to the bearing change. Therefore it seems reasonable to assume that the cross-coupling produced by the center seal was approximately 15,000 to 18,000 lbf/in (i.e., the point on the horizontal axis where the existing LBP bearing curve goes negative, but the original LOP bearing curve is still positive).

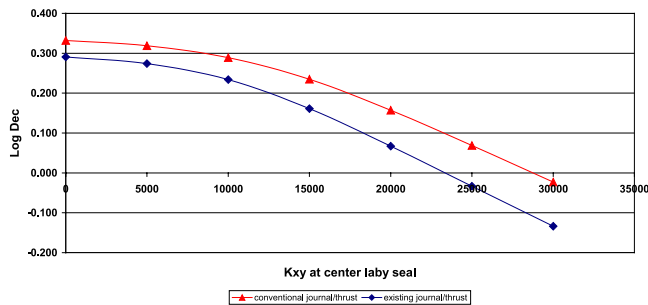
Figure 30. Stability Map Comparing Existing and Conventional Journal Thrust Arrangements.

to lower the synchronous response. Additionally, during the investigation into the root cause of the stability problem, it was discovered that one of the journals was actually 0.001 inch oversized. Since the bearing clearances were already tight, this certainly contributed to the original high bearing temperature problems. Furthermore, it seemed very odd for this compressor manufacturer to supply a thrust bearing of this type (i.e., journal bearing between two thrust collars). If a conventional journal/thrust arrangement (where there is only one thrust collar outside the journal) were used, the bearing span would be reduced by 1.73 inches. This would greatly improve the stability of the compressor (Figure 30). This is a significant contributor to the low margin of stability for this compressor.

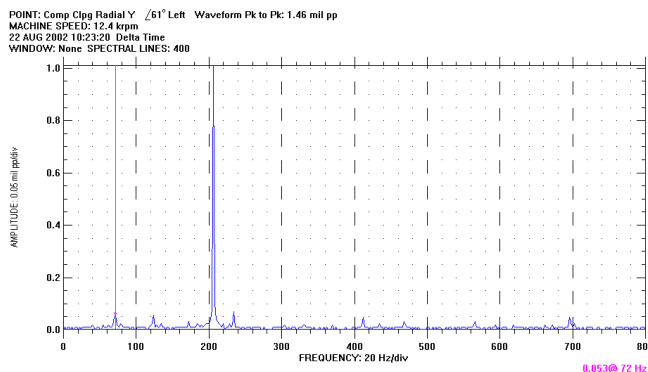
Figure 31. Compressor Drive End Radial Vibration after Bearing Modification.

The new LOP bearings were installed in May of 2002. After the bearing change, the overall vibration levels were less than 1.5 mils at the maximum operating speed of 12,500 rpm (prior spectra were only at 11,000 rpm) and the subsynchronous component had vanished (Figure 31). Likewise, the bearing temperatures are all at acceptable levels (< 175°F). The compressor has continued to operate at this same vibration level for the past year and a half.

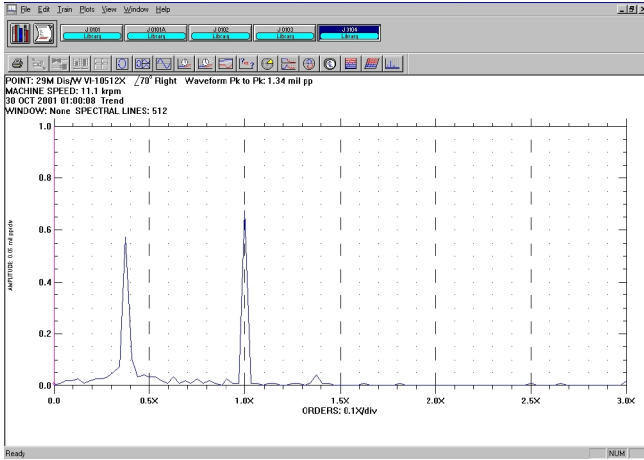
Figure 33. Spectrum from Compressor Drive End Radial Probe Showing Subsynchronous Peak at 4000 CPM.

The second compressor is a horizontally split, multistage, side-load ethylene refrigeration/export compressor with dry gas seals in a Midwest olefins plant (Figure 32). The compressor typically operates between 10,500 and 11,000 rpm and is driven by a 6500 hp steam turbine. The original bearing design was a five-pad LOP bearing with center pivots. In 1997, the compressor was overhauled as part of a normal unit turnaround. A few years later, in 1999, a radial subsynchronous vibration that coincided with the first natural frequency of the compressor began to appear (Figure 33). At first the frequency was small in magnitude, but it continued to grow with time. The subsynchronous component was worse in the summer months and could only be kept at low levels by maintaining the oil temperature in a very tight band of a few degrees, toward the cool end of the normal range.

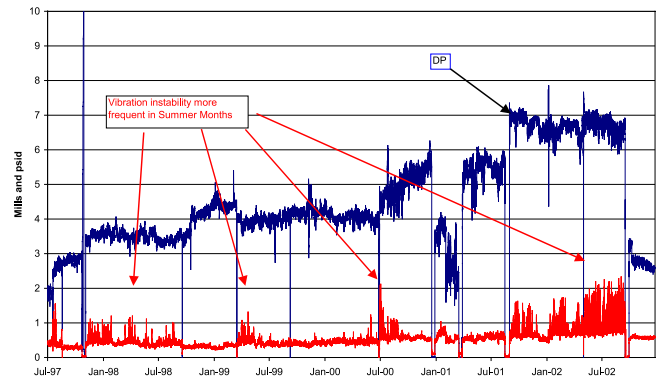
Figure 41. Balance Line Differential Pressure and Radial Vibration since 1997.

1997. A correlation between the balance line differential pressure and the radial vibration excursions on the compressor could be seen when plotted back to 1997 (Figure 41). Since the subsynchronous vibration seemed to be tied to increased flow through the balance line, it was suspected that the seal had suffered some type of failure that would allow increased flow. The director of a major university's research laboratory was contracted to provide the seal coefficients shown in Table 2, as well as Figures 42 and 43 for different clearance and inlet velocity ratios. As mentioned in the prior case study, the  $K_{xy}$  values were reduced so that the whirl frequency coefficients were equal to the inlet velocity ratios. The estimated leakage based on balance line differential pressure was close to the calculated leakage for the seal with 0.020 inch clearance.

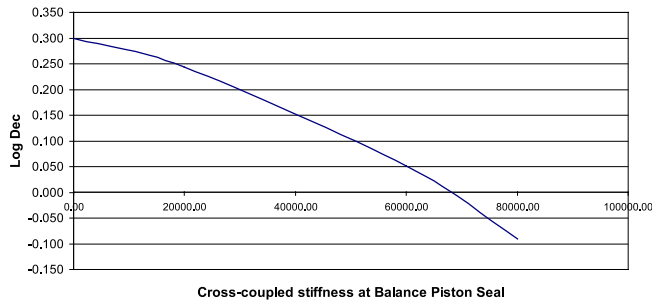
Figure 44. Effect of Cross-Coupled Stiffness on Compressor Stability with Original LOP Bearings.

A stability map for different values of cross-coupling at the balance piston (with the original five-pad LOP bearings) is shown in Figure 44. Since the calculated value of the cross-coupled stiffness produced by the balance piston seal was only 30,930, this indicates that the rotor is quite stable with the original LOP bearings. According to the calculations, the balance piston seal does not produce enough cross-coupled stiffness to drive the compressor

unstable. It was deduced that the balance piston seal had suffered a severe failure that was causing it to produce more cross-coupled stiffness than the code predicted. The decision was made to split the case during the upcoming outage and inspect the balance piston seal, instead of just changing the bearings, because the analysis indicated a significant failure of an internal component to drive the machine unstable. Additionally, this plant had experience with a

previous design stationary abradable seal failing catastrophically when process pressure closed the seal onto the shaft. To address the instability, an alternate stationary balance piston seal was designed using an aluminum honeycomb to run against the rotating teeth to provide a more robust seal and additional resistance to swirl.

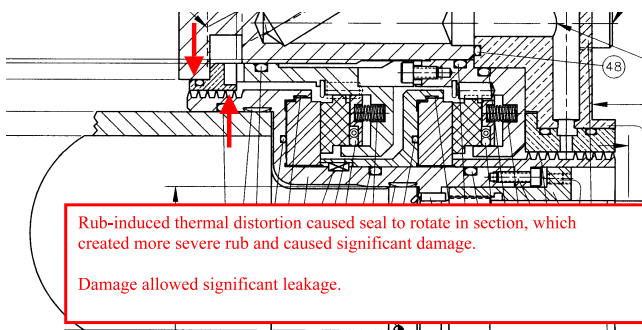
Figure 45. Dry Gas Seal with Buffer Gas Labyrinth.

The compressor was shutdown in September of 2002 to inspect the balance piston seal and determine the source of the subsynchronous vibration. The balance piston seal and rotating teeth were found to be in excellent condition. However, the buffer gas labyrinth seal in front of the dry gas seals (Figure 45) had rubbed very hard (Figures 46 and 47). The rotating teeth ran against a stationary aluminum seal. The seal had rotated in the section (inboard side closing into the shaft, outboard side opening away from the shaft), apparently due to thermal distortion initiated by a rub. The distortion exacerbated the rub, causing further damage. The clearance on these seals had been quite tight by design (0.004 to 0.005 total) to reduce the amount of buffer gas consumption. The failure of these seals caused the high differential pressure in the balance line due to excessive buffer gas flow from the discharge end seal. Likewise, the rubbing undoubtedly excited the first natural frequency of the rotor. The compressor was reassembled with the new Fluorosint® stationary buffer gas seals with a larger clearance and the new LBP bearings. There was no subsynchronous vibration present after startup (Figure 48) or in the past year.

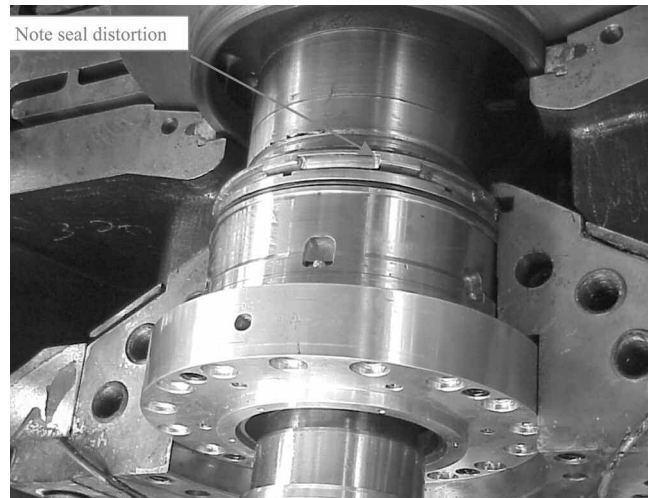
Figure 46. Damaged Buffer Gas Labyrinth.

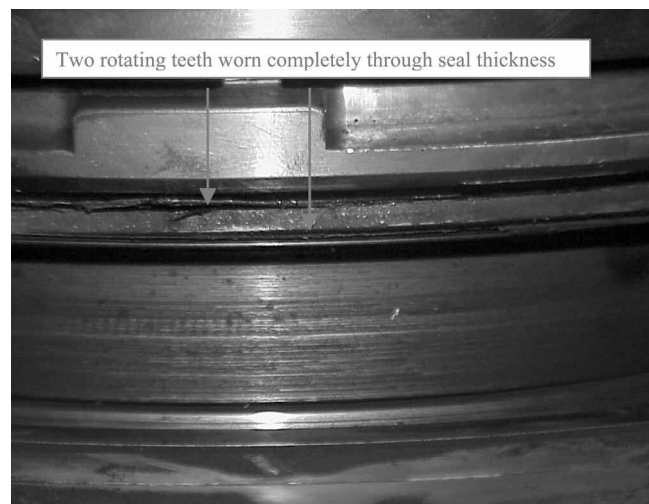
Figure 47. Damaged Buffer Gas Labyrinth Seal.
