ELIMINATION OF FLOW-INDUCED INSTABILITY FROM STEAM TURBINE CONTROL VALVES

ABSTRACT

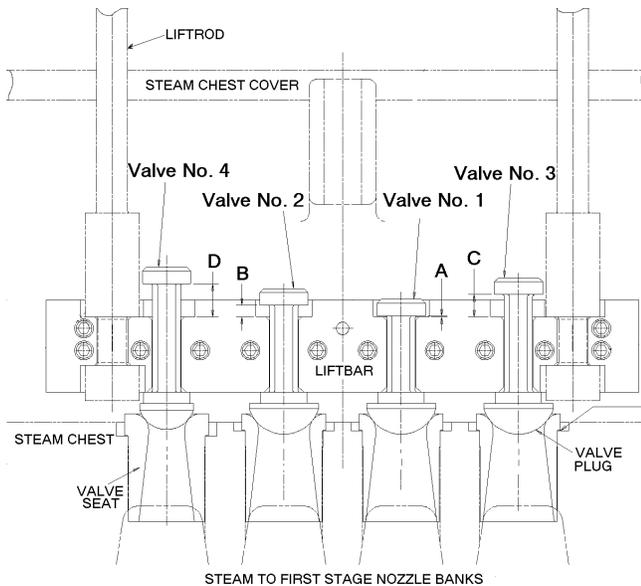
Figure 1. Valve Rack in Closed Position Showing Initial Clearances, A Through D.

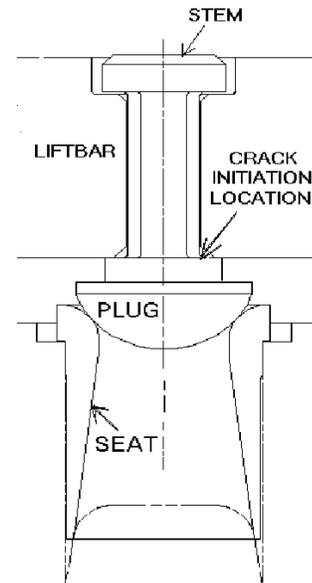
lifting the valves, the support point of each open valve is near the top of the stem. If there were only cantilevered bending involved, the maximum stress would be near the support point. The fretting on the valve stem surfaces shown in Figure 3 indicated that the valve plug was vibrating so much that it was exceeding the clearance between the sides of the stem and lift bar, with maximum bending stress near the bottom instead of near the top of the stem, where it is held by the lift bar. The stem cross section is rectangular, to prevent spinning of the valve. (Piping strain on the casing also had to be corrected during the shutdown, and it was found that the rotor rubbed during a vibration excursion from a rotor bow.)

Figure 2. Valve in Closed Position Showing Initiation Point for Fatigue Crack.

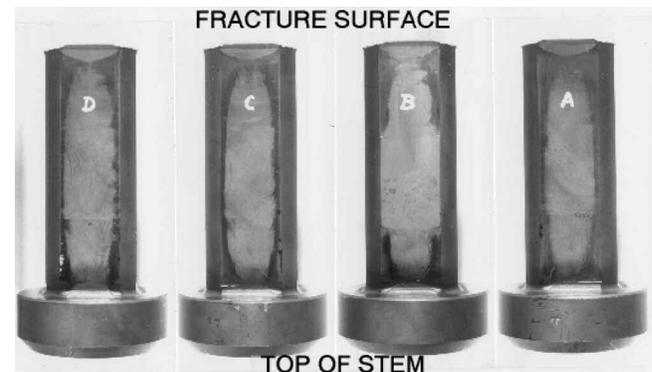
When the steam turbine was taken apart, it was found that the plug portion of valve No. 2 had broken off and had driven the seat into the steam chest wall approximately 0.7 inch. It was very surprising that the valve failed near the plug (Figure 2). As the lift bar moves through the clearances A through D shown in Figure 1,

Figure 3. Valve Failure with Evidence of Rotating Bending from Fretting Pattern Found on All Four Sides of Stem.

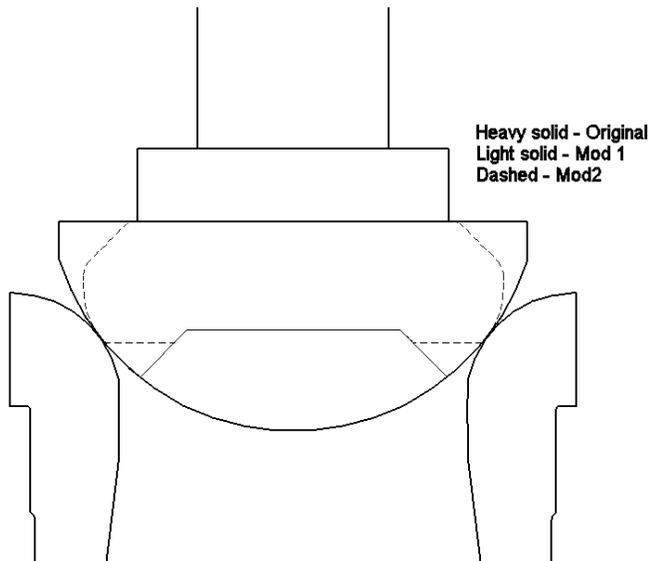
Figure 4. Cross Section Through Valve Showing Original and Modified Plug Shapes.

The turbine was repaired and reassembled with a "Mod 1" valve design. These new valves were made from valves of the original design by machining a countersink in the bottom of each plug, as shown in Figure 4. After the Mod 1 valve plugs were installed, a second failure occurred, but this time it was valve No. 1 that failed when it was near its cutout lift and valve No. 2 was beginning to open, similar to the situation with valve No. 2 during its earlier failure. Operating speed was higher, near 3500 rpm, and a large hammering noise existed prior to the failure. The turbine had started to shake immediately during startup while running with the valve rack lifted 32 percent, and had continued for 50 minutes until valve No. 1 failed. The noise was likened to one's vehicle tires traversing rumble strips. The term "rumble-strip vibration" was thus used to refer to this severe vibration.

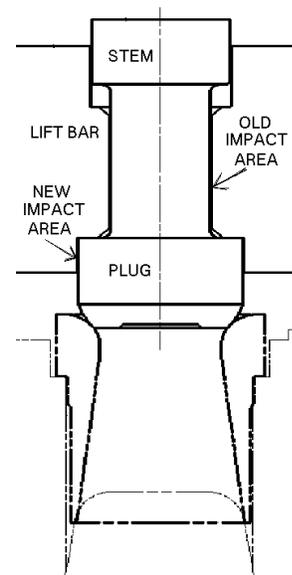
Figure 5. Stronger Plug and Stem Design with Mod 2 Plug Shape.

After the Mod 1 valve failed, a second revision, Mod 2, was installed (also requiring a modified lift versus area curve). These valves were made from Mod 1 valves and were similar to another valve design with which the turbine manufacturer had success in the past. The Mod 2 plug shape is shown in Figure 4. Due to damage to the steam chest, the new valve No. 1 had to be made longer so it could reach the seat. It was also decided to run with inlet pressure reduced by 12 percent. These Mod 2 valves remain in operation with mild vibrations at times, but have not failed, and there have been no severe extended "rumble-strip" vibrations. A plant shutdown to install a new "hybrid valve" design to replace the Mod 2 valves has been delayed. Even though other changes were made to reduce risk of a third failure, the steam turbine has been operating for approximately three years with the undesirable vibration. A short-term fix shown in Figure 5, with dynamic stresses reduced by a factor of three, was also designed and supplied in case there was a third failure.

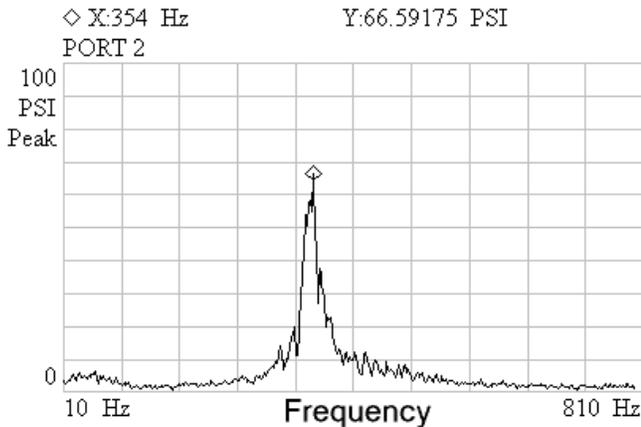
In Figure 7 is shown the frequency spectrum for the pressure port transducer downstream of valve No. 2 just before there was severe vibration. At other valve lifts, the high amplitudes near 350 Hz sometimes reached ± 400 psi due to the "organ pipe" resonance described in APPENDIX A. Analysis of pulsation frequencies gave

Figure 7. Pressure Pulsations at Port 2 Before High Vibration of Valve No. 2.

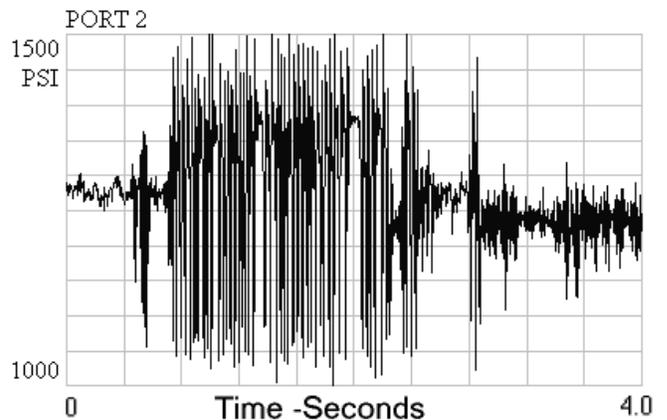
In Figure 8 is a long time trace period of four seconds showing intermittent high “rumble-strip” vibration. By using this time scale, the result filters out the high frequencies, including the “organ pipe” resonance for the port frequency near 350 Hz. The high amplitude changes are occurring at a rate between 30 and 40 Hz. Since the frequency of the sharp pulses near 35 Hz is well below 350 Hz, amplitudes should be accurate, just as is the static pressure. Zooming in with a quarter-second time window shows extremely high changes in pressure at a rate of 30 to 40 Hz, as

Figure 8. Time Trace of Port 2 Pressure Pulsations During Vibration Transient.

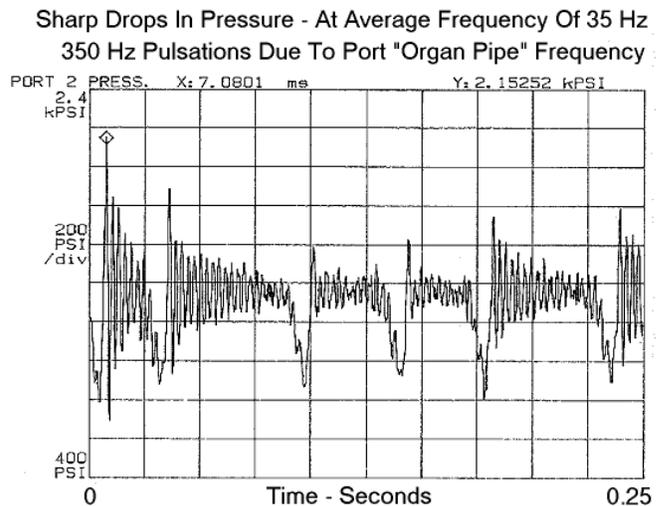
shown in Figure 9, an amplitude versus time trace, and Figure 10, a typical spectrum plot. The character of the pulsations is complex, and there appears to be a beating effect since the high frequency content shows a tremendous pulsation amplitude at frequencies near both 350 and 385 Hz. Beating occurs when an excitation frequency is near a natural frequency, with response for each frequency. One of the frequencies could be the port frequency or the valve “hanging mode” frequency, that is, the frequency of the fundamental bending mode with the valve stem supported by pressure loads clamping it to the lift bar. The difference in frequencies, 30 to 40 Hz, can be seen in the plots, and is the rate of the “rumble strip” vibration. This was deemed to be the rate that the valve stem was slamming against the lift bar in a rotating fashion, causing the fretting shown in Figure 3. In addition, with a rotating pressure field from the flow instability, the flow past the entrance to the port would be very erratic. The sharp changes at 30 to 40 Hz are such that there is high harmonic content, including nine and 10 times, that is in the range of the “hanging mode” natural frequencies of the valve at that lift point. The response would be amplified for both valve frequencies that are close together for the two transverse directions for a cantilever.

Figure 9. Port 2 Pressure Pulsations During High Valve Vibration.

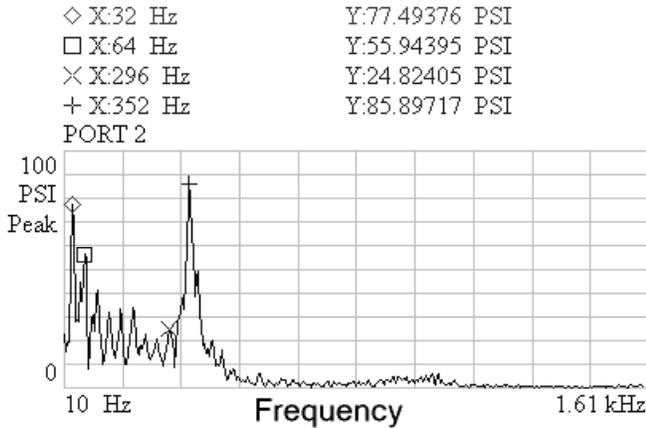
Figure 10. Port 2 Pressure Pulsation Frequency Spectrum During High Valve No. 2 Vibration.

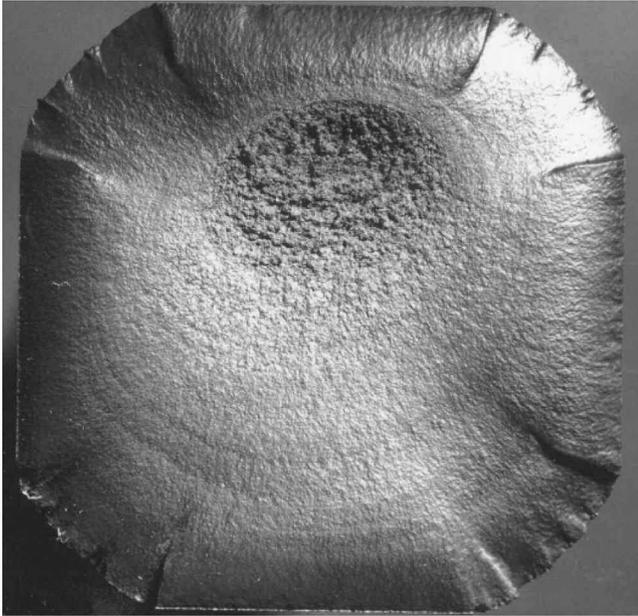
Traditional stress analysis was first used to determine when the maximum nominal bending stress in the uncracked ligament exceeded the ultimate strength of the AISI 422 stainless steel material, 118,000 ksi near 900°F. Such a stress can be induced by the bending moment, which was calculated to be 12,800 in-lb for the dimensions of the final fracture cross section. The nominal bending stress at the crack initiation site in the uncracked cross section induced by the same bending moment was then calculated to be 20.2 ksi. With this high stress just before the final fracture, there should have been some plastic deformation in the uncracked ligament, but none was found. It may have been that the bending moment was lower at the instant of final fracture. However, in order to attain such a high nominal stress in the uncracked ligament, significant plastic deformation should occur prior to the final fracture. Macroscopic observations of the fracture surfaces,

Figure 11. Fracture Surface of Second Failure, Valve No. 1 Mod 1, with Smooth Fatigue Surfaces (Rough Surface Was Final Fracture Area).

visible on the two failed valves, led to the conclusion that the final fracture of the remaining ligament was not predominantly plastic. Therefore, a second calculation of the critical stress at the final fracture was obtained from the fracture mechanics analysis method given by Glinka and Newport (1987) and Glinka and Shen (1991).

Knowing that the critical stress intensity is $90 \text{ ksi-in}^{-1/2}$, the nominal bending stress was calculated to be 18.3 ksi. Because the critical stress at the final fracture was induced by bending moment for a stress of 18.3 ksi, this also had to be the fluctuating stress for the entire fatigue stress cycle.

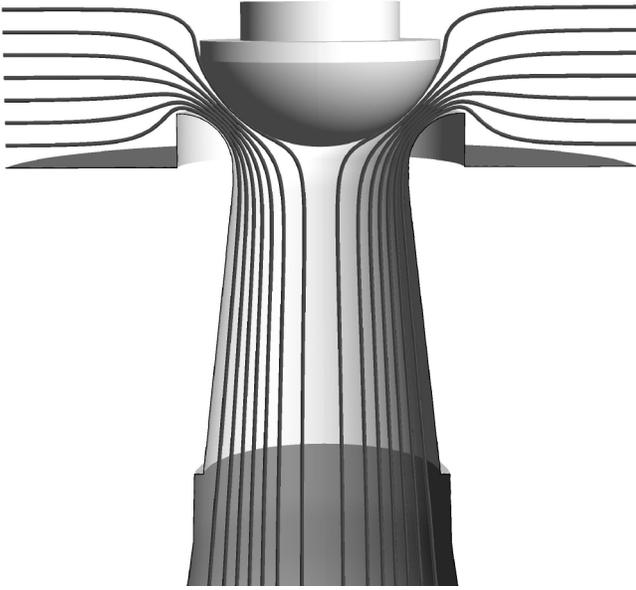
CFD results of the original valve design showed strong core flow at the lifts analyzed, the type of flow considered unstable. Figure 12 shows predicted streaklines at 0.639 inch lift, the lift at which the failure occurred. The figure includes the valve plug and a cutaway view of the valve seat flow surface in the steam chest. The streaklines show the path of steam flowing between the plug and seat and downward through the venturi portion of the seat. The streaklines meet under the plug and fill the downstream passage, exhibiting core flow.

Figure 12. Original Valve with Flow Streaklines.

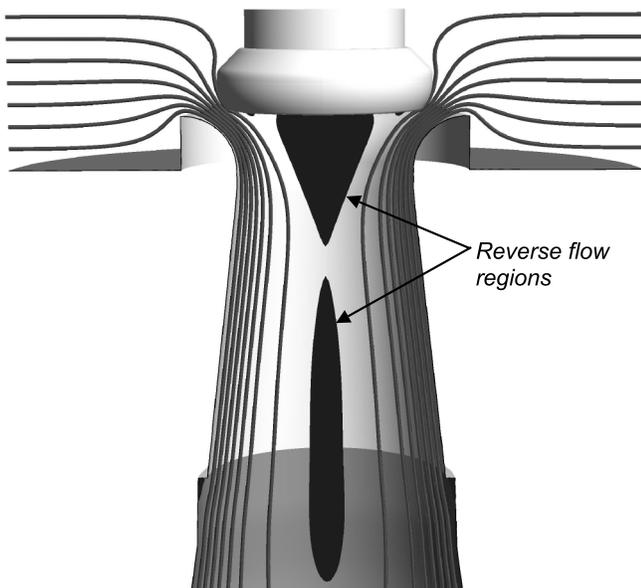
Figure 13. Cutoff (Mod 2) Valve with Flow Streaklines and Reverse Flow Regions.

CFD predicted strong annular flow at low lift, but with the annularity weakening and the central recirculation region dissipating at high lifts. Any valve will, of course, eventually lose annularity and transition to simple flow through a venturi as it opens wide enough, but it appeared the cutoff valves' loss of annularity might appear at too low a lift, perhaps affecting the lift at which the failures occurred. The large-radius seat did not appear to improve annularity significantly.

Test results did not confirm the trends seen with CFD. The cutoff valve with the original seat had significant pressure fluctuation at all lifts, similar to the original valve. Yet the cutoff valve with the large-radius seat had much lower pressure fluctuation at all lifts.

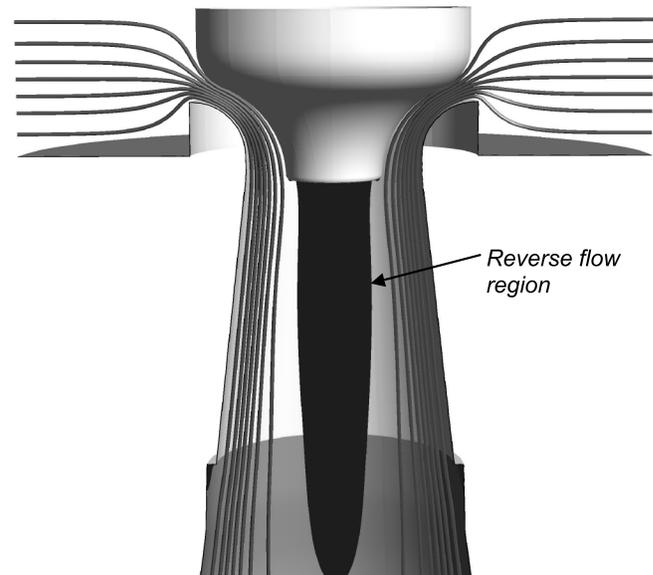
The concave plug was designed to force flow explicitly downward along the seat walls in an annular flow field at high lifts, such as where the failures occurred. This plug, along with its predicted streaklines and reverse flow region at its design lift, is shown in Figure 14. The plug had a sharp corner like a cutoff plug, to force flow to separate from the plug once it was properly oriented. At lower lifts, however, the plug and seat formed a diverging passage. Flow followed the plug wall rather than the seat wall, so the flow was guided toward the center of the valve, encouraging core flow at low lifts. CFD predicted good annularity at high lifts, but core flow at low lifts. Test results confirmed this trend, showing low pressure fluctuation at high lift but high fluctuation at low lift.

Figure 14. Concave Valve with Flow Streaklines and Reverse Flow Regions.

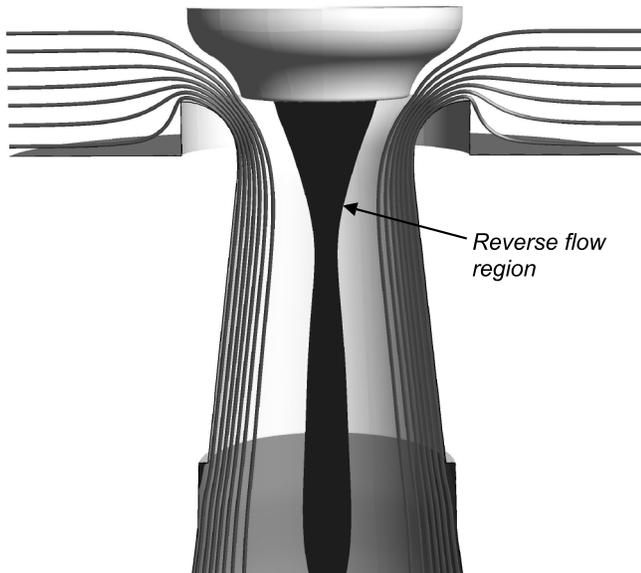
CFD predicted annular flow at both high and low lift. Test results confirmed this trend, showing low pressure fluctuation at all five lifts tested.

Figure 15. Hybrid Valve with Flow Streaklines and Reverse Flow Regions.

The hybrid plug was chosen as our new standard governor valve design. Although the hybrid valves have not been installed in the turbine that experienced the failures, they have been installed as original equipment in two other turbines. The valve racks were also modified to reduce valve stress, similar to the configuration shown in Figure 5. One turbine has been operating for over a year, the other for over two years. Neither has experienced a governor valve failure, and noise and vibration levels have not been excessive.
