TURBINE REMANUFACTURE—ONE OPTION FOR RELIABILITY AND EFFICIENCY IMPROVEMENT

A case study of a remanufacture of a steam turbine is presented. The turbine has been in service for 20 years. Thermal and physical stresses have taken their toll on the turbine casing and supporting hardware.

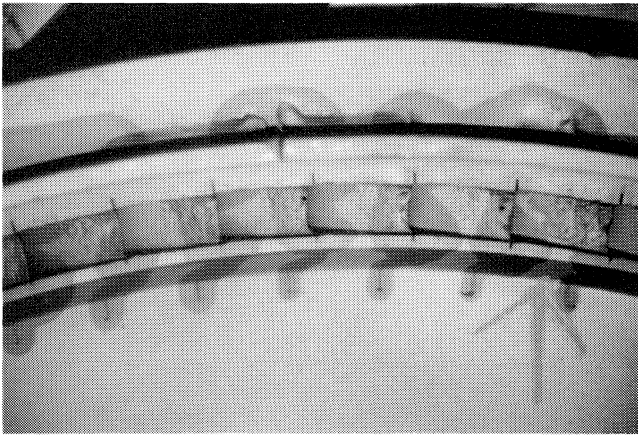
Figure 2. View of Nozzle Erosion.

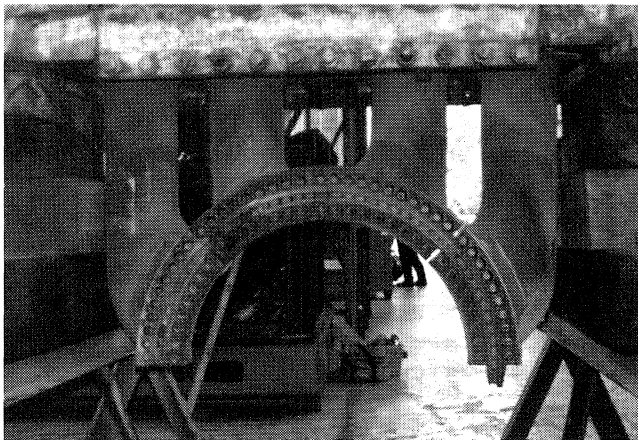
Figure 3. Incoming View of Nozzle Fingers.

The nozzle segments were determined to be repairable in place, therefore, the nozzles were not removed (Figure 14). To ensure there were no unseen problems, the nozzles were checked with a fiber optic borescope, on the high pressure side. The results were recorded on video tape for future inspection and reference.

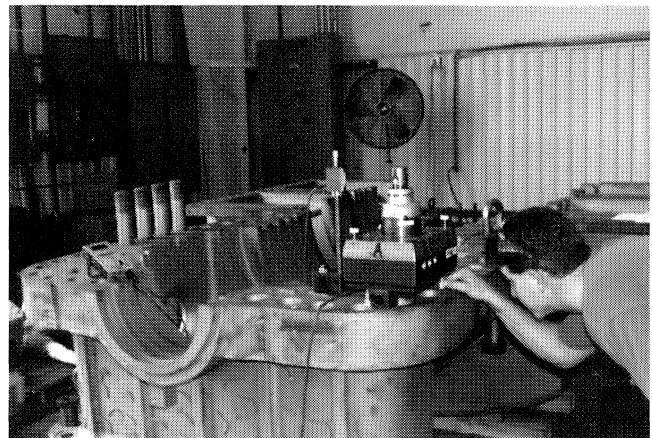
Figure 4. Laser Mapping Setup.

The first laser mapping operation determined the extent of existing casing distortion in the horizontal splitline. It was now clear that some distortion did exist, and the total elevation readings confirmed the readings obtained with the optical equipment onsite in 1992. However, the nature of the distortion was of considerable concern to the project team. The "longitudinal hump," expected by the project team, was instead a vertical offset between high pressure and the low pressure casings. The vertical offset was caused by the nature of the vertical joint. One could almost speculate that the four quarters of the case had been manufactured in separate facilities and then brought together for final assembly. When the casing quarters were assembled, the findings are summarized below:

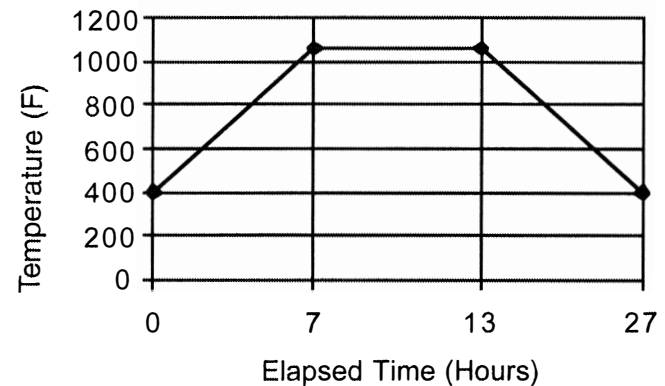
Figure 8. Stress Relief Temperature Chart.

Prior to stress relief, the shells were bolted together and tightened up with the old bolts. The unit was placed in the gas-fired furnace and brought up to annealing temperature where it was held for six hours. After the six hour period, the furnace temperature was lowered with a controlled cool down to 400°F. Total elapsed time was 30 hours (Figure 8).

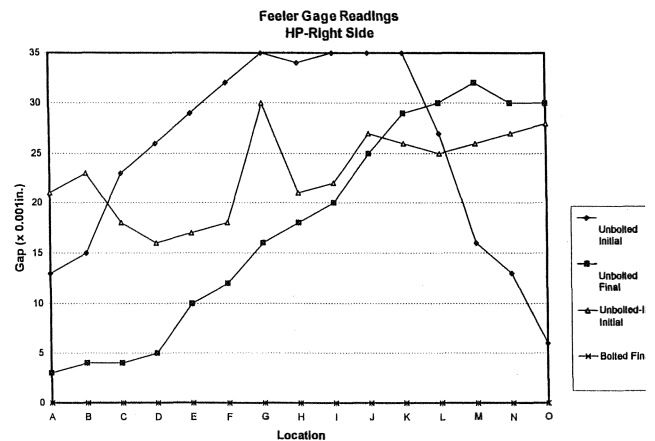
Feeler gauge readings were taken during the repair process. These checks were taken at various times with various amounts of bolt force. An illustration of the readings is shown in Figure 10, taken before and after repairs, on one side of one half of the HP case, in the bolted and unbolted state. The readings are typical of the decrease in horizontal joint gaps in the turbine section, as a result of the heat treatment process.

Figure 10. Casing Feeler Gauge Readings.

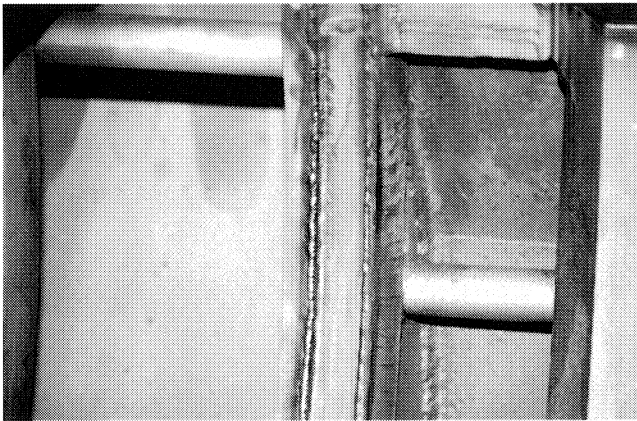
Figure 11. Diaphragm Fits Being Welded.

The LP diaphragm fits were welded (Figure 11) because little parent material was left on the support side of the fit. Crush pads were added to the LP bearing housing bores to compensate for the boring.

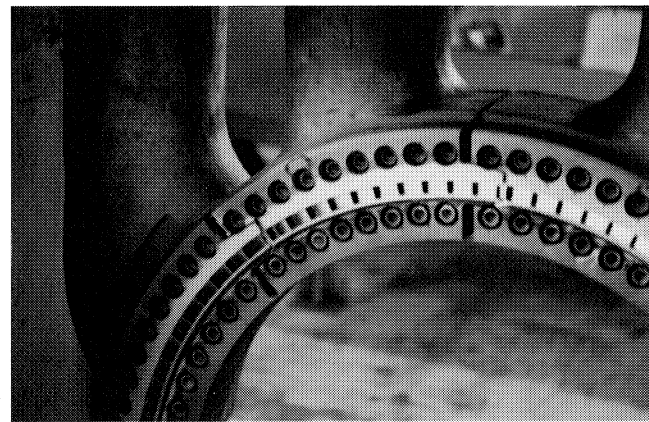
Figure 14. Repaired Nozzle Fingers.

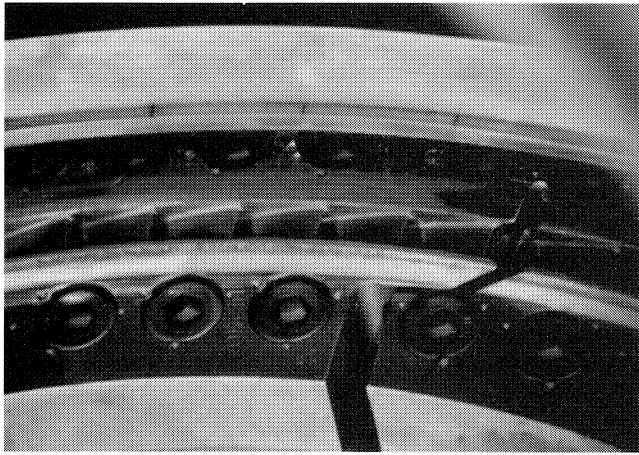
Figure 15. Closeup of Nozzle Vanes.

The extraction nozzle was weld repaired to return its area to design (Figure 15). A 410 stainless steel GTAW process was used. The extraction nozzle ring was post weld heat treated along with the diaphragms. The antirotation/alignment pin hole for the extraction stage upper half was found elongated and had to be reamed to correct. A new stepped alignment pin was made from B-16 material and installed at final assembly.

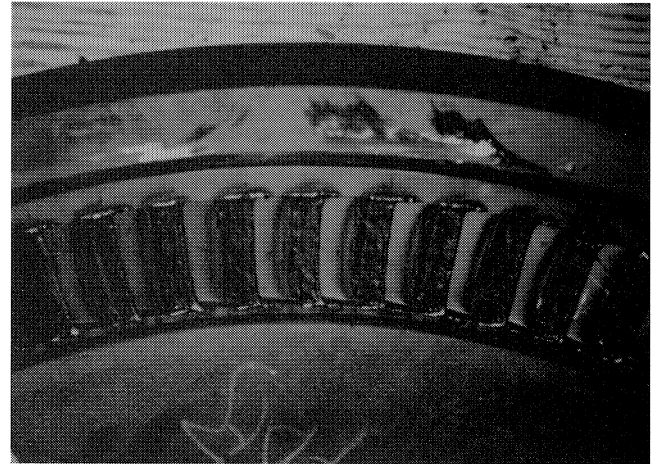
Figure 16. Diaphragm Partitions Being Welded.

(Figure 16). Several required weld repairs and machining of the horizontal splittlines at the outer diameter. All the diaphragms were cut back and welded on the sealing faces, and all received crush pads on the opposite faces. This was done to save time at assembly, because all the diaphragm fits were welded and machined and brought to a uniform width.

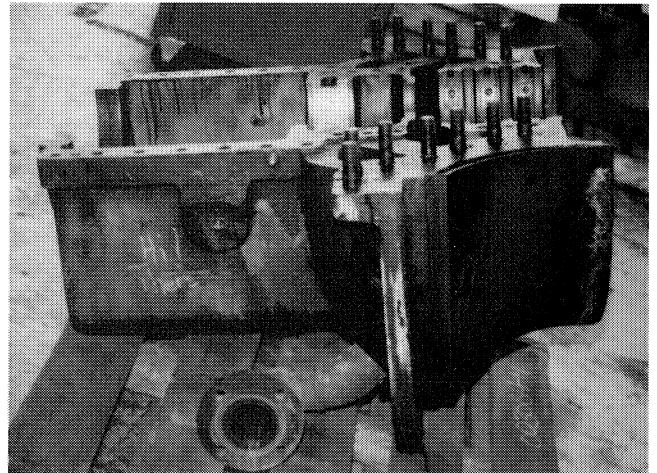
From measurements of the bearing housing (Figure 17) and the casing, it was determined that the cause of the bearing misalignment was a severely warped vertical mounting face. Correction of this problem involved machining both vertical faces true and installing a soft metal shim to keep axial spacing the same (Figure 18).

Figure 17. Incoming View of Bearing Housing.

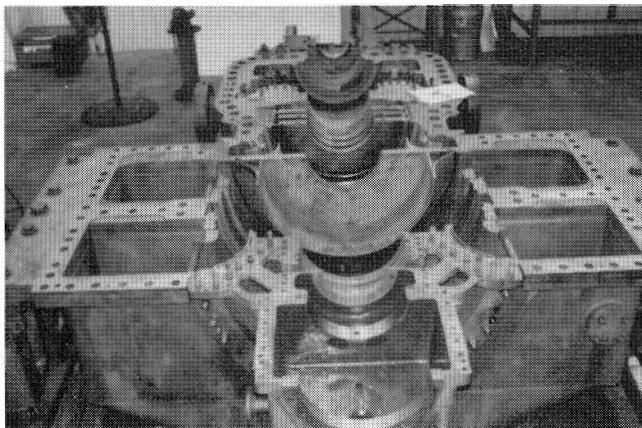
Figure 18. View of Repaired Bearing Housing.

Even though the bearing fit was true to the seal fits, it averaged 0.010 in out-of-round with several areas greater than 0.010 in. A total of 0.021 in on diameter was removed to achieve 100 percent cleanup.

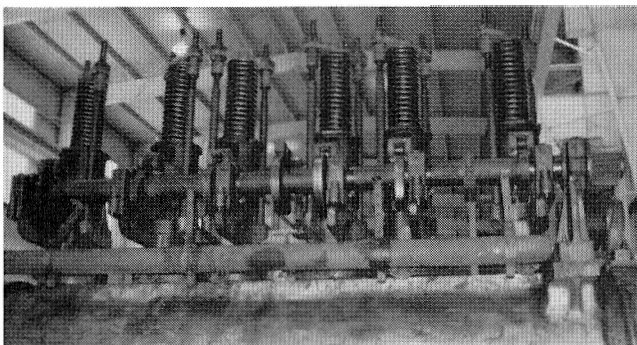
shaped head. At certain lifts, or steam flows, the steam forces would become unbalanced and cause considerable vibration throughout the valve train. This led to premature wear on the valve gear components, instabilities in speed control, and frequent online maintenance. In addition, the inlet valves were attached to their lifting mechanism via threads on the valve stem. Rotation of the valve was prevented by a radial set screw that dogged into the threaded area of the stem. This antirotation device produced a stress riser and had become the initiating point of several past valve failures.

Figure 19. View of Valve Rack. Incoming.

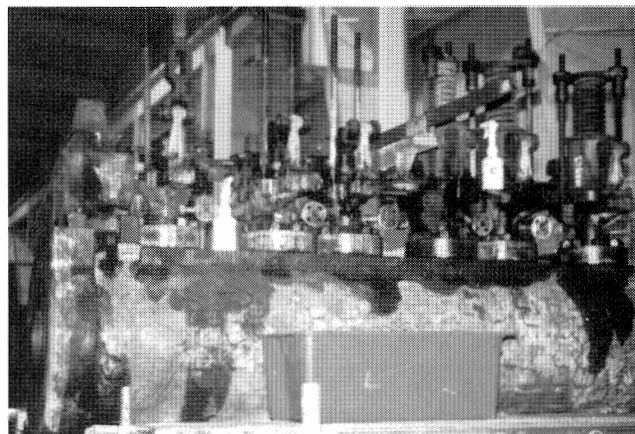
Figure 20. View of Valve Rack. Final.

The OEM offered a redesigned valve package (Figure 20) that addressed the problems that had been encountered. The revised valves were manufactured such that attachment to the stem is accomplished by a split clamp instead of threads. This eliminated the stress risers in the threads. Modifications to the valves included making the head straight with very little taper on the seat. Four small diameter holes were drilled through the valve body to aid in equalizing forces across the valve.

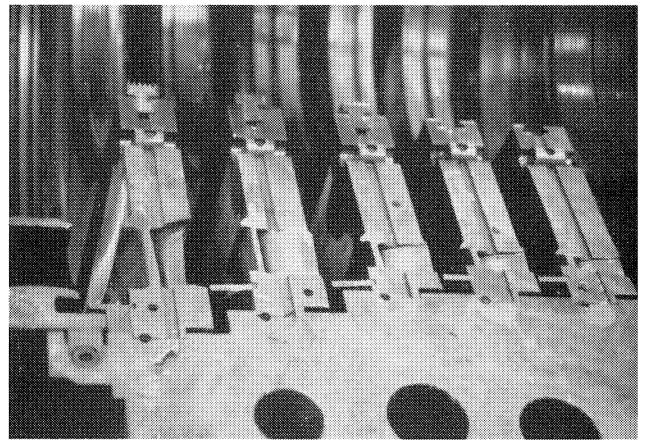
Figure 25. Old Diaphragm Seal Rings.

Originally, the seventh stage diaphragm had a bolted-on ring with radial seals (Figure 25). This ring was replaced with a new ring of the same design, but tighter clearance (Figure 26). The third through sixth stages were modified to accept bolted-on radial seal rings. The application of radial seal rings reduced blade tip sealing clearance to less than half that of original design in every stage. In several stages, the resulting clearances were less than 25 percent of design.
