IS THE DRY COUPLING REALLY CAUSING YOUR VIBRATION PROBLEM?

Guill A. Cornejo

Joseph P. Corcoran

ABSTRACT

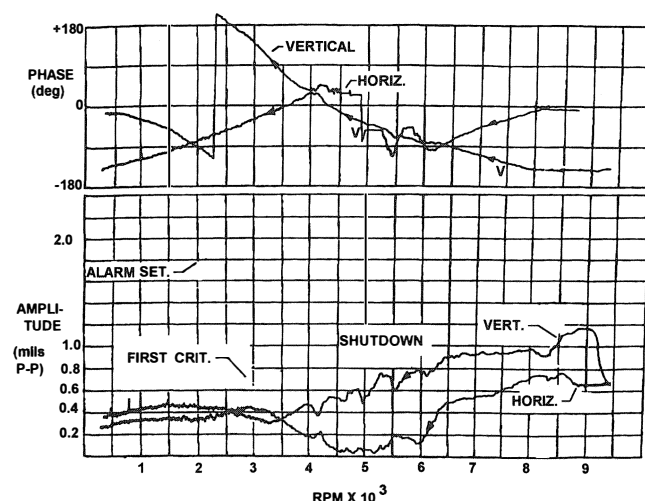
Figure 2. Axial Plot Response with High Vibration Shutdown.

As mentioned before, one unit downloaded with full control of the recycle valve and cool down cycle and the newer unit did not. The Bode plot response depicting a shutdown episode is presented in Figure 2. Except for the apparent high runout at very low speed, the synchronous response did not yield a clear indication of the cause of the shutdown. At first it was thought that the shutdown was caused by an instrumentation problem. This was not the case, as it was found out later.

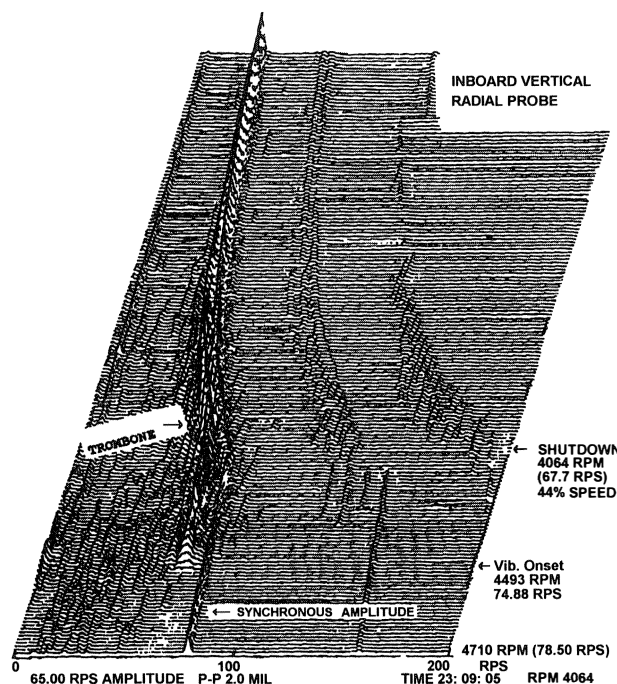
Figure 3. Unit 2 Normal Stop Including Shutdown at 60 Percent Speed; Vendor #1 Coupling.

Vibration data were tape recorded for a normal stop that included the shutdown. A waterfall is depicted in Figure 3 of the

forward radial noncontact probe which experienced the shutdowns. The problem was transient high subsynchronous vibration after initiating the normal stop. The subsynchronous vibration only showed up during the controlled downloading and run-down, but not when the unit was operating at full load.

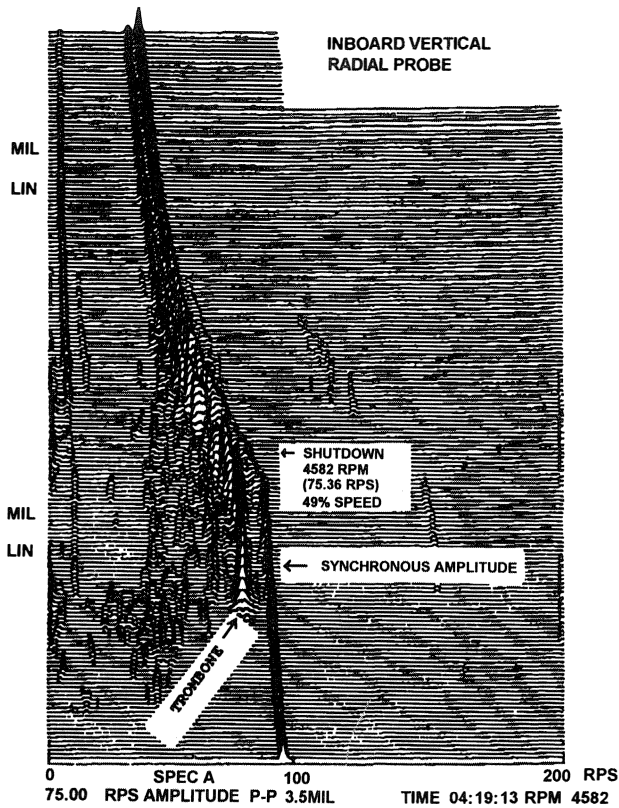
Figure 4. Unit 2 Normal Stop Including Shutdown at 60 Percent Speed; Vendor #2 Coupling.

pling. This result was not expected and quickly made an over-simplified problem into a complex one. At this time, the shutdown subsynchronous vibration phenomena was called the "trombone," based on the audible tone heard from a speaker. The image of the unpopular plant operator who initially suspected an alignment problem improved dramatically among his peers. The results from the data also deactivated anyone's blame on any dry coupling design.

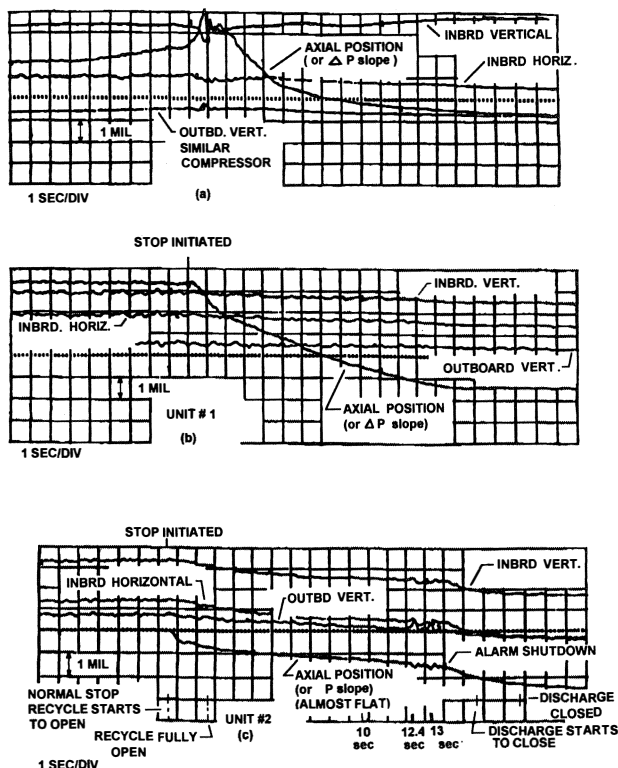
Figure 7. Unit 1 and Unit 2 (Vibration at 60 Percent Speed) and Similar Unit Radial and Axial Shaft Position Corresponding to ΔP Fluctuations.

A normal stop comparison is shown in Figure 7 of the radial and axial shaft response of the unit that operated without problems (unit 1), the unit experiencing the shutdowns and alarms (unit 2), and a similar unit at another station. Data for the similar unit correspond to the same condition presented in the previous figure. Journal position is depicted in Figure 7 with respect to the bearing 6:00 position given by the inboard bearings' X and Y probes and the outboard bearing's Y probe.

From Figure 7, it is concluded that there was ΔP activity in unit 2 (Figure 7 (c)) after the normal controlled stop was initiated. Unit 2 ΔP activity was very different from the one experienced by unit 1 (Figure 7 (b)) which was deemed a unit with normal ΔP response. By analogy and comparison with a similar compressor, Figure 7 (a), it was concluded that a ΔP flat slope followed by a ΔP discontinuity was causing what was earlier called "trombone" vibration.

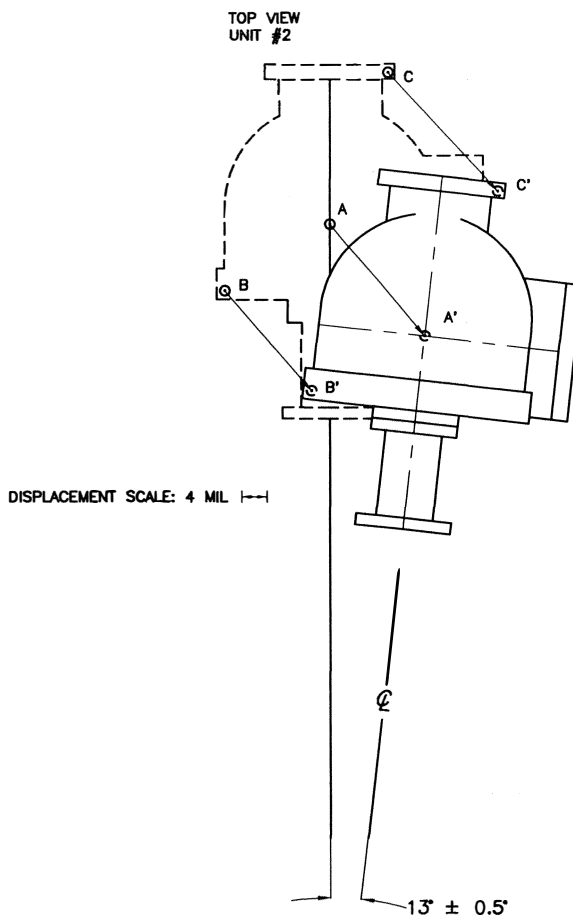
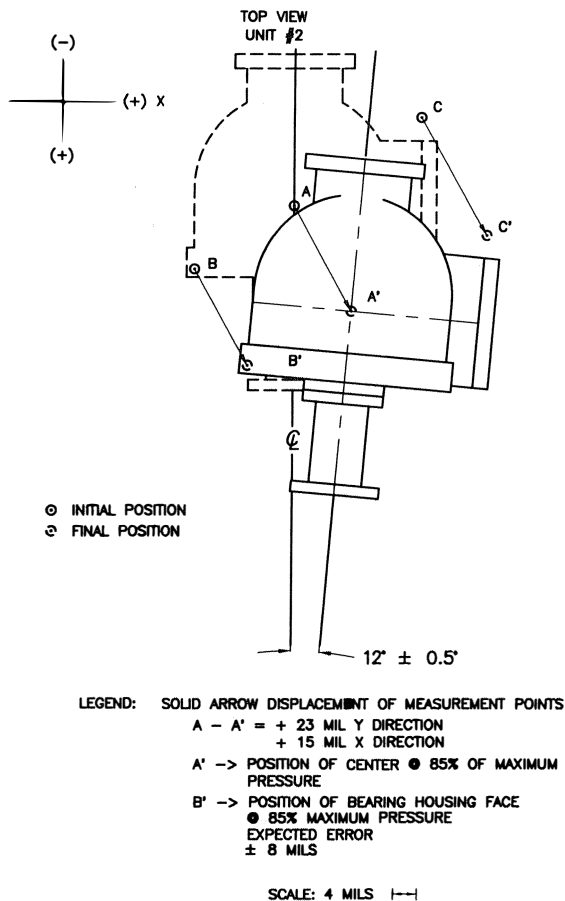
The results of the alignment study are presented in Figure 8 and Figure 9. The top view of the compressor is shown in the figures in terms of initial position (dotted lines), intermediate, and final alignment positions (solid lines). The initial position was a result of suction header pressurization (Figure 8). This was followed by operating thermal expansion of the discharge header (Figure 9). The final misalignment was considered severe with a vectorial magnitude greater than 0.125 in. The centerline of the compressor shaft actually went down and away from the expected self alignment condition.

The root of the shutdowns during controlled stops was not the dry disc coupling designs of the two different vendors, but a combination of pressurization and thermal expansion of the piping and an inadequate recycle piping system. This combination resulted in the “trombone” or subsynchronous vibration

The gear coupling ran better than the three different disc couplings in the sense that when the gear coupling was used, the alarm was often tripped instead of the shutdown switch. The vibration was still there, but not as severe. The coupling vibration was a symptom of the problem, not the cause. Changes to the piping thermal growth and the recycle loop were the final solution to the vibration problem.

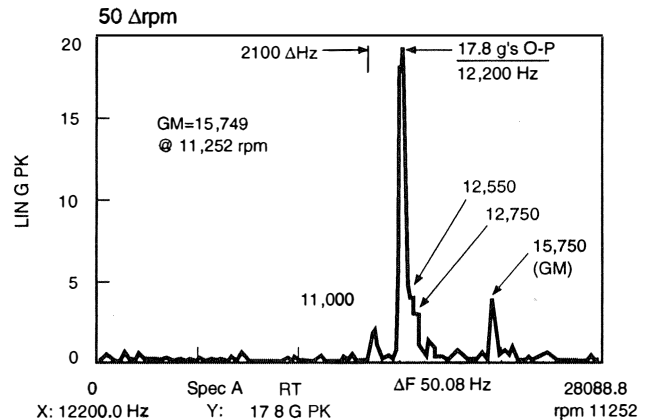
Figure 11. Spectral Analysis of Gear Vibration.

When the package was string tested (rather than load tested) at the factory, the vibration monitor showed two spikes (Figure 11) reaching levels above shutdown settings. This was observed as the power train was accelerated from 75 percent speed to 100 percent speed. This type of phenomena had not been observed before in similar package configurations featuring the same driver, the same gearbox, a "wet coupling" (gear-spline lubricated style) and other vendor compressors. Because this new compressor required skewed alignment figures, it was thought that the dry coupling design was pushed to a poor performing condition, and thus the unusual gearbox spiking.

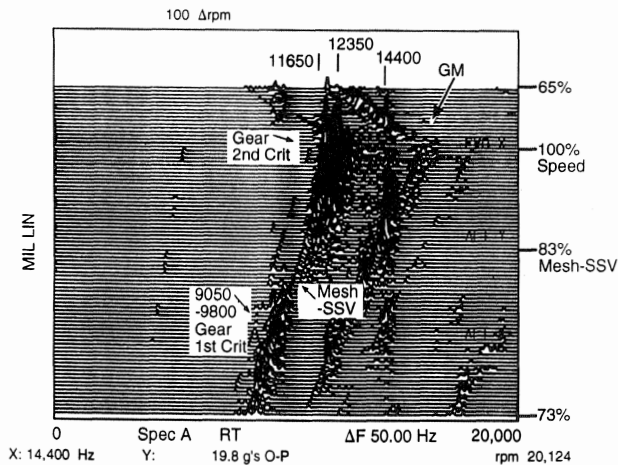
Figure 13. Spiking Phenomena.

The spiking phenomena is depicted in Figure 13 by means of a "waterfall" display of the output accelerometer. The speed swept from 73 percent to 100 percent speed and returned to 65 percent speed. The largest amplitude was registered at 19.8 g O-P at 14.4 kHz. Mesh subsynchronous vibration (Mesh-SSV) is shown at the 9 kHz and 12.4 kHz range. Gear mesh spiking is shown at 14.4 kHz. Actual gear mesh (GM) as a function of

speed is indicated by a soft diagonal line. The gear mesh vibration always tracked speed.

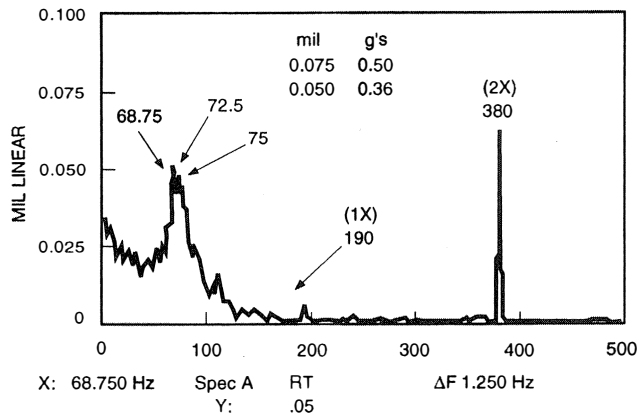
Figure 15. Peak Hold Spectrum - Axial Probe on Compressor Outboard End.

The peak hold spectrum is shown in Figure 15, from a hot break away to 100 percent speed (lube temperature 131°F), of the axial probe on the compressor outboard end. The ANF of the partially preloaded system is shown at 73 Hz and it appears well damped with an amplitude of 0.05 mil p-p. The 380 Hz spike corresponds to 2× the speed of the compressor shaft (190 rps) at 100 percent speed.

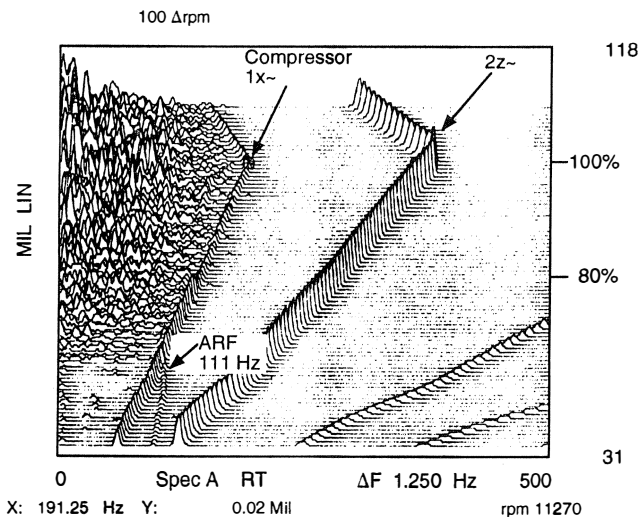
Figure 16. Waterfall of Axial Compressor Probe.

The waterfall of the axial compressor probe is shown in Figure 16 on the compressor outboard end at cold breakaway. The ANF of the pre-loaded dry coupling was measured at 111 Hz, with again, a low amplitude.

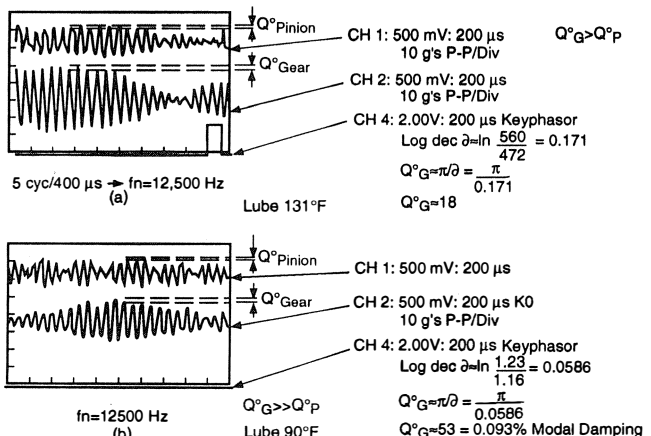
Figure 17. Gear Accelerometers Waveform Comparison.

The Q^o of the mesh-SSV (12.4 kHz) was measured at 18 and 53 for a steady-state lube oil temperature of 131°F and at 90°F, respectively. A comparison is shown in Figure 17 of the waveform from the input (pinion) and output (gear) accelerometers during excitation of the 12.5 kHz spiking and 14.4 kHz spiking.

Based on the high Q^0 , the cause of both the mesh-SSV and a critical speed excitation was addressed as a gear teeth profile error. This was a gear teeth quality issue not a gear design issue. Both large amplification factors ($Q^0 = 18$ and 53) made the spiking phenomena a non acceptable response based on the scales of Table 2. At this time, it was possible to attach a quantitative magnitude to an otherwise qualitative rejection due to gear spiking.

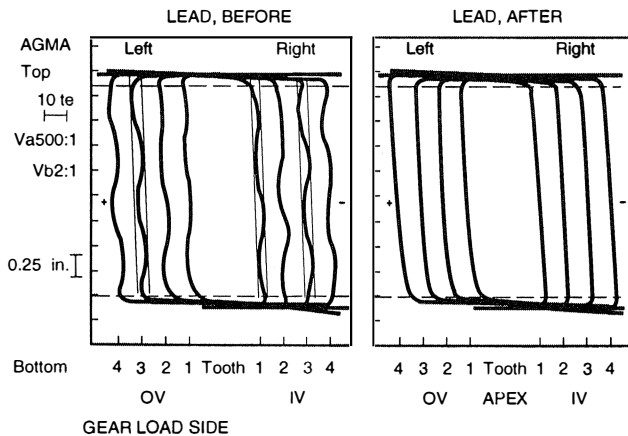
Figure 18. Gear Lead Before and after Rework.

The before case in Figure 18 shows the lead tracing with two high points. Lead is a measurement taken on the tooth flank, along the pitch diameter. The magnitude of the high points shown by the traces exceeded the vendor specification.

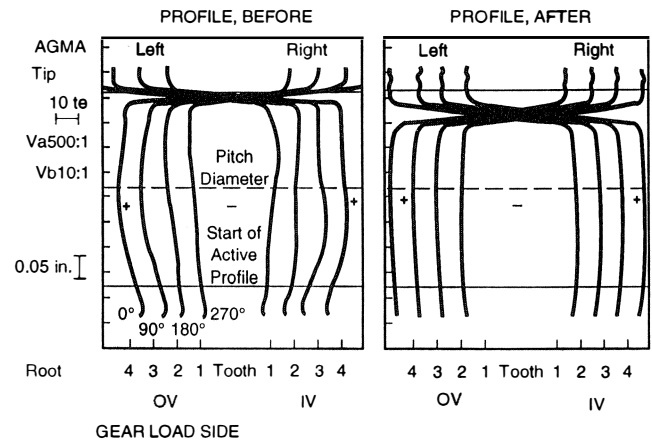
Figure 19. Gear Profile Before and after Rework.

The before case in Figure 19 shows the profile had a large protrusion just below the pitch diameter. Profile is measured along the tooth flank from the major OD corner of the tooth towards the root of the tooth. The magnitude of the protrusion shown by the traces exceeded the vendor specification.

- The cause of the mesh-SSV and mesh spiking phenomena was gear teeth profile error. This finding was firmed up from the measurement, the calculation and the comparison of the operating amplification factor of the gear at 131°F and at 90°F at 12.4 kHz, Q^0 was equal to 18 and 53, respectively.

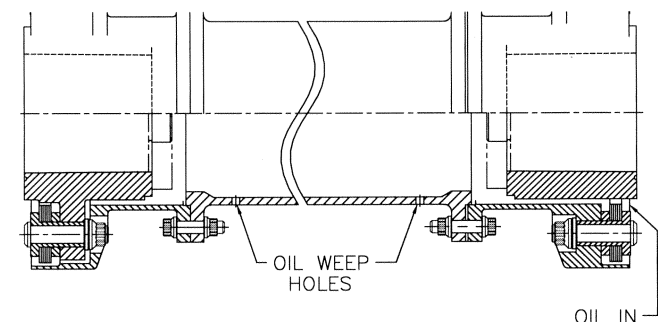
Figure 20. Oil Weep Holes.

This case involves a coupling similar to Figure 20. Reports from an OEM's test stand indicated an 80 percent running frequency subsynchronous vibration, which was attributed to oil whirling inside the dry coupling.

Compressor oil meant to drain out of the coupling guard had gotten inside the coupling and could not get out. It formed a layer inside the spacer, which spun at a different speed than the coupling causing the subsynchronous readings.

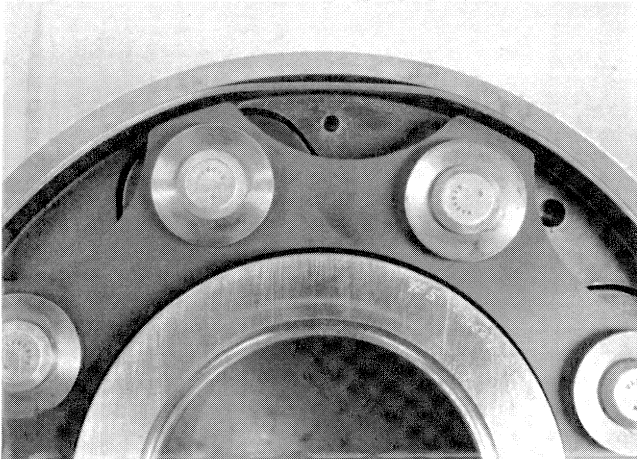
Figure 21. Windage Shroud Dent in Hub Assembly.

Upon inspection, it was discovered that there was a significant dent in the antiwindage shroud of the coupling disc pack assembly. This dent was not easily discernible to the naked eye. A flexible pad wrapped around the circumference of the shroud highlights the dent, as shown in the photograph of Figure 21. The displaced metal in the dent was calculated to produce a difference in unbalance of approximately 4.0 gr-in in the component assembly. This error was well beyond the allowable API 671 balance tolerance for this subassembly, and it was concluded that this error could have caused the excessive vibration.

Not only was there damage to the shroud, but whatever caused the dent was of such a great force that the disc pack actually tin-canned slightly—meaning that there was elastic deformation in the pack that caused slightly buckled discs. These temporarily deformed discs were also not easily visible.

After the coupling was repaired, it ran well on test. However, it was not ever determined exactly when the damage occurred. It definitely occurred after the coupling was balanced at the coupling manufacturer's plant, but before the test run at the purchaser's facilities.

There was some suspicion that the shipping container was inadequate, so, to cover all bases, better boxing was supplied for the repaired assembly and subsequent shipments. Also, all personnel who could possibly handle the parts at both facilities were notified to be careful and to check for damage if any coupling components were dropped or bumped severely and to look for this damage in all areas, especially the critical areas of the component part locating pilots, and flexible elements.

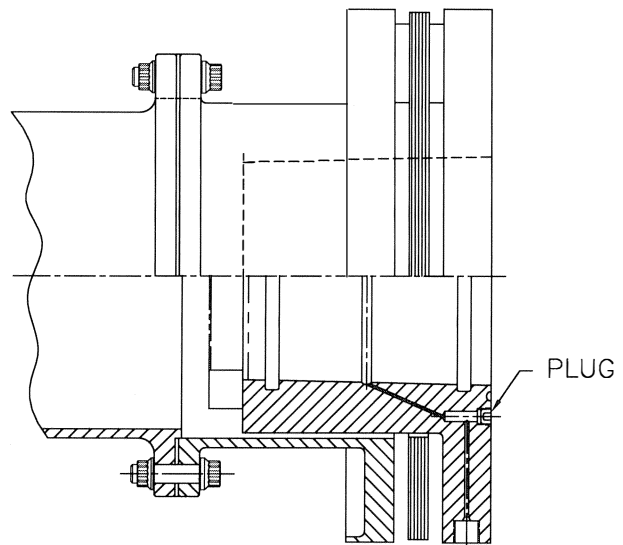
Figure 22. Oil Distribution Hole Arrangement and Plug.

The problem that occurred in the field was that this plug had inadvertently been left out of the hub, and this error was not

discovered until the user tried to hydraulically install the coupling hub. The hydraulic fluid leaked out of the unplugged hole and the hub could not be installed.

The solution to the problem was not to simply install a replacement plug. It was more complicated than that. The coupling had been precision balanced without the plug installed. To add the plug would mean introducing an unbalance of 2.8 gr-in (the plug weighed 1.4 grams and was located on a 2.0 in radius). This was well above the subassembly allowable unbalance and could have caused excessive vibration if the rotors were very sensitive to unbalance forces. More than that, the coupling had been assembly check balanced, so the entire coupling had to be shipped back to the factory and rebalanced (with the plug installed in the hub) on a rush basis to get the plant back on line on schedule.

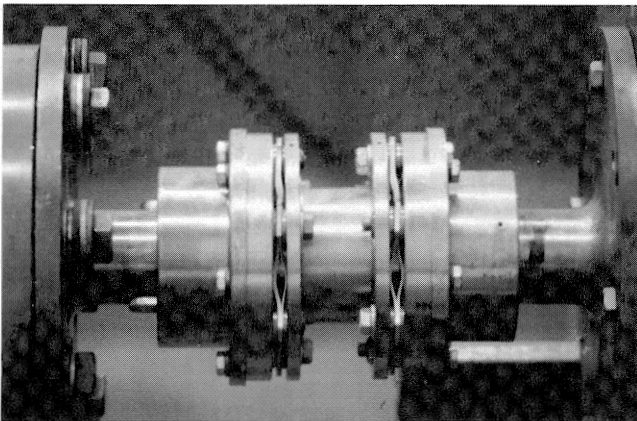
Figure 25. Buckled Disc Packs.

that the disc packs in the coupling had developed gaps between discs and looked “buckled.”

Coupling field engineers were on site for the next startup and confirmed the clicking noise, which appeared this time at 400-420 rpm. Inspection of the coupling revealed that it had developed “tin-canning” (an elastic deformation of the disc packs where the disc pack links are buckled) as in Figure 25. In addition to the noise and the buckled discs, the spacer was shuttling axially between the disc packs during the startup.

It was decided to “beef-up” the coupling in case there was unforeseen torque loading. Fifty percent thicker disc packs and special tight fitting bolts replaced the existing design.

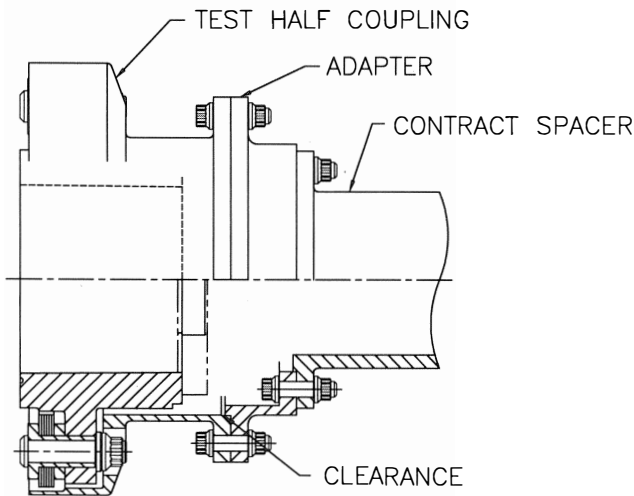
Figure 28. Case 5b Adapter Arrangement.

Upon inspection, it was found that the test stand coupling was a combination of a 1986 manufactured reduced moment high performance disc half coupling, attached to an adapter plate of unknown manufacture, connected to the contract spacer and compressor high performance disc half coupling, shown in Figure 28.

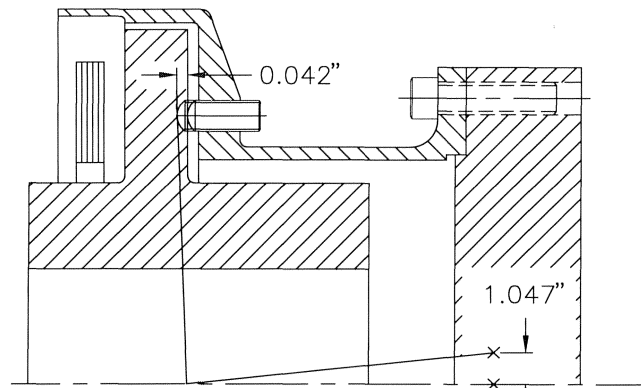
Figure 32. Running Angle Before Failure.

Indentations of the rigidifying setscrews in the coupling hubs attest to these forces, statically determined to be 8000 pounds force to make the largest indentation. Knowing the depths of indentation, as shown in Figure 32, the worst case angle was determined to be 0.32 degrees.
