RETROFIT OF A STEAM TURBINE WITH DRY GAS SEALS

The solution to a chronic utility problem, with a critical natural gas compression unit, at the Ammonia plant at Du Pont's Beaumont, Texas facility, is described. The most critical problem, chronic steam leakage from the turbine and subsequent oil system contamination, was corrected by the installation of noncontacting spiral groove seals. In addition, vibration problems caused by coupling lockup and subsequent premature coupling failure were solved by replacing the grease lubricated gear type coupling with a nonlubricated flexible coupling. A feature of the coupling is a keyed hub, designed for hydraulic removal.

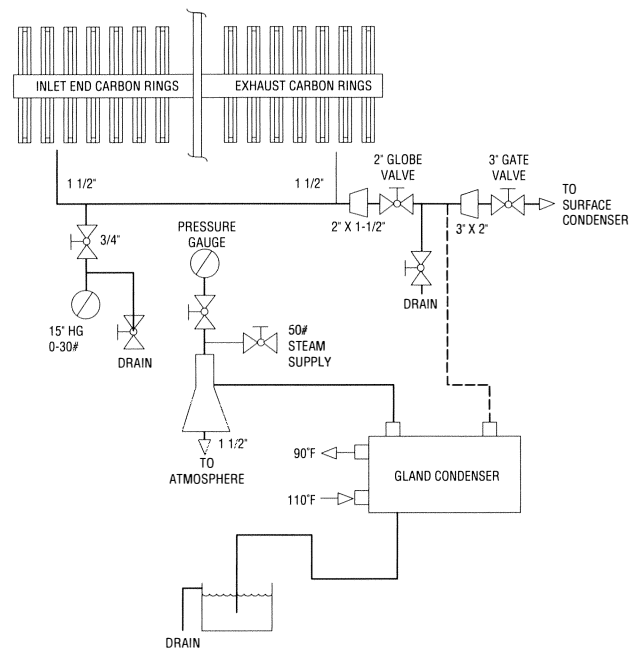
Figure 3. Schematic of Leakage System to Gland Condenser.

ring seals with a leak off line to a gland condenser, as shown in Figure 3. Typically, carbon ring life is short in high back pressure service. It was not uncommon for the leakage rate to be excessive after running only one week. Every time the plant came down, there was a standing repair order to change the carbon seal rings. These costs are detailed later.

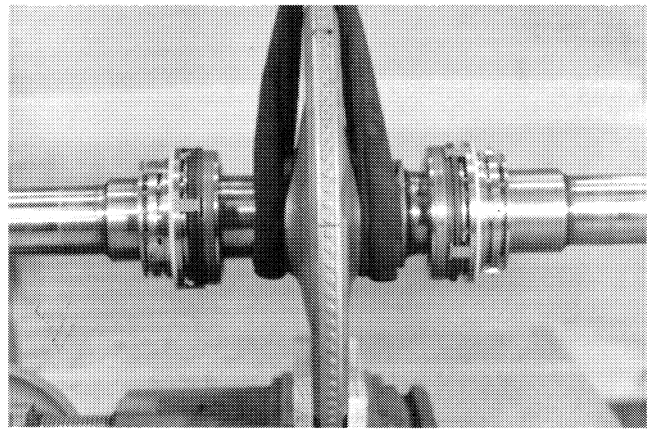
Figure 7. Turbine Rotor with Dry Steam Seals Installed.

A progressive balance procedure was done on the spare rotor before seals were installed. Once the seals were installed on the shaft (Figure 7), no further balance checks could be made because some parts of the cartridge were stationary in service. For this reason, it was recommended that the rotor be progressively balanced to minimize effects of removing and reinstalling rotor parts.
