AN EXPERIENCE WITH NONSTANDARD COUPLING APPLICATION

Du Pont Polymers

Beaumont, Texas

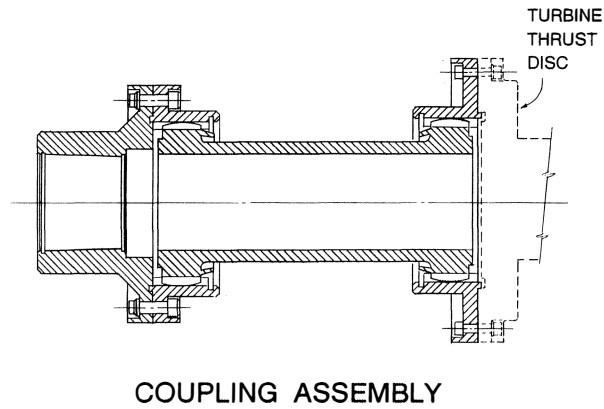
Figure 2. Turbine Thrust End Flange and Coupling.

the integral turbine hubs, marine style gear couplings were used. Marine couplings have the teeth on the spacer rather than on the coupling hub. To be consistent, the compressor ends of the couplings were also marine style. The thrust end of the turbine had an integral flange that was larger than normal to accommodate both the thrust disk and the bolt circle for the coupling (Figure 2). The bolt circle for the flange was 13 1/2 in, compared to a normal 9 11/16 in, thus requiring a special sleeve design. Because of space limitation, the integral turbine hubs were located within the turbine bearing housings, as shown in Figure 3. The top half of the turbine bearing housing had to be removed to assemble the coupling, as can be seen in Figure 4.

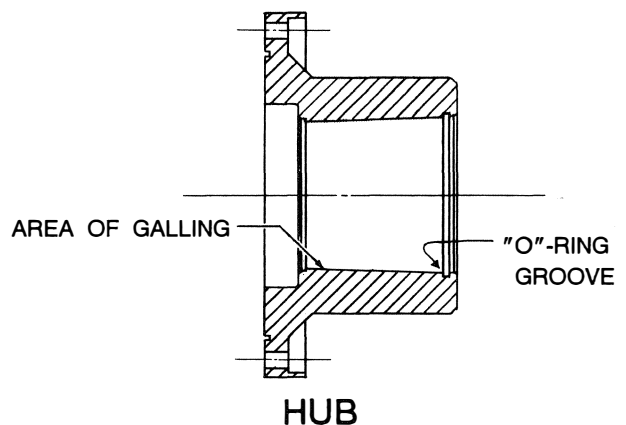
Figure 6. Compressor Hub, "O"-Ring Groove, and Galled Area.

Coupling problems began even before the initial startup. The O-ring groove in the compressor coupling hubs was not a standard design, and neither metric nor American standard O-rings would fit (Figure 6). The "best-fit" O-ring was selected and used for the first installation. When one of the compressor hubs galled during

installation, it became a concern that a problem of O-ring leakage, due to its being the wrong size, could make the coupling hub nonremovable in the field.

The space limitation of the installation required that the outboard flanged face of the mounted hub be closer to the shaft end than normal. This large flange so close to the shaft end inhibited proper bore expansion during installation. As a result, the outboard end of the hub could drag and gall as it was pushed onto the shaft (Figure 6). The hubs were installed and removed 12 times with

galling occurring on three occasions. So far, the damage has required only light dressing of the shaft, but the possibility for greater damage is a concern.

The hub O-ring groove was incorrectly sized by the compressor manufacturer. The supplied standard metric O-ring was too small and the next size was too large. No standard metric or American O-ring fit this particular groove size. The OEM's proposed "solution" was to stretch the smaller O-ring to fit the larger bore groove. This was done on the initial installation because of the time constraints, but was unacceptable for a permanent solution. If the O-ring ever failed to seal, the whole rotor would have to be removed for coupling removal, because heat cannot be applied in the field.

Attempts at repairing the galled hubs were unsuccessful. The 0.001 in deep gall marks in the hub bore were removed by regrinding the bore. Unfortunately, even this small change in the bore diameter caused the final hub location to move too far onto the shaft, exceeding the allowable axial spacing for the coupling spool piece. For the taper involved, this 0.001 in increase in bore diameter moved the hub 0.030 in further onto the shaft. This was unacceptable, and new hubs were needed. The spare couplings were installed, but later removed prior to the November 1982 startup in favor of new instrumented (torque monitoring) couplings, which arrived just in time for the restart. Since the initial startup, the galling problem has resulted in three hubs being scrapped because they advanced too far onto the shaft after grinding.

Resizing the O-ring groove would have required additional reworking of the hubs and was not a desirable option at the time. Eventually, a domestic O-ring manufacturer was found who could custom make the correct size, an enormous quantity had to be purchased for them to take the "special" order.

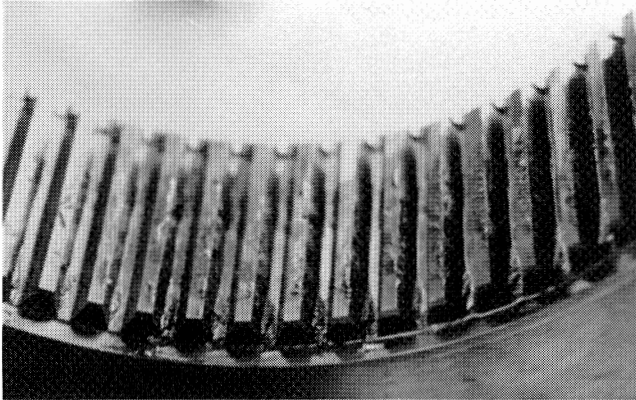
Figure 7. Worn Coupling Gear Teeth.

An inspection in 1983, after one year of operation, revealed significant wear on the coupling teeth adjacent to each end of the turbine (Figure 7). The couplings were replaced, and one year later an inspection revealed the same rapid wear problem. No corrective action was taken because the plant was mothballed due to poor product demand.

During the first shutdown in 1983, the gear teeth on the turbine side of both couplings were found to have significantly more wear

than those on the compressor side. This rapid wear occurred even though the coupling teeth were nitrided to a Rockwell C-50. The couplings were replaced, but similar tooth damage was again discovered during the second shutdown in 1985.

The upper limit for trouble free operation was 5.0 ips, which was not a very large margin of safety. This, combined with the heat coming from the turbine, could produce a potential problem. Carrying the analysis further, the expected temperature rise of the exiting oil was a moderate 38°F for the recommended 5.0 gpm supply, 2.5 gpm per mesh. However, if a blockage or misdirected flow reduced this to 1.0 gpm on the turbine side, the expected temperature rise was 98°F, and with 120°F inlet oil and the heat from the turbine, temperatures were quickly approached where the lubricating qualities of oil could begin to break down [4].

The problem was finally diagnosed as insufficient oil flow through the turbine coupling oil spray nozzles. The turbine manufacturer provided increased capacity spray nozzles for the turbine side of each coupling, and the problem has not recurred.

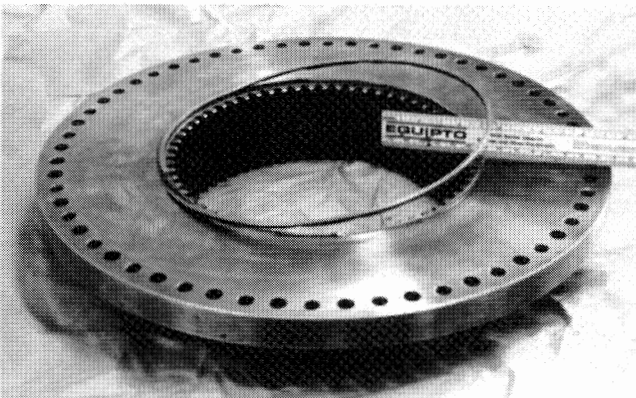
Figure 8. Coupling Rabbet Failure.

New couplings were installed when the plant was returned to production in 1986. After 2½ years service, the coupling sleeve rabbet ring at the thrust end of the turbine was found to have failed by fatigue (Figure 8).

In August 1988, a coupling inspection revealed that the coupling on the thrust side of the turbine again had extreme wear and fretting damage on the turbine side teeth. This was after the oil flow had been increased to the turbine side of the coupling and had been operated long enough to believe the abnormal wear problem was corrected. The inspection also revealed that the external rabbet on the coupling sleeve had fretting damage and a portion had failed from fatigue. The approximately 1/8 in \times 3/16 in \times 8.0 in diameter external rabbet had completely sheared about 200 degrees around the circumference. Looking for the cause, no dimensional errors were found, but the bolts and bolt holes exhibited wear marks.

One possible explanation could have been loose coupling bolts. Loose bolts would have allowed the sleeve flange to move, causing the fretting damage and a side loading to be placed on the external rabbet. This could have resulted in the fatigue failure. Once the rabbet failed, oil could escape this area and leaked between the flanges, starving the coupling teeth of lubrication and causing the tooth fretting damage.

Another possible explanation for the rabbet failure could have been that the bolts were tight, and the coupling sleeve flexed under load. The large bolt circle (13.5 in) on this end of the turbine required an equally large coupling sleeve mating flange. With the large diameter of the flange and relatively thin cross section, distortion from misalignment forces could have been enough to cause relative motion at the locating rabbet. This could have created an interference loading, causing the external rabbet to fail.

According to Roark [5], the relative motion at this rabbet is proportional to α/t^3 , where alpha is the angular rotation coefficient for the ratio of flange OD over ID, and t is the flange thickness. On the turbine end, α/t^3 is 2.2 vs 0.5 on the compressor side of the coupling. For any future couplings, if α/t^3 is much over 0.5, a close look will be taken at the flange design.

The damage evidence seemed to support the conclusion, but loose bolts were not reported when the coupling was disassembled. Just to be safe, extra care was taken to properly torque each of the 30 bolts on the turbine side of the coupling during reassembly. The coupling manufacturer's recommended installation torque is 50 percent of the bolt material yield strength. To make sure the bolts were tight, a change was made to the bolt manufacturer's recommended torque of 80 percent of the yield strength.

No way is known to correct this problem short of a major redesign of the existing coupling or changing to a different style coupling.

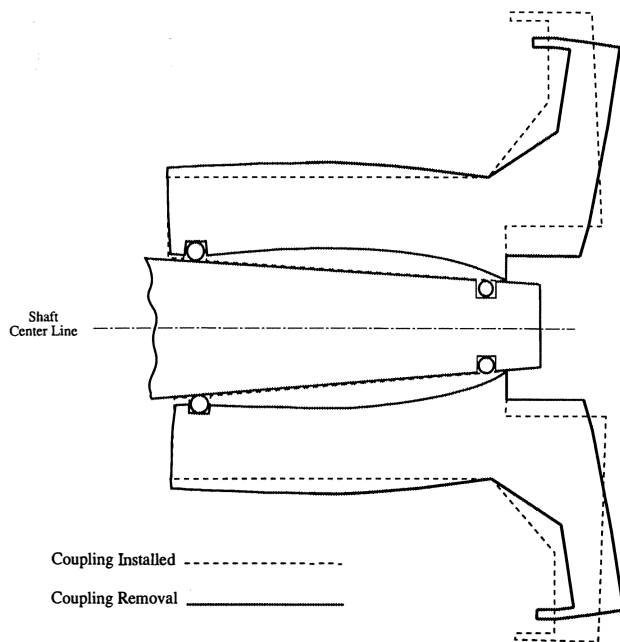
Figure 10. Hub Expansion from Hydraulic Pressure.

A finite element analysis was done to model bore expansion during hub installation with hopes of finding a possible modification to stop the galling (Figure 10). No modification was found that satisfied all concerns.
