REPAIR SEVERELY DAMAGED ROTORS BY SUBMERGED ARC WELDING

Jim Heeter

Marketing Manager, Deltex Service Division

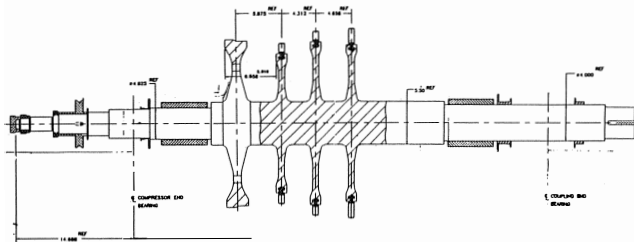
The following case study involves a rotor from a four stage steam turbine (Figure 1). The rotor is forged with integral wheels (monorotor). After some months of operation, during a routine inspection, cracks were discovered in the outer radial faces of the first stage Curtis wheel. Surface inspection indicated that the

Figure 1. Diagram of the Rotor Assembly for the Nominal 22 In Forged Turbine.

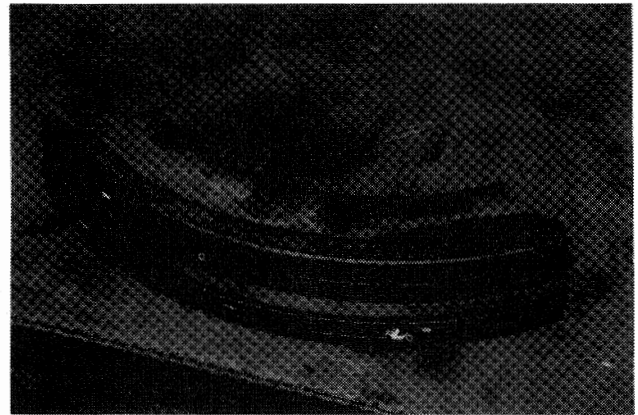
cracks were possibly due to stress corrosion believed to have been caused by caustic introduced accidentally with inlet steam. The laboratory analysis required the machining off of the outer rim in full cross section segments.

Figure 2. Segment Removed from the Rim of the Curtis Wheel.

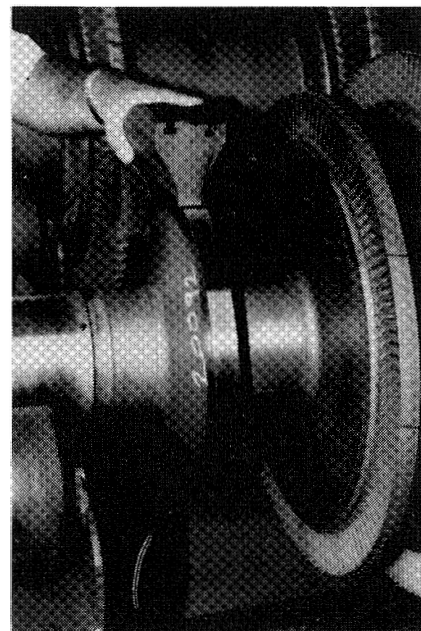
The rotor was delivered to the repair facility with the damaged part of the wheel removed (Figures 2 and 3). Discussions that followed caused the planners to recommend removal of more of the rim (Figures 4 and 5) in order to assure that all the damaged material had been eliminated, and to facilitate welding from the shaft upward, which would place the HAZ out of the steam path.

Figure 3. Relationship of the Removed Segment to the Remaining Rim of the Curtis Wheel.

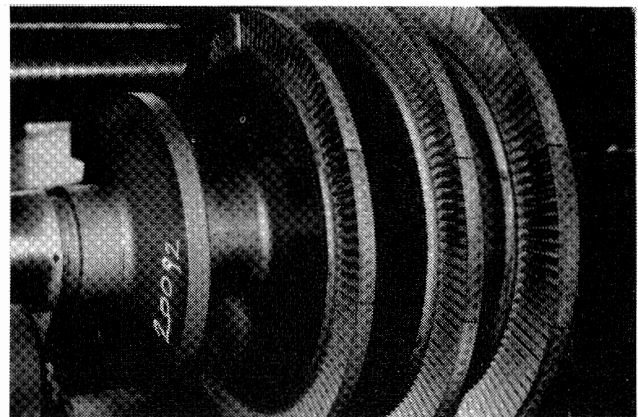
Figure 4. The Remaining Portion of the Rim of the Curtis Wheel as Received at the Shop.
