# RECENT CASE HISTORIES WITH COUPLING ENCLOSURES

Michael M. Calistrat

Michael Calistrat and Associates

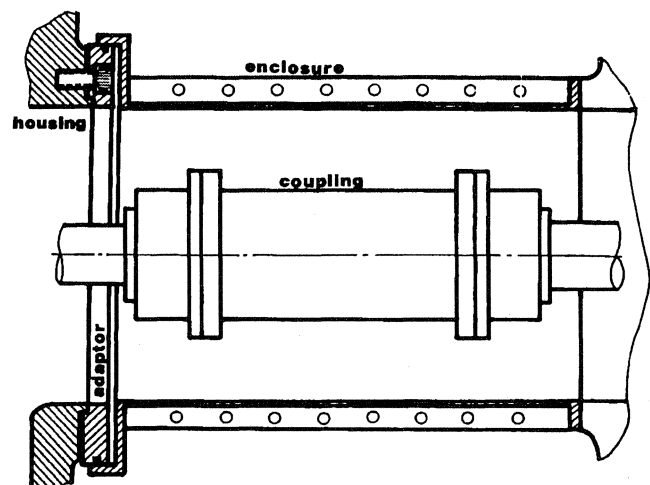
A fire that caused a long shutdown at a plant of Quantum Chemical Corporation prompted their safety department to search for other "fire hazards" in the plant. Such fire hazards were found to be the continuous oil leaks from the gear coupling enclosures on steam turbine to centrifugal compressor drives. The basic enclosure design, as manufactured by the OEM, is shown in Figure 1. Pounds of RTV sealant could not stop the oil leaks. In order to minimize the resulting mess, the maintenance department fabricated steel trays, which were placed under the enclosures to catch the spills. The oil was flowing from the trays into barrels placed near the compressors. These barrels had to be emptied daily of the accumulated oil. A study of the existing enclosures showed that the main leaks occurred at the connections with the compressor cases, and at the horizontal split lines. The author redesigned the enclosures; the main improvements over the original design are:

Figure 1. Rigid Enclosure, OEM Design.

ures resist offset movement between the two machines. Evidently, the enclosure is too weak to prevent the machine movements, and the end result is the distortion of the enclosure, and inevitable oil leaks.

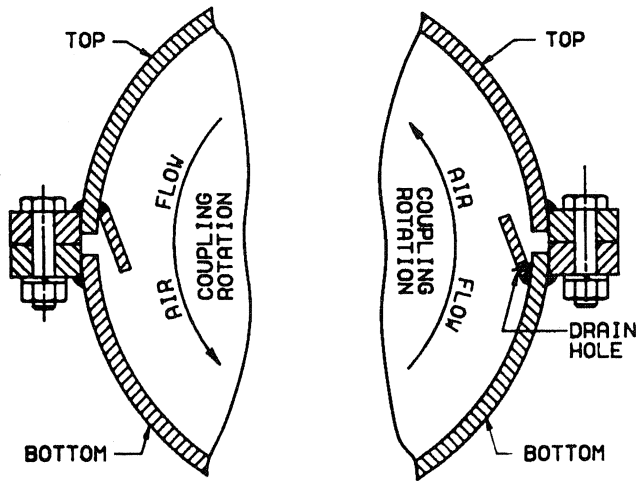
Figure 2. Dynamic Sealing for Flange Joints.

- The split lines incorporate dynamic seals, based on the design proposed in the first paper, and reproduced now in Figure 2.
- The enclosure was made to "float" at both ends, rather than being rigidly attached to the turbine. *Rigidly attached encl-*

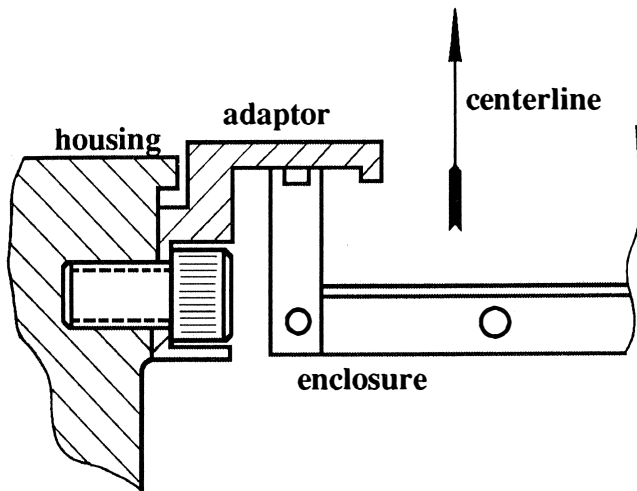
Figure 3. Redesigned Enclosure-to-Compressor Seal.

- The side seal was moved to a radius that is smaller than the enclosure drain point, as shown in Figure 3. The enclosure-to-compressor connections of the original design generated pools of oil that could not be drained, and which contributed to the continuous leaks.

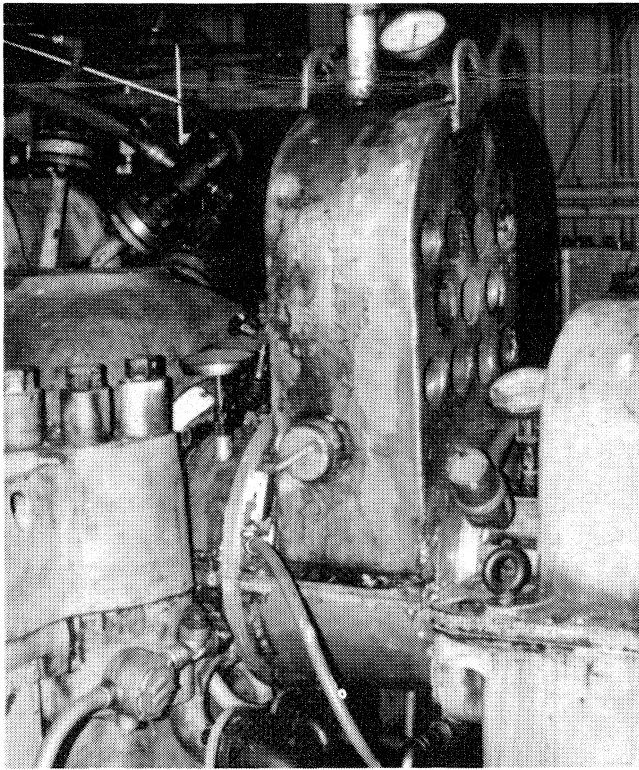
In an attempt to reduce this high temperature, which could have caused the deterioration of the oil leaking from the compressor seals into the enclosure (at the rate of 150 gal/day!), a new enclosure was fabricated. The idea behind the new design was to significantly increase the enclosure's surface area in order to improve the heat radiation. The new enclosure design is shown in Figure 4. In hindsight, it is easy to see that the odd-looking birdhouse design could not have worked. The boiler type tubes intended to increase the heat transfer were at the same time impeding the smooth air flow inside the enclosure, aggravating the turbulence. The end result was a slight drop in enclosure temperature, which still ranged between 250 and 300°F. The oil that continued to leak from the machines was exiting the enclosure at the same temperatures, and was not allowed to go back to the reservoir because of possible degradation.

Figure 4. Increased Surface Area Enclosure Design.

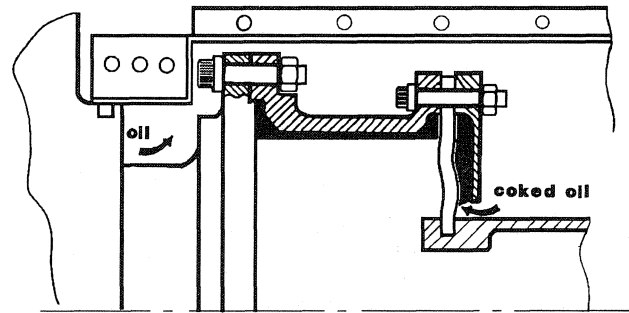
- The enclosure side wall was very close to the coupling bolts. This configuration made the coupling operate as a blower, causing a large negative pressure at the steam turbine oil seal. Oil flowed into the enclosure from that bearing.

Figure 5. Fabricated Enclosure and Locked Coupling.

- The drain line was fabricated from a 3/4 in electrical conduit, in the belief that a *dry* coupling enclosure would operate *dry*. In addition, the drain line was perpendicular to the enclosure wall, and no baffle was added.

- No breather was provided. The enclosure was intentionally made air tight as, at the time of the retrofit, a vacuum (5.0 in of water) pump was installed at the oil tank, in order to improve the flow of the oil returning from the bearings.

The temperature of the enclosure must have been *very high*. After the accident, coked oil was found inside the enclosure, as well as inside *and outside* the coupling. Lubrication experts estimated the coupling temperature at about 700°F! It is amazing that the coupling continued to operate for three years. Eventually, it failed during a cold December.

The condition of the coupling immediately before the failure is sketched in Figure 5. The dark area represents coked oil. The density of this substance was amazingly high. The author had to use a screwdriver and a hammer to break it into pieces (Figure 7). This high density was caused by the large centrifugal acceleration (4,500 g) in the coupling, which tightly packed every particle of coked oil as it entered the coupling. Eventually, the space between the first diaphragm and the guard disk was completely filled with rock-solid coke.

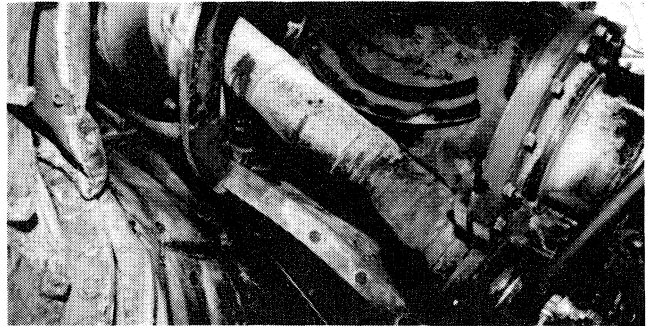
This is a very difficult application for any dry coupling, which connects the discharge ends of both turbines. In addition to the operation at high temperatures, the coupling has to accommodate a significant axial shaft movement. Because the OEM was late in delivering a new enclosure, the maintenance department fabricated a new one *onsite*. A partial sketch of the fabricated enclosure is shown in Figure 5. It incorporated a few significant mistakes, which eventually caused the diaphragms at the steam turbine end to rupture, the failed coupling to rip the enclosure, and the steam turbine shaft to bend. The appearance of the coupling after failure is shown in Figure 6.

Figure 6. Equipment Failure Caused by an Improperly Designed Enclosure.

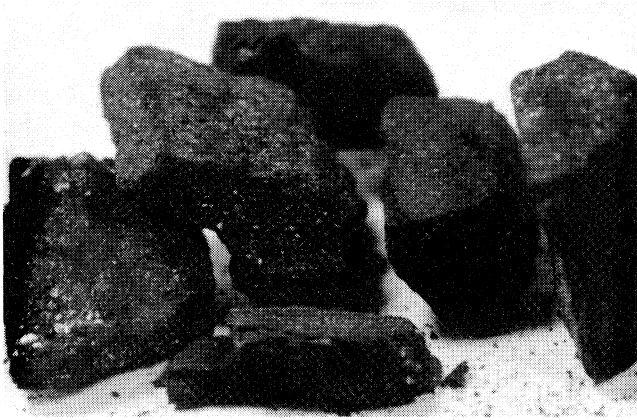
Figure 7. Coked Oil that Blocked Coupling Movements.

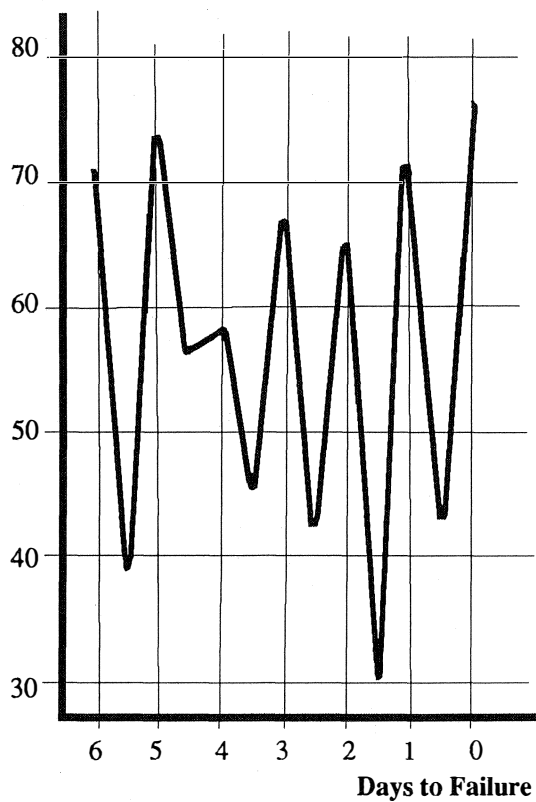
The failure was triggered by large axial shaft movements, which demanded from the coupling a flexibility it no longer had. The axial movements were caused by freak winter conditions in South Texas. The temperature variations during the six days before the failure is shown in Figure 8. Adding to the 45° temperature variations in the air, the machines and the skid were also heated by the sun during the day. The resulting thermal movements caused the breaking of one diaphragm after another.

Figure 8. Ambient Temperature Variations before the Failure.

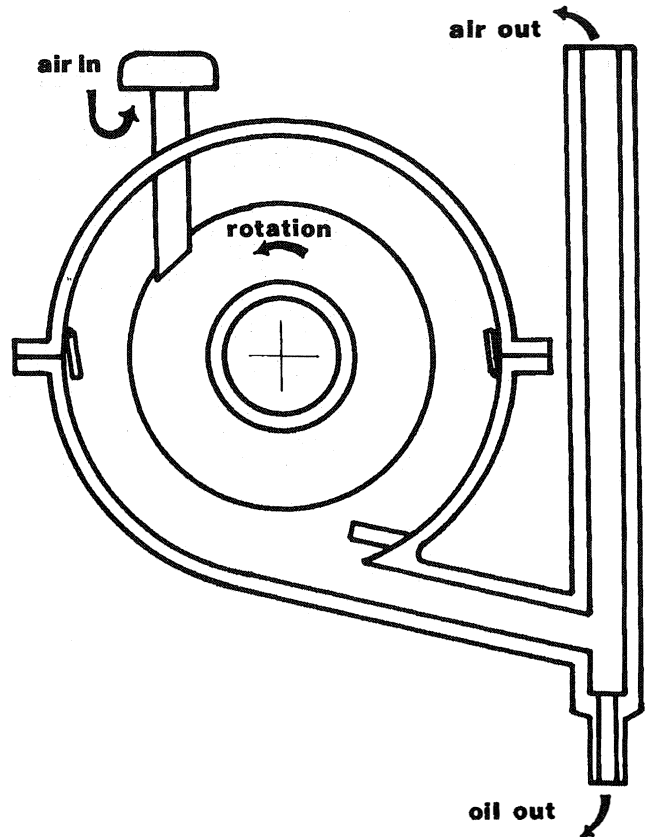
Figure 9. Enclosure with Air Cooling.

- Two drains and two breathers were incorporated. The drains were provided with air escape piping (Figure 9), and provisions were made to increase the air flow, if necessary, by connecting the breathers to the plant air supply.

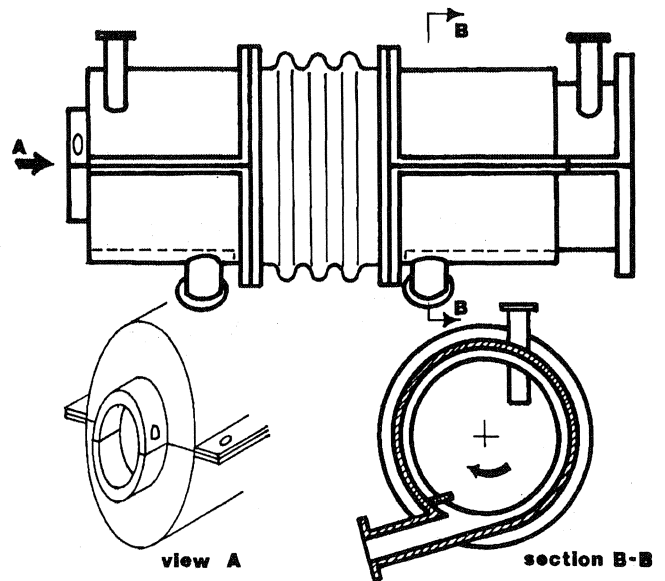
Figure 10. Redesigned Enclosure.

- The side walls were moved as far as possible from the coupling bolts.

A drawing of the new enclosure is shown in Figure 10, and a piping diagram is shown in Figure 11. With all these improvements, the enclosure still operated hot because of heat radiated toward it. An air blower was added to move the hot air that surrounds the enclosure, which has now operated satisfactorily for close to two years.

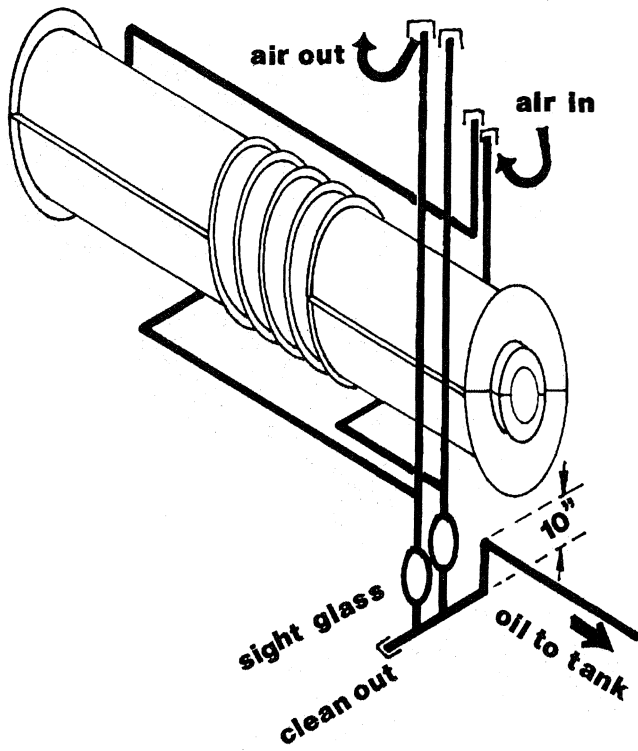
Figure 11. New Enclosure Piping Diagram.

- A 10 in trap was built in the drain line, ensuring the oil return *without* breaking the vacuum in the oil reservoir.

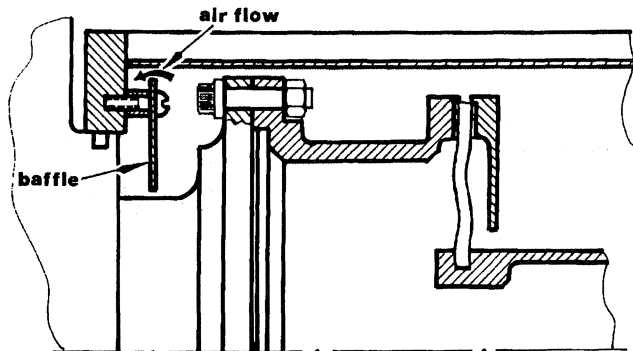
Figure 12. Vacuum-Breaking Baffle.

• The method recommended in Figure 7 of the 1985 paper for the reduction of oil being sucked out of the machine seals proved ineffective at high speeds or when couplings with abrupt diametral changes are used. A more effective method to break the vacuum present in the vicinity of the bearing seals is shown in Figure 12. The baffle must have a small clearance at the shaft, and about one inch clearance at the enclosure.

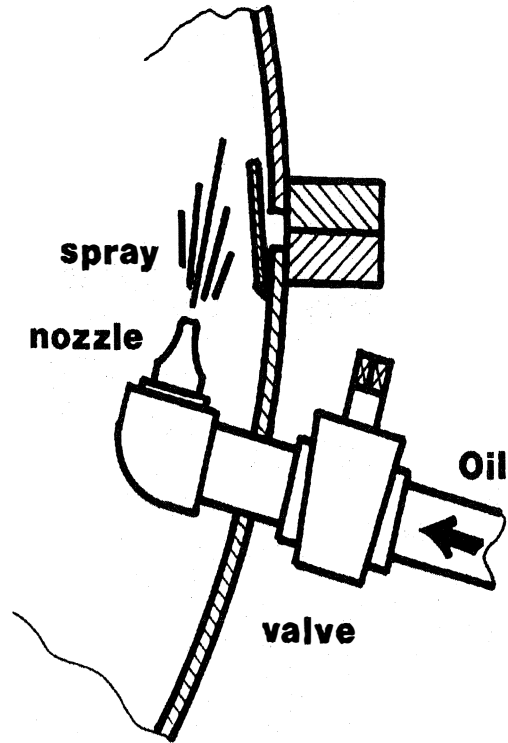
Figure 13. Enclosure Cooling with Oil Spray.

closure, and only in the direction of the coupling's rotation. Rather than performing oil flow calculations, the author recommends the installation of an oil valve in the circuit, as shown in Figure 13, and the adjustment of the flow until an acceptable temperature is achieved. Two nozzles must be used, at the ends of the enclosure, with one drain at the center.
