MAXIMIZING AN ETHYLENE PLANT'S TURBOMACHINERY RELIABILITY

John R. Dugas, Jr.

Sabine River Works

E. I. du Pont de Nemours & Company, Incorporated

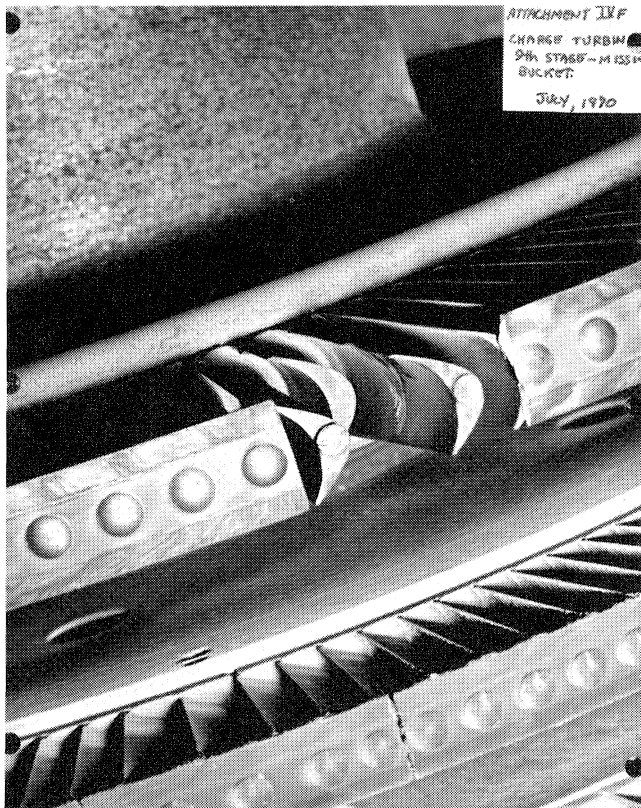
The charge gas and propylene refrigeration compressor steam turbine drivers experienced turbine blading failures shortly after initial plant startup due to resonance excitation of the ninth stage buckets (Figure 2). By working in conjunction with the original equipment manufacturer (OEM), the turbine blading problem was identified and solved by redesigning the ninth stage blades so that the resonant frequency was effectively moved outside of the turbine operating speed range. This correction was made in 1968 and is detailed in a technical service letter issued by Turbodyne [1]. This incident increased sensitivity to turbine blade problems and all future modifications to turbines were studied thoroughly before implementation. This attention resulted in no further turbine blade problems to date.

Figure 2. Turbine Rotor with Broken Blade and Shroud.

A contributing factor to turbine blade failures was the poor steam quality which caused blade corrosion. In addition, poor quality steam fouls the turbines and necessitates on-line turbine water washing to improve effectiveness. Online water washing was a common occurrence prior to 1982, and was performed as frequently as one to two times per month in the first few years of operation. It is a risky operation and has caused one turbine thrust bearing failure. Major improvements were made in steam quality, mainly by using demineralized water as boiler feedwater, and by installing an additional inline steam separator in the waste heat steam system to remove entrained liquid in the saturated steam prior to super heating. Steam quality has improved to the point that only two water washes have been required since 1982.

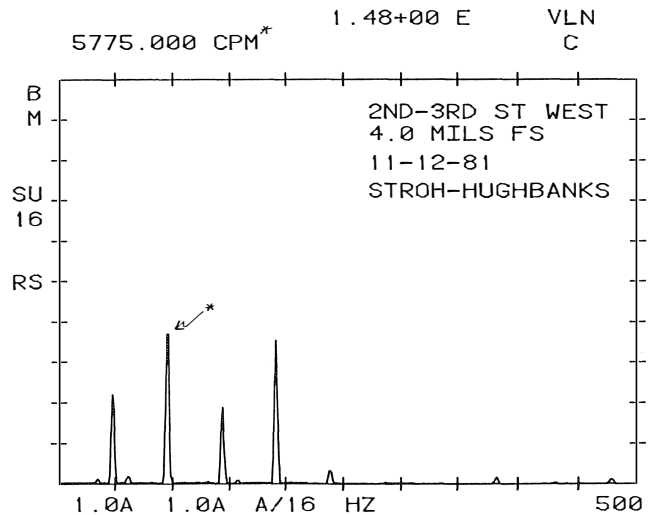
The charge gas compressor train experienced reverse rotation during several shutdowns, due to unbalanced flow conditions in the compressor minimum flow system. In addition, the charge gas compressor train, along with the propylene and ethylene refrigeration compressor trains, exhibited numerous bearing instability problems (Figure 3). In October 1981, an unscheduled shutdown resulting from an electrical power failure resulted in a plant outage, which eventually extended to 32 days because three successive plant startup attempts had to be aborted because of bearing instability. The second/third stage case of the train was assembled and disassembled three times before the problem was finally corrected.

Figure 3. Frequency Spectrum of Bearing Stability Problem.

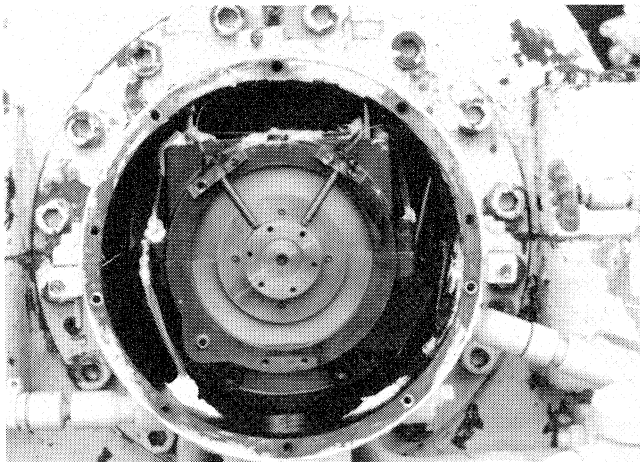
The original equipment installed in 1967 did not include proximity probes for vibration monitoring. An attempt was made to retrofit the machinery with proximity probes in 1969, but the installations were misapplied. Initial vibration data was questionable and the monitors were mostly ignored by the operating technicians in favor of seismic data which was also questionable. In 1982, x-y proximity probes (Figure 4), dual axial position probes, and dual embedded bearing thermocouples were installed with associated monitors. This provided accurate data, which when used in conjunction with real-time analyzers and oscilloscopes, helped return confidence to the operating technicians and provided early detection of equipment problems. A computerized, online monitoring system (Figure 5) was added in 1985.

Figure 4. Proximity Probe Installation.

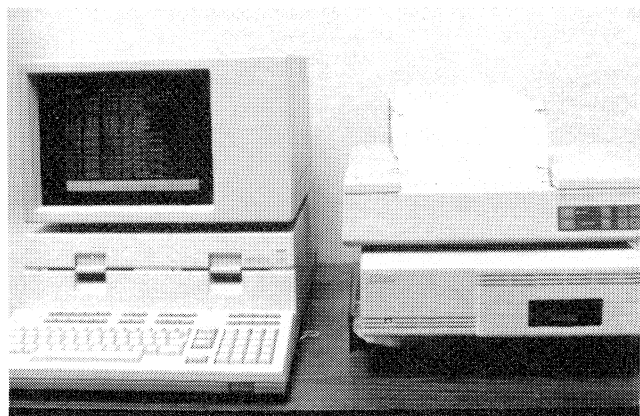
Figure 5. Computerized Online Monitoring System.

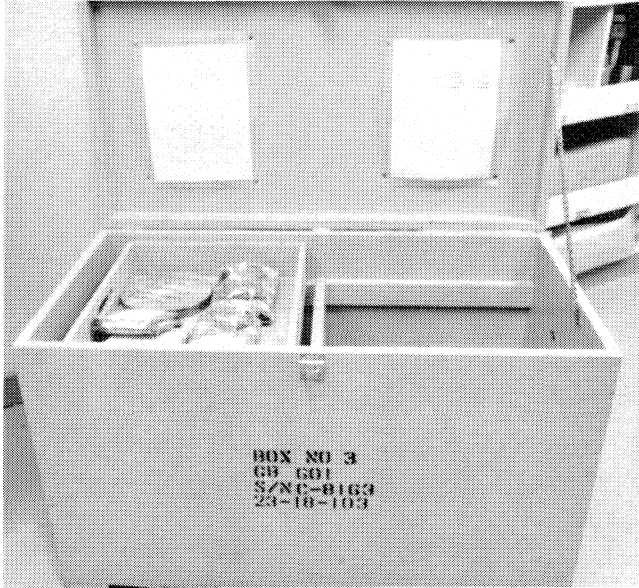
Figure 10. Shutdown Box Containing Compressor Seal.

Implementation of the machinery overhaul is enhanced by the use of "shutdown boxes." These boxes are clearly labeled as to the contents and placed at strategic locations during the overhaul. One box contains all the special tools which were developed in conjunction with the OEM. Other boxes contain seals (Figure 10), couplings, bearings, etc. There are also empty boxes for storing parts removed during the overhaul. All boxes have lids and are waterproof.
