EMERGENCY TURBINE REPAIR PROCEDURES

ABSTRACT

Emergency repairs of a cracked steam turbine disc can be accomplished effectively by using sound basic engineering principles. One such method used to expedite a repair is reported.

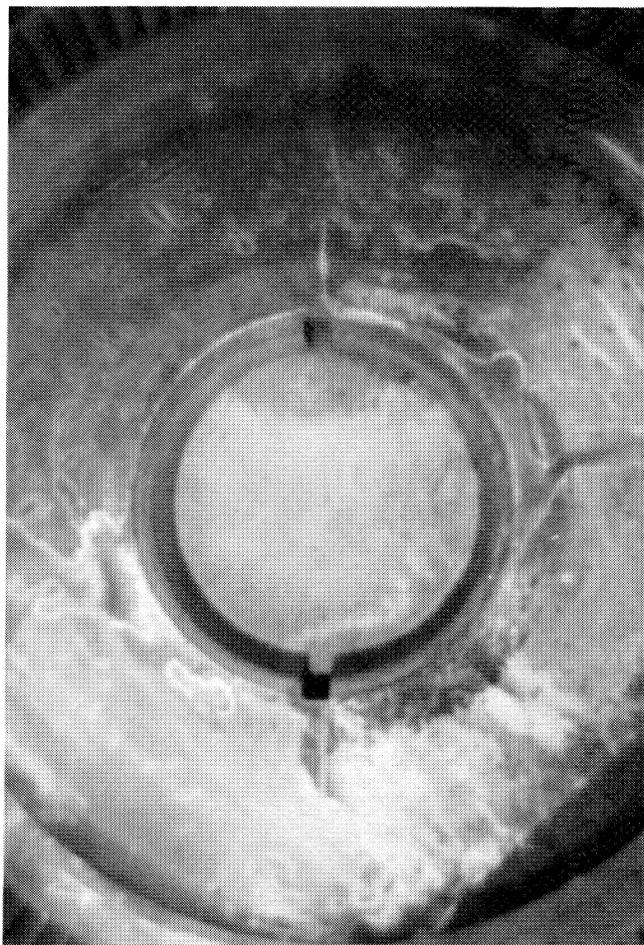
Two ratau wheels fully bladed and 21 in diameter, operating in a turbine at 600 psig, 680°F, 3500 hp, 150 psig exhaust, and 3000 rpm experienced singular cracks at each keyway (Figures 1 and 2). Availability of a spare rotor or spare discs was not expedient at the time, necessitating an expeditious solution for the problem.

Figure 1. Single Cracks at Both Keyways.

The Hartford Steam Boiler Inspection and Insurance Company was the insurer of this turbine, and became very much involved. It was a total union of user, repair shop and insurance company advising to protect all parties concerned. Due to the past history of the rotor, all concerned were confident that this was a one time incidence of stress corrosion cracking due to a new boiler startup (Figure 1). On the basis of this assumption, it was agreed that the following approach be utilized:

- drop affected wheels
- acquire test specimen of material and have analyzed
- use wet metal particle to examine and determine extent of cracking and crack lengths
- bore out cracked area to sound metal and recheck for cracks (wet mag particle)
- purchase and machine a “do-nut” of suitable material to replace the cracked portion that was bored out. (A “do-nut” is a cylindrical piece of metal slightly thicker than the wheel being repaired and having inner and outer radii close to dimensions required for final repair).
- determine hardness of wheels at different representative locations.
- heat treat rough machined “do-nut” to acceptable hardness and weld to disc
- recutting the keyway is not recommended...rather, install blanks in the shaft and shrink on repaired wheels.

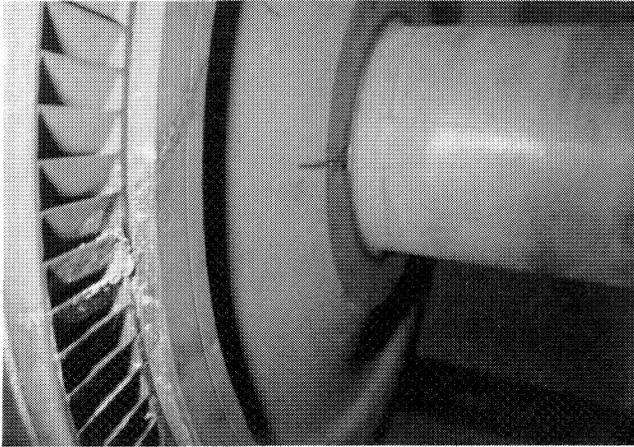
Figure 2. View of Crack.

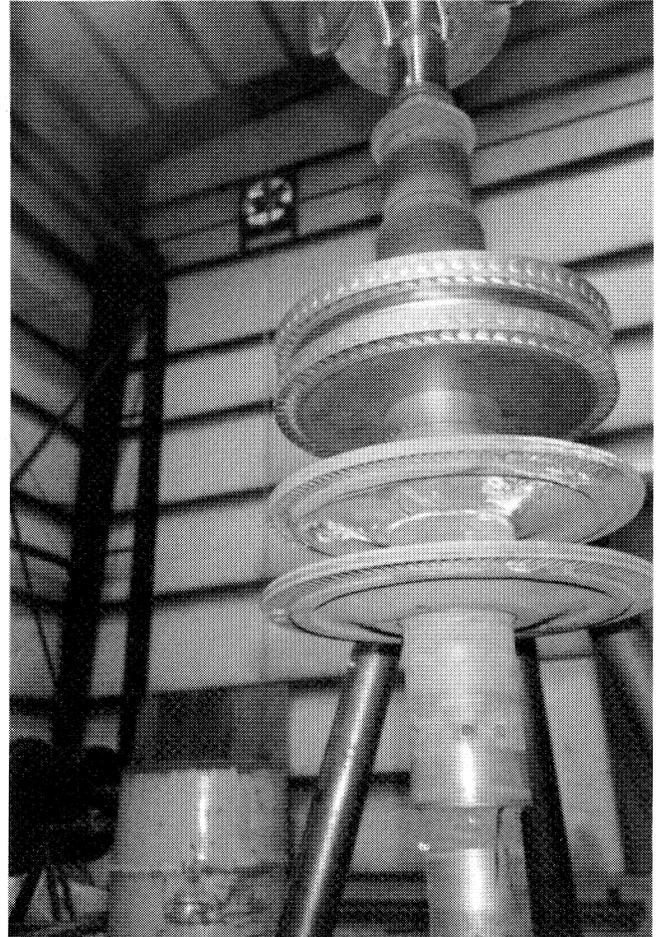
The rotor depicted in Figure 3 showed clearly visible damage. A closer view of this is portrayed in Figures 1 and 2.

Figure 3. Rotor Before Unstacking.
