MAJOR REVAMP AND RETROFIT OF IDENTICAL PROCESS COMPRESSOR TRAINS

Standard Oil Chemical Company

Port Lavaca, Texas

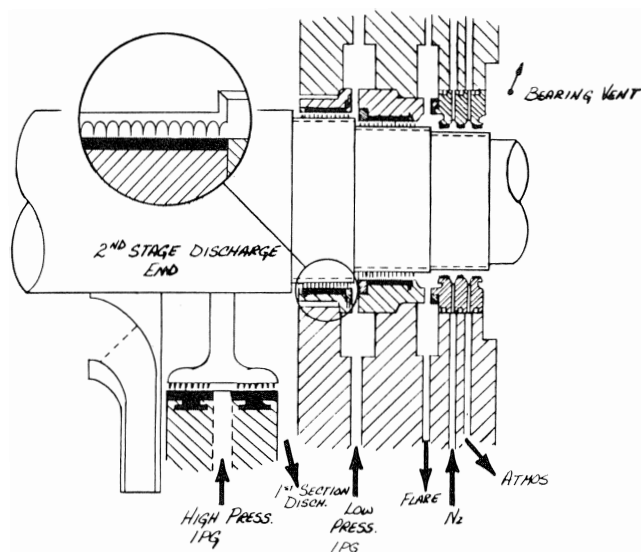
Figure 8. Process Compressor Discharge End Seal System Modification.

A number of problems were experienced with this seal system: erosion of the Fluorosint 500® labyrinth teeth; high nitrogen costs; higher than expected buffer gas flows; and, high maintenance replacement cost. In one case, loss of a seal resulted in the contamination of the lube oil system with solids from the process gas. Another problem was the buildup of solids between the stationary labyrinth teeth. Solids would harden and actually cut into the stainless steel shaft sleeve.

To improve the shaft sealing system, the plant engineers set out with the following objectives: reduce nitrogen consumption; improve mechanical reliability; and, reduce the maintenance replacement costs.
