RADIAL AND THRUST BEARING PRACTICES WITH CASE HISTORIES

Charles Jackson

Monsanto Company

Case histories for 13 selected bearing design conversions for specific end results are presented. They were selected out of a group of bearing designs over a 25 year span to give a varied array of non-repetitive case histories. In addition, some ideas for proper measurements are also included.

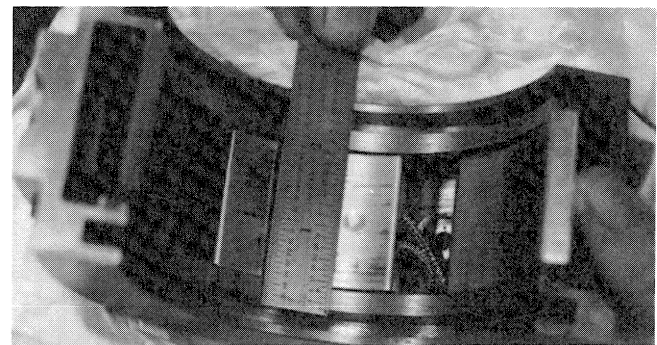
Figure 7. Dimpled Radial Tilting Pad Bearing from Centrifugal Compressor Bearing Retainer Assembly. Dimples due to air voids from pretinning and babbitt puddling over temperature sensor—1980.

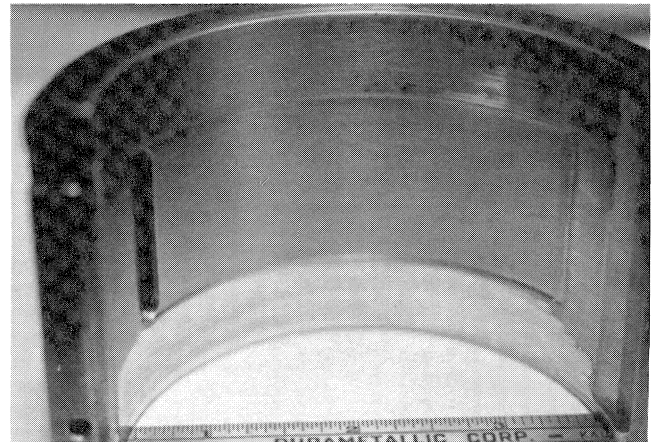
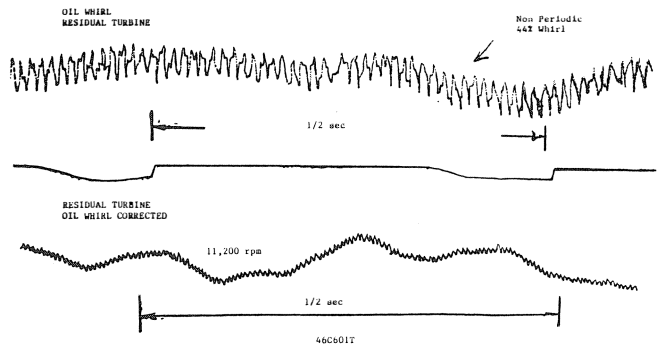
A steam turbine operating at 7000 hp and 10,500 cpm was driving two centrifugal bodies and would go into oil whirl exceeding 5 mils at 43 percent of speed as the third steam inlet valve began to open. The bearings were pressure dam type.

First, the steam valves were “gagged” open and the turbine was brought up to speed and loaded using the trip and throttle valve (TTV). No whirl was experienced, indicating that partial admission lifts to the rotor initiated the whirl (Figure 9).

Davey Vibrograph Trace of turbine in 442 whirl. Note non periodic blip of 4 1/2 frequency through the synchronous signal.

Figure 9. Pressure Dam Bearing Removed After Pure Oil Whirl at 43-44 Percent Speed. Contact of babbitt by journal has occurred, i.e., eccentricity ratio = 1.0. Davey Vibrograph tape from shaft “fish tail” also shown. Non-periodic (stationary) blip is 0.43X frequency.

The vendor had an existing design for a four lobe bearing which required two weeks to obtain. This bearing resolved the problem for a total of fourteen years without incident (to date).

Note: To allow operation during the two weeks hiatus, the pressure dam bearing was rotated to be placed on the major axis of the journal motion. This position was determined from the orbit of the shaft-to-bearing motion. The anti-rotation pin was removed and relocated to put the dam at the 9 o'clock position. The turbine was then loaded manually and the governor valves were put in service from an open position, thus allowing the turbine to operate in a limited whirl cycle of 2.5 mils to 3.0 mils at a 43 percent speed frequency (0.43X).

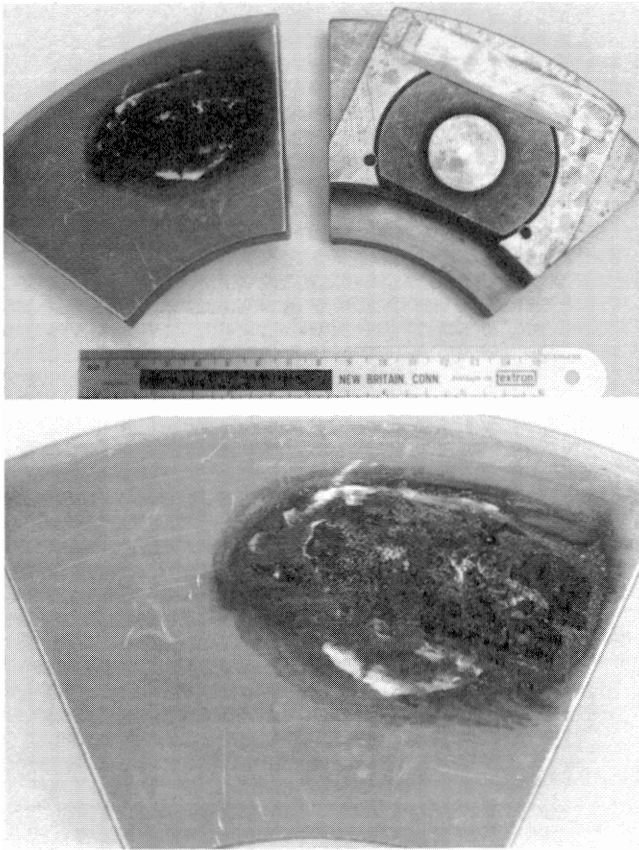
Two hot gas expanders driving axial and radial flow compressors, along with a startup helper turbine, were reduced in thrust bearing life from several years to 4000 hours, after converting to synthetic oil. The conversion had been made after a million dollar fire loss from a coupling failure, with subsequent oil spray onto the 1200°F turbine casing (Figure 10).

Figure 10. Thrust Pad from a Hot Gas Expander Turbine Suffering from Overheating (Baking) due to Synthetic Oil. This bearing had 4000 hours duty at removal.

After fire prevention isolation valves were installed, the oil was converted back to conventional turbine oil with no ill effects.

Note: A conversion to synthetic oil can be more easily done today than 15 years ago because of better synthetic oils. Consideration for additional cooling and oil flow may be necessary over hydrocarbon or mineral oils. In this specific case, the lubricity, specific gravity and viscosity had been matched well, but the synthetic oil had a lower specific heat, resulting in more heat for the same load, leading to a half-year service life.

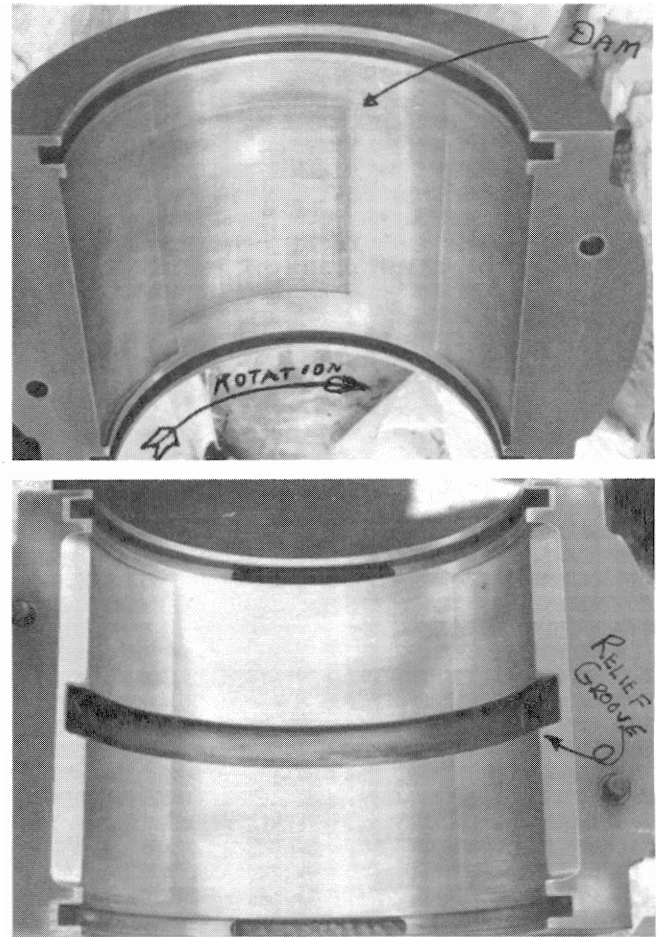
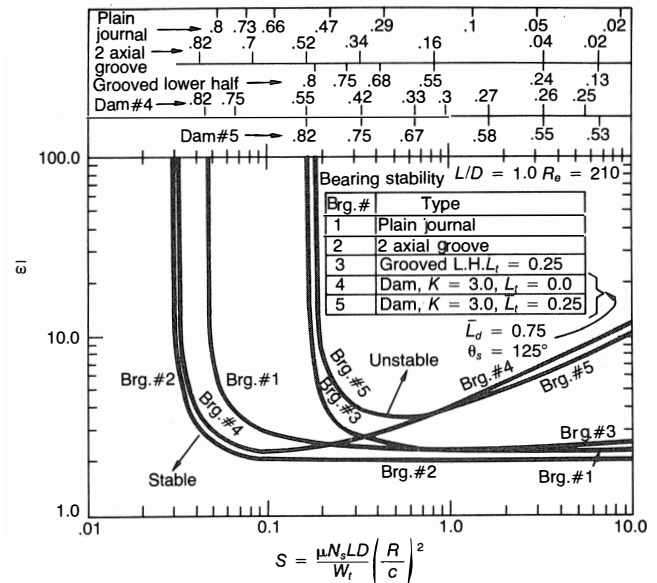
On a similar problem of the turbine driver of the same train, the lathe work on the babbitt to form the pressure dam was incomplete. Conventionally, the pressure dam is oriented to have a pad angle of about 125 degrees-140 degrees. Dam depths have been too deep to be effective for years (Figure 11). The oil entering this dam, which is perhaps 75 percent of the bearing width, may feed into an involuted slot and often enters

at the horizontal feed slot. A relief groove may also be provided in the center of the lower half to remove babbitt area, thereby increasing bearing pressure. The machine work was somewhat sloppy and a rib of surface metal remained, which interrupted the oil flow causing the rotor to vibrate at full speed (Figure 11) [3].

Figure 11. Pressure Dam Configuration with Relief Groove in Lower Half. Relative stability curve is also shown for comparison [3].

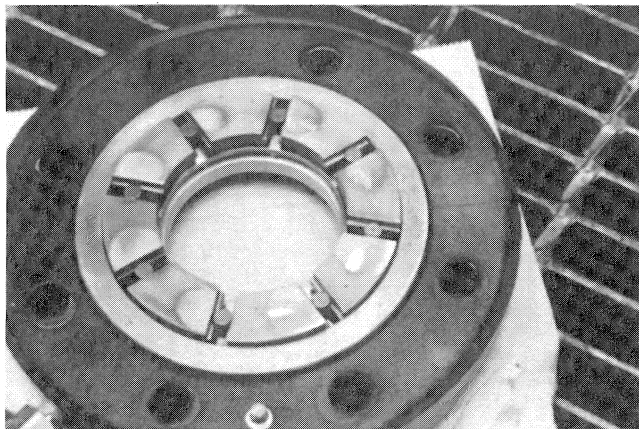
A synthesis (syn) gas high pressure (HP) compressor for a 1000 tons per day (T/D) methanol plant operated for several months before loading the thrust bearing to a deflection of 22-25 mils, which activated the axial position shutdown monitor and shut the unit down. Typically, no radial vibration increase was noted, but there had been an increase in the static balance chamber pressure behind the balance piston of about 10 psi (350 psig to 360 psig). Also, the operator had noted the balance line had been increasing in temperature.

On disassembly, the balance piston labyrinth clearance was 45 mils versus a design clearance of 15 mils. The balance piston may have been installed with excessive clearance, possibly burned in before mechanical shop testing. This was confirmed on bundle reinstallation, as the lower tilting pad carrier did not lift the rotor off its labyrinths, requiring a relocation (5 mils lift, 4 mils left) (recentering) of the bearing housing in the casing head. No repeat of this problem occurred in the next 15 years (Figure 12).

Figure 12. Thrust Pads on Overload with Rotor Deflection at 0.025 in. Taken from HP Barrel Compressor Operating at 10,500 rpm.

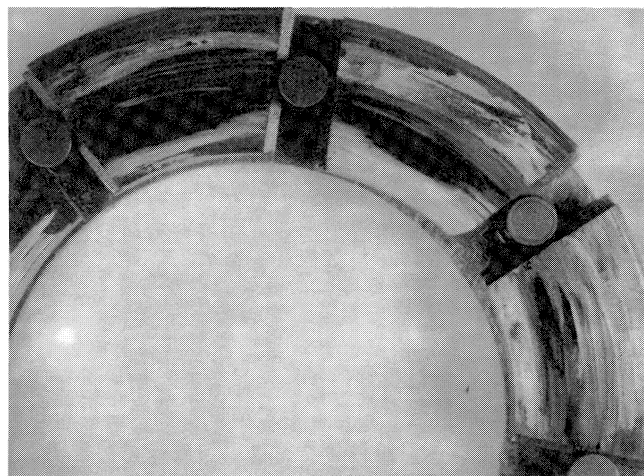
A similar series of thrust bearing failures occurred on a syn gas train in which the thrust bearings failed six to eight times, due to a "cavitation" type failure, as opposed to thrust load. Further, it always occurred during surge, due to a drop in molecular (mol) weight of the gas (loss of CO₂ feed in the gas). This rotor will oscillate in the axial direction during surge because it is a high pressure case, 350 psig to 700 psig, with five of eight stages active, due to a three stage blank (bridge over) (Figure 13).

Note: This cavitation damage has a similar appearance to black scab or "wire wooling". Wire wooling was experienced in the 1970s on 15-5 ph thrust collars at 500 ft/sec surface speeds.

Figure 13. Similar Thrust Pads to Figure 12, but with "Black Scab" Appearing Failures Due to Cavitation. Corrected successfully with directed lube designs.

After a discussion with a tribologist, an outside bearing company was directed to design a new active copper backed pad thrust assembly with *directed* lube provision along the *articulating* level links, rather than beam detectors (a poor leveler at best). This installation has proven to be successful for more than five years, while suffering surges and loss of mol weight severe enough to pop relief valves, yet without failure. The logic was to defeat cavitation, *negative* pressure, via spray nozzles; i.e., *positive* pressure at the pad entrance.

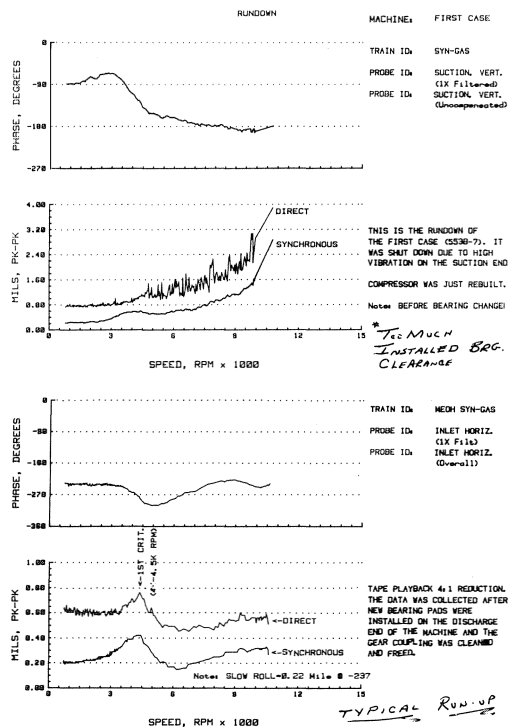
A barrel compressor using five pads, load-on-pad (LOP) bearings, which operated at 11,000 cpm with relative vibration 3 mils peak-to-peak (P/P) (76 μ m) first indicated a bad balance. This run-up followed assembly on a repair, following eight years of successful and smooth service. Case vibrations were typically very low (0.04 inches per second peak (ips)) (2 μ m/sec) (Figure 14).

Figure 14. Bode Plot of a Barrel Compressor Which Had Been Successfully Repaired and Balanced but Installed with Excessive Clearance (11 mils versus 7 mils) from Pad Retainer Brinnelling. The retainer was machined out, chrome plated and rebored to obtain the proper pivot circle (clearance).

Since a lift check had not been performed on reassembly (normally a common practice), the train was shut down for four hours for a lift check. *Eleven* mils of clearance was determined and *seven* mils was required. A spare retainer with pads was assembled, confirmed by plug gage check and installed. The vibration was low through the critical speeds, operating in the 1 mil P/P (25 μm) range, and less at the full operating speed.

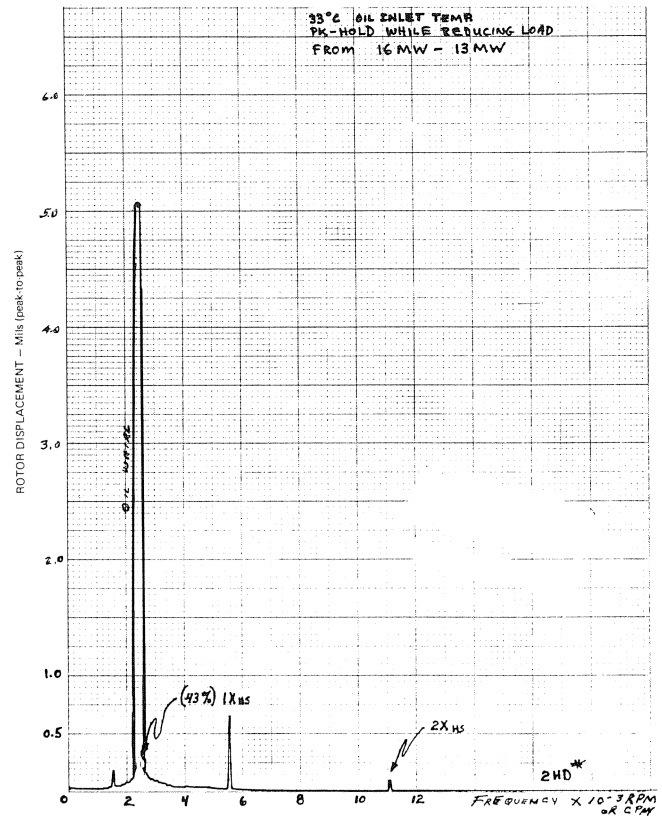
A 22 MW (30,000 hp) steam turbine driving a gear and alternator went into 43 percent pure oil whirl after 6 MW of load was applied. Whirl continued up through higher loads, 13 MW, 16 MW, etc. The bearings were plain axial groove bearings with 60° relief on each side at 7 in and 8 in, a length to diameter ratio (L/D) of 0.5 and a diametrical clearance of 11 mils and 12 mils, respectively. There was a load relief groove in the top half for no apparent reason. The operating speed was 5511 cpm. The vibration went above six mils at the whirl frequency and was not whirling at no load.

Figure 19. Spectrum of 30,000 HP Turbine Shaft in Pure Oil Whirl with Axial Groove Bearing.

The turbine manufacturer converted to a lemon bore (elliptical) bearing with 2.5:1 convergence and oriented this bearing's butt joint 30 degrees against the rotation direction. This put the turbine in a limit cycle of up to 1 mil at 43 percent

The company installed an offset half bearing [4] which was installed with its butt joint 45 degrees off the bearing housing split line (against the rotation direction). This bearing was stable at all loads, entirely removed the sub-rotation 43 percent frequency and has operated six years without fault. Babbitt temperatures dropped to 170°F. Only the exhaust end 8 in \times 4 in bearing was converted to the offset half bearing style.

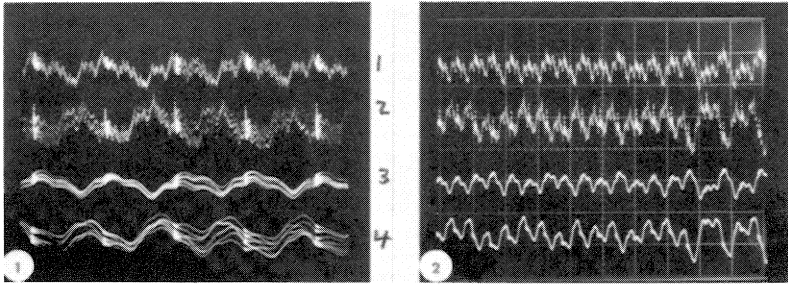
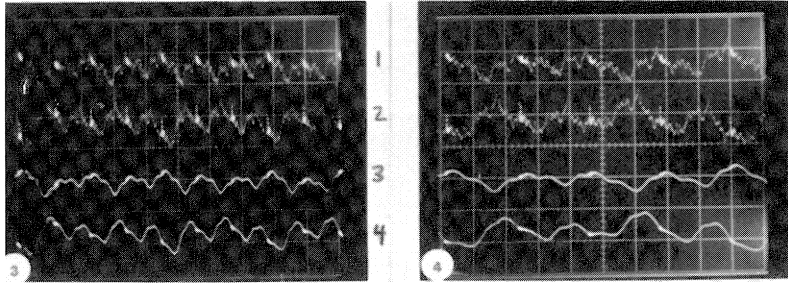
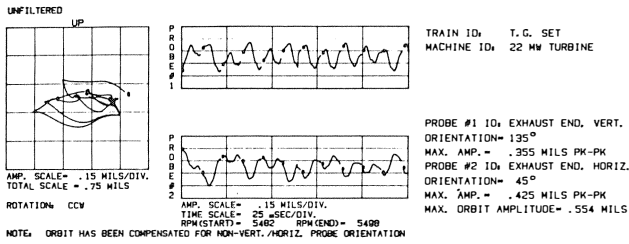
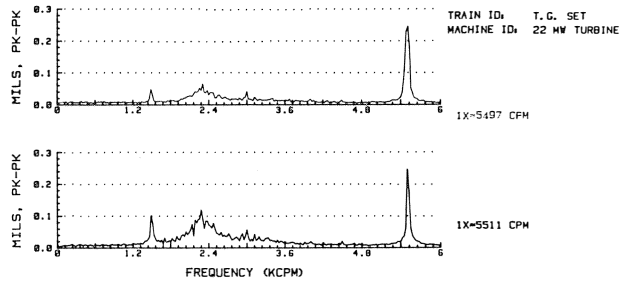
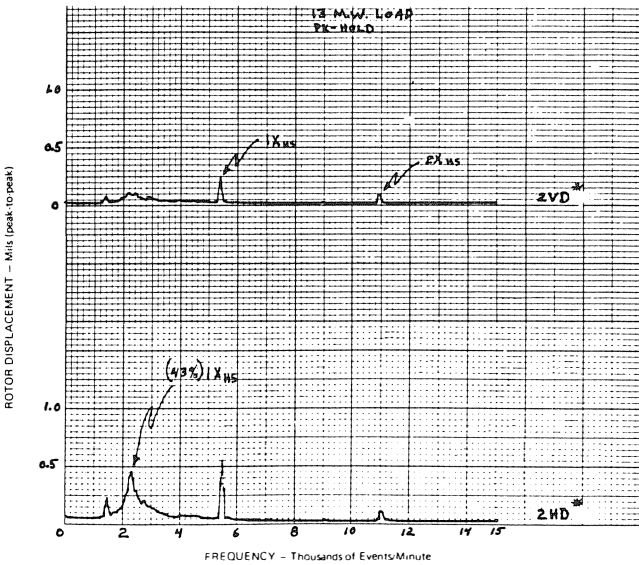
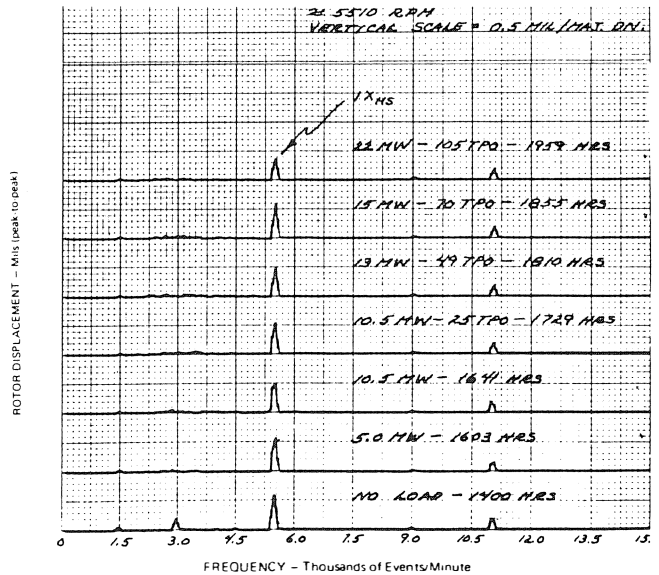
Figure 20. Scope Traces of Restrained (Limit Cycle) Oil Whirl on Lemon Bore Bearing.

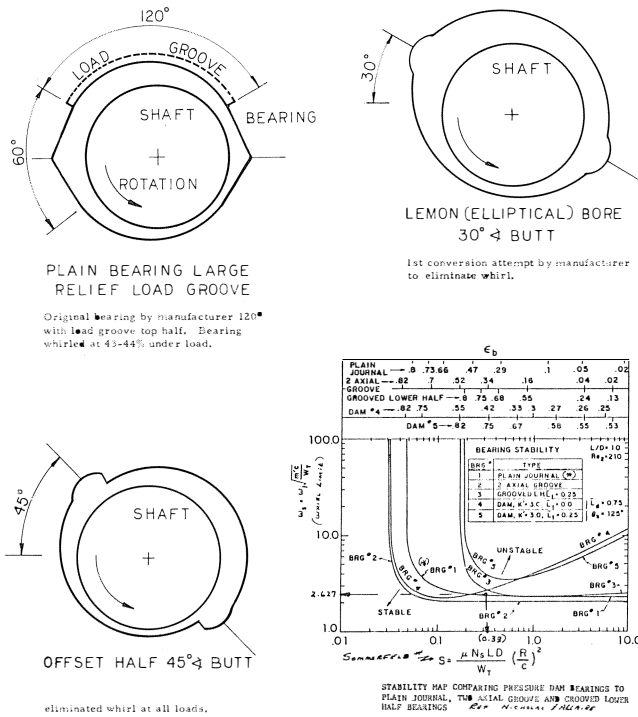
Figure 21. Summary of Three Bearings Employed in Correction. Original axial groove by turbine OEM, lemon bore by OEM, offset half bearing by user.

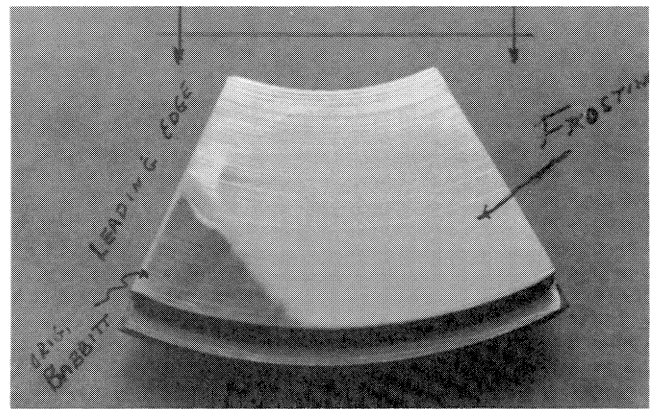
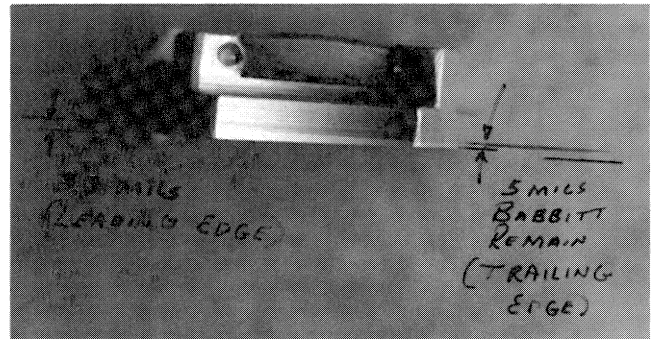
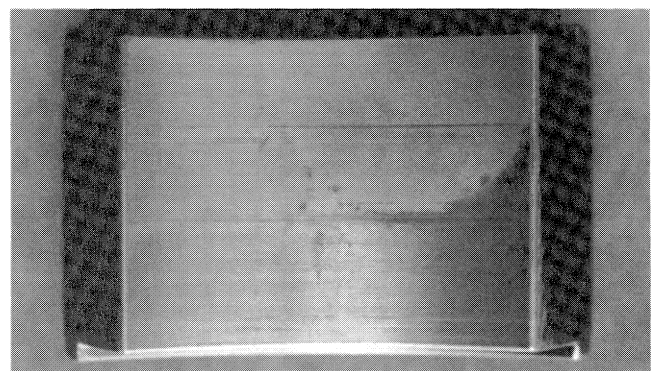
A low pressure (LP) condensing steam turbine at 7500 hp and 11,000 cpm drives through a 17,000 hp topping turbine (HP) in a syn gas train driving two barrel compressors. The thrust bearing monitor for axial movement of the rotor progressed over a period of time to 28 mils and the unit shut down. Two mils of babbitt were remaining on the trailing edge of the pads and "frosting" was noted in a tapered pattern from the trailing edge progressing with more babbitt towards the leading edge, which still had 30 mils (0.76 mm) of original babbitt remaining.

Improper welding, i.e., the welding ground attachment location, was not in extremely close proximity to the weld work, had been performed. A steam line thermowell leak had been repaired in the steam line near the LP turbine, and a weld repair had been made in the LP barrel compressor's thrust balancing line (Figure 22).

Figure 22. Frosting on Both Thrust and Radial Pads.

The removed LP turbine rotor was degaussed to one gauss and the balance of rotor cases (rotor inside) was degaussed to a maximum level of six gauss. Two grounding brushes were installed. An axial type fine wire brush was installed on the blind end of the HP compressor shaft. A radial fine wire brush [5] was installed on the oil wetted coupling spacer tube at the LP turbine exhaust. These direct current (DC) bleeds were monitored for more than a year until the next scheduled turnaround. Operations was overjoyed after experiencing three runs of less than one year. All four rotors and four closed casings were degaussed separately at that time and the radial brush was removed. Two years later this system was rechecked for electromagnetic buildup and found clean.

The thrust bearing was upgraded to seven in from six in with copper backed pads and flooded type directed lubrication using spherical pad seats resting on level links. This was a 50 percent load capability uprate and babbitt temperatures on the clean (unsalted) turbine startup reduced from 225°F to 160°F.

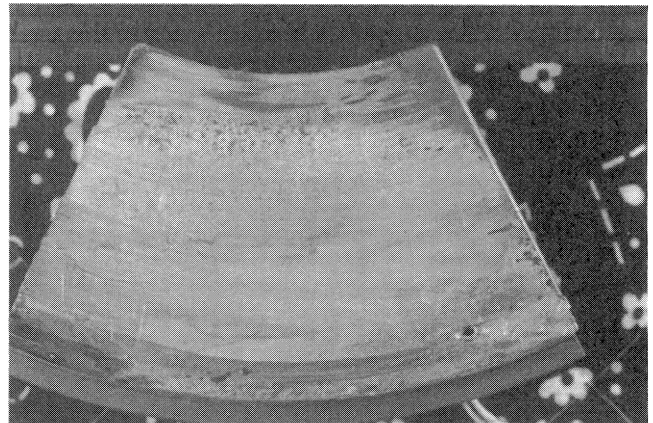
With an uprate of the air turbine, the refrigeration turbine failed in 1984 due to overload (Figure 23).

Figure 23. Pad Failures Due to Overload on a 15,000 HP Steam Turbine.

The adjacent air turbine had increased its first stage pressure from 290 psig to 432 psig which accompanied a pad temperature rise of 170°F to 220°F.

The 15,000 hp refrigeration drive turbine has an integral thrust collar. The active thrust bearing way, however, was converted for the following upgrades:

- Copper backed pads over steel backed pads.
- Seven pads over six pads (shorter pads).
- Offset ratio changed from 0.5 to 0.55. (Pivot is 55 percent from leading edge to assist oil into the pads. Failed pads had front (leading) edge damage).
- Flooded directed lubrication supply.
- Spherical seated level plates and pads (Figure 24).

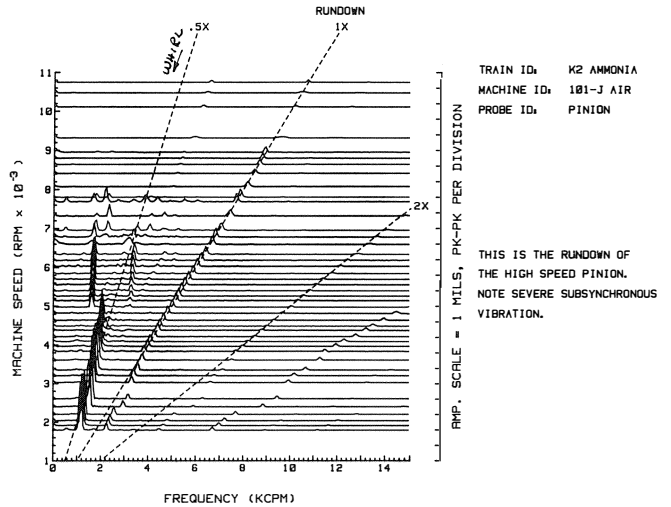
Two compressor train gear boxes with plain sleeves have been recorded to show oil whirl during startup and shutdown, but not at full load (Figure 25). This has been more of an aggravation and noise sensitive phenomenon rather than damage. Only one set of bearings has been replaced in eight years and they were pounded, i.e., a "road map" pattern in babbit.

Figure 25. Run-down Data Showing the Gear Pinion Going Into Oil Whirl on Unloaded Run-down. Converse is true on start-up.

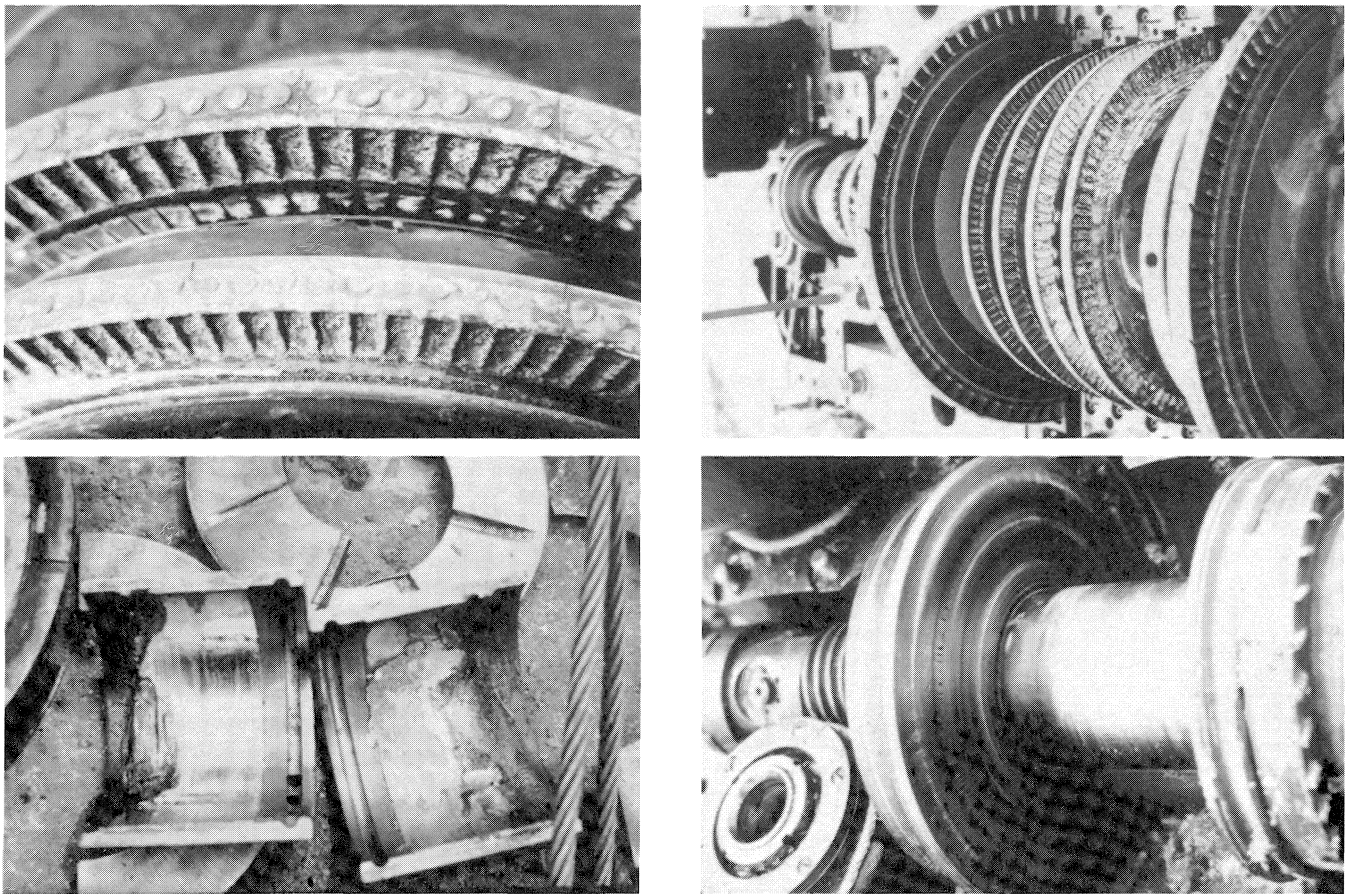
An 18,000 hp steam turbine drives two ethylene centrifugal compressors at about 4500 cpm. This train was not on automatic thrust shutdown. The thrust and radial bearing failure, illustrated in Figure 26, was one of a sequence starting in the mid 1970s that ended up putting thrust axial movements on automatic shutdown in the plant. Warning (alert) alarms are at 15 mils from the commissioning clear thrust active position, with automatic shutdown (danger) at 25 mils from the same reference.

Figure 26. Thrust and Radial Bearing Damage with Hot Tears in the Thrust Collars and Salted Blading on Fourth and Fifth Stages on an 18,000 hp, 10 Stage Turbine.

The problem on this ten stage turbine was salting, due to ingestion of brine and treated water into the boiler feedwater, due to leaks in the internal exchangers of a flash evaporator. This salt, primarily NaCl, settled out selectively on the fifth and sixth stage blading (dew point of 500-525°F), obstructing the flow to a 40 percent or less flow passage area. This overloaded the tapered land thrust bearing, which melted and caused hot tears in the thrust disc. The radial bearing overheated and melted the babbitt (high tin babbitt melts at 415°F). The melted babbitt flowed down the drain oil pipe and resolidified, blocking the oil flow. The rotor journal turned blue. All turbine blading contacted the diaphragms and the shrouds cut into the diaphragms in places. Even though one million dollars was lost, the turbine was returned to service within one week, using blading tongs for blade straightening. The time-before-manual shutdown was four to five minutes. Thrust bearings will fail in less than 30 seconds.

Both thrust alarms activated and, after rotor contact was made, the radial vibration alarms activated (Figure 26).

The rotor was cleaned. The contamination to the boiler feedwater (BFW) was corrected through exchanger repairs. Steam conductivity meters and alarms were installed to monitor the steam conditions. The thrust bearings were replaced with self-leveling copper backed pads, but this was probably not needed. Self-leveling thrust pads are always a good idea to make allowances for any field imposed misalignments for whatever the reason.

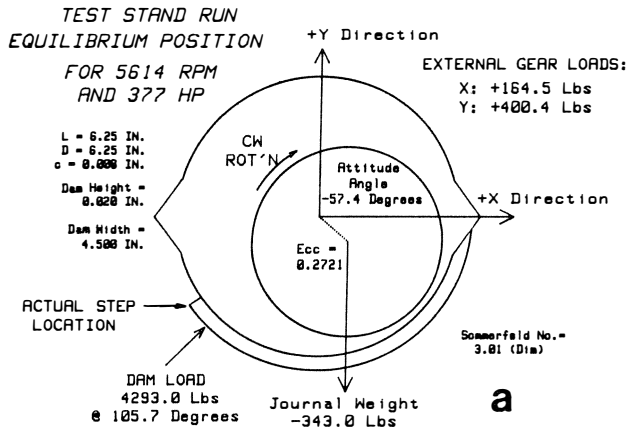
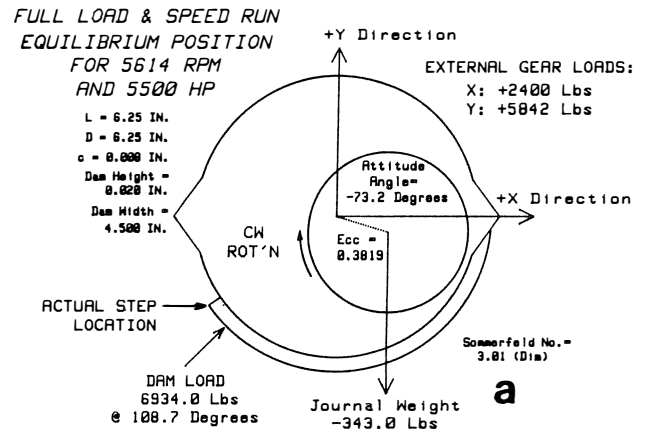
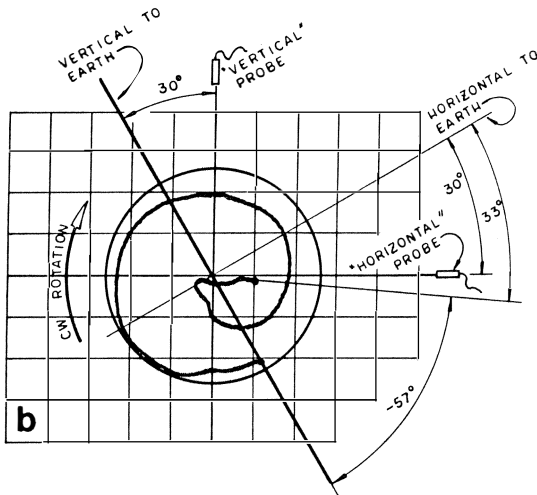
The actual position of the pinion during shop testing is shown in Figure 26b. The actual position of the pinion shaft under full load in the field is shown in the eccentricity plot, Figure 27b. The pinion was utilizing only 63 percent of the bearing clearance, but did not seem encouraged to go into the upper half of the bearing.

DRIVER-END VIEW OF PINION PRESSURE DAM BEARING NONSTANDARD INVERTED DAM DUE TO UPMESH PINION THIS IS THE TEST STAND CASE - 377 HP @ 5614 RPM

DRIVER-END VIEW OF PINION PRESSURE DAM BEARING NONSTANDARD INVERTED DAM DUE TO UPMESH PINION THIS IS THE FULLY LOADED CASE - 5500 HP @ 5614 RPM

Figure 27. (a) Finite Element Analysis of the Pinion Bearing for the Shop Test at Full Speed with a 377 HP Dynamometer. (b) Actual Pinion Position as Recorded from the Two Proximity Probes at 60° and -30° Using a Two-Channel Storage Oscilloscope. The actual bearing clearance was laid out on the scope.

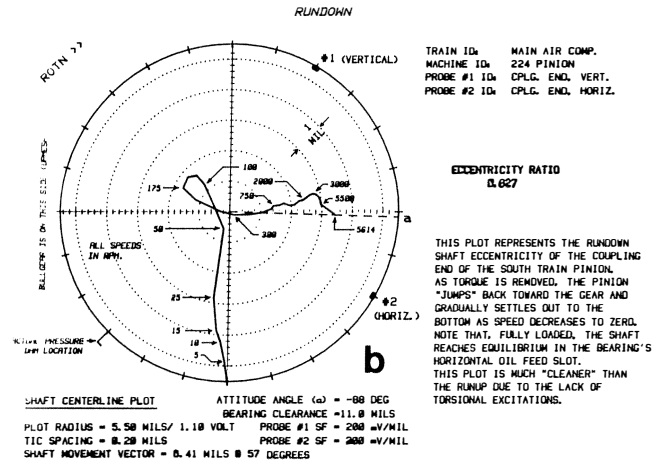
Figure 28. (a) Finite Element Analysis of the Pinion as in Figure 27 (a), but at Full Load. (b) Eccentricity Plot.
