STRUCTURAL INTEGRITY OF LARGE STEAM TURBINE ROTORS

ABSTRACT

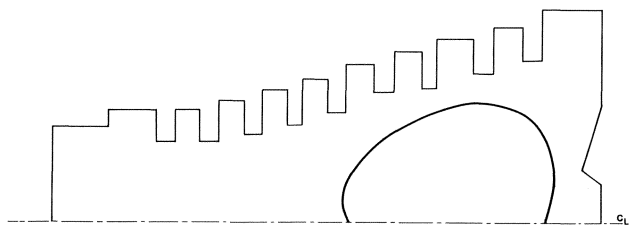
located approximately 180° apart, both with the size and shape indicated in Figure 5. The initial diagnosis of the failure mechanism as a creep-fatigue interaction has been presented in Reference 2, which describes the operating history, material properties and other factors. The rotor forging had been given a production ultrasonic examination but had not been examined from the bore surface. Further analysis tended to discount the role of creep and implied the existence of near-bore cracks of critical size early in the life of the rotor, since the number of fatigue cycles was only approximately 200. The two large cracks were concluded to be dynamic cracks that had stopped.

The origins of these cracks were found to be in stringers of manganese sulfide inclusions in regions of dendritic segregation. The origins, the larger of which was approximately 5.5

Figure 5. 225 MW IP Rotor Crack.

inches in axial length by 0.3 inch in radial extent, exhibited intergranular fracture which could be reproduced in a room temperature impact or tube burst test in material from the vicinity of the fracture. The size and location of the larger

origin was consistent with the measured fracture toughness and calculated stress-temperature history for a cold start. No definite evidence of subcritical crack growth could be found. It was concluded that the origins could have been detected and sized by present-day bore ultrasonic examination procedures.

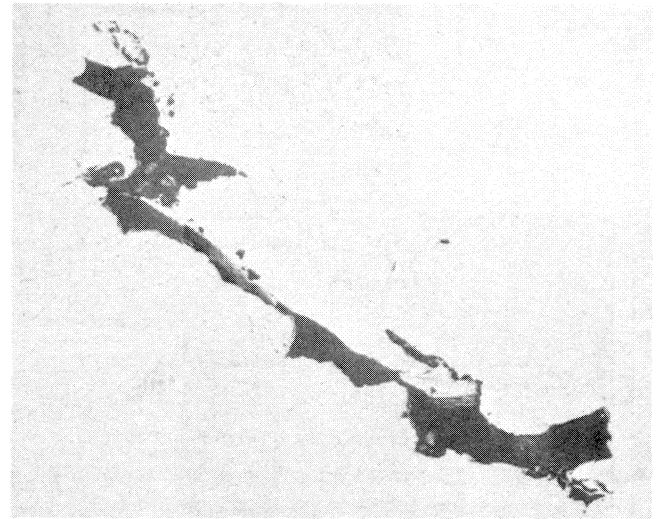
Figure 6. Typical Flaw in a Different IP Rotor Revealed by Sectioning. Magnification = 100×.

Figure 6 illustrates a flaw that is typical of those found in two of the rotors and is essentially a partially closed gas or shrinkage pore with associated forging laps and small MnS inclusions. Figure 7 shows a section through a large holding indication in an IP rotor donated to the RP502 project. This flaw was the basis of a recommendation by the manufacturer to retire the rotor. The flaw has slag-like inclusions and some MnS particles comprising the dark branches, which are surrounded by a relatively dark etching region, indicating chemical segregation. It is thought that this region was initially connected to the central pipe and that it represents shrinkage that was filled with slag before forging. Certain areas appear to

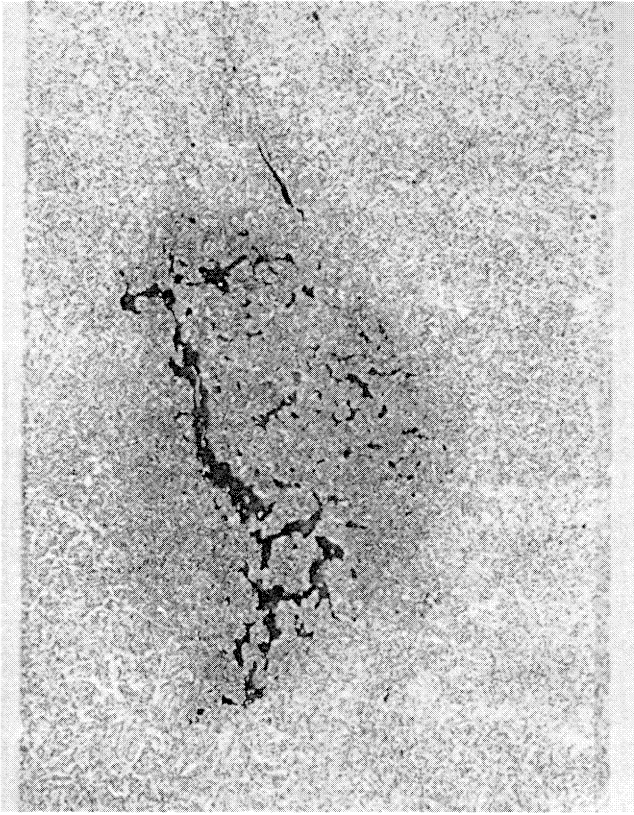
be crack-like; however, there is no evidence of any service-induced cracking associated with this flaw.

Figure 7. Radial-Tangential Section Through Holding Indication in IP Rotor. Stress Axis Is Horizontal. Nital Etch. Magnification = $20\times$.

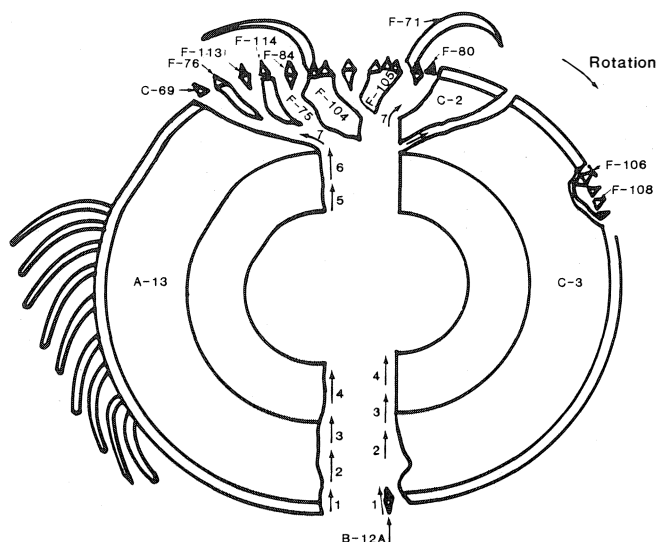
The physical distortion on the fracture surface indicate the following failure sequence. The initial cracking started near piece B-12A

Figure 11. Sketch of the Fractured Disk Labeling the Pieces Recovered and Indicating the Crack Progression.

(at Point 1 of Figure 11) and propagated radially inward (Points 1-4) to the bore. Figure 12 shows a view of the fracture surface on piece A-13. Once it had fractured through, centrifugal force caused piece A-13 to pull away from the shaft and distort (bend), primarily at the other end of piece A-13. As piece A-13 lifted away and bent, the stresses at the bore (Point 5 of Figure 11) increased and initiated a brittle cleavage crack, which split to produce the many small pieces (e.g., F-75, F-104, F-105, C-2).

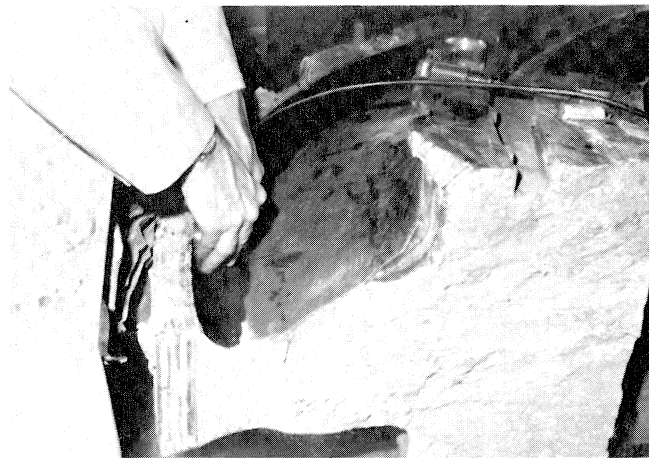
Figure 12. View of the Primary Fracture Origin Area on Piece A-13.

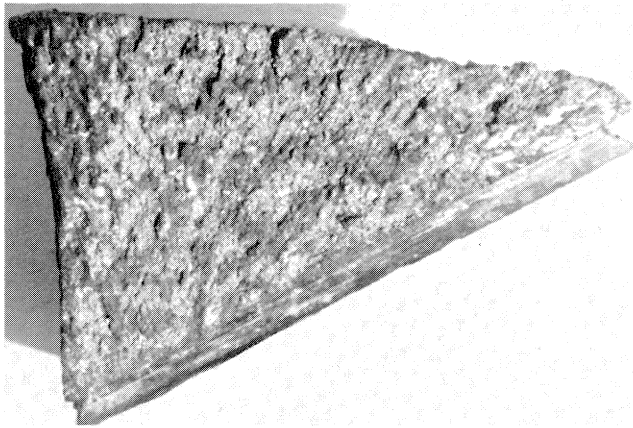
The primary fracture surface is shown in Figures 13 and 14. The crack initiated on the rim slot approximately 0.15 inch in from the inlet face. In the subcritical crack growth region, the fracture was primarily transgranular quasi-cleavage, with some interspersed intergranular fractures. The critical crack size appeared to be nearly a quarter-elliptical corner crack of radial depth 0.15 to 0.20 inch and surface length along the groove of 0.60 inch.

Figure 13. Photograph of Primary Fracture Side of Turbine Disk Fragment. The Machined Surface at Bottom of Figure is Bottom of Rim Slot. The Balance of the Inlet Face of Disk Is at Left. Disk Steeple Has Been Cut Off as Shown in Figure 14.

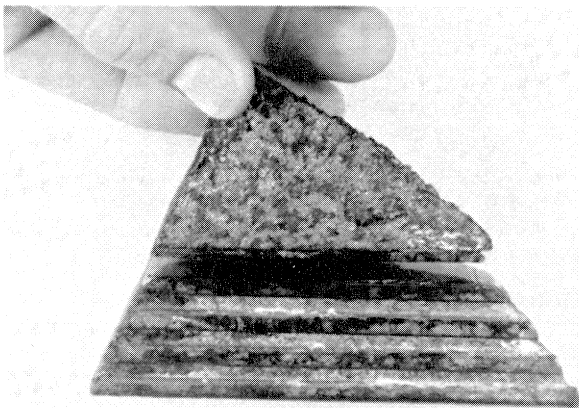
Figure 14. Relationship of Fracture and Fir Tree.

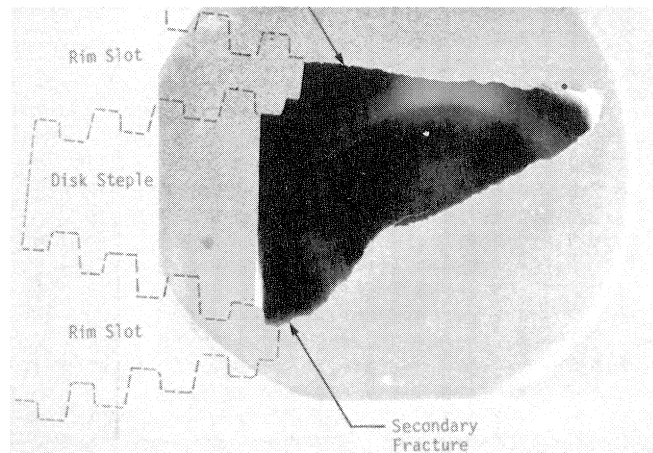
Figure 15 is a metallographic section through the primary fracture origin and parallel to the inlet face of the disk. The primary fracture surface is along the top, with a portion of the rim slot in the upper left-hand corner. The secondary fracture surface is running diagonally from upper right to lower left.

The microstructure was relatively coarse and bainitic, with no observed microstructural inconsistency at the fracture origin. Some corrosion pitting and secondary cracking at the grain boundaries were observed just below the fracture surface, at the machined surface. Evidence of cold work, extend-

Figure 15. Metallographic Specimen Through Primary Fracture Origin and Parallel to Inlet Face of Disk. Primary Fracture Surface Is Along Top With Portion of Rim Slot in Upper Left-hand Corner. Left Edge of Specimen Is the Result of Cut to Remove Fir Tree. The Lower Edge of the Specimen Is the Result of a Secondary Fracture from Adjacent Rim Slot. (Approximately 1.5 \times).

ing approximately 0.001 inch into the material, was visible on the machined surface.

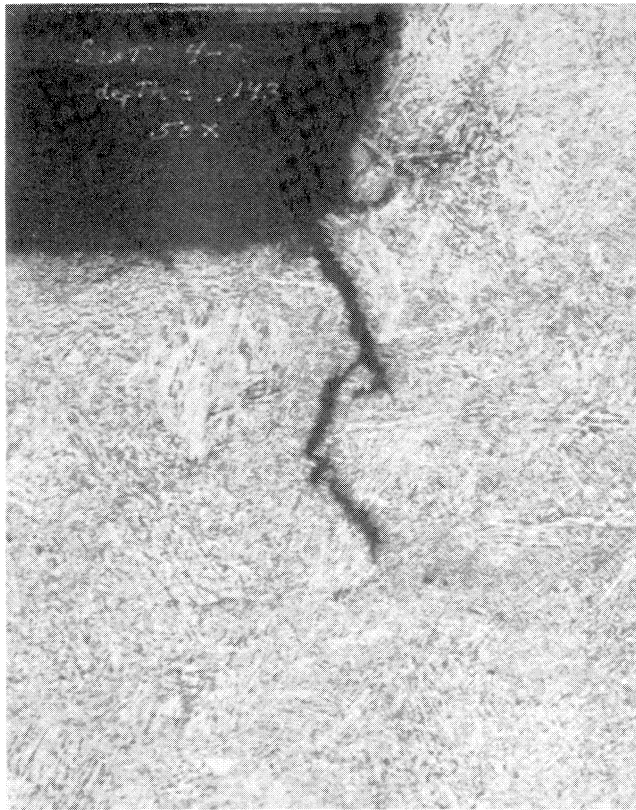
Nondestructive inspection of the other rim slots in the failed disk revealed other crack indications. Several of these indications were metallographically examined by progressively polishing parallel to the disk face. Perpendicular to the plane of the crack, the characteristics of each crack varied considerably along its length, as shown in Figure 16. At some locations the crack was very wide and contained some corrosion product, while at other locations it was very tightly closed and barely visible in the micrographs. Some crack branching was observed, and in some planes the crack appeared to be discontinuous. In general, the crack path appeared to be independent of the microstructure, although some of the branching appeared to be along bainite packet boundaries.

Figure 16. Etched, Metallographic Cross Section of a Secondary Crack Found by Nondestructive Inspection in Rim Slot Number 4. Note Variation in Width of Crack. (50 \times , left; 100 \times , right).

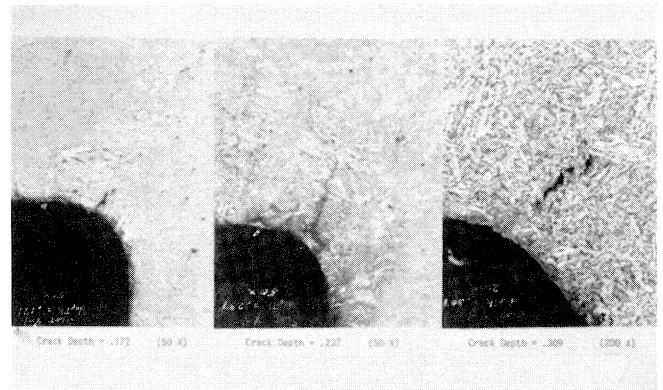
a 3 mm detection threshold indicated that dovetail slots 4-1, 4-2, 5-2, 11-1, and 11-2 definitely were cracked. Metallographic sectioning of the dovetail slots indicated that all the slots identified by the eddy current tests were indeed cracked. Figure 17 shows the crack in dovetail 4-1, and Figure 18 shows the crack in dovetail 4-2. Figure 19 shows the crack in 11-1 that was missed by the magnetic particle tests. It is evident that the magnetic particle test is only able to detect the larger open cracks, while the eddy current test is able to detect much smaller and tighter cracks.

Figure 17. Dovetail Slot 4-1 at Various Depths Below the Inlet Surface. Nital Etch.

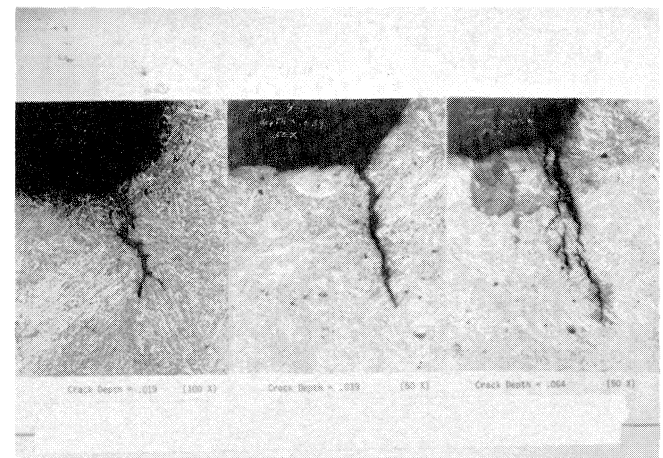
Figure 18. Dovetail Slot 4-2 at Various Depths Below the Inlet Surface. Nital Etch.

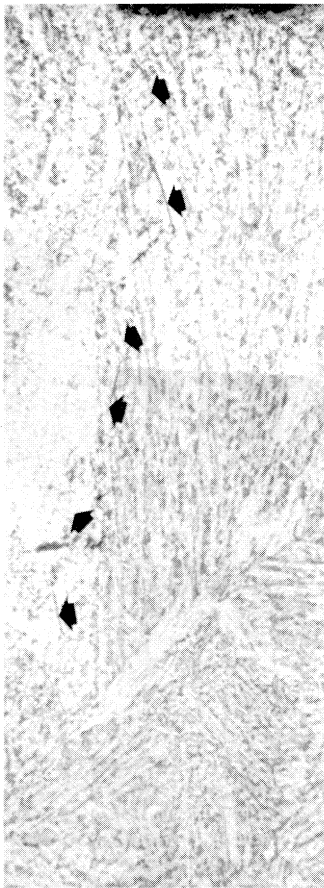
Figure 19. Crack in Groove 11-1 at 0.202 in. Magnification = 250 \times .

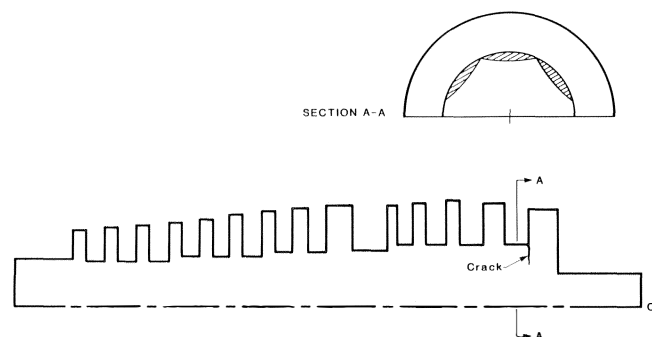
Figure 21. Transverse Crack Initiating at a Filler Radius Diaphragm Groove.

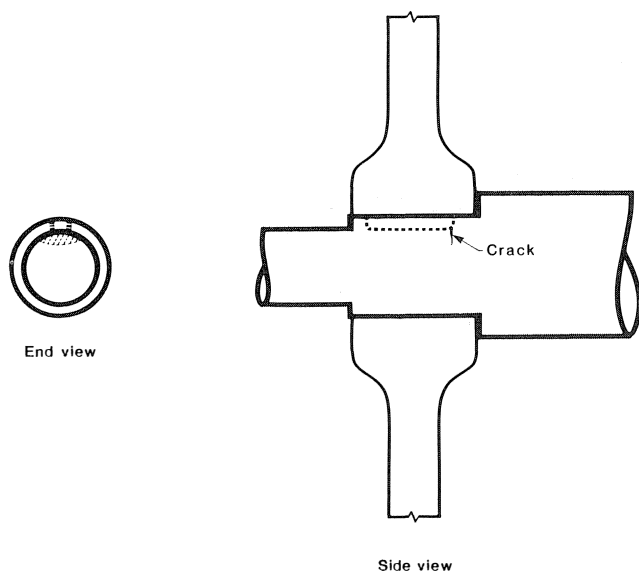
Figure 22. Transverse Crack Initiating From a Keyway.

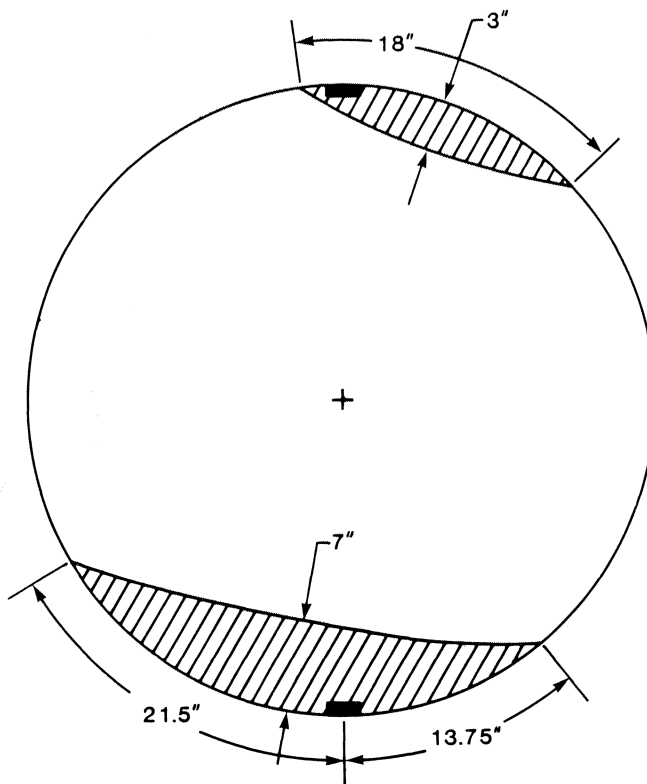
The rotor was subsequently examined by ultrasonic inspection, and two transverse cracks were identified near the midspan of the double flow LP rotor. Both cracks were under the inlet edge of the first shrunk-on turbine wheel bushing on the governor end. These cracks were later identified by destructive sectioning to be approximately 180° apart and to exhibit the dimensions shown in Figure 25. The cracks were located across the two shaft keyways used to antirotate the bushing to the shaft, and propagated circumferentially along the edge of the contact area between the bushing and the shaft. The circumferential propagation of the cracks was generally in a direction opposite to the rotation, which is consistent with fatigue cracks propagated via rotating bending. The crack surfaces revealed bench marks characteristic of changing stress or cyclic frequency conditions, and the spacing of the observed fatigue striations suggested propagation by HFF.

Oak Creek #7 shaft diameter 39.569" at LP inlet stage

Figure 25. Representation of 320 MW Steam Turbine Shaft Transverse Cracking.
