# RESIDUAL OIL BURNING EXPERIENCE AT THE PUTNAM PLANT OF FLORIDA POWER & LIGHT COMPANY

**William J. Hensler**

Operations Superintendent

Florida Power and Light Company

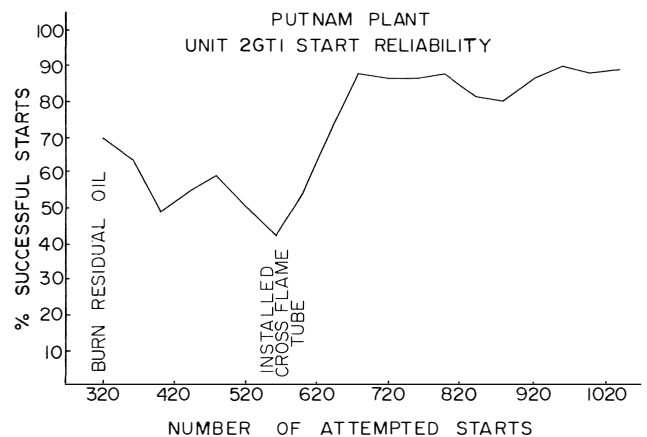
Figure 4. Gas Turbine Starting Reliability.

1. As shown in Figure 4, installation of the cross flame tube between burner 1 and burner 16 caused a noticeable increase in starting reliability.
2. The purge air system uses combustor shell air to purge the burners. Since flow through this system is caused only by the pressure drop across the combustor basket, any air leakage in the piping, flexible hoses or fittings will cause the air flow through the nozzle to stop or reverse. This reverse flow allows oil mist and products of combustion to enter the burner air passages and the atomizing air system. All of the changes which involve purging the atomizer air system address the symptoms of the inadequate purge system. The installation of the welded two-inch diameter atomizing air ring header reduces the pressure drop through this header and improves the quality of the purge system. This header has only been installed on 2GT2 and it has had a noticeable impact on starting reliability. Sixty-four of the last 65 attempts were successful and the one failure was not ignition related.

The starting reliability of all the four gas turbines at Putnam Plant has averaged 86% for the last four months and it is anticipated that the goal of 95% will be achieved in the near future.
