# ELECTROMAGNETIC SHAFT CURRENT PROBLEMS A USERS VIEWPOINT

This article covers a user's experience, viewpoint and resolution, with destructive stray shaft currents on a centrifugal split-case design compressor. The compressor is driven by a 33,000 HP 13-stage condensing turbine. Shaft currents have been noted by many rotating equipment users for years and had been mostly associated with wet turbine steam causing a static current. A common type grounding brush, in continuous contact with the shaft, was used to bleed off all excess currents to ground. These brushes generally proved successful where "static" conditions were present. However, at times severe currents were generated causing quick bearing deterioration. The brushes simply could not carry the current away.

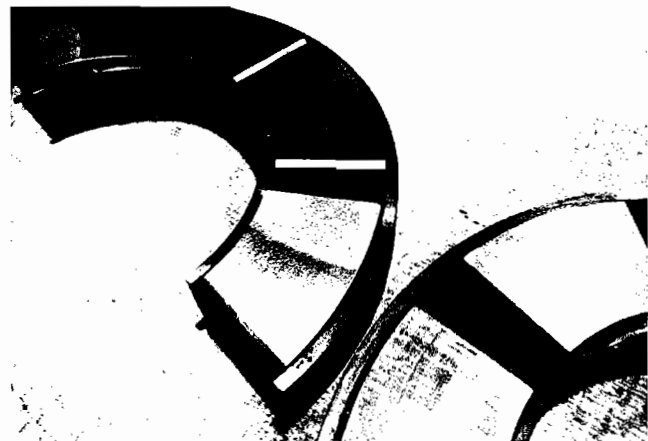
Figure 2. Erosion and Frosting Patterns on the Bearings.

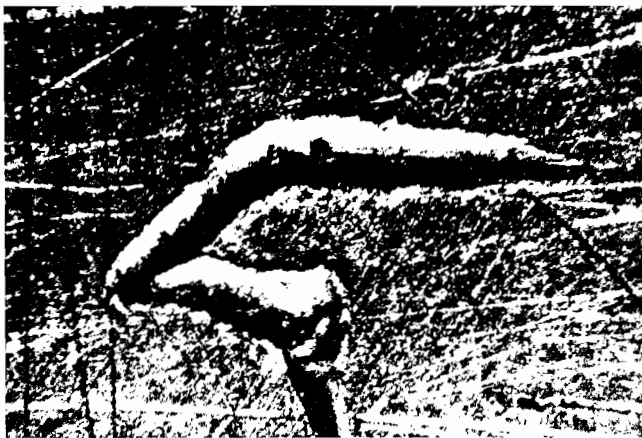
Figure 4. A Bearing Pad 100X Showing a Typical Spark Track.

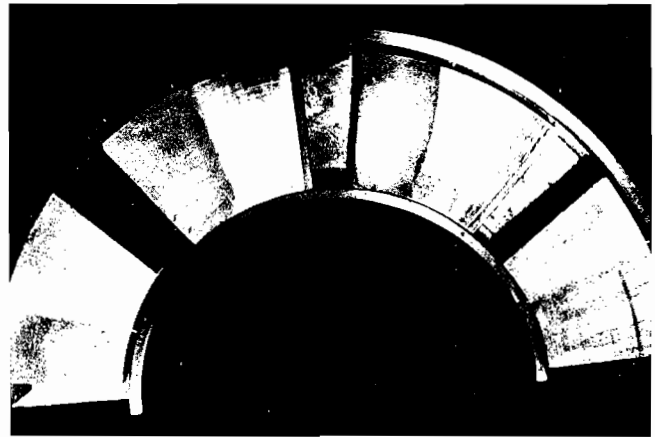
Figure 5. Turbine Thrust Pads Showing Frosting on  $\frac{1}{2}$  of All Pads. Pad babbitt deterioration begins on the trailing edge.
