# TURBINE ROTORS WHIRL AFTER DYNAMICALLY STABLE DESIGNS ARE UPRATED

**Fred L. VanLaningham**

Union Carbide Corporation

The problem of steam turbine rotor whirling following uprating of a stable design and the measures taken to define the problem and implement a solution are described.

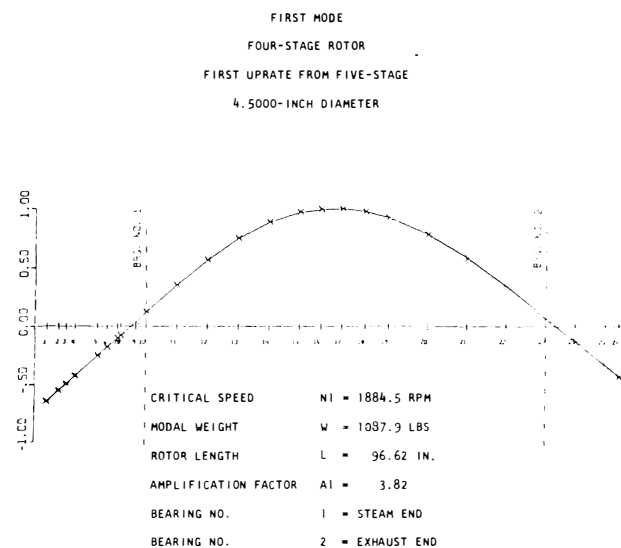
Critical speed calculations indicated that the root of the problem was that the 4-wheel rotor mode shape had the nodal points almost exactly on the bearing, and that until this critical mode shape was altered to get the nodal points away from the bearings the rotor would continue to be unstable (Figures 2 and 3).

Figure 2. Mode Shape of Original Four-Stage Rotor First Undamped Critical Frequency.

1. Increase the diameter of the rotor shaft enough to achieve the maximum critical frequency increase and machine the diaphragms for larger steam seals.
2. Change from a built-up rotor to a solid-forged rotor as hysteresis whirl has not been observed with solid rotors.
3. Increase the diameter of the rotor shaft to the limit permitted without machining the bore of the dia-

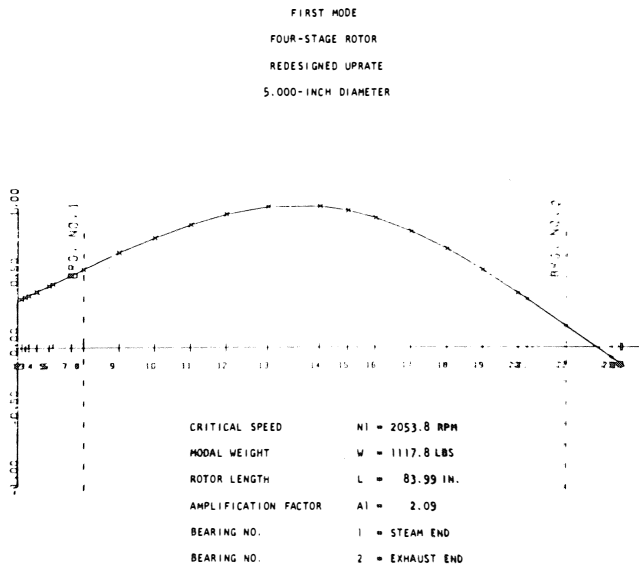
Figure 3. Mode Shape of Revised Four-Stage Rotor First Undamped Critical Frequency.

Our selection of the Case No. 3 rotor diameter allowed us to use the diaphragms without machining and to install different seals that had a larger ID but with the same size OD as before. The seal material was also changed to Ni-Resist which was more forgiving and would have less chance to set off vibrations in the event of a touch or rub.

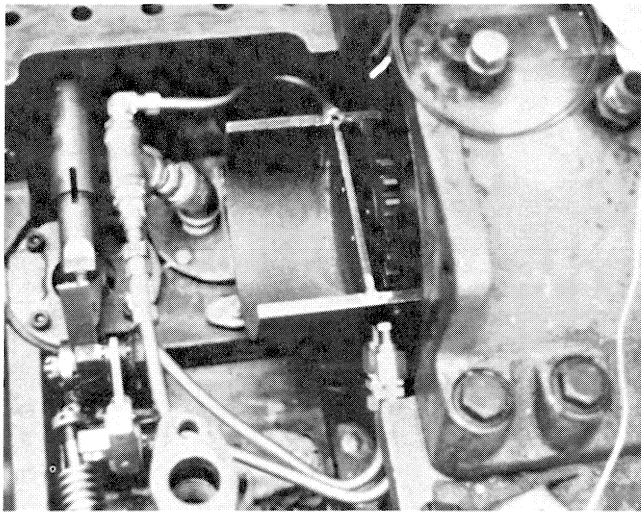
Figure 4. View of Steam End Bearing Housing Showing Shortened Rotor, Probe Mounting Bracket and Toothed Speed Wheel.

For all three cases, reduce the amount of the overhung weight by shortening the coupling end and shorten the governor end of the rotor by removing the overspeed trip bolt and oil pump drive, and modify the trip system to a total electronic overspeed and governing system as shown in Figures 4, 5, and 6.

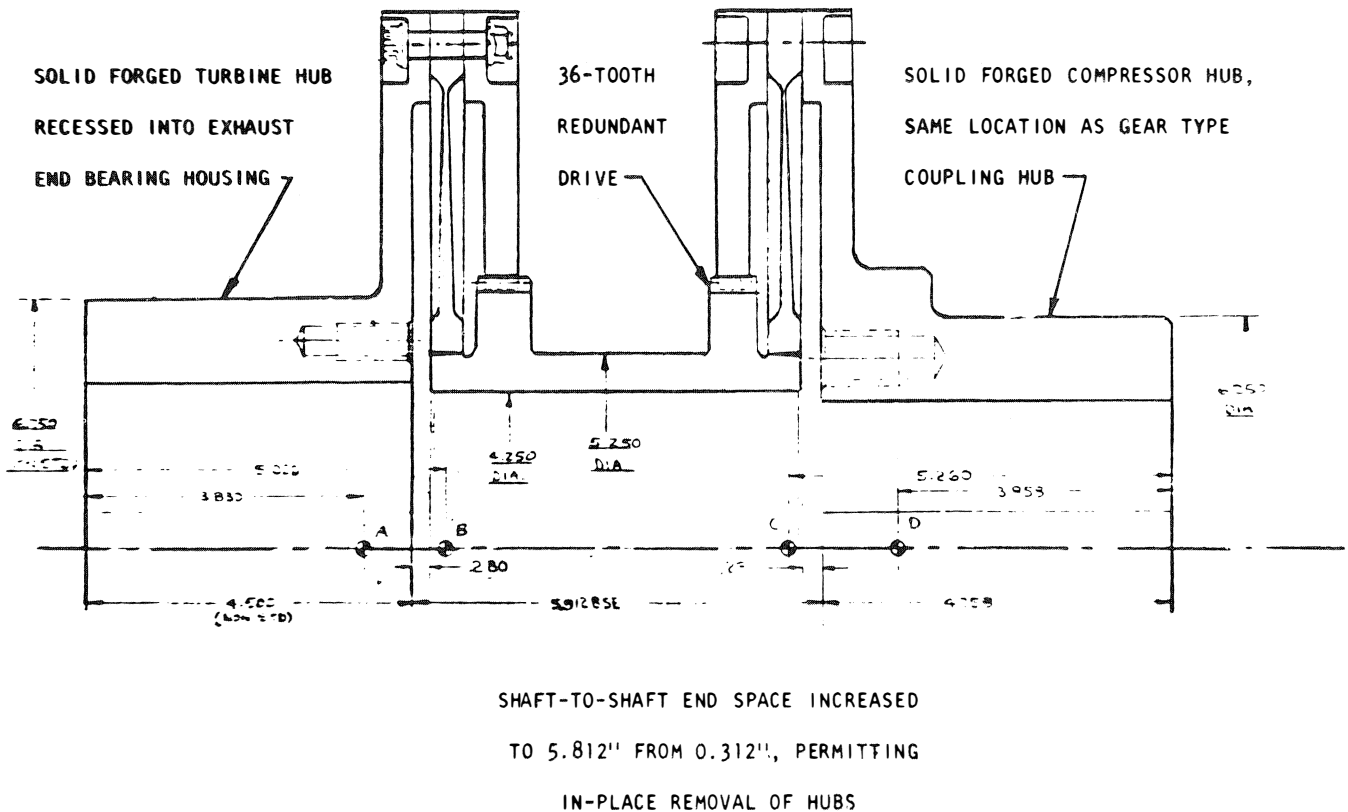
Figure 7. Contoured Diaphragm Special Flexible Coupling with Redundant Drive.

At the time the proposal was made to utilize Case 3 which also included removal of several inches from both ends of the shaft, we investigated the use of and selected a diaphragm-type coupling with a center dropout spool in order to remove or replace the hubs without removing the rotor from the compressor or from the turbine. A diaphragm coupling with a backup gear unit or tooth coupling mounted concentrically with the diaphragms was designed and manufactured. The backup drive is sometimes called "come-home drive" in the marine industry (Figure 7). However, the turbine manufacturer had to alter the bearing housings in order to allow the hub of the coupling to extend back into the bearing housing with an oversized oil labyrinth sealing the bearing housing on the hub. This meant that the shaft keys and keyways had to be sealed with elastomeric compound to prevent oil from the bearing housing from being expelled through the coupling.

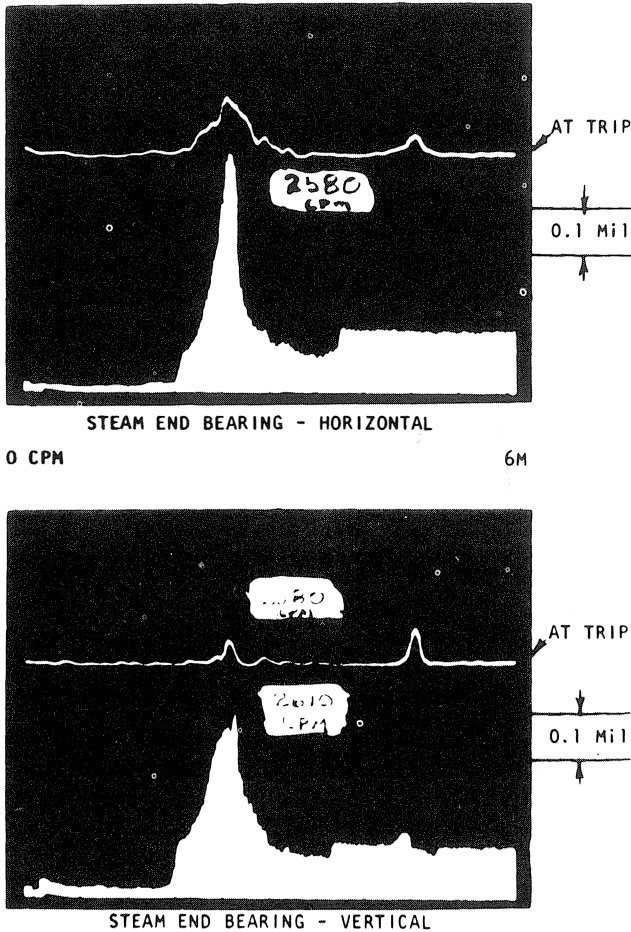
ROTOR VIBRATION  
5.000-INCH DIAMETER SHAFT

the machine (Figures 8 and 9). This activity is present on all units; however, we do not see it as a vibration problem but as activity only, especially when at design speed the total amount of rotor vibration peak-to-peak double-amplitude is 3/10 of a mil. We continued with the modification of rotors to the larger shaft diameter, replacing the coupling with the diaphragm type, shortening the shaft, and installing the electronic overspeed trip system.

Figure 8. Photos of Real Time Analyzer Scope Face (Peak Hold) During Solo-Overspeed Check.

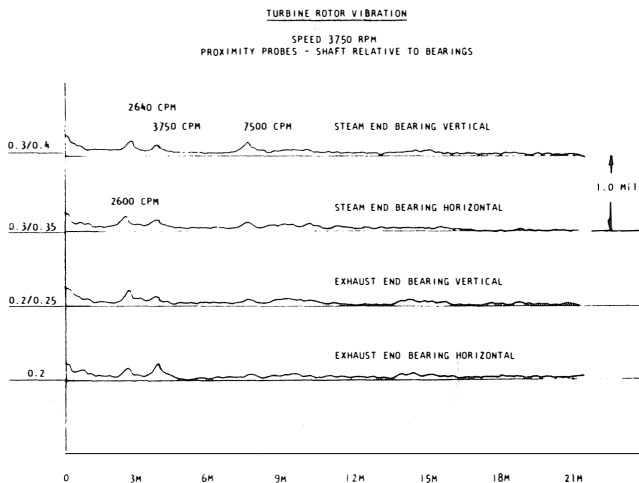
Figure 9. Plots of Frequency VS. Amplitude of Turbine Rotor Vibration, Coupled to Compressor Operating at Reduced Speed.
