# REJUVENATION OF USED TURBINE BLADES BY HOT ISOSTATIC PROCESSING

**G. VanDrunen, Ph.D.**

**J. Liburdi**

Westinghouse Canada Limited

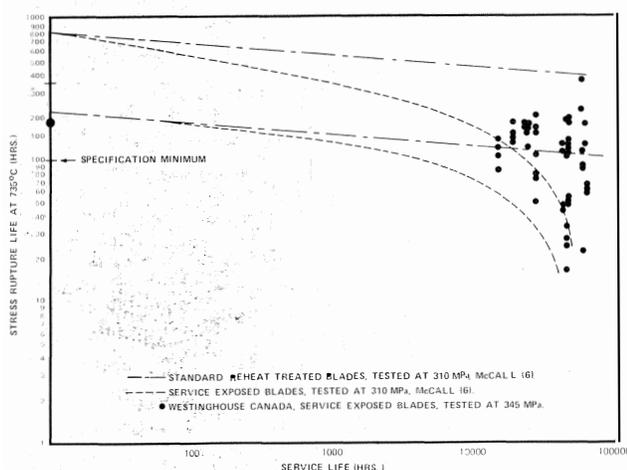
It is not known to what extent each of the above mechanisms contributes to turbine blade degradation during service. It is also probable that each alloy will respond differently to a particular temperature stress combination. Figure 1 shows the typical variation in stress rupture life determined at 735°C (1350°F) with service time for forged Inconel X-750 blades. The data for the machines was taken from McCall [6]. It should be noted that the tests conducted by us were conducted at 345 MPa (50 Ksi), while McCall's data resulted from tests at 310 MPa (45 Ksi). Both data sources display considerable scatter; some is undoubtedly due to variations in initial (new) material properties and differences in machine operating conditions. Additional reasons for large scatter are that the data includes values from both W62 row 3 blades and W92 rows 4 and 5 blades. Figure 1 indicates that, after 40,000 hours service, about half of the blades evaluated could not meet the new blade stress rupture specification value of 100 hours at 345 MPa/735°C. The blades which were selected for the HIP rejuvenation program had been in service for approximately 45,000 hours and exhibited the lowest life of all blades tested (Figure 1) (15 to 35 hours as received).

Figure 1. The Variation of Remaining Stress Rupture Life at 735°C with Service Time in Forged Inconel Alloy X-750 Turbine Blades.

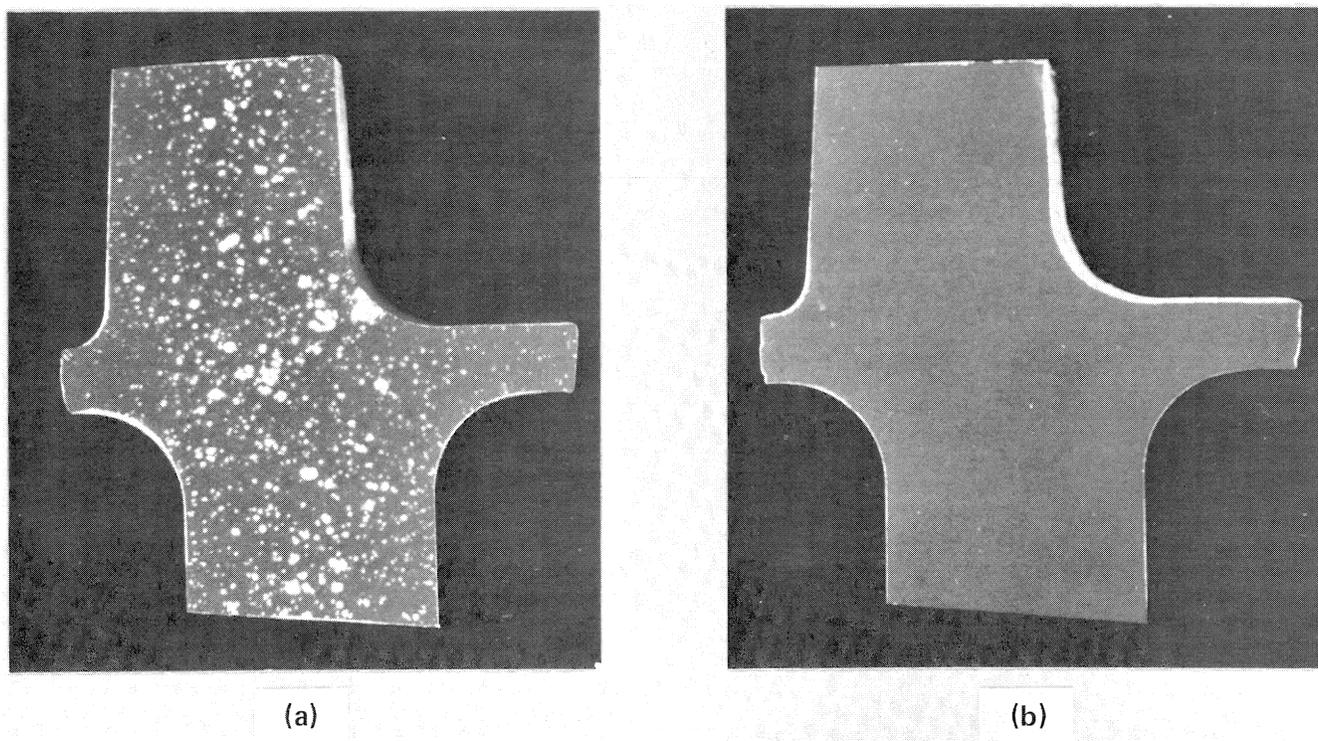
Figure 2. Fluorescent Penetrant Indications on Sections Cut from the Root-Airfoil Transition of Investment Cast Turbine Blades. (a) As Cast; (b) Cast Plus HIP Processed.

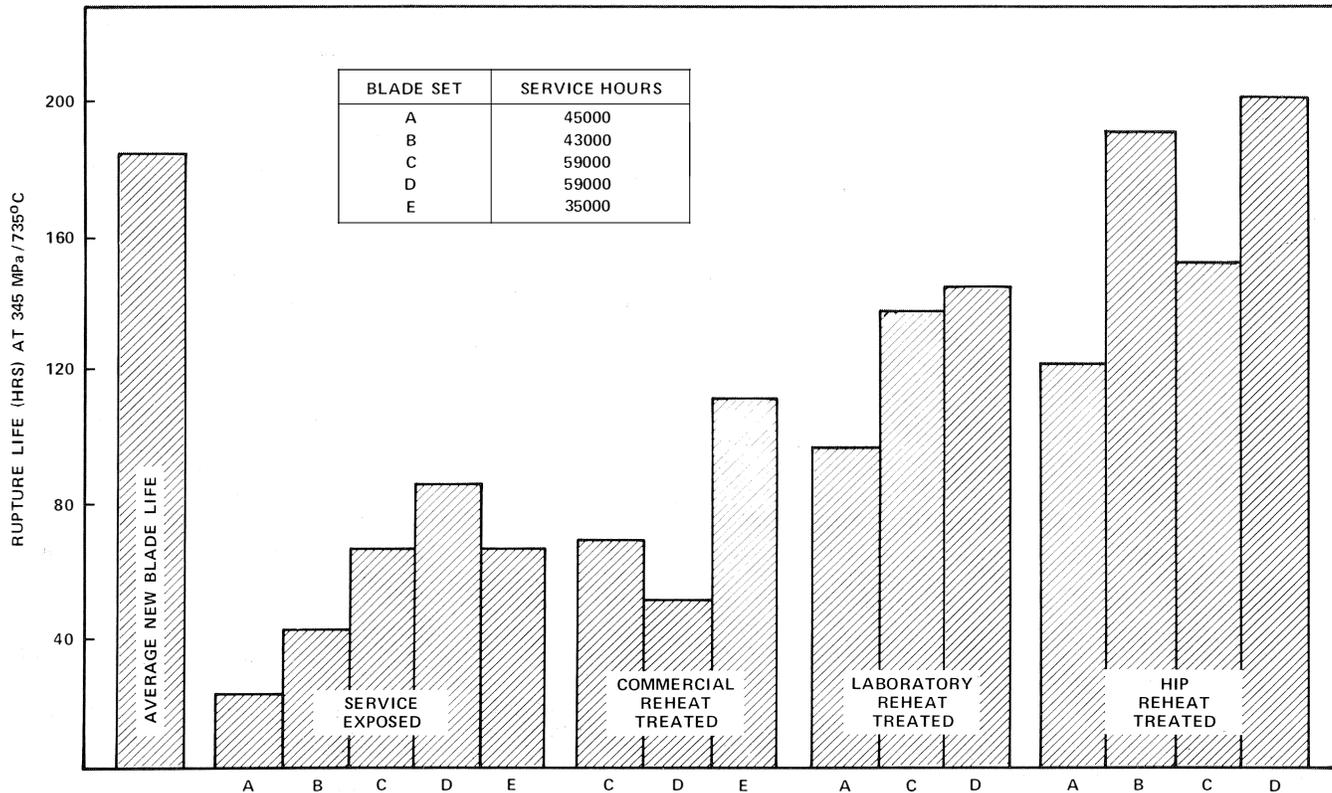
The results of this work, presented in Figure 3, clearly show that the HIP processed material is superior to both commercial and laboratory conventional reheat treated material. The laboratory treated blades should represent the maximum property improvement attainable by this approach, since ideal temperature control and cooling rates were employed and the microstructure was fully restored. Therefore, the improvement achieved using the HIP cycle must be due to complete removal of service damage.

Figure 3. Comparison of Stress Rupture Life at 345 MPa/735°C (50 KSI/1350°F) in Service Exposed, Commercially Reheat Treated, Laboratory Reheat Treated and HIP Reheat Treated Used Inconel X-750 Turbine Blades.

With the distinct advantage of HIP reheat treatment evident in Figure 3, a cooperative program was conducted with Trans Canada Pipe Lines to process a complete blade set and return them to service. The blades are forged Inconel X-750, with 45,000 hours of service and are identified as Set A in Figure 3.

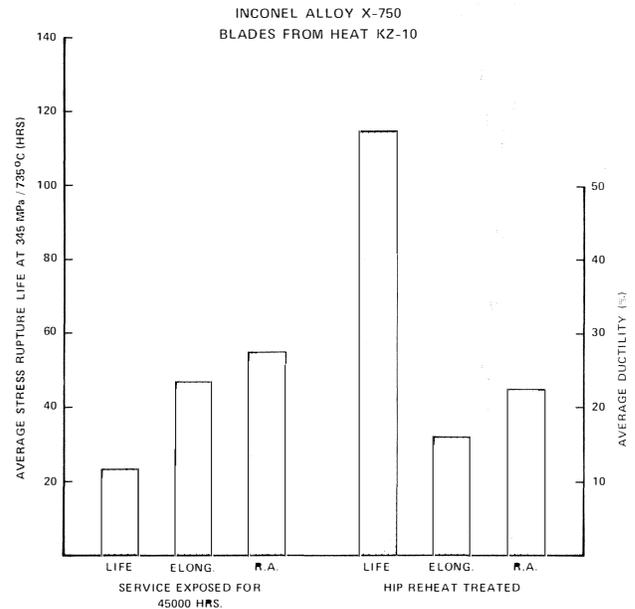
The service exposed and HIP processed conditions were initially established by testing ten specimens of each condition at 345 MPa/735°C/(50 Ksi/1350°F). The averaged results are presented in Figure 5. The results are nearly identical to the Set A results in Figure 3, which indicates that with due care, production scale HIP processing can duplicate preliminary laboratory results.

Figure 5. Bar Chart Comparison of Before and After Stress Rupture Properties at 345 MPa/735°C (50 KSI/1350°F) of the HIP Processed Blade Set.

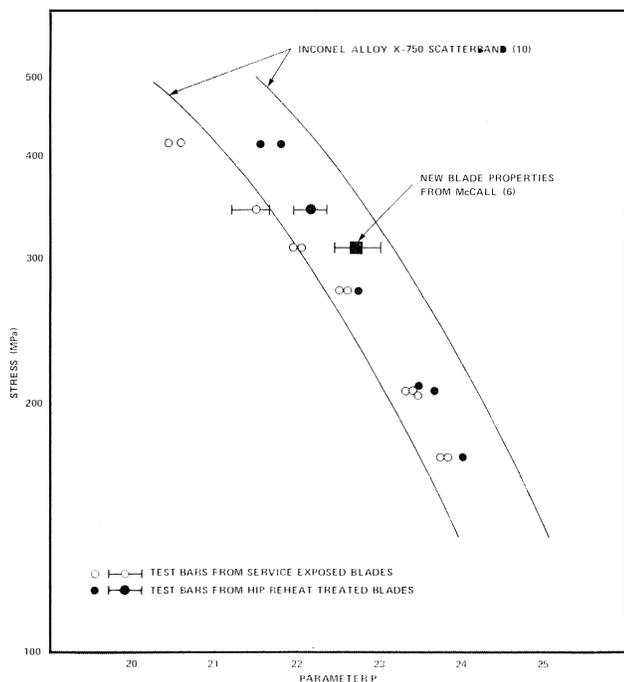
In addition to the above results, material in both the service exposed and HIP reheat treated condition was tested at various stress/temperature combinations. Test parameters were chosen so as to yield an average life of 100 hours for the HIP treated material. The results are presented in the Larson-Miller plot of Figure 6. The HIP processed results fall nearly in the centre of the Inconel X-750 scatterband [10] indicating that this condition is comparable to what one could expect for new blade properties.

Figure 6. Larson-Miller Plot ( $P = T \times 10^{-3} (20 + \log t)$ ,  $T$  in  $^{\circ}\text{K}$ ,  $t$  in hours) Showing Service Exposed, New and HIP Processed Blade Stress Rupture Properties.

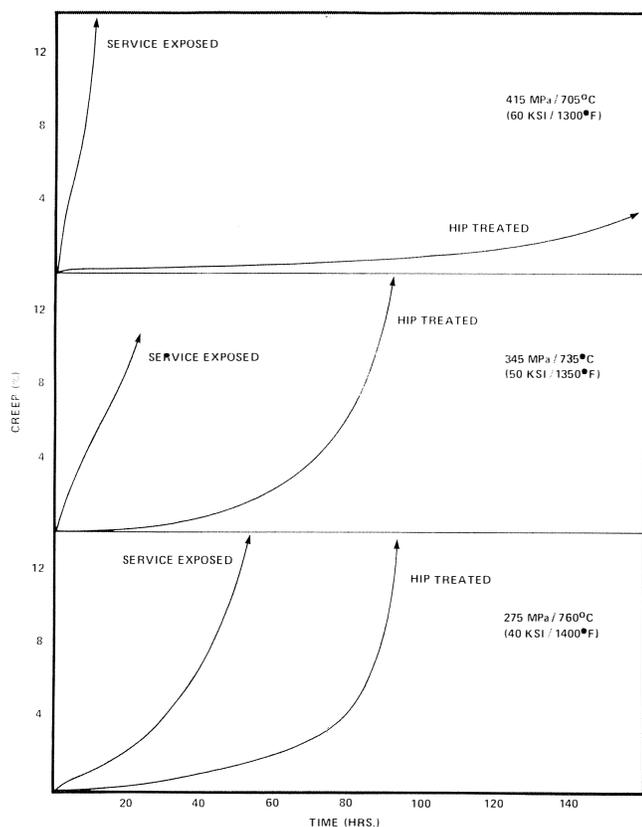
Short term creep rupture tests were conducted at three stress/temperature levels. Representative creep curves are presented in Figure 7. In all cases, the HIP reheat treated material clearly exhibits a secondary creep stage which is virtually absent in the service exposed material. Again, as previously noted in Figure 6, the differences between the service exposed and HIP processed material decrease as test temperature is increased.

Figure 7. Creep Rupture Curves Comparing the Service Exposed and HIP Reheat Treated Conditions at Three Stress/Temperature Combinations.

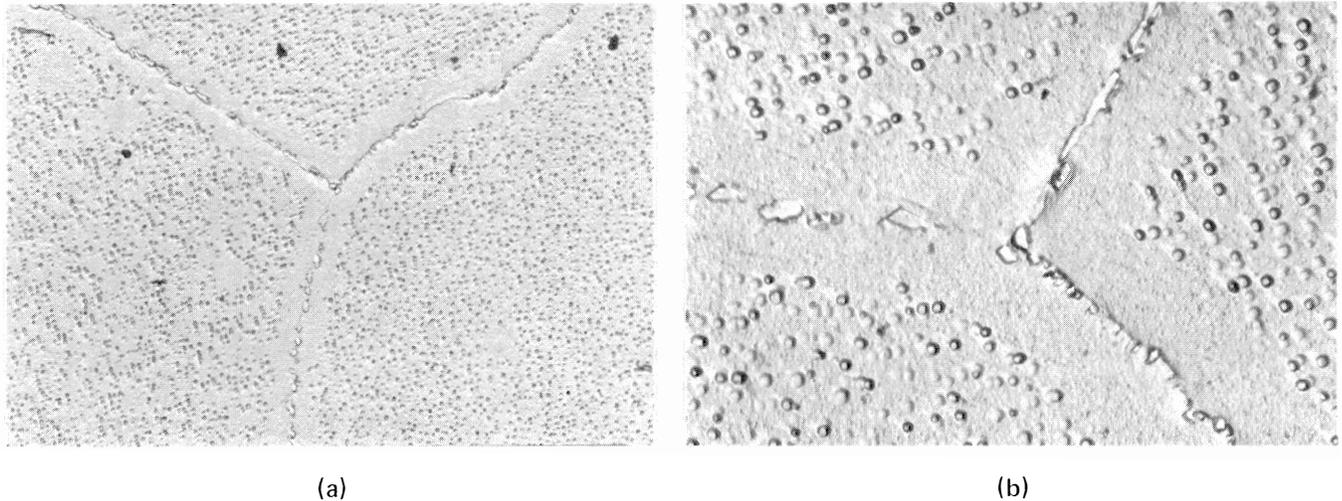
The only obvious microstructural differences between service exposed and HIP treated material were revealed in shadowed carbon replicas. The HIP treated microstructure, Figure 8, is comparable to that reported for new material by Raymond [9]. The intragranular  $\gamma'$  is spherical, 0.15 to 0.2  $\mu\text{m}$  in diameter, while the grain boundaries have a well defined "denuded" zone containing nearly unresolved  $\gamma'$  particles approximately 0.01  $\mu\text{m}$  in size. By comparison, the intragranular  $\gamma'$  in service exposed materials is cuboidal, 0.2  $\mu\text{m}$  in size, indicating that some coarsening has occurred (Figure 9). Considerably more  $\gamma'$  coarsening is apparent near the grain boundaries. The original denuded zone has divided into three zones, Figure 9 (b); very little if any  $\gamma'$  is observed immediately adjacent to the grain boundary; in the central zone of  $\gamma'$  particles are cuboidal and range in size from 0.1 to 0.15  $\mu\text{m}$ ; the zone furthest from the grain boundary contains coarsened spherical  $\gamma'$  0.02 to 0.04  $\mu\text{m}$  in diameter. The considerable  $\gamma'$  coarsening in the regions next to the grain boundaries is believed primarily responsible for the lower service exposed properties. The severely overaged condition would result in reduced strength leading to the localization of deformation to the grain boundary areas. Such inhomogeneous deformation will result in cavitation and eventual failure at the preferred failure sites; i.e., the grain boundaries.

Figure 8. Carbon Replicas Showing the Microstructure of an HIP Processed Blade. (1) 3500X; (b) 10500X.

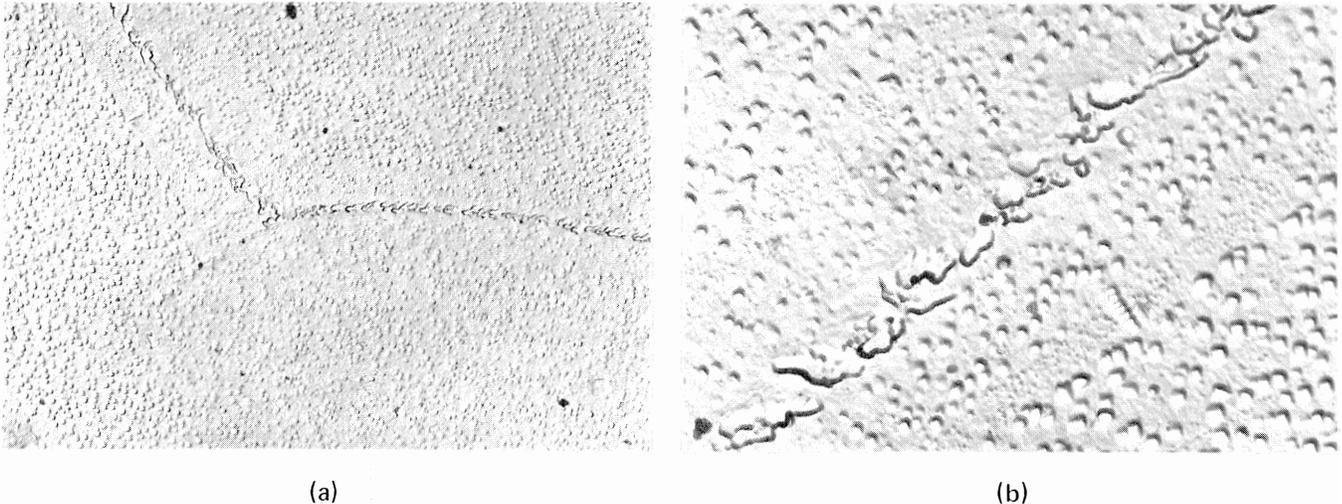
With regard to grain boundary morphology, there appears to be a heavier carbide film in the service exposed material which was subsequently broken up during the HIP reheat treatment; however, a quantitative analysis of the relative amounts and effect was not carried out.

Figure 9. Carbon Replicas of the Microstructure of a Service Exposed Blade. (a) 3500X; (b) 10500X.
