DISTORTION OF SPEED CHANGER HOUSINGS AND RESULTING GEAR FAILURES

Fred L. VanLaningham

Senior Staff Engineer, Systems and Machinery Management

Union Carbide Corporation

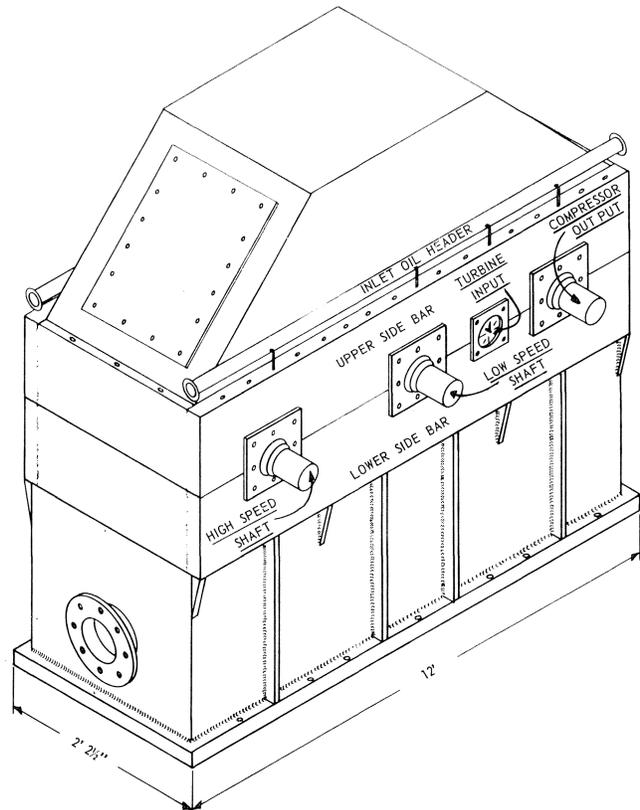
Figure 1. Triple pinion single helical gear speed increaser/reducer showing base plate at extreme bottom of enclosure.

The housing was disassembled and the babbitt thrust face of both low speed bearings were badly wiped. Wiping had also occurred on the inboard side or next to the thrust faces of both journal bearings. Prior to the failure, the system was operating normally and nothing unusual was noted. The most probable cause for such a failure is insufficient thrust or axial clearance. Clearance had been checked and recorded during the post-mechanical running test inspection at the builder's plant and again after installation at the job site. The only clue to the cause of failure was that during the time thrust bearing temperatures were rising, thunder showers were occurring. We concluded that this failure was caused by thermal bowing inward of the housing side bar sections thus decreasing the axial or thrust clearance. The higher temperature inside of the housing due to windage, hot oil mist, etc., relative to the outside of the housing had caused the housing side bars to bow resulting in a loss of clearance. The higher temperature inside of the housing due to windage, hot oil mist, etc., relative to the outside of the housing had caused the housing side bars to bow resulting in a loss of clearance. The higher than normal thrust bearing temperatures we had experienced resulted from the heavy Gulf Coast thunder shower cooling the exterior, increasing the temperature differential, and resulting bowing enough to totally wipe out both thrust faces. Figure No. 2 indicates the side bars bowing.

The unit was repaired temporarily with replacement bearings machined for increased axial clearance plus insulating the entire outside surface of the housing. The manufacturer then redesigned the low speed bearing arrangement changing from the plain journal bearings with taper land thrust faces to two double element type TDO tapered roller bearings. The unit on the main oil pump side was fixed, and the unit on the motor generator side floating. The calculated life of the roller bearings is about 125 years. After modification, the insulation on the exterior of the housing was removed.

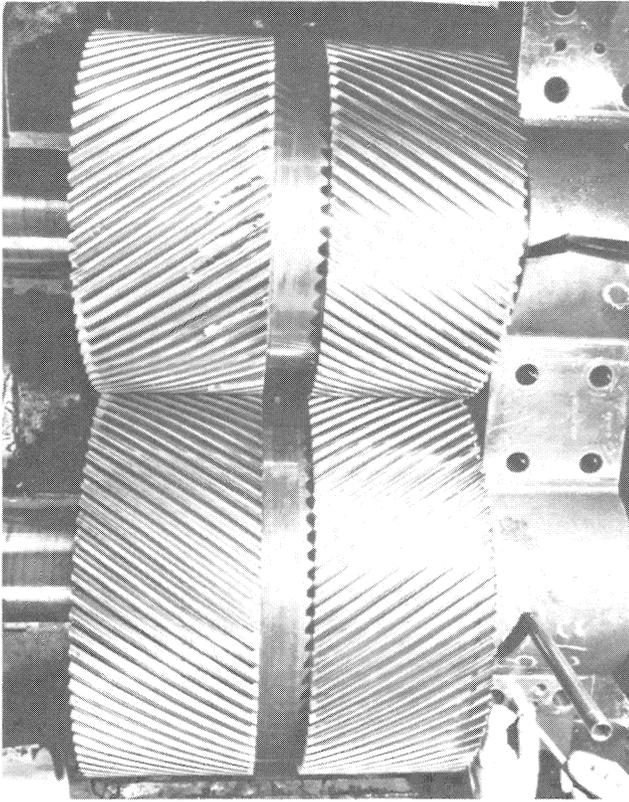
The number one unit failed after 23,500 hours of service and had teeth broken out of the pinion near the apex on the input or turbine helix as shown in Figure 3. In addition to the pitting, which was similar to the number two unit, near the apex on the loaded flanks of the gear, pitting was also evident near the edge on the output or compressor helix as can be seen in Figures 4 and 5.

The gears had no doubt failed due to an internal alignment difficulty that had concentrated the load resulting in localized fatigue failure. Distortion of the housing, its foundation, or barreling of the gear and/or pinion in the center due to nonuniform heat rejection from the gears were possible causes.

Figure 3. Photograph of failed double helical speed increaser gears as upper half of housing was removed. Fatigue breakage is evident on pinion.

A shield was installed in addition to the previous lubrication and cooling spray modifications. The units have operated continuously except for planned preventive maintenance for the past six years with no reoccurrence of the failures. Routine inspections of the gears indicate excellent tooth contact and no further indications of distress.

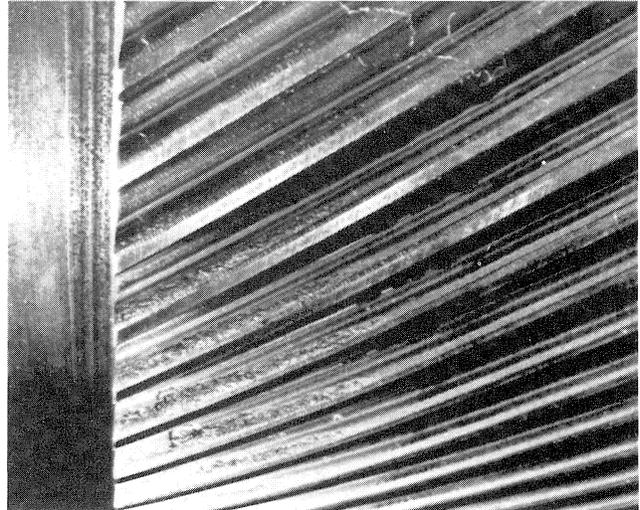
Figure 4. Photograph of low speed gear turbine side helix loaded flanks showing destructive pitting and spalling.

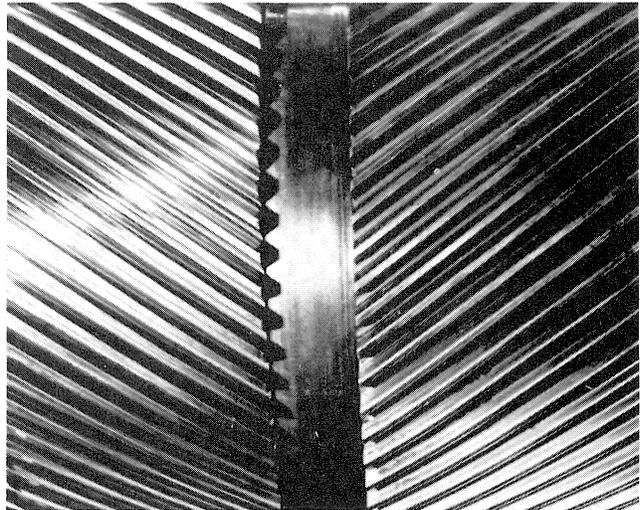
Figure 5. Photograph of low speed gear showing pitting on loaded flanks of both helices. Additional markings on compressor side helix can be seen in lower right hand corner.

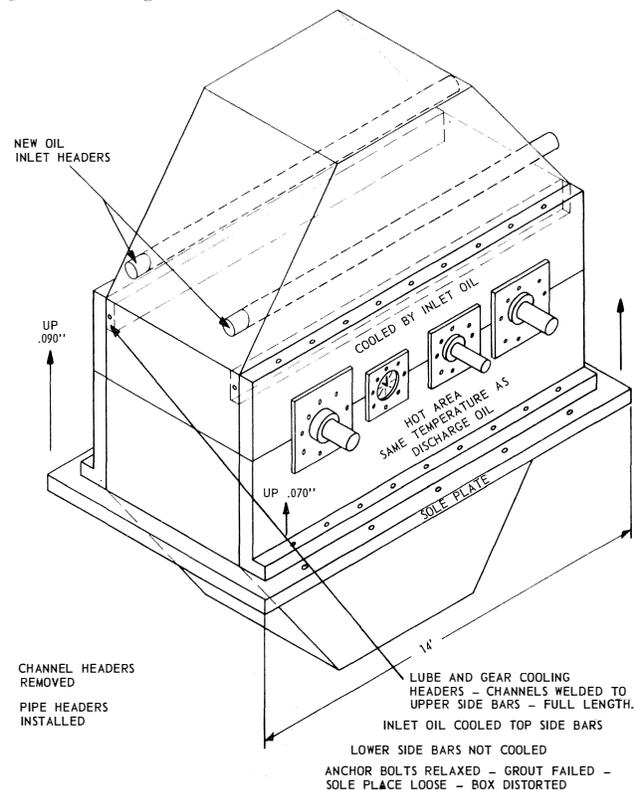
The bowing, we thought, most probably was the result of a temperature difference between top and bottom halves of the housing. How this condition could exist became clear when the lubricating oil header design was reviewed. The filtered and cooled oil entered at one end of the housing just above the horizontal centerline, i.e., the upper half. Once the oil entered the inlet nozzle and passed through the housing, the flow divided equally to each side into two identical oil headers. The headers were formed by two 1-1/2 in. by 5 in. channels welded to the inside of the two upper side bars or rails and ran the full

Figure 7. Triple pinion double helical unit indicating cut over sole plate mounting and location where distortion was greatest plus location of original and as modified oil inlet headers.

Redesign of the internal lubrication and cooling system was relatively simple. The channels welded to the rails were removed, and two full length pipe headers were welded into the end panels that were relatively thin compared to the heavy rails. Jacketed braided hoses were connected and tack welded to prevent loosening to threaded couplings welded into the pipe headers. Both faces of every mesh are sprayed. Sixty spray nozzles cool and lubricate the three meshes of the four gears. See Figure 7.

After modification of the housing, the grout was chipped out, the soleplates removed, optically leveled, and regouted with epoxy resin grout. The units also had bearing metal temperature detectors and noncontacting vibration probes installed while the modifications to the lube system was being done. Both units as reinstalled are monitored continuously.
