ANALYSIS OF THREE IMPELLER FAILURES: EXPERIMENTAL TECHNIQUES USED TO ESTABLISH CAUSES

Charles Bultzo

Exxon Company, U.S.A.

ABSTRACT

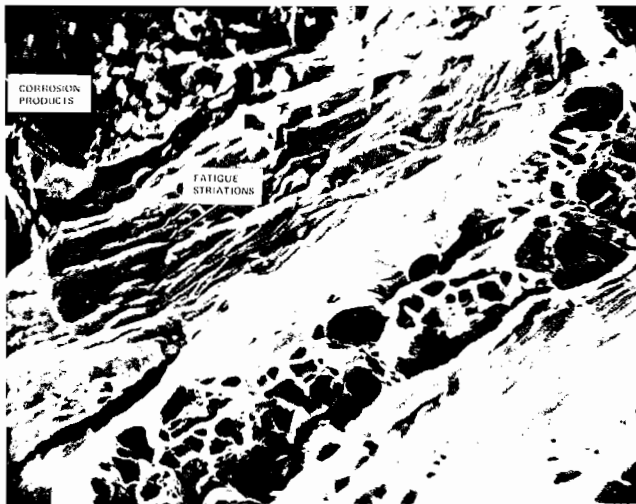
Both the vendor and Exxon's research facility made independent analysis of the metallurgy of the second failed impeller. The vendor reported yield strengths approximately 33 percent higher than that observed by our facility. (This included in-house and "third party" use of microtensile specimens.) As shown on Figure 2, a scanning electron microscopic fractographic examination of a crack that was in progress and opened for examination indicated the presence of both fatigue and corrosion products. It was Exxon's position that the failure was due to the following:

1. The physical properties of the material were below design.
2. With a high base stress and some forcing function that added a substantial stress over a brief period, fatigue had occurred during the period of the abnormally higher stress. As the crack progressed, the opened surfaces were subjected to a light corrosive attack.

Figure 2. Scanning Electron Microscopic Fractographic Examination of a Crack.

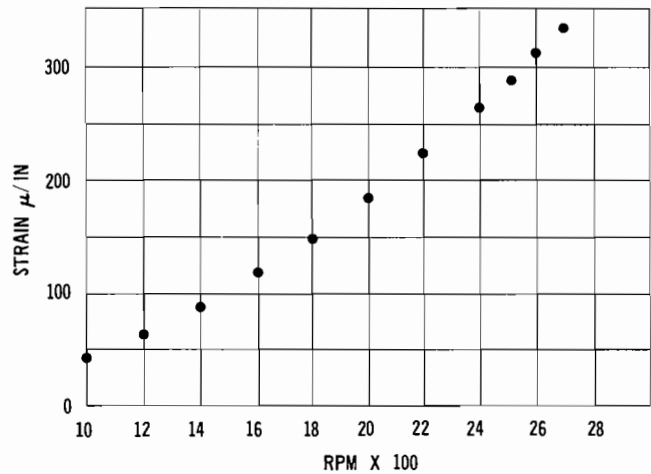
The extrapolated stress level was approximately 47 percent higher than that predicted by the vendor. Since there was commonality in the predicted stress analysis by both Exxon's system and the vendor's system, it gave rise to the credibility of known computer programs used for the evaluation of stress analysis in impellers. Historically, it has been assumed that the highest stress would occur at the impeller eye. However, this test and subsequent tests on the second-stage impeller from this rotor and smaller riveted impellers from other rotors disallowed this premise. One of the leading authorities on the subject of impeller stress analysis agreed and suggested that

Figure 6. Effect of Speed on the Strain in First Stage Impeller.

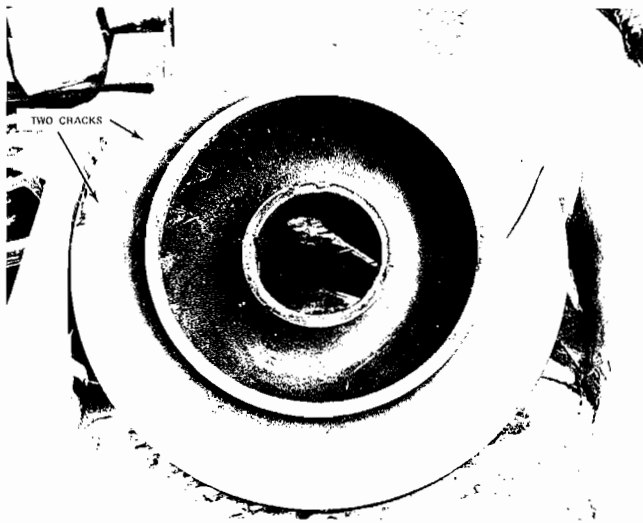
After the first SAE 4330, 90,000-maximum-yield, first-stage impeller had been in service approximately eight months, it was removed from service during a scheduled downtime of the process unit. The overall performance of the compressor had dropped below the "like new" performance. This, combined with the lack of operating data with the SAE 4330 material in this wet gas service, dictated an inspection of the rotor. Figure 11 shows the condition of the first-stage impeller as it was found during this inspection. It should be noted that there are three cracks present; two appear to be approximately 180 degrees from the large single crack. The two cracks are in adjacent vanes. The main crack followed the back side trailing edge of the vane as shown on Figure 12.

Figure 11. Condition of First Stage Impeller During Inspection, After Eight Month Service.

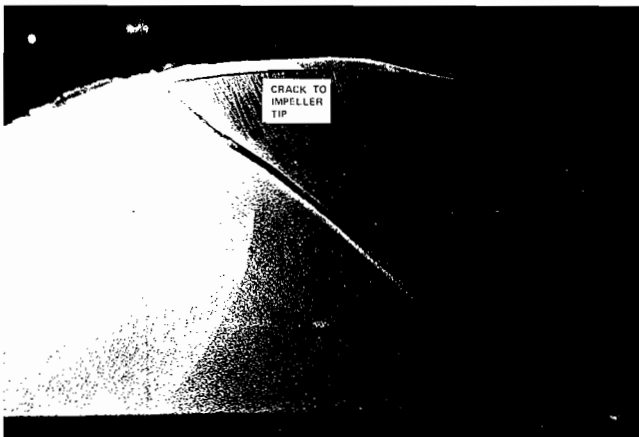
Figure 12. Crack on the Back Side of the Trailing Edge of the Vane.

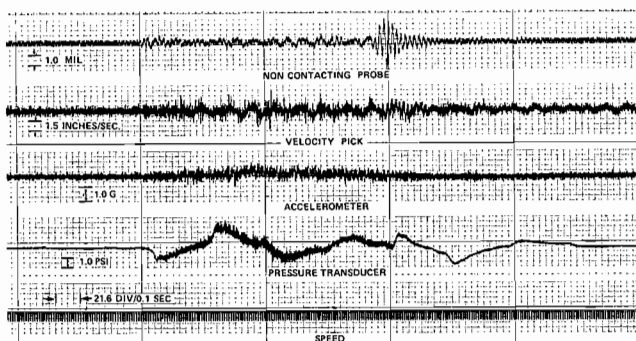
The compressor was put into surge by slowing it down. The resulting phenomena were recorded simultaneously on magnetic tape and are shown on Figure 15. As can be seen, the noncontacting probe indicated an apparent drop in shaft speed from 7,000 cpm to approximately 3,500 cpm when actually the speed had been reduced only 200 cpm. Further, the amplitude of the shaft radial vibration increased approximately 400 percent. At the same time, the pressure in the inlet casing was observed to rise substantially. Also, acceleration and velocity levels showed substantial increases. Reducing the tape speed from 30 inches per second to 3-7/8 inches per second, a 7.74 to 1 step down showed these phenomena more clearly (Figures 16A, B, C, and D). The magnetic tape was also used in conjunction with a realtime analyzer. The presence of a very strong 560-cycles-per-second frequency was indicated. This is shown on Figure 17. It could be concluded that during this surge period, which lasted for 1.5 seconds, the back flow of gas generated white noise. One of the very strong frequencies in this noise was in the league of the same 560-cycles-per-second frequency mentioned earlier. This procedure was repeated at least five times to obtain additional data. Each time, some new information was observed. All the data point to the conclusion that the unknown forcing function was acoustically generated during surge. This caused the first-stage impeller to vibrate in a manner that caused the fatigue phenomena to become manifest. Further, since no problems have been experienced with the other five impellers, it was decided that all future efforts would be directed toward developing better understanding of the vibratory characteristics of the first-stage impeller and their relationship to the acoustical phenomena present during surge.

Figure 15. Compressor Analysis: Data as Unit is Approaching Surge.
