UPTHRUST PROBLEMS ON MULTISTAGE VERTICAL TURBINE PUMPS

Donald R. Smith

Stephen Price

Engineering Dynamics Inc.

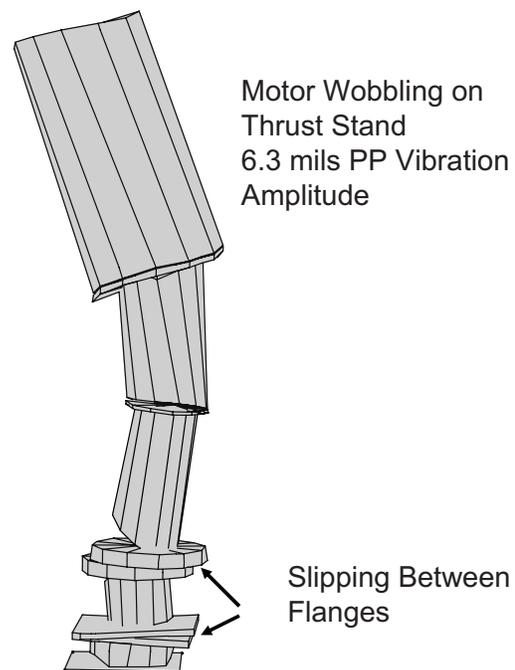
Figure 6. Operating Deflection Mode Shape at 1× Running Speed.

The ODS indicated that the motor was “rolling” or “wobbling” on top of the thrust stand. In addition, slipping was observed between the flanges connecting the discharge head to the barrel. Subsequent to the ODS testing, several of the flange bolts were determined to be loose and were tightened; however, tightening the bolts did not reduce the vibration to acceptable levels.

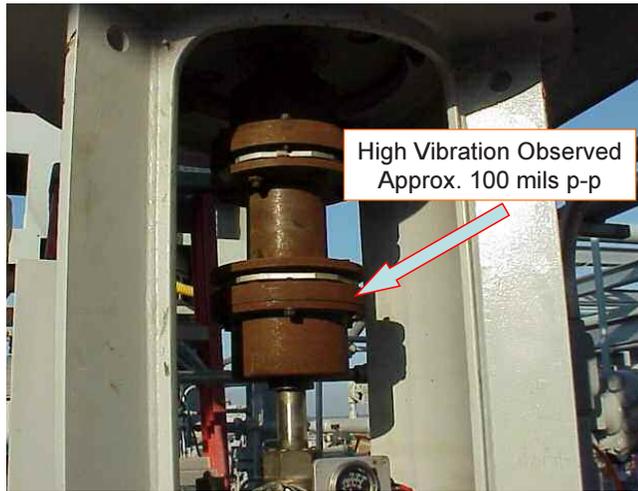
Figure 7. Excessive Vibration on Pump Coupling and Pump Shaft.

During the process of obtaining the ODS vibration data on the motor and thrust stand of pump A, excessive vibrations were visually observed on the pump coupling. The vibration levels on the pump coupling hub and the upper pump shaft were estimated to be in the range of 100 mils peak-to-peak (Figure 7). These

vibration levels were clearly excessive and were considered to be in the danger level. The observed vibration levels on the motor coupling hub were significantly lower compared to the pump coupling hub, which indicated that the coupling was effective in isolating the vibration between the pump shaft and the motor shaft.

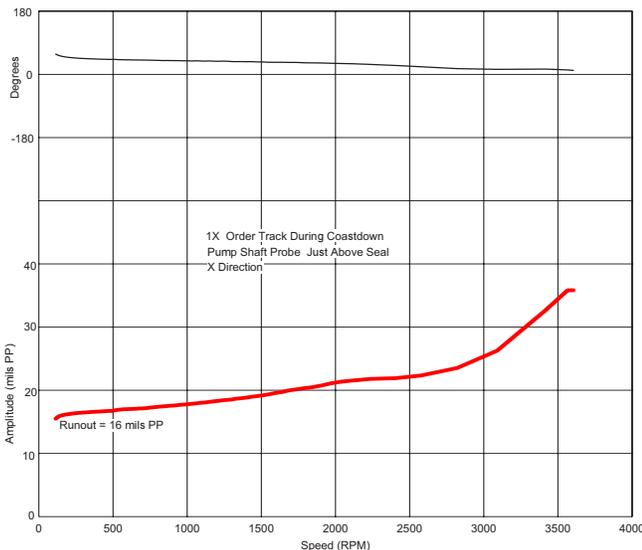
Figure 8. Bode Plot of Pump Shaft Vibration During Coastdown.

After the proximity probes were installed, the pump was started, operated at full speed for only a few seconds, and then shut down. Figure 8 is a plot of the 1× running speed shaft vibration and phase (Bode plot) during the coastdown. At operating speed, the pump shaft vibration near the seal was approximately 36 mils peak-to-peak. Slow roll data indicated that the shaft runout was approximately 16 mils peak-to-peak (note that this pump had been in service for approximately 500 hours at the time of the test).

This runout greatly exceeded the allowable runout at the seal. API 610 (1995) states that the total indicated runout shall not exceed 0.0005 inch per ft (4 μm per 100 mm) of length, or 0.003 in (80 μm) over the total shaft length.

The shaft vibration and runout data were reviewed with the pump manufacturer. Everyone agreed that the vibration levels were considered to be dangerous and could result in a failure of the coupling, shaft seal, and/or thrust bearing. The excessive runout indicated that the shaft was probably bent.

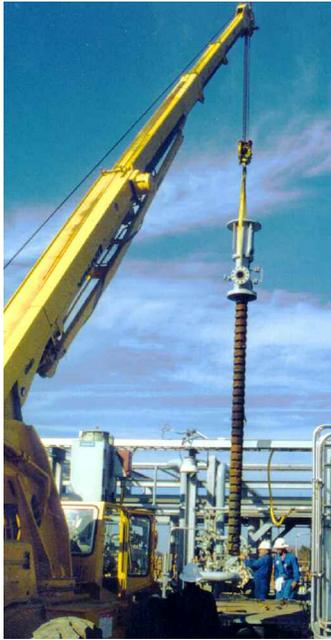
Figure 10. Pump Assembly Being Removed.

The problems experienced by the pumps (excessive motor vibration, excessive shaft vibration, bent shafts, and seal problems)

were all classical symptoms of excessive upthrust. The pump manufacturer agreed and indicated that the pump thrust had not been recalculated for operation with ethane. All three pumps were then returned to the manufacturer for restaging (Figure 10).

The 31-stage pump was originally supplied with 15 standard impellers and 16 hydraulically balanced impellers for operation with gasoline. For operation with ethane, the pump was reconfigured with 28 standard impellers and only three hydraulically balanced impellers.

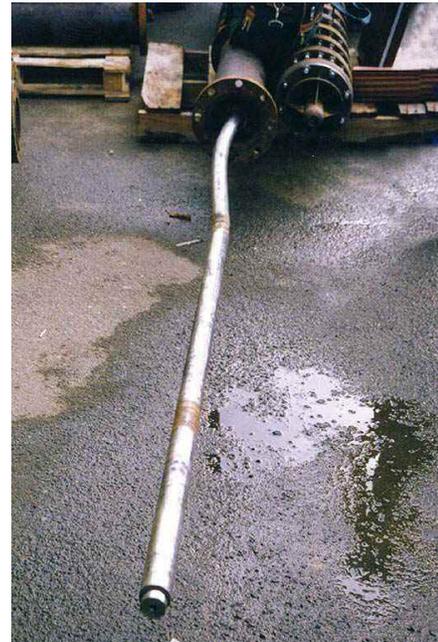
The pump rotor was seized and the intermediate shaft was bent several inches (Figure 13). The shaft had to be cut into several pieces to remove the impellers (Figure 14). The shaft showed excessive wear at all of the bearing locations (carbon bushings). All of the carbon bushings were destroyed. The carbon bushings were

Figure 13. Pump Shaft from Pump A. (Shaft was bent after the shaft seized. The motor tripped on high amps.)

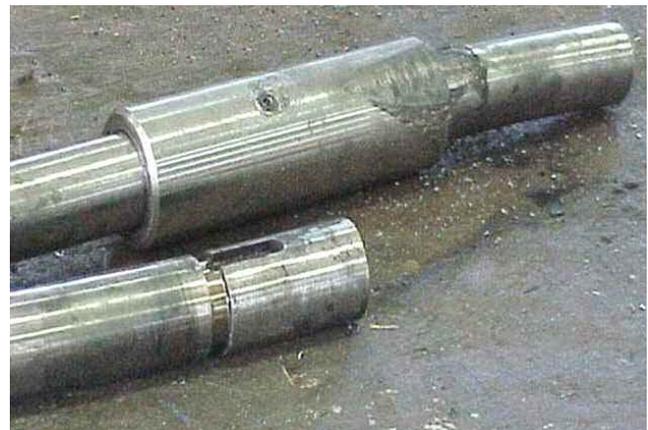
Figure 14. Damaged Pump Shaft Cut into Pieces to Remove Impellers.

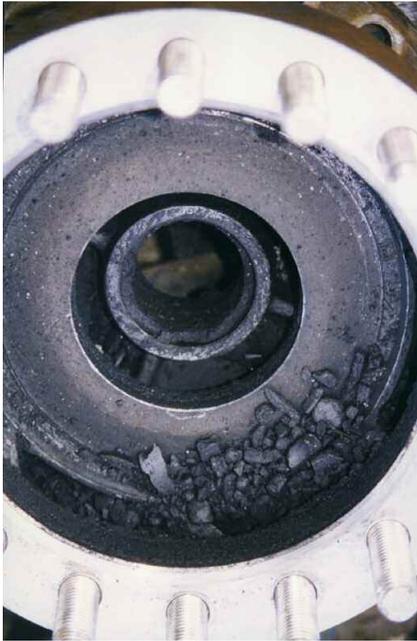
broken into several small pieces, which were lodged in the impellers (Figure 15). In addition, there were also large quantities of carbon powder in the impellers. All of the wear rings were badly worn and there was evidence of galling between the wear rings on the impellers and the wear rings on the stationary parts.

Figure 15. Impeller from Pump A During Disassembly after Pump Failure. (Note carbon particles and dust from destroyed carbon bushings.)

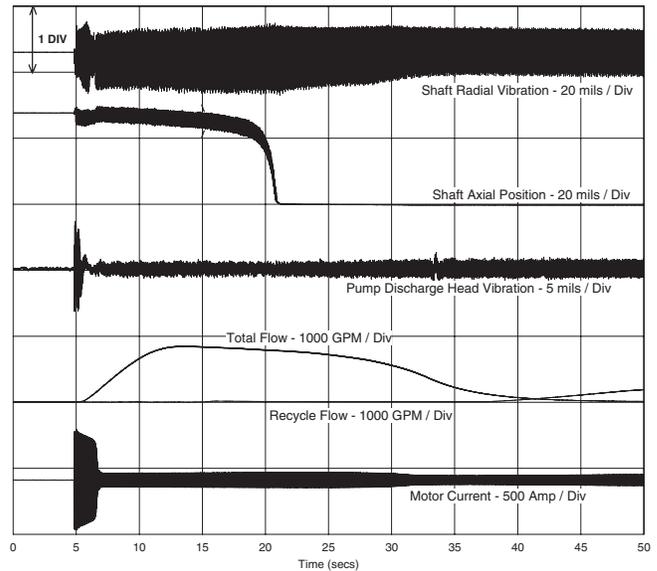
Figure 19. Time-Domain Plot of Shaft Radial Vibration, Shaft Axial Position, Flow, and Motor Amps During Second Startup of Pump C with Fully-Open Discharge Valve.

The shaft was in the upthrust position for approximately 15 to 20 seconds until the discharge pressure increased above 200 psi. As shown in Figure 19, the shaft vibration decreased as the pump discharge increased above 200 psi, because the pump downthrust increased with the higher discharge pressure. As discussed, the pump is designed to operate in downthrust with the shaft in tension.

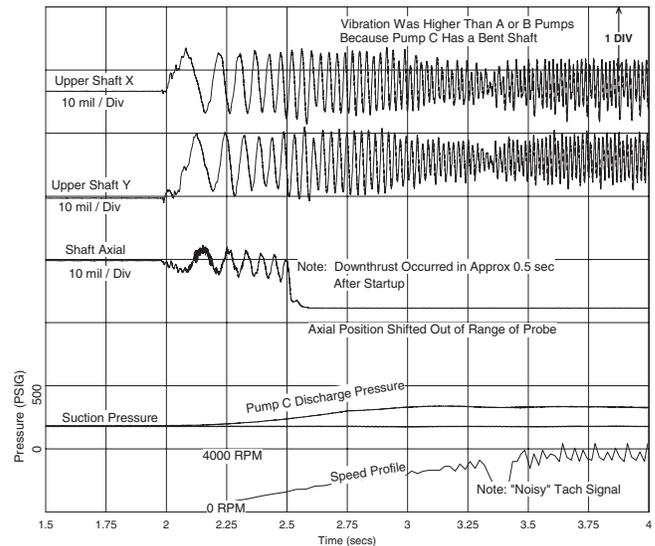
Figure 20. Time-Domain Plot of Shaft Radial Vibration, Shaft Axial Position, Pressure, and Running Speed During Startup of Pump C with Partially-Closed Discharge Valve.

The pump reached full speed in approximately 1.5 seconds (Figure 20) and the discharge pressure immediately increased to approximately 350 psi in approximately 1 second. The pump shaft position changed from upthrust to downthrust in approximately 0.5 seconds (Figure 20) compared to approximately 15 to 25 seconds when the pump was started with the discharge valve in the fully-open position.

As shown in Figure 20, the pump shaft radial (X, Y) vibrations were reduced when the pump shaft changed to the downthrust position. The radial vibration levels remained fairly constant over a large flow range after the pump switched to the downthrust condition.
