# RELIABILITY IMPROVEMENT AT PETROTRIN REFINERY - PUMPS AT NO. 8 CDU. 1997 to 2003

Presented by : Stanley Deonarine  
Head, Mechanical Eng.  
Petrotrin Refinery  
2003 October 31

# PROBLEM – TO IMPROVE PUMP RELIABILITY ON TWELVE BAD ACTORS

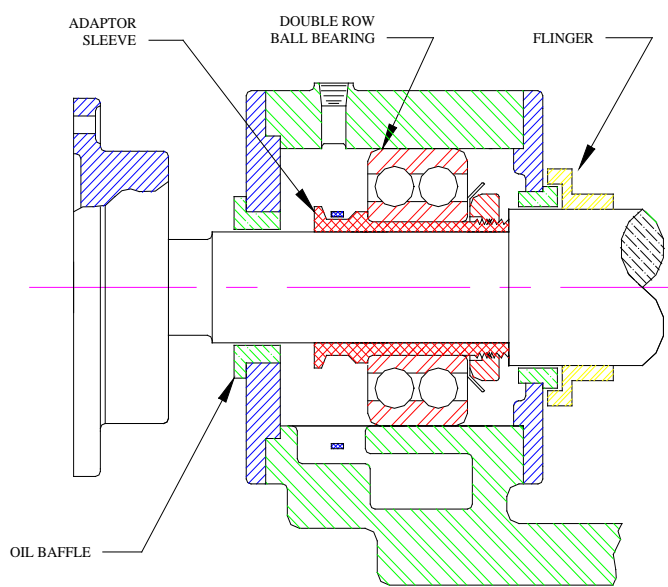
OLD DESIGN

- ☞ Compare design of existing pump/turbine (40 years old) to modern design built to API standards.
- ☞ Particularly, look for design issues which lead to bearing overheating. Also, how is the bearing mounted to the shaft ? ( refer to slide 13 ). Check for fretting & looseness of parts.
- ☞ These causes affected four pumps(TT-3134/36/38/40) and twelve turbines seriously.
- ☞ Can redesign be done in-house or should it be referred to the OEM ?
- ☞ Or should a new pump/turbine be bought ?

- ☛ Replace 12 turbines (40 years old) by new machines (API-611). Design new turbines to consume excess LP (65 psig) steam instead of 450 psig steam.  
STATUS – Completed.  
OPTION CONSIDERED – upgrade of old turbines by the OEM is technically sound but the cost is about the same as for a new turbine.
- ☛ Upgrade bearing/shaft design on 4 pumps to eliminate the adaptor which fitted as a sleeve between the radial ball bearing and the shaft.  
Refer to slide 13. STATUS – 2 pumps completed.  
OPTION CONSIDERED – Purchase of upgraded pump from the OEM is technically sound but the cost is much higher.

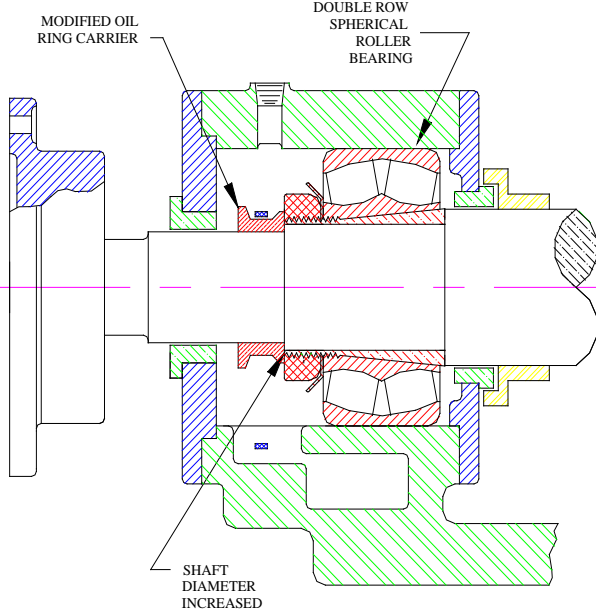
MODIFIED DESIGN

**NOTE:** SHAFT WITH ENLARGED BEARING SEAT. ADAPTOR SLEEVE ELIMINATED. BEARING HOUSING IS THE SAME

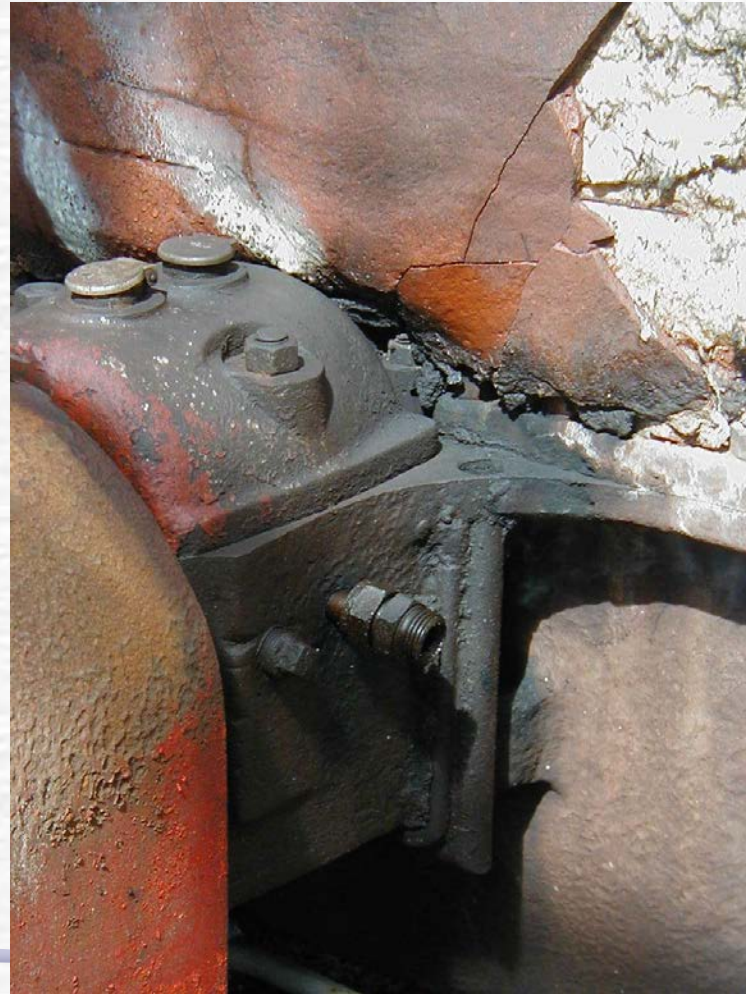
# Obsolete Turbine

- ☛ Program duration – 1997 Jan to 2003 Aug.
- ☛ Mean Time Between Overhauls (MTBO) was low at 13 months for pumps and 6 months for turbines (shop overhauls only).
- ☛ Plant production was occasionally disrupted by turbine breakdowns.
- ☛ Maintenance cost was high at US\$ 9,380. per pump p.a. average.

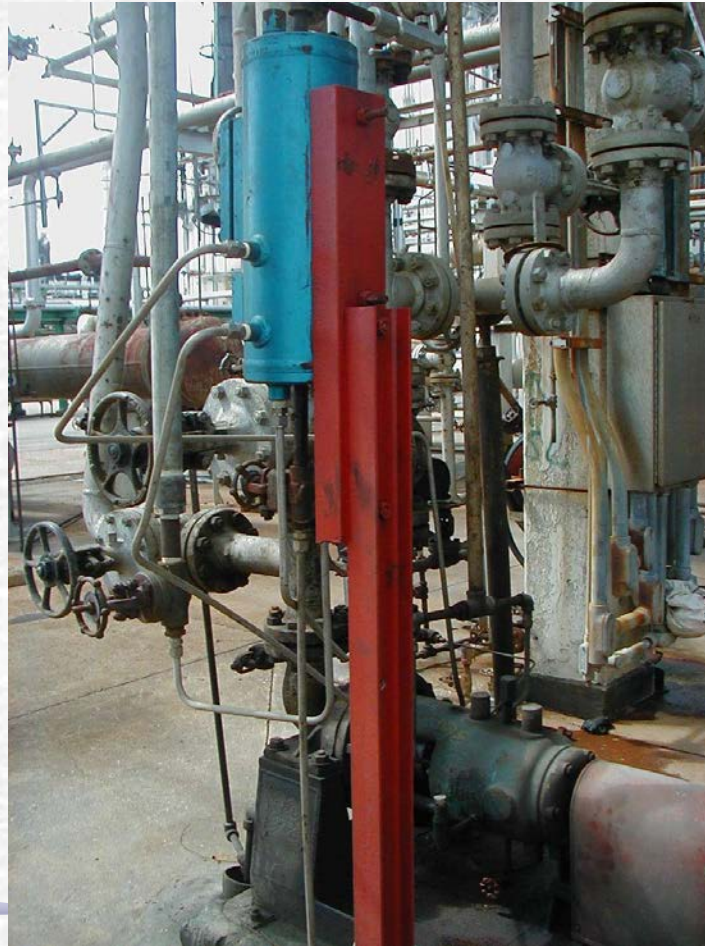
# Barrier Tank on LPG Pump

- ✦ Examine seal faces and o-rings. Check for cracked/worn faces and embrittled o-rings. 40 year old seal designs (stellite vs carbon faces) were suffering rapid wear/overheating. These causes affected 2 LPG pumps(TT-3100/01) and a gasolene pump(TT-3158).
- ✦ On packed pumps, check for rapid grooving of sleeves. These causes affected 4 pumps (TT-3118/20/46/50). Cost of leakage – US\$4,000. per pump p.a.

- ☛ At low suction pressure (2 psig), switch to another supply tank in order to avert onset of pump cavitation.
- ☛ For 4 pumps with packed glands, fit new mechanical seals (Silicon carbide vs carbon faces, alloy 718 bellows).
- ☛ For 2 LPG pumps and a gasoline pump, replace old seals by new tandem seals with outer seal in standby mode at atmospheric pressure. Multi-port flush. (Silicon carbide vs carbon faces - spring loaded).
- ☛ STATUS - All above completed except for the gasoline pump.
