# A CASE HISTORY-IMPROVEMENTS TO AN EXISTING COOLING TOWER SUMP AND HORIZONTAL SPLIT CASE PUMPS

In adding a second urea plant in 1974 at a Midwestern nitrogen plant, higher cooling water requirements necessitated the construction of an additional cooling tower. A 130 million Btu/hour cooling tower was installed with two 18×20-22H horizontal split case pumps rated for 13,000 gpm at 115 ft total dynamic head.

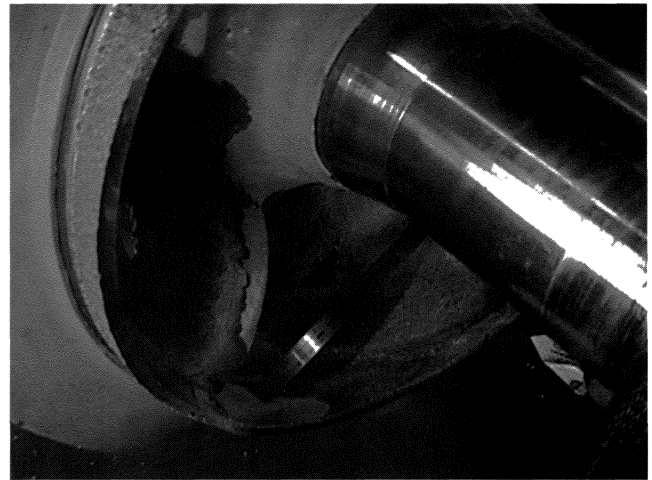
As previously stated, the reoccurring high maintenance costs became the driving factor for review of the pumps and the cooling water pumping system. Due to pump failure, reduced pump performance, or scheduled down time, the impeller, wear rings, shaft sleeves, bearings, and packing were replaced every 2.5 to 4 years. The typical material costs were approximately \$16,000, with labor costs at approximately \$1300 per repair. Typically, the damage found to the pumps included cavitation damage (Figure 1) and discharge leakage flow (Figure 2).

In an effort to reduce the damage to the impellers due to what was perceived as cavitation and vortices, material changes of the impeller were made to extend impeller life. The initial pumps were provided with iron impellers. Per Hydraulic Institute (1994), iron is not a recommended material of construction for impellers, due to the aerated condition of cooling water. As recommended, bronze impellers were installed in 1985. A ceramic metal coating was also applied to the bronze impellers. This can be seen in Figures 1 and 2. In 1988, with the increase of the impeller diameter, new impellers were purchased in 316 stainless steel material. This material is also recommended by Hydraulic Institute (1994) for use in cooling water services. During the review of materials for impeller metallurgy enhancement, a harder, more wear resistant material was desired. Other materials than cast 316 stainless steel (ASTM A743 CF8M), such as a 13 percent chromium iron (ASTM A487 CA6NM), were considered. However, these nonstandard, wear resistant materials for split case pumps were not available from the original equipment manufacturer (OEM) to meet the delivery requirements of the owner.

Figure 1. Cavitation Effects on a Bronze Impeller with Ceramic Metal Coating.

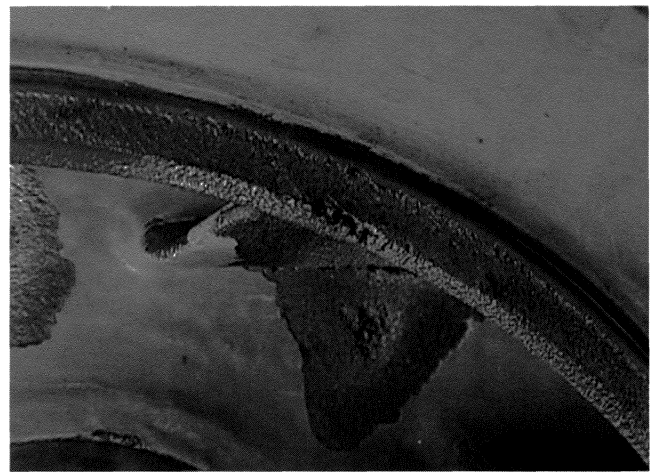
Figure 2. Discharge Leakage Effects on a Bronze Impeller's Wear Ring.

- **Wear rings**—Again, the cast iron wear rings that were originally installed were later changed to bronze. The previous Figure 2 shows the effects of discharge leakage flow on the bronze wear rings at the impeller tips. This type of damage cannot be seen in Figures 3 and 18, showing the 316 stainless steel impeller wear rings with bronze case wear rings.

A change to a polyetheretherketone (PEEK) material for the wear rings was made in December 1997, with the cooling water basin modifications. The characteristics of toughness, strength, chemical resistance, low coefficient of friction, and wear resistance make PEEK materials ideal for the substitution of metals in wear rings. The installation of PEEK case wear rings and 316 stainless steel impeller wear rings allowed for the clearance to be reduced to

0.014-inch, compared with the 316 stainless steel and bronze wear ring clearance of 0.034-inch.

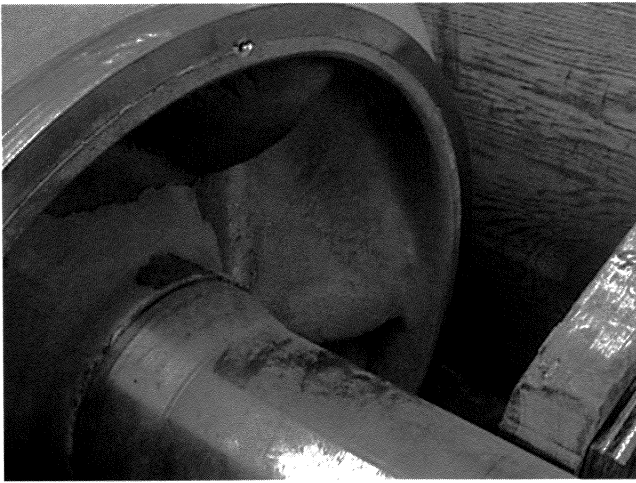
Even with the change of operating conditions in the pumps and materials of construction, damage was still occurring to the 316SS impellers (Figure 3). Of course, the continued use of metal wear rings required typical clearances as recommended in the petroleum industry. This, in turn, reduced pump performance.

Figure 3. Cavitation Effects on a 316SS Impeller with Ceramic Metal Coating.

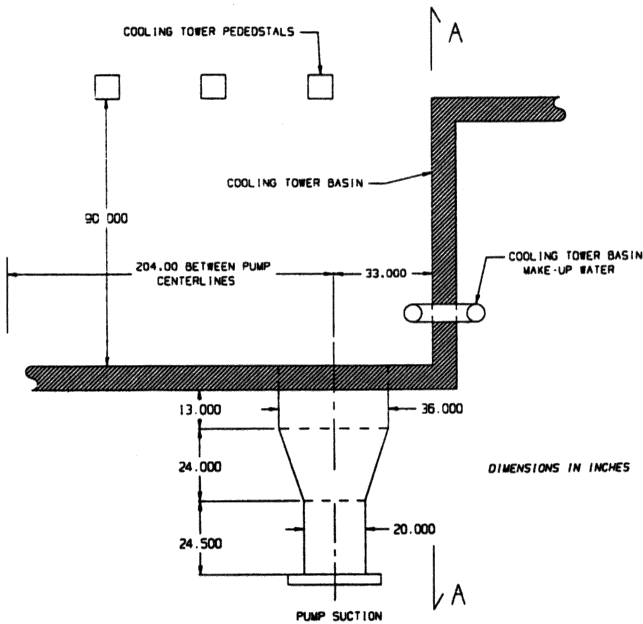
Figure 4. Original Cooling Tower Basin—Plan View.

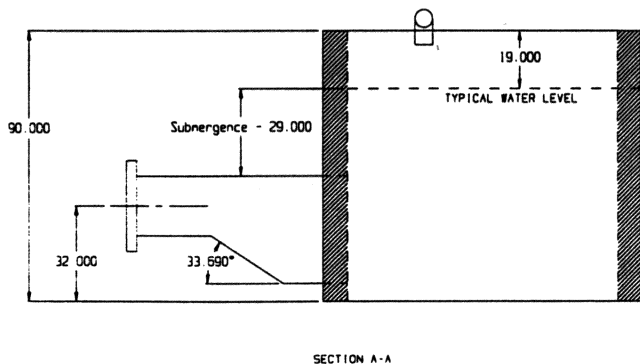
Figure 5. Original Cooling Tower Basin—Elevation View.

As can be seen in Figure 5 and Figure 7, a standard eccentric reducer is installed in the horizontal position. With the eccentric reducer positioned in this fashion, there are no pockets for air to become trapped. It is therefore unlikely that cavitation is occurring due to air entrapped in the suction piping being drawn into the pump with the incoming water flow.

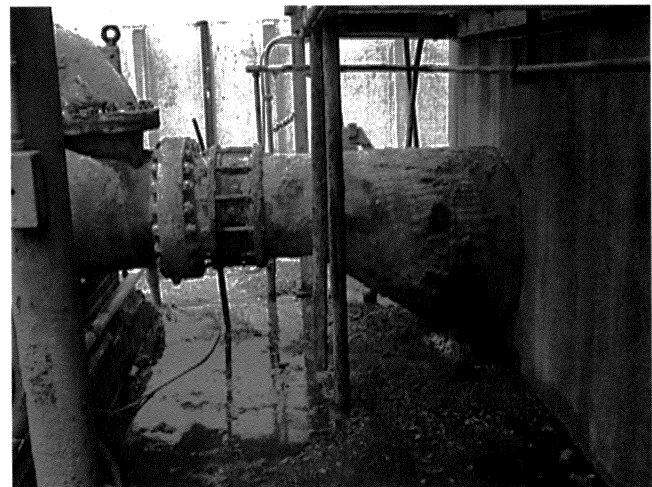
Figure 7. View of Pump Suction Inlet Piping.

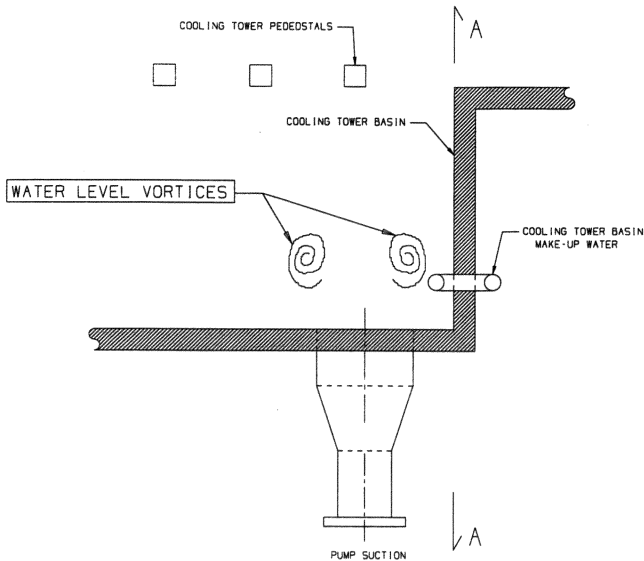
Since the construction of the cooling tower basin, water level vortices have been present. Both pump units always had two vortices located near the suction piping inlet, as is depicted in

Figure 8. Based on Hydraulic Institute's (1994) Vortex Classification System, as shown in Figure 9, the vortices were a Class 4, due to the air/vapor bubbles observed in the core. Occasionally, Class 5 vortices were also observed. As this chart depicts, large amounts of air and any top-water floatables would be immediately pulled into the vortex, and eventually into the pump.

Figure 8. Location of Water Level Vortices.

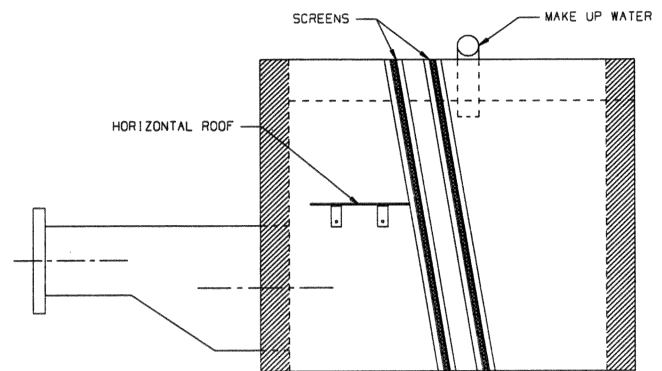
Figure 15. Elevation View of Cooling Tower Basin with Modifications.

Utilizing Figure 10 and Figure 14, modifications were made to the sump to reduce or eliminate vortices. Four modifications were made to the cooling tower basin at the pump suction inlets as described below and shown in Figures 15 and 16.

- **Make up water**—The cooling water basin make up water was located approximately 24 inches from the suction inlet of one pump. It also emptied into the basin significantly above the water level. Although cooling water is inherently aerated, the turbulence caused by the original arrangement created additional bubbles and a larger vortex. To improve the piping arrangement, the make up water pipe was extended down below the water level.

- **Perforated baffle**—The installation of a perforated baffle in front of the suction inlet allows for “straightening” of the flow and equalizes the distribution of the velocity into the pump suction inlet. In lieu of a “perforated baffle,” stainless steel mesh screen, with 5/8-inch openings, was utilized. The existing sump design limited the location of the screen from the suction inlet, as recommended by Ingersoll-Dresser Pump Company (1988) and Hydraulic Institute (1994). The installed location was the best to allow complete access to the screens.

- **“False wall”**—As the pump suction inlets are not located near separation or cell walls as recommended, it was necessary to fabricate and install a “false wall” to assist in improving the pattern of the inlet flow (Figure 17). This false wall was also fabricated of stainless steel. This wall was located approximately 64 inches from the side basin wall to reduce the velocity of the water entering the suction inlet to the recommended 1 ft/sec (or less) velocity. This wall also supports the screens, as well as the horizontal baffle as described below.

- **Horizontal baffle over the pump suction inlet**—Typical submergence over the pump suction inlet was approximately 29 inches. Based on the Ingersoll-Dresser Pump Company (1988) and Hydraulic Institute (1994), the submergence should be one foot for each foot per second velocity at the suction inlet diameter. This corresponds approximately to 49 inches of submergence for the original capacity and 34 inches of submergence for the revised capacity. As this level of submergence is not possible in this cooling tower water basin, a horizontal baffle was installed. Ingersoll-Dresser Pump Company (1988) states that the submergence required by the pump can be

reduced by half with the installation of a horizontal baffle. Existing valves installed on the suction inlet wall required that the horizontal baffle be installed as near to the wall as possible, without interfering with the valves. The horizontal baffle was extended to the screens. It must be noted that no reference could be found to recommend the height above suction inlet for the horizontal baffle. The horizontal baffle was also constructed of stainless steel material. To also assist in reducing the possibility of vortex formation, the level of the water in the cooling tower basin was maximized.

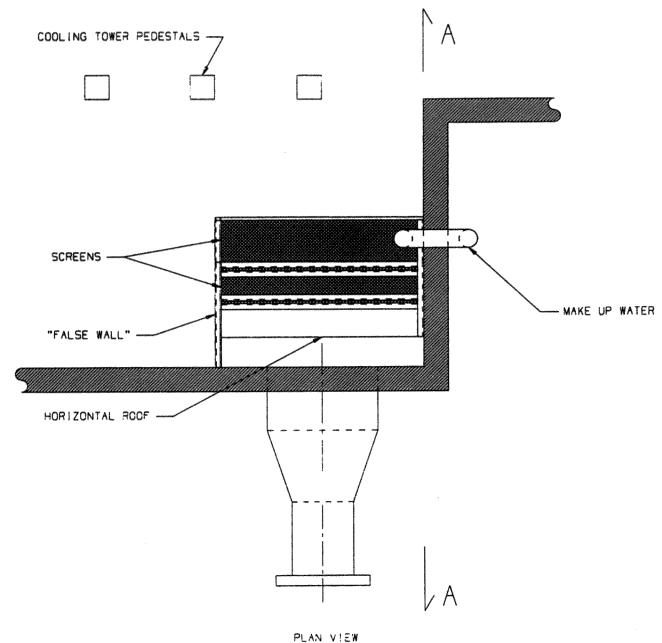
Figure 16. Plan View of Cooling Tower Basin with Modifications.

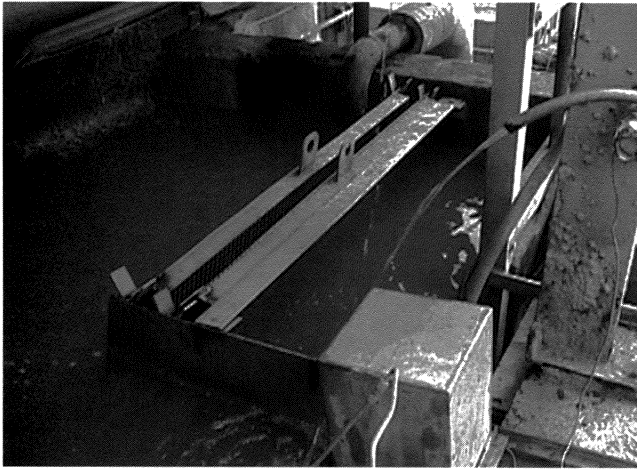
Figure 17. View of "False Wall" and Screens.

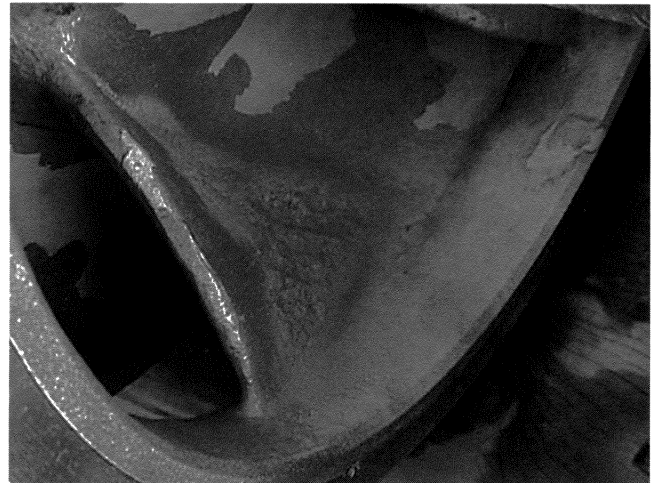
The material of the impeller was later changed to 316 stainless steel material, with a ceramic coating. The damage to the stainless steel material was considerably less, as seen in the previous Figure 3 and Figure 18. The damage on the suction side of the vanes has not penetrated the vanes. The 316 stainless steel impeller shown in the figures was replaced after 5.5 years of being in service. There is noticeably less wear than with the bronze impeller. The additional life of the impeller assisted in reducing the operation and maintenance costs of the pumps. In addition, the amount of wear found can now be used to estimate the optimum time to replace the impeller, while meeting system requirements and keeping operation and maintenance costs minimized.

Figure 18. Damage to 316 Stainless Steel Impeller.

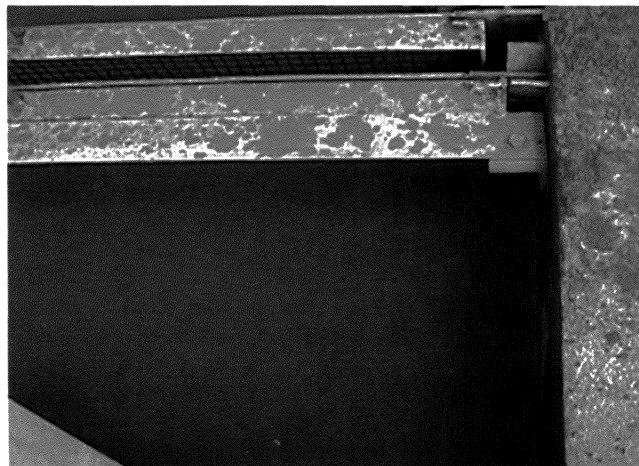
- *Visual*—As can be seen in Figure 19, the vortices, as indicated in Figure 8, are no longer present. A smooth, stable flow into the pump suction inlet can be observed. The nonexistence of the vortices is a tremendous improvement over the ever-present, violent vortices that previously existed.

Figure 19. View of Suction Inlet Area.
