AN INNOVATIVE UPGRADE AND PERFORMANCE RERATE OF LARGE, HIGH SPEED, HIGH TEMPERATURE, MULTISTAGE BARREL PUMPS

BP Oil Grangemouth Refinery Limited

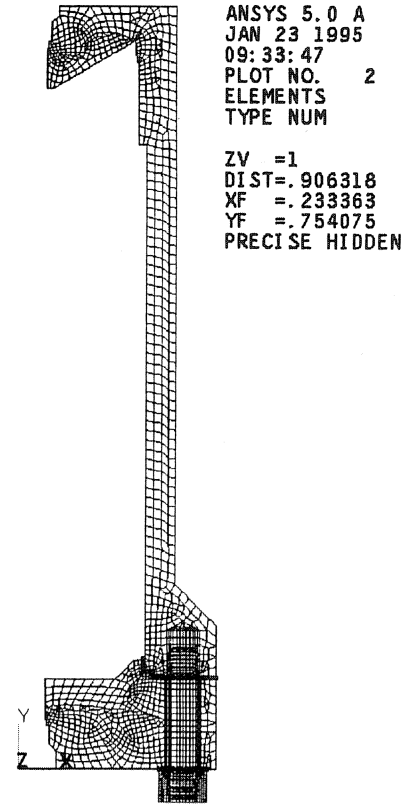
Figure 3. Barrel Stress Analysis for Pump P-301—Gasket Seating.

Assessment of the existing barrels for the increased pressure recommended using ASME VIII Division 1 sizing calculations, but they revealed that the thickness of the existing pressure boundary was inadequate. Since the cost of three complete new barrels/covers with subsequent extra installation cost was very high, it was decided to perform an indepth ASME VIII, Division 2 stress analysis. This was done in two steps:

From all these detailed stress evaluations, it was decided to manufacture a new barrel for pump P-302, while for pump P-301 and P-303 the existing components were used. The existing components (barrel/cover) were still slightly modified as a result of the vibration survey to change the pump feet stiffness and the bearing bracket stiffnesses. This is described in detail in the next

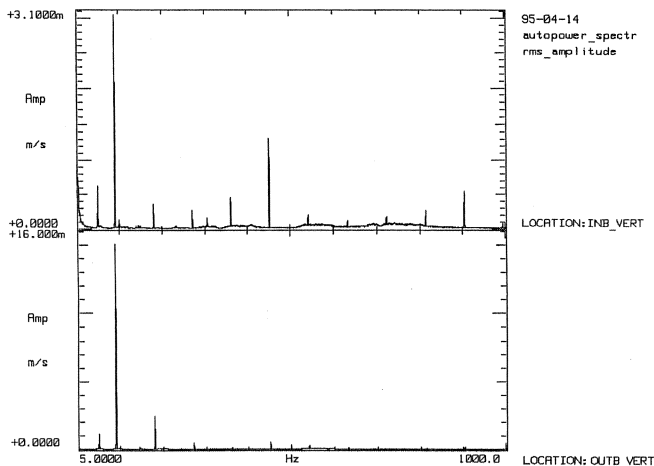
Figure 6. Operational Spectra—Pump P-302.

The root cause survey first started with vibration levels and spectrograms of the existing units operating with either fresh feed or recycle feed or, for P-303, both fresh and recycle feed product. Figure 6 shows a typical measured bearing housing spectrogram on P-302, operating with recycle feed.

- When pumping recycle feed, overall vibrations at the inboard bearing housing are high in horizontal and axial direction. These elevated vibrations are due to higher vibrations at the vane passing frequency, the 1× speed vibrations are not affected.
- At the outboard bearing of P-302, a very high 1× speed vibration is measured in vertical direction.

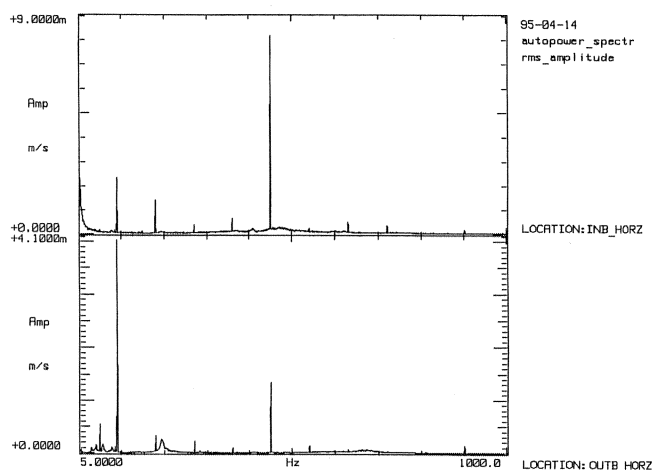
Figure 7. Operational Spectra—Pump P-303.

Figure 7 shows a typical measured bearing housing spectrogram on P-303 with recycle feed. In summary, the vibrations show dominating peaks at 1× speed and 5× speed, the impeller vane passing frequency (Table 5).

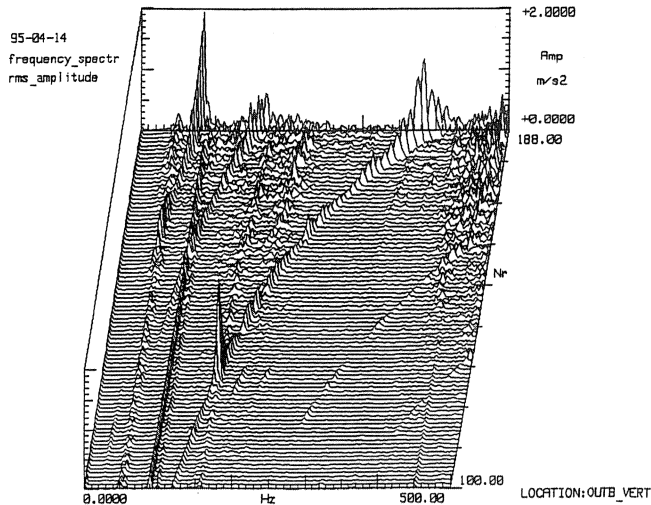
Figure 8. Campbell Diagram for Pump P-302.

Figure 8 shows the Campbell diagram of pump P-302, the outboard bearing housing vertical direction.

On this unit, several resonances are directly observed at almost 50 Hz and 90 Hz. The magnification of the $1\times$ speed at 90 Hz is clearly observed, and also magnification of the $1\times$ speed vibrations at 50 Hz, the motor operating speed.

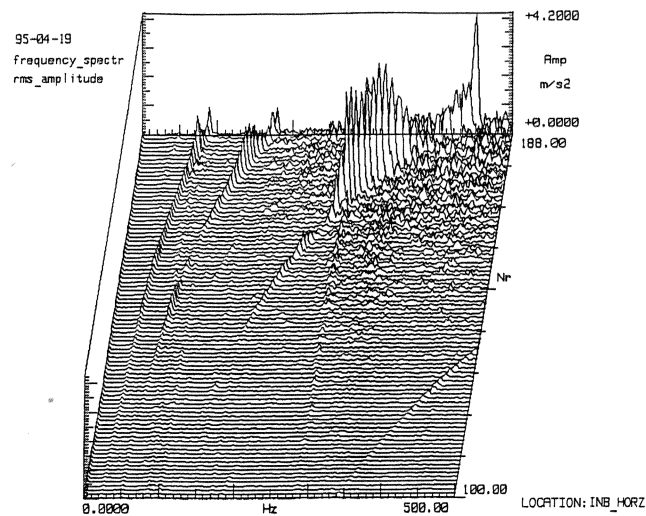
Figure 9. Campbell Diagram for Pump P-303.

Figure 9 shows the Campbell diagram for pump P-303 at the inboard horizontal plane for fresh feed and recycle feed. The large values at vane passing frequency on recycle feed show up as a forced vibration problem. At a speed just below operating speed, there are some indications of resonances.

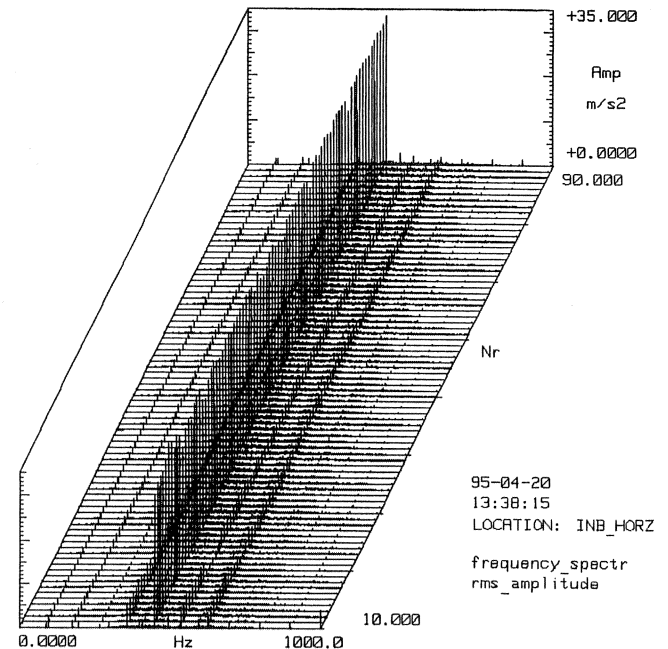
Figure 10. Bearing Housing Vibrations of Pump P-302 Versus Flowrate.

flow dependent. Figure 10 shows the vibration spectrograms while operating pump P-302 from minimum flow to full rated flow. No influence is observed.

Since the difference in vibration between fresh feed and recycle feed was large but not flow dependent, the elimination method for finding the root cause necessitated the following root causes to be verified by analysis, measurement, etc.

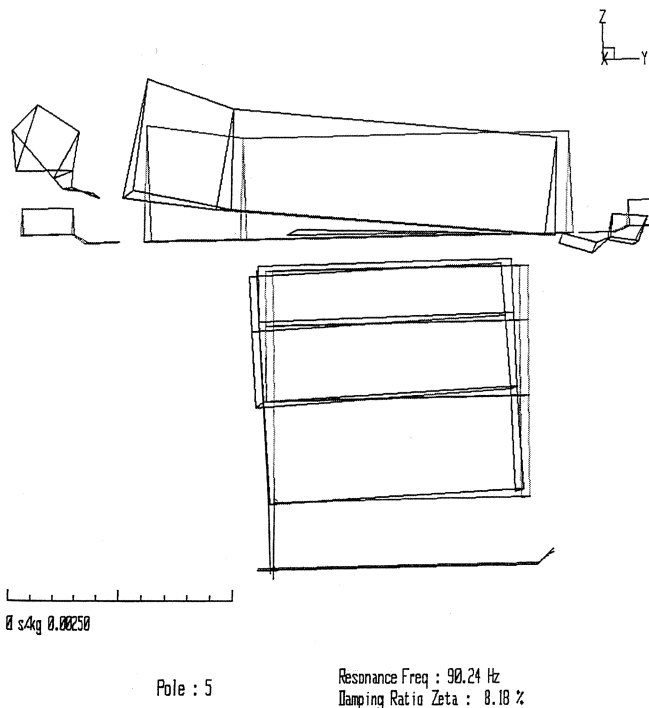
Figure 12. Modal Analysis of Pump P-302.

Figure 12 gives the mode shape of the 90.25 Hz mode, which shows large deformation of the inboard housing out of phase with the pedestal deformation.

Furthermore, a local bearing bracket resonance was found at 482 Hz. This resonance will be excited by vane passing forces if pump speeds are in the range of 5300 to 6300 rpm. By stiffening the brackets, a sufficient separation margin can be realized, avoiding an excitation of the resonance. Since all pumps are identical, the structural resonances of the pumps will occur at the same frequencies, with certain tolerances (bolting torque, material differences, temperature changes). Modifications to cope with resonance problems were proposed on all units as follows:

- Replacement of the five vane impellers by seven vane impellers for fourth and fifth stage of pumps P-301, P-302, and P-303 (recycle feedpumps)
- Geometry change of center bushing and balance bushing on all pumps to allow for interchangeability
- Replacement of pump support construction by pedestals mounted on a thick, rigid plate welded to the baseplate; implementation on all pumps, to eliminate pedestal resonances
- The barrel feet and bearing brackets will be replaced by new designs with increased stiffness on all pumps.

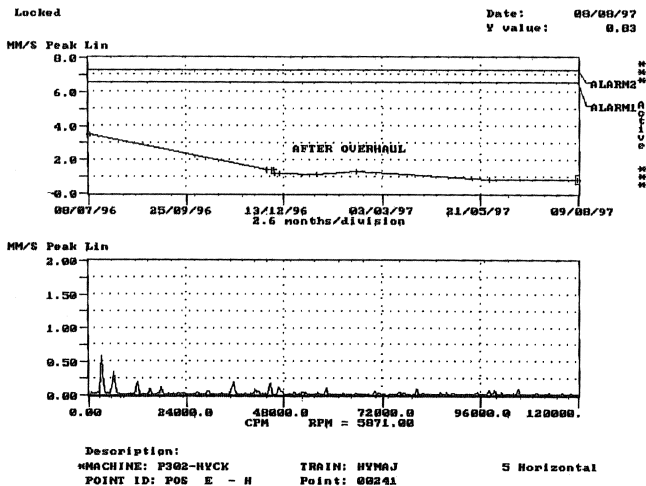
Figure 13. Pump P-302 Inboard Horizontal Vibrations after Overhaul.

All three pumps were commissioned satisfactorily, with minimal delay, and have operated completely trouble free. Vibration levels remain within the agreed limits (Figures 13 and 14) as has seal oil consumption. At the time of writing, P-301 has been in operation for approximately 2500 hours, P-302 for approximately 5000 hours, and P-303 approximately 90 hours.
