# A CASE STUDY: UNUSUAL PROBLEMS DISCOVERED DURING THE RERATE OF 2800 HP BOILER FEEDWATER PUMPS AND TURBINES

**John P. Henderson**

Novacor Chemicals (Canada) Ltd.

## ABSTRACT

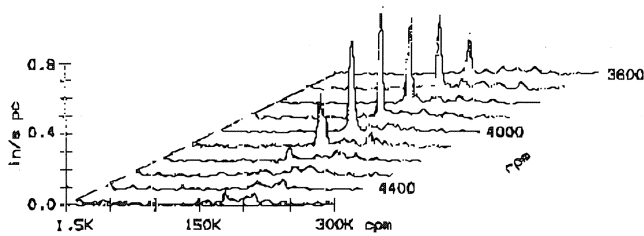
Just before Christmas, an operator happened to be passing by and heard an unusual squeal emanating from the turbine. By the time the engineers arrived with vibration instruments, everything was quiet and vibrations were normal. They decided to do some testing. The "B" pump was put on manual and the speed was varied through the operating range. The "A" pump was left on automatic and adjusted its speed to provide the required flowrates. A dual channel analyzer was programmed for automatic data capture every 100 rpm. A resonance was discovered around 4000 rpm and reproduced the squeal. The vibration energy was fluctuating but extremely high, and was occurring with a specific spike around 162,000 cpm (Figure 3). It was measurable all over the turbine but was highest around the governor valve area (in the 3.0 in/sec and 10 g range). When operating at the resonance speed, they could visibly see the vibrations causing the trip lever to walk off the knife edges. They concluded that this resonance was the root cause of the mysterious trips and the broken governor valve stems. The knife edges were not in particularly good condition. They were replaced and the turbine placed on manual at 4200 rpm where vibration levels were normal and more analysis began. Note that similar vibration resonance patterns were noticed on the "A" pump, but with much reduced vibration amplitudes.

Figure 3. Waterfall Spectrum of OB Turbine Bearing Before Modifications (Vertical Direction).

The analysis pointed to problems with the nozzle ring-governor valve combination. The manufacturer's rerate calculations consist of a simple table showing maximum power, plus a margin, vs flow passing capabilities of various nozzle ring and valve/seat combinations. The horsepower requirements nudged them into the biggest valve/nozzle ring combination available for this turbine. However, further investigations revealed that this table was based on standard mechanical governor data with a maximum valve travel of 0.6 in. The new electronic governor utilized a control valve actuator with a permissible travel of 1.0 in. The company had awarded the governor conversion to the turbine manufacturer specifically to avoid this sort of confusion, but it happened anyway.

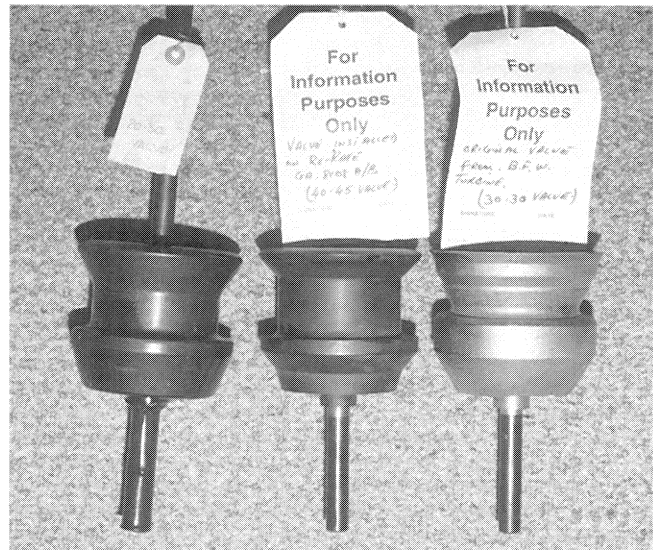
Another test was performed measuring inlet and outlet pressures and temperatures, steam chest pressures, valve stroke, vibration levels and speed in an attempt to correlate stroke to critical pressures. It was unsuccessful. It appeared that they had to put the turbine on manual away from the resonance and forgo the energy saving benefits and the major justification of the electronic governor conversion. But, having progressed so far, the engineers decided to try one more time and install the "more stable" 20-30 degree valve that had finally arrived on site. Note that the physical appearance of the 20-30 valve is identical to the 40-45 valve, except for the machining of the valve angle. The 30-30 valve is a different design and casting (Figure 4).

Figure 4. Turbine Governor Valves Left 20-30, Center 40-45, Right 30-30.

After the fiasco with the performance of the previous valve, their enthusiasm was somewhat dampened. The 20-30 valve was installed and a complete test was performed throughout the speed range. They were very pleasantly surprised to find that all traces of

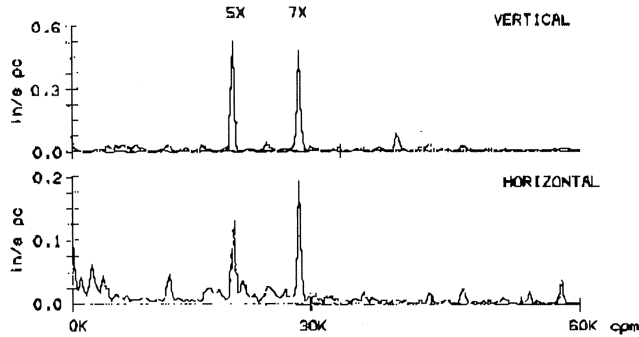
flows were established, overall vibration readings were 0.4 to 0.6 in/sec. When analyzed, all the energy was coming from peaks that were at 5x and 7x running speed (Figure 5). Note that the new pump internals had a seven vane impeller on stages 5 and 6, and five vane impellers on the other stages. The "B" pump had higher vibration levels while the "A" pump also exhibited lesser energy peaks at 3x, 4x and 6x of running speed indicating some kind of looseness (Figure 6). Note that there was little vibration concerns on the outboard bearing. This could be explained by the stabilizing effect of the throttle bushing to that end of the pump.

Figure 5. Typical Frequency Spectrum Of "B" Pump Before Modifications.

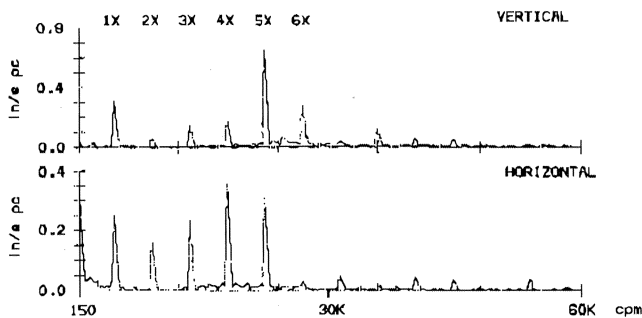
Figure 6. Typical Frequency Spectrum Of "A" Pump Just Before Modifications.

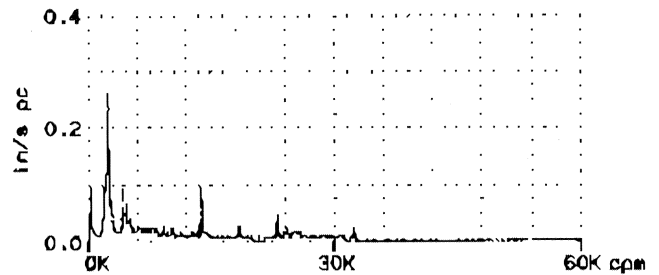
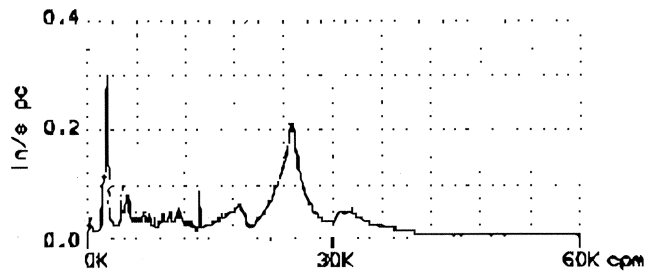
The "B" pump was shut down. A vibration probe was placed on the I/B bearing housing in the vertical plane. A baseline signature was recorded. Then the housing was struck with a rubber mallet numerous times. The frequency analysis showed a definite spike occurring at 25,200 cpm (Figure 7). The process was repeated with the vibration probe in the horizontal direction. A spike was also noticed at 23,175 cpm, but at half the amplitude. This correlated with the field vibration measurements that always showed higher readings in the vertical direction. For our operating speed range of 3700 rpm to 4500 rpm, the 5x range is 18,500 cpm to 22,500 and the 7x range is 25,900 cpm to 31,500 cpm. This could explain the strange variance of the 5x and 7x spikes in our field testing.

Figure 7. Results of Resonance Testing Of IB Pump Bearing Housing (Vertical Direction).

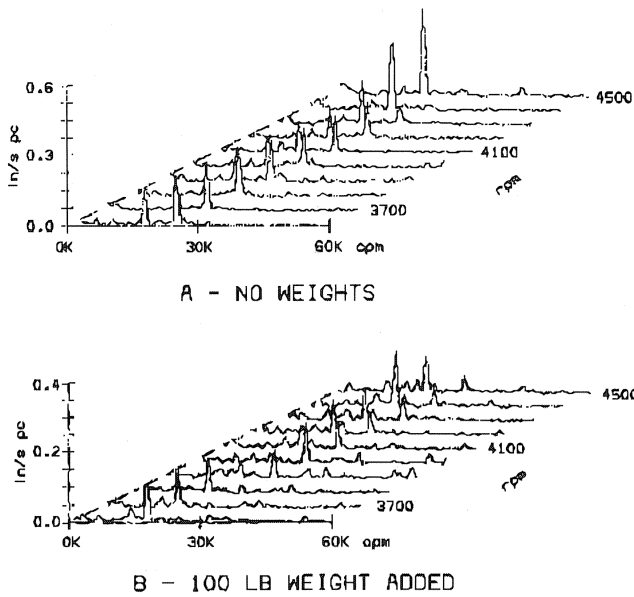
Then weights were added to the bearing housing in an attempt to alter its natural frequency. A long threaded rod was installed in the bearing housing lifting eyebolt tap and first 65 lb and then 100 lb of lead weights were bolted in place. The pumps were run through the operating speed range and vibration levels were compared to the baseline. The engineers discovered that 100 lb of weight significantly changed the overall vibration levels and the magnitude of the 5x and 7x frequency spikes as the speed varied (Figure 8).

Figure 8. Waterfall Spectrum Showing Effects of Adding Weights to Pump IB Bearing Housing (Vertical Direction).

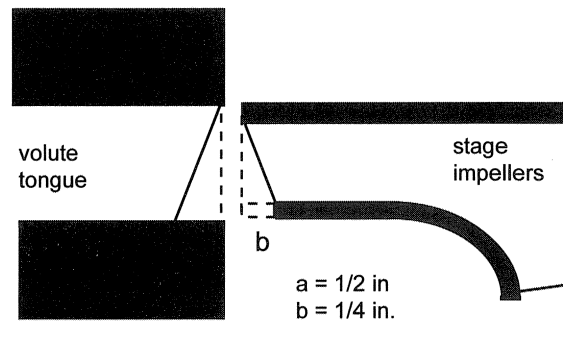
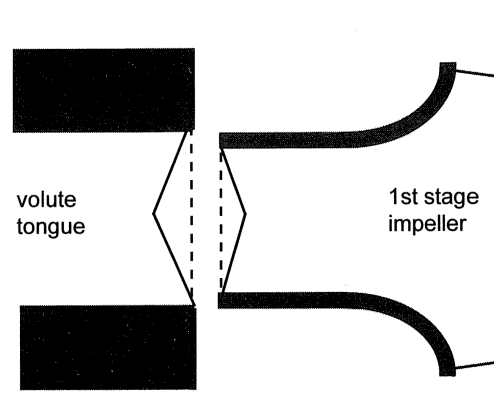
cy vibrations and specify that the gap shall be "at least six percent." The "as built" gap of 6.8 percent was marginally acceptable. The manufacturer developed a repair recommendation to increase this gap in very creative fashion. Instead of just trimming the impellers and underfiling to restore the head, they trimmed the impellers at an angle. And the angle cuts were in the opposite direction of the volute trims. The theory was to create a "scissoring" action that would not only increase the effective gap, but would change the energy distribution over the volute tongue to lessen the magnitude of the pulsations. The eye side of the impeller tips were cut back about 1/4 in and the volute tongues 1/2 in in the opposite direction. The first stage was a double suction and the same theory was used resulting in "V" cuts (Figures 9 and 10).

Figure 9. Impeller/Volute Trim Detail.

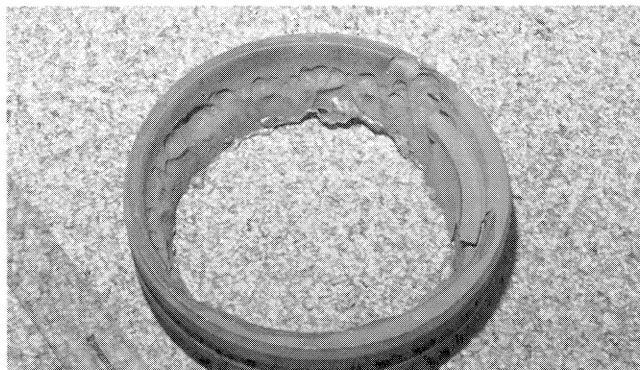
When the pump O/B end cover was removed, severe cavitation damage was discovered. The throttle bushing and sleeve are overlaid with welded stellite material. The sleeve on the shaft had contacted the stationary bushing. They had welded themselves together and spun in the support. This had opened a leak path and the interstage pressure of 1000 psi had cavitated the 3/4 in housing almost to failure (Figure 11). The investigators did experience some system upsets during start up that might have caused excessive rotor movement and contact. Another plausible explanation was improper installation. They discovered that the bearing housings had not been realigned after the new internals were fitted. Note that the company did not employ the services of the manufacturer's service representative during the original installation to reduce costs. The company did have them onsite for all the rebuilds.

Figure 11. Cavitation Damage to Throttle Bushing Holder (Cut Off End Cover).

The end cover was shipped to the manufacturer's repair center to have the washed out holder cut off and a new ring welded on. A new throttle bushing was installed and the repaired end cover was back onsite within three days. The new suction end cover with the heavier bearing supports was installed (Figure 12) and the bearing housings were carefully aligned. The new pump bundle was fitted without incident.

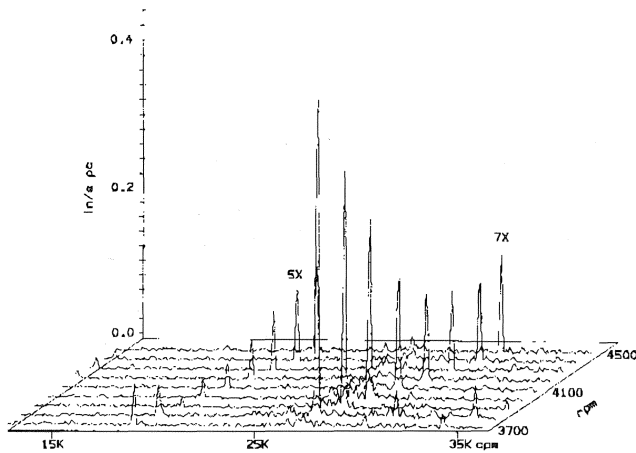
Complete success was almost achieved. Overall vibration levels were way down to acceptable levels. However, the spectrum analysis showed that the vibration energy was still coming from 5 $\times$  and 7 $\times$  peaks, albeit at much lower levels. As speeds were lowered and the pump was pushed back on the curve, the 5 $\times$  spike dropped off but the 7 $\times$  peak increased to 0.4 in/sec at 3900 rpm indicating that there was still some sort of resonance (Figure 13). Also, the repaired "B" pump now operated at 85 rpm faster than the "A" pump indicating that the underfilling did not restore the head expected. It was a little disappointing to the perfectionists but the unit was turned over to Operations without restrictions. Shortly after, the pump was shut down for a minor turbine repair and the bearing housing resonance test was repeated. The previous vertical resonance had all but disappeared.

Figure 13. Waterfall Spectrum Of "B Pump I/B Bearing After Modifications (Vertical Direction).
