THE USE OF BASIC HYDRAULICS TO SOLVE FIELD PROBLEMS: THREE CASES

CASE 1: COOLING WATER PUMP CASE STUDY— CAVITATION PERFORMANCE IMPROVEMENT

CAVITATION DAMAGE AS RELATED TO OPERATING POINT

CASE 3: USE OF BASIC PUMP HYDRAULICS TO SOLVE PUMP MAINTENANCE PROBLEMS

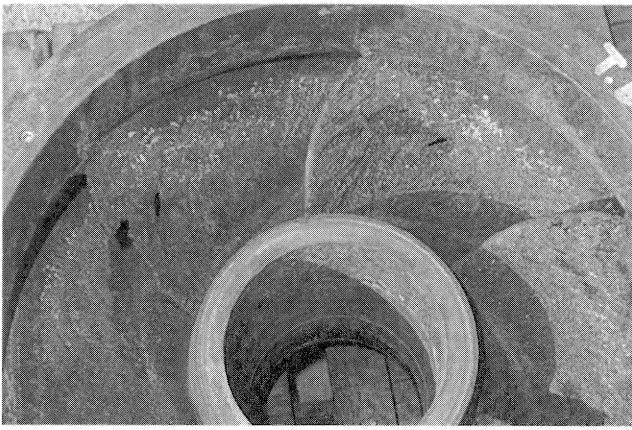
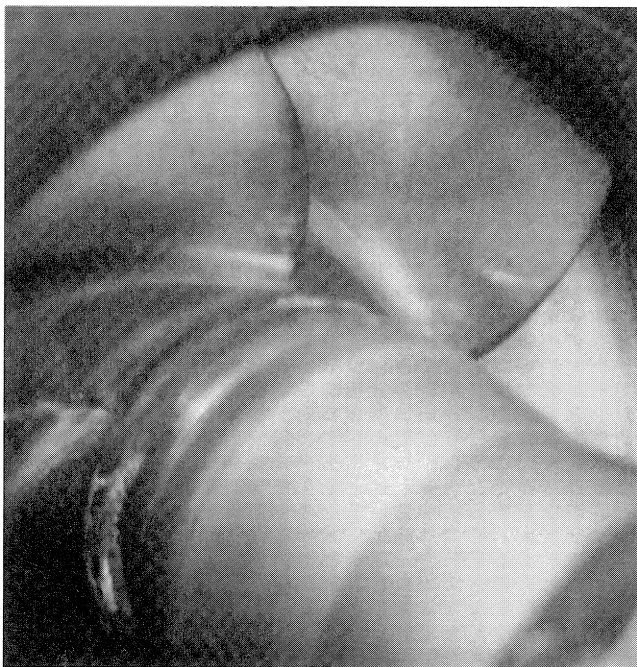
Figure 5. Comparison of Cavitation Damage of Existing Design Impeller: Cast Iron vs 316SS.

A comparison is shown in Figure 5 between the cavitation damage to the impeller after approximately six months operation. Pump "B" (iron impeller) shows a significant damage on the suction side of the blades, at the shroud region. Some damage (not visible on the picture) was found also on the pressure side, which suggested a combination of low flow cavitation (suction side effect), and recirculation (pressure side effect). Since pumps operated over the wide range of flows during the course of the year, it was impossible to relate the damage pattern to the operating flow. However, a noise data was taken at different flows, and results plotted on Figure 6 (triangles). A well defined region of flow recirculation onset is at about 13,500 gpm, which is close to a theoretical prediction by Fraser's method.

Cast Iron (Pump B): Extensive Damage at Impeller Inlets (Starting at the Shroud Area, Suction Side; Some Damage on Pressure Side). (12 months operation)

316SS (Pump C): Very Little Damage (Minor Pitting at Blade Inlets, Shroud Area).

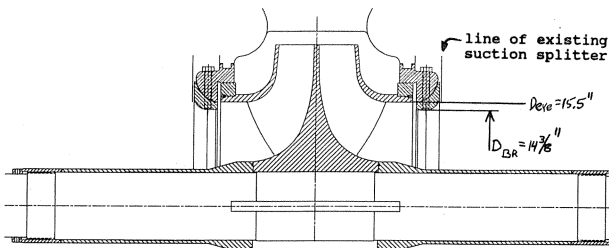
Figure 6. Bullring Modification of Casing Ring (Attempt to Reduce Eye Recirculation)

In order to reduce recirculation, as well as to better match flow angle to the blade angle, a special bullring (Figure 7) was attached to the existing casing rings. Even though the axial length available to fit this ring (between the impeller shroud face and the suction splitter, as shown on Figure 7) was limited, this special "bellshape" curvature of this ring should further enhance flow distribution into the eye. The noise data were again taken over the range of flows (Figure 6, circles), showing improved noise characteristic at low flow, no substantial change at the midrange, and noisier operation at higher flows.

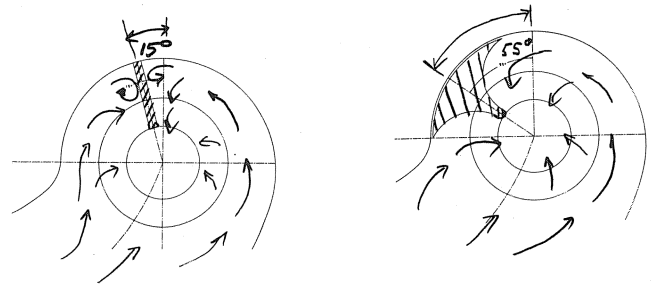
Figure 7. Comparison Between the Old (Left) and New (Right) Splitter Design for Better Flow Feed into the Impeller Eye.

The following modification was aimed at improving flow distribution around the impeller inlet. The original suction splitter is only 15 degrees from the vertical line, and was shaped poorly, as shown on Figure 8 (left). Much better designs are given [3], and these guidelines were followed, as shown on Figure 8 (right)—much better contouring, and spitter centerline moved to 55 degrees from the vertical. In order to accommodate such modification in the field, the old suction splitter was ground off, and a new one was attached to the casing ring (Figure 9). The noise data for this modification is shown on Figure 6 (squares). Note that the whole noise curve is shifted downwards by about 3 dBA, and gets even more significantly better at the very low flow.

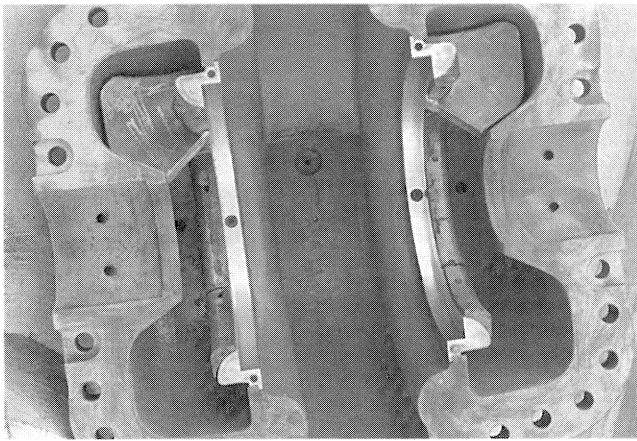
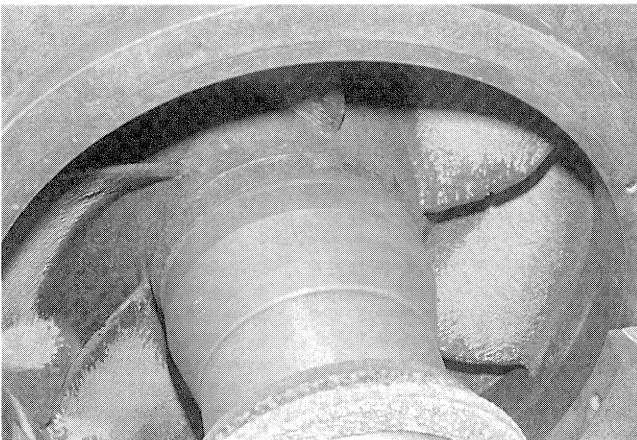
After three months, the pump "A" (with above modifications) was opened up and inspected (Figure 11). The damage pattern was different than before; it spread more evenly over a wider area of the suction side of the blades, but the depth of damage was less than originally experienced. It was apparent that the incremental improvement by the modification of the splitter and a bullring was not enough to achieve the desired impeller life of five years.

Figure 10. Special Bullrings and a Profiled New Splitter Shown Installed in the Casing, (top); on the bottom are Impeller Inlets, Suction Side, after Operating with above Combined Modifications for (3) Months.

Note the Damage Region now is in the Middle of the Blade, as Compared to original Damage Pattern (no Modifications) near Shroud.
