# RELIABILITY IMPROVEMENTS TO A HIGH PRESSURE, HIGH TEMPERATURE, THIRTEEN STAGE CHARGE PUMP

**Dave A. Johns**

Shell Oil Company

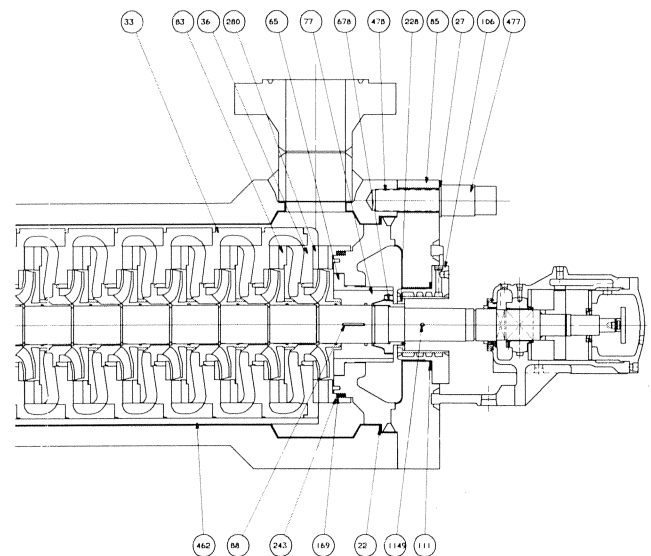
Figure 2. Discharge Head Assembly.

The head to case joint has been a leakage area in the past.

The original pump assembly specifications called for clearance between the pump head and casing. Designers of the pump, in an effort to maintain rotor to case alignment, also wanted the head parallel to the case within 0.002 in. Asking a machinist to tighten 24, 2.0 in studs holding a 500 lb chunk of steel and keep the surfaces parallel within 2.0 mils is like winding a Rolex with an impact wrench. This is a challenging task under ideal laboratory conditions, and nearly impossible under field conditions. The metal to metal case fit has several advantages:

The modification required machining the discharge head, the mating surface of the casing, and the inner discharge head. All other machined faces and bores were welded and remachined so that the entire case was brought back to factory specifications.

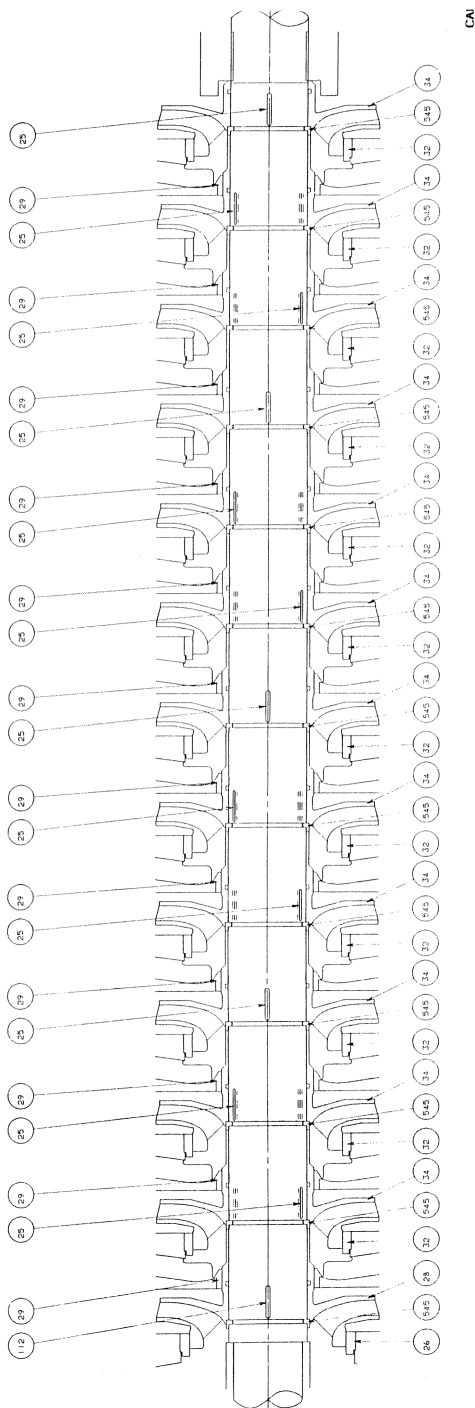
Figure 3. Rotor Assembly.

The original shaft was the same diameter from the first to the last impeller, with each impeller driven by a single key. Proper axial impeller position was established by a shaft shoulder on one end with impellers and sleeves stacked from this shoulder.

- Galling probability during rotor assembly increases with the length of same diameter shaft that impellers and sleeves have to pass over.
- Axial stack-up errors are likely, because everything is referenced from one point, the shaft shoulder.
- Difficulty maintaining rotor straightness, which depends upon the squareness of the impeller hub and spacer sleeve faces when the components butt together.

The new design shaft has several features to ease assembly and increase stack-up accuracy. Starting from the first stage, the shaft diameter under each impeller is progressively smaller. Therefore, the impeller has clearance on all fits except the mounting fit. Each shrunk fit impeller is individually located by split rings which fit into machined grooves on the shaft. The impeller is machined to retain the rings. The sleeves are fabricated as part of the impeller instead of each being a separate item.

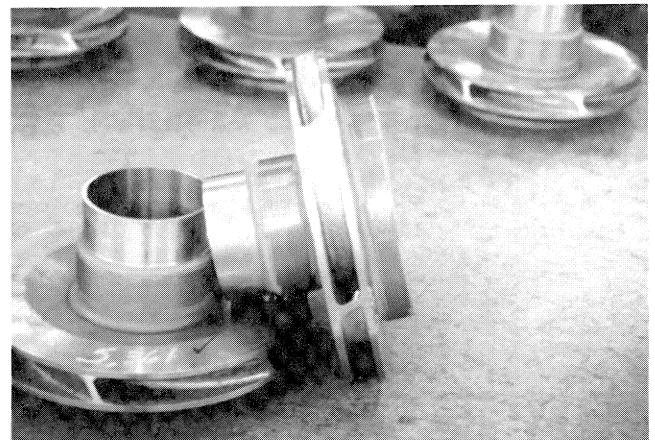
Figure 4. Impeller with Counter Rotating Spiral Grooves.

Standard wear rings attached to the impeller by tack welds or set screws were originally supplied. These separate impeller wear rings tend to crack and come off of the impeller if suddenly heated, such as during mechanical contact or the pump running dry. These loose metal parts then go on to cause further damage in the pump. The following modifications were made to minimize the potential damage to the pump due to wear ring touch off or failure.

- The rings and mating bushings were made with spiral grooves on the surface instead of the typical smooth surface (Figure 4). The grooves in the rotating part are in the opposite direction of the grooves in the stationary part. The counter spiral grooves have two benefits:

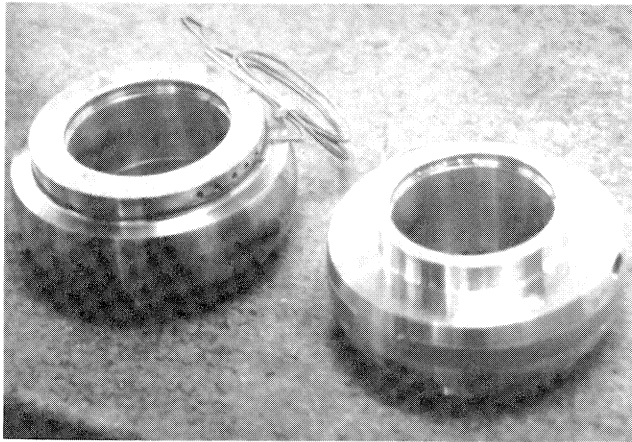
Figure 6. Spherically Seated Babbitt Lined Journal Bearings.

The pump's radial bearings are spherically seated babbitt lined sleeve bearings (Figure 6). Original design required the bearing crush to be adjusted by varying the gasket thickness on the bearing housing horizontal split line. This is a time consuming task and end results were of questionable accuracy. Present day precision bearing manufacturing techniques eliminate the need for an "adjustable" bearing housing split line. Elimination of the split line gasket required machining of the horizontal split line and reboring of the spherical seat. After machining, the housings were centered and doweled into position on the pump case.

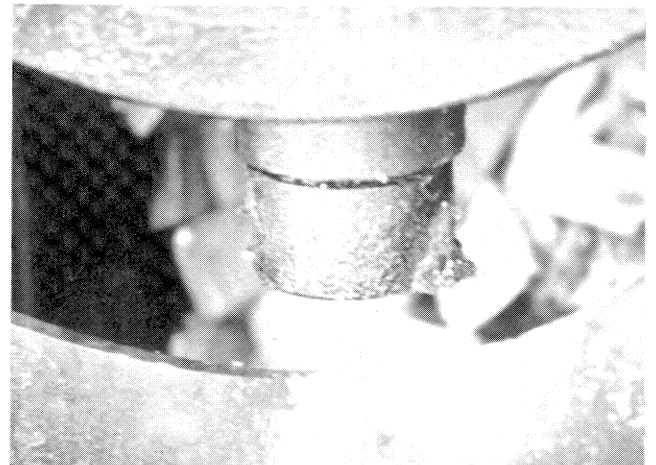
Figure 8. Coupling End Centering Pin Stuck to Case.

- The hold down bolts and dowels were bent.
- The coupling end (suction end) centering pin was stuck to the case, attachment welds had failed (Figure 8).
- The supports for the centering key and pin were bent.
- Suction and discharge flanges were out of square with centerline.

Based on the above observed damage, it was obvious that the pump's existing provisions for thermal growth control were inadequate. The existing thermal growth control scheme included:

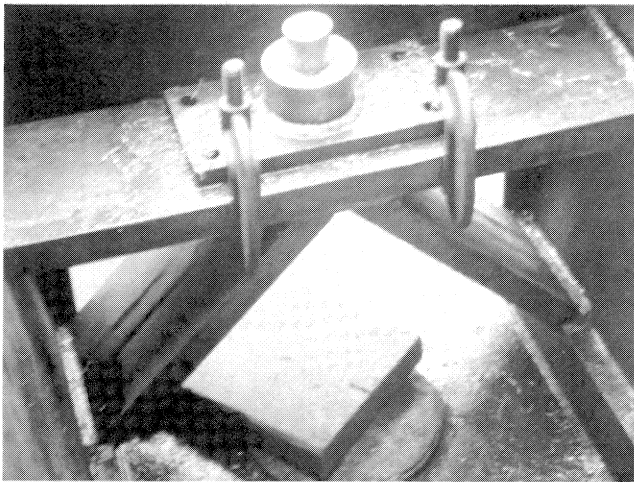
Figure 9. Typical Coupling End Centering Pin.

- One centering pin at the bottom of the coupling end (Figure 9).
- An axial key under the thrust end (Figure 10).
- Both the centering pin and the axial key had the female part on the case and the male section mounted on the pump base.
