ROTATING EQUIPMENT PUMP RELIABILITY UPGRADING PROJECT

Ed Ringstead

Shell U.K. Limited

Stanlow Manufacturing Complex

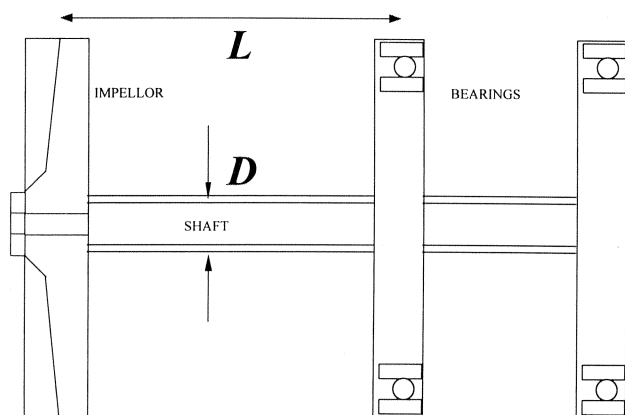
Figure 2. Standard Bearing Type.

A simplistic measure of shaft deflection, as seen in Figure 2, is a ratio of overhang to shaft diameter, i.e., L^3/D^4 ratio. Evaluation of the pump shaft population indicated at least 40 percent were in excess of the factor 300, while the recommended maximum factor is 75. Consequently, this inherent shaft flexing problem would lead to premature bearing and seal failures.

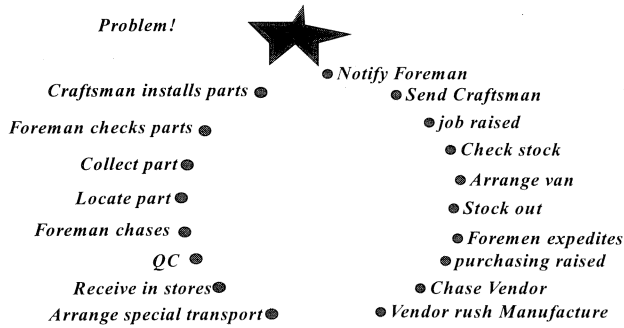
Figure 3. Firefighting.

A significant number of manhours was expended in repairing equipment failures. This was due to the method of failure reporting, i.e., operators would report via a computer job card system that a pump was noisy or leaking—typically the latter. This inevitably led to an unplanned maintenance outage for the pump as the fault had been detected at a stage at which the seal was leaking and required immediate attention. This resulted in fire fighting maintenance involving urgent requests to stores for spare parts, progress chasing with vendors for unavailable spares and overtime working to get the equipment back online (Figure 3).

The introduction of the Reliability Team, who condition monitored critical equipment (by vibration monitoring) on a planned

basis, flagged up defects at an early stage and resulted in a reduction in unplanned downtime.

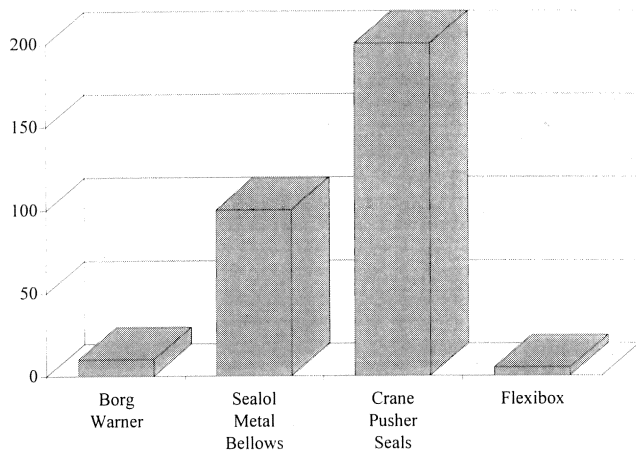
Figure 4. Mechanical Seal Distribution.

The existing mechanical seal distribution (Figure 4) across the department consisted of approximately 200 wedge type multi-spring pusher seals and 100 edge welded metal bellow seals, with a small number of single spring pusher seals. The metal bellow seals had been introduced with the recent addition in 1988 of a new operating unit. Previous maintenance supervision had also converted troublesome pusher seals with edge welded metal bellows.

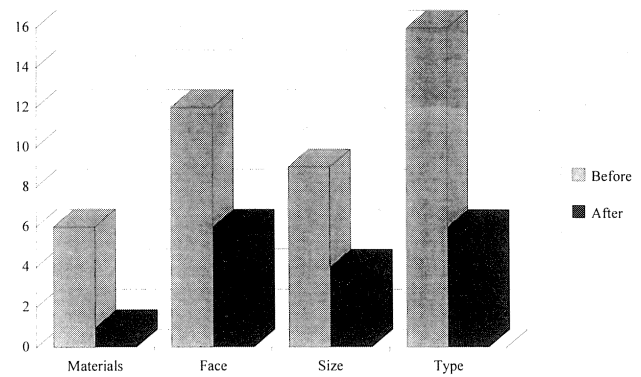
Figure 5. Seal Inventory Complexity.

An analysis of the seals population, shown in Figure 5, revealed a wide variety of design, size, material, and seat styles in the pusher type distribution, while the metal bellows population had a very small range of configurations. The only variation in the bellows seals was the use of silicon carbide as the rotating face in abrasive applications.

A consequence of the large number of seal variations and the fact that seal spares were held at individual component level, was the very high stock levels required (882 individual items).

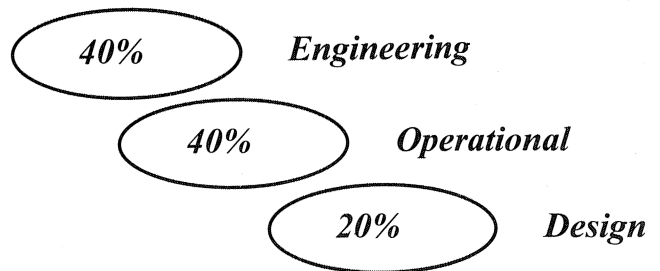
Figure 6. Causes of Failure.

Between January 1988 and April 1989, 259 seal failures occurred across the department. The Central Refinery Rotating Group had been monitoring seal failures and carried out a detailed survey on this specific department and had examined 57 seal failures as part of a refinery-wide reliability survey. To elaborate a little on these failure modes the following comments attempt to clarify some of the more significant failures. Of all of the failures an underlying fact was that 80 percent were associated with people problems (Figure 6).

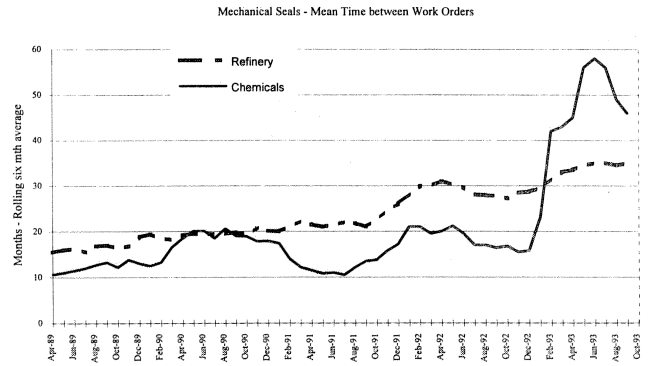
Figure 7. Mechanical Seals—Mean Time between Work Orders.

Seal failure rates are now at their lowest point ever, with only 52 failures of the converted seals since May 1990, an annualized rate of less than 23 failures a year—less than 10 percent of the previously experienced failure (Figure 7).

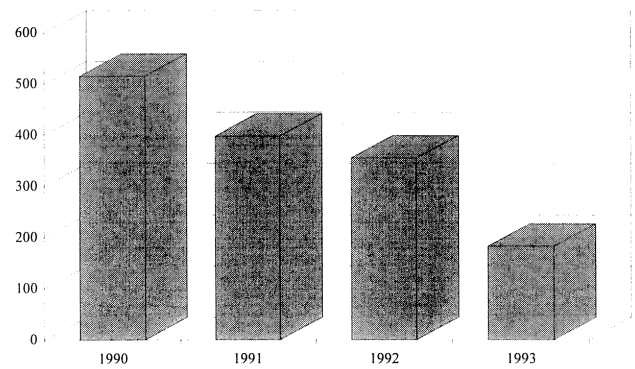
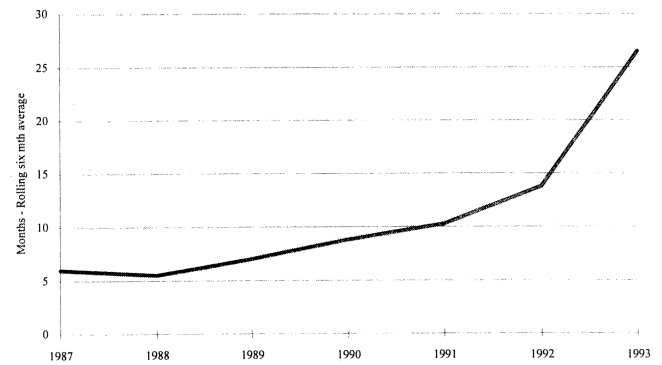
Pump maintenance costs have fallen steadily over the course of the project, from £515,000 in 1990, £397,000 in 1991 to £365,000 in 1992 (Figures 8 and 9).
