ROOT CAUSE ANALYSIS OF FIVE COSTLY CENTRIFUGAL PUMP FAILURES

Heinz P. Bloch

Machinery failure analysis and troubleshooting are often pursued in a somewhat haphazard, unstructured fashion. This paper presents a novel, proven, and well focused approach which can quickly lead to the root cause identification of virtually any component distress. This repeatable method is based on the premise that components fail only if they are subjected to undue force, a reactive environment, time-based exposure, or extreme temperature. However, while these failure mechanisms will tell how and why a failure mode such as brittle fracture, melting, etc., might have occurred in chemical or metallurgical terms, failure mechanisms do *not* define the root cause of failure.

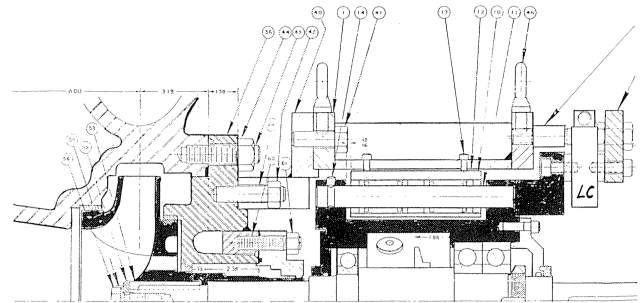
Pump owner and pump manufacturer agreed to perform a field test on this failure-prone pump. A special test rig, Figure 1, was designed and fabricated by the pump manufacturer. It consisted of means to allow the pump rotor-bearing assembly to move in the axial (impeller thrust) direction. The total axial movement was limited so as not to exceed permissible impeller travel. Also, the axial thrust value was measured by three load cells (Figure 1), whose connecting cables are visible in the field test setup shown in Figure 2.

Figure 1. Design Drawing of Centrifugal Pump Axial Thrust Test Rig.

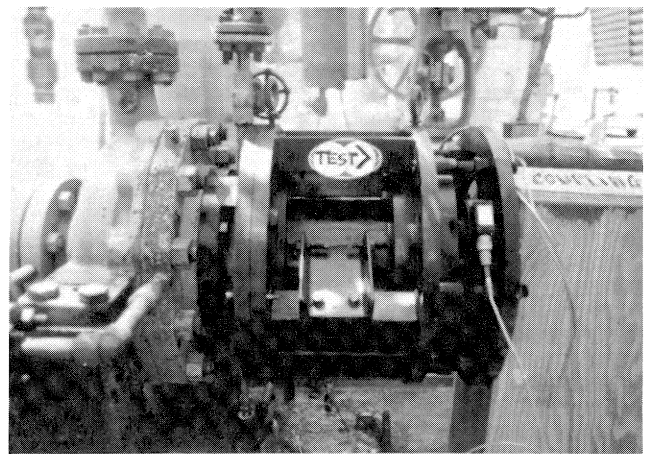
Figure 2. Field Installation of Special Bearing Housing Which Verified Centrifugal Pump Axial Thrust to be Excessive.

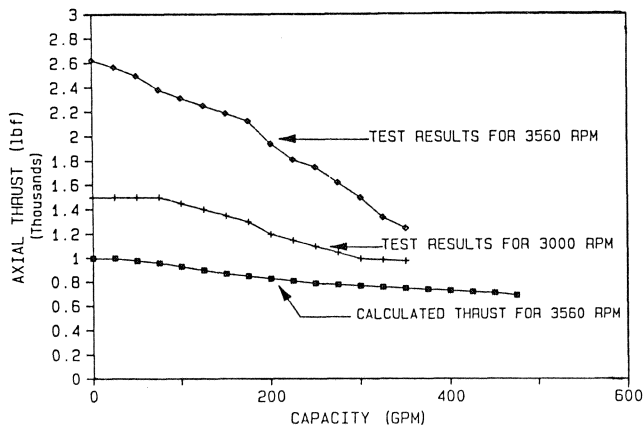
Test results were plotted and compared to the manufacturer’s calculated and originally anticipated thrust values for this pump. As indicated in Figure 3, the experimentally verified thrust at shutoff was 2.6 times greater than anticipated. Since ball bearing life varies as the cube of the load changes, the life of the pump bearing would thus be reduced by a factor of 17.

Figure 3. Experimentally Verified (Actual) Rotor Thrust Exceeds Manufacturer's Anticipated Values by a Factor of 2.6.

The test results convinced both the operating company and the pump manufacturer that the pump internals had to be redesigned to limit hydraulically induced thrust values to more reasonable limits. Obviously, the basic agent of the bearing failure mechanism was excessive force.

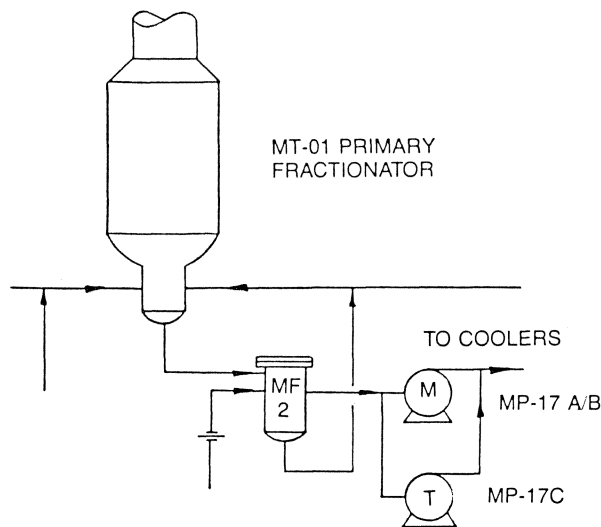
The pump in Figure 4 is identified as one of the MP-17 A or B sets feeding 320 gpm of tar at temperatures around 500°F from the primary fractionator tar boot and coke filter MF-2, through tar coolers and on to downstream process equipment. Pump design inlet and discharge pressure conditions were 10 psig and 300 psig, respectively.

Figure 4. Flow Schematic Showing Tar Pump (MP-17A) Involved in Fire Event.

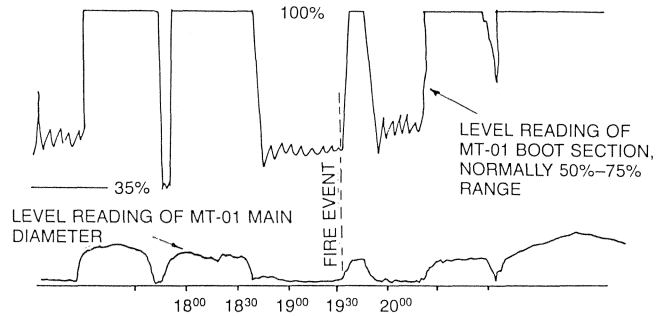
Satisfactory operation is graphically represented in Figure 5, the strip chart obtained from the trend recorder for fractionator boot and main vessel level. At 17:30, or 5:30 p.m., the chart shows the boot level to be 100 percent. About 10 minutes later, the boot level was reduced to 35 percent for approximately 5 to 10 minutes before finally returning to 100 percent. The chart verifies that the boot level never dropped below 35 percent on the day of the failure incident. Therefore, pump operation errors or off-design service conditions did not seem at fault and were ruled out.

Figure 5. Strip Chart Showing That Adequate Liquid Level Existed in Suction Drum at all Times.

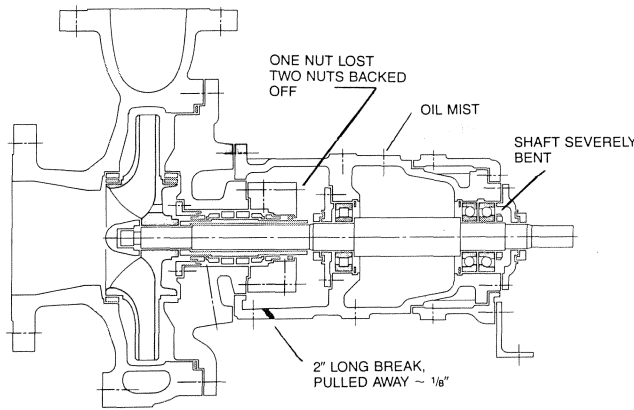
When the pump was dismantled, the seal area was found in clean and undamaged condition. Some solids were found in the impeller. Impeller wear rings and inboard bearing appeared satisfactory. The duplex thrust (outboard) bearings were totally destroyed. Severe metal loss was noted on virtually every bearing ball. Many balls were deeply embedded in the inner race; the ball separators had disintegrated. The shaft was severely bent in the region adjacent to the duplex bearing lock nut (Figure 6). Two of the four seal gland nuts had loosened, a third one had fallen off completely. A pedestal support bracket a point A had not been connected to the pump casing. The ductile iron bearing bracket was fractured at point B.

Figure 6. Schematic Cross-Sectional View of Centrifugal Pump.

fire. Excessive friction resulting from severe and near-instantaneous bearing failure could have caused the shaft to bend. Extreme vibration was certain to be generated and could have caused the less-than-optimally installed seal to release pumpage. By this time, the outboard bearing area was thought to have been red hot, causing spilled pumpage to ignite.

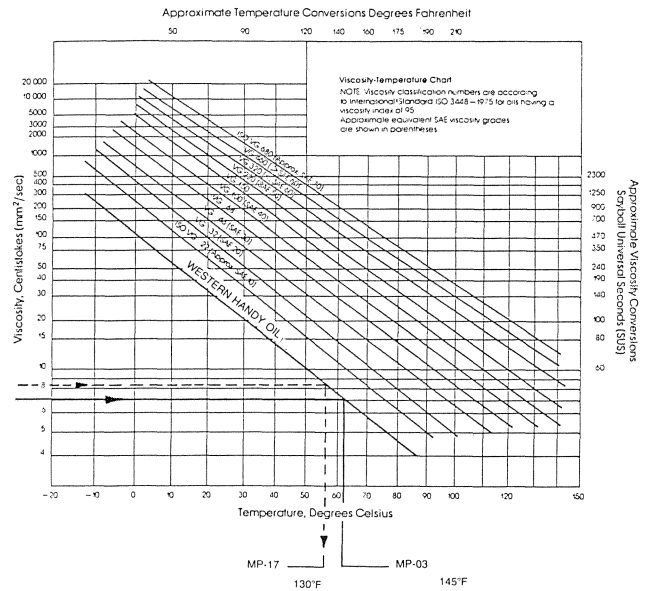
The chart in Figure 7 was used to determine the viscosity required to adequately lubricate the MP-17 bearings. At a mean diameter of 87.5 mm and a speed of 3570 rpm, a minimum lubricant viscosity of 8.3 cSt is required. As shown in Figure 8, maintaining this minimum viscosity is possible only if operating temperatures do not exceed 130°F. Newly installed duplex and double row thrust bearings will, however, experience temperatures well in excess of 130°F. Although a superior grade oil mist lubricant was supplied to these particular pump bearings, the mist lube could not overcome the diluting effect of the inferior low viscosity oil which was present in a "trough" formed by the bearing outer race at the six o'clock position. The existence of this "trough," or minisump explains why oil mist lubricated bearings in horizontally arranged pumps and drivers generally survive for periods of eight or more hours after the oil mist supply has been turned off. Unfortunately, if the minisump is filled with a dilutant, the beneficial effects of applying highly viscous lubricants cannot come into play until the damage is done.

Figure 7. Temperature-Viscosity Chart Illustrates that Excessively Low Viscosity Lubricants Will Not Support Oil Film at Temperatures Typically Encountered by Process Pumps.

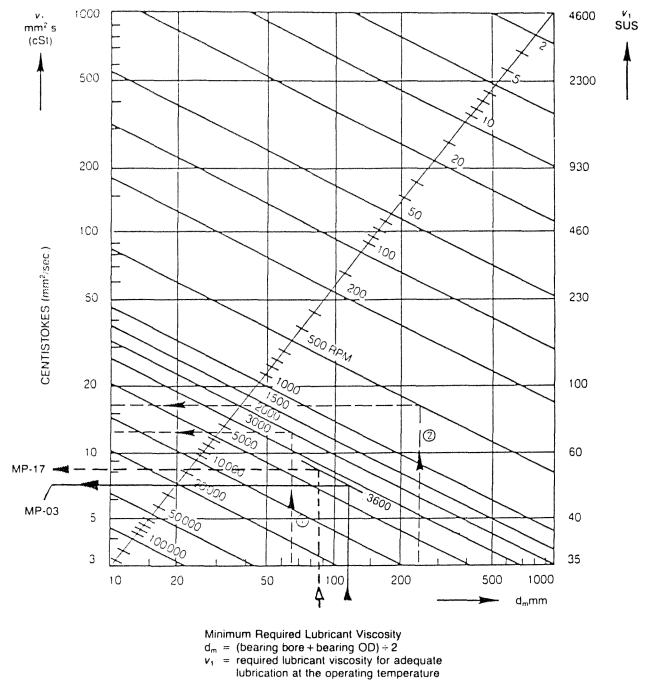
Figure 8. Oil Viscosity Requirements Plotted vs Mean Bearing Diameter and Shaft Speed.

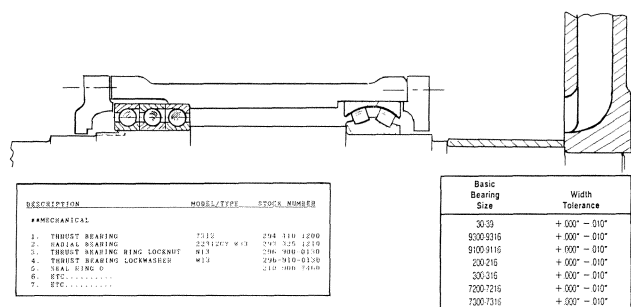
The analysis strategy consisted of a review of the vibration records, repair history, spare parts consumption, and physical examination of bearing and impeller wear patterns. Since the pumps had been designed and manufactured by an experienced company and were generally running quite well, the cause categories "Faulty Design," "Fabrication or Processing Errors," and "Assembly or Installation Defects" were not considered high on the list of probable failure initiators. There did not appear to be any material defects on either the badly worn bottom bearing or the slightly cavitation-eroded impeller vanes. Accordingly,

Figure 9. Bearing Housing Showing Ball Thrust Bearings Which Failed Frequently.

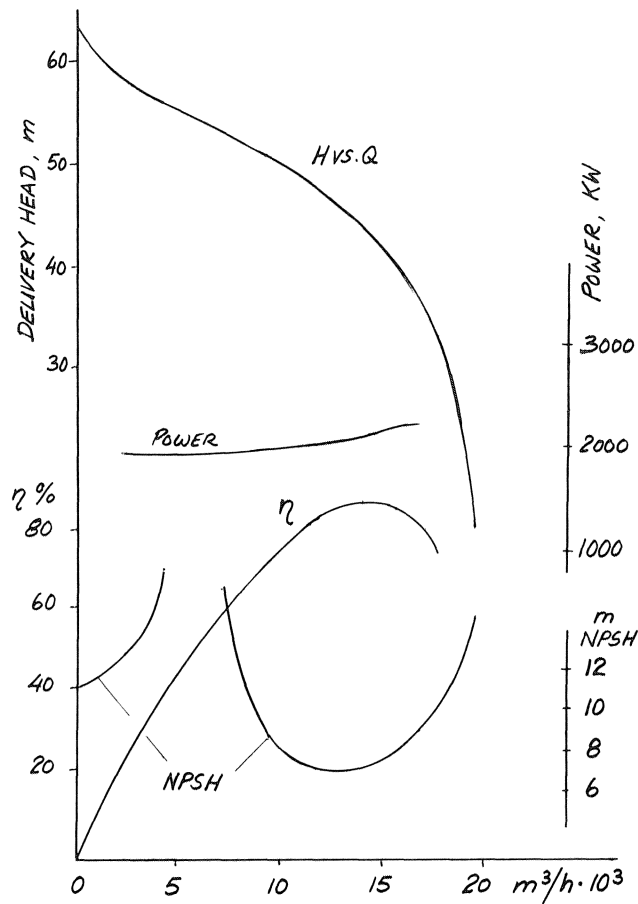
Figure 10. Performance Chart for Vertical Pumps in Seawater Intake Service. Note NPSH trace.

When operating at throughputs in the vicinity of 5,000 cubic meters per hour, the required NPSH (net positive suction head, largely a measure of inlet pressure) would be exceedingly high, certainly twice the NPSH required at 10,000 cubic meters per hour. With the available NPSH for each seawater intake pump essentially fixed at roughly 12 meters, reductions in throughput flow from the customary 8,000 cubic meters per hour per pump could rapidly drive the pump performance into the cavitation range where high vibration would be encountered. The equipment owner was advised to consider installing an automatically controlled low flow bypass loop or a combination of supervisory instrumentation and seawater consumer-to-pump-operator communication link (audio-visual electronic interface). This would give the utility crew sufficient time to always have only that number of pumps on line which would be needed by the downstream processes while at the same time satisfying the flow requirements of each individual vertical pump.

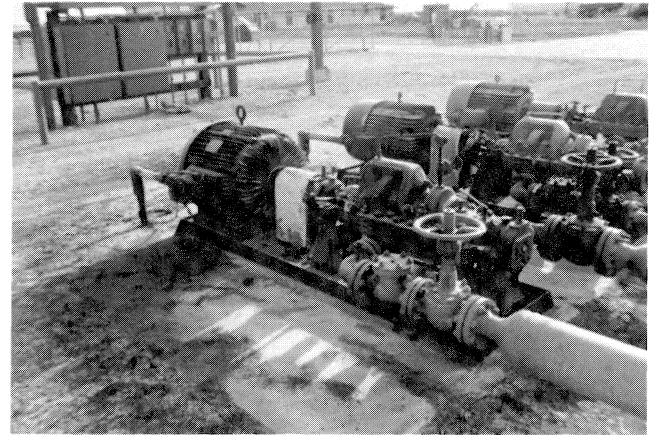
One of the more tragic pump failure incidents occurred at a hydrocarbon processing plant in the U.S. Gulf Coast area in 1982 (Figure 11). It involved the pump shown in the foreground of Figure 12.

Figure 11. Propane Pumps Involved in a Disastrous Flash Fire.

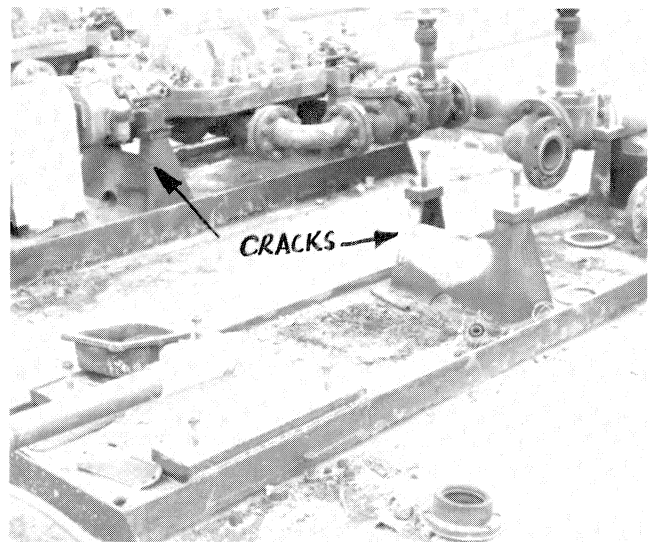
Figure 12. Broader View of Pumps in 1982 Hydrocarbon Processing Plant Accident.

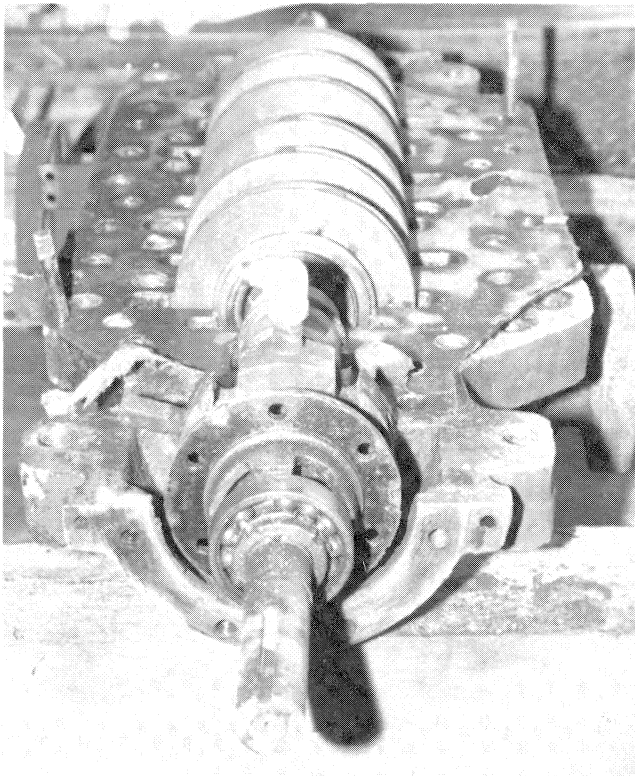
Figure 13. Pumps Internals Immediately After the Fire.

- Severe internal misalignment now caused the ball separator on the radial bearing (near drive end) to disintegrate (Figure 13).

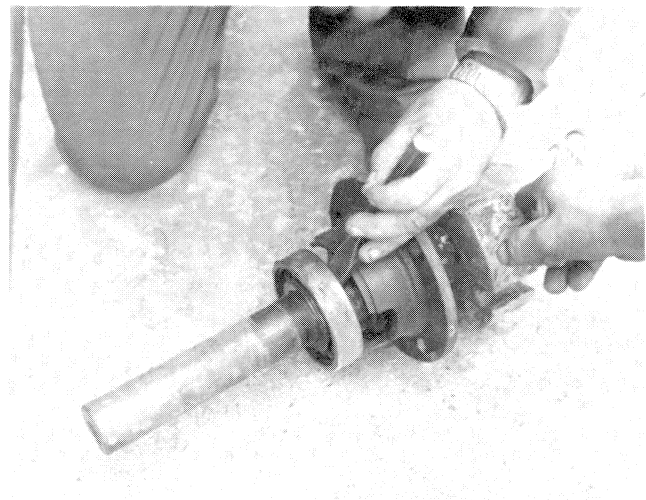
Figure 15. Questionable Procedure for Removing Rolling Element Bearings (Pump Inboard Side).

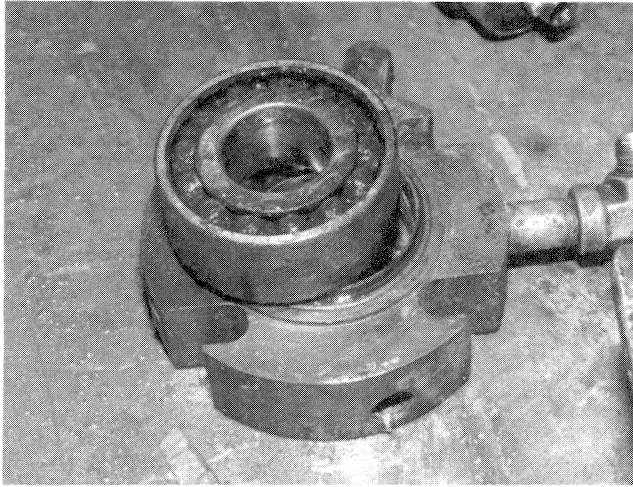
Figure 16. Double-Row Thrust Bearing Showing Adequate Lubrication at Time of Pump Failure.

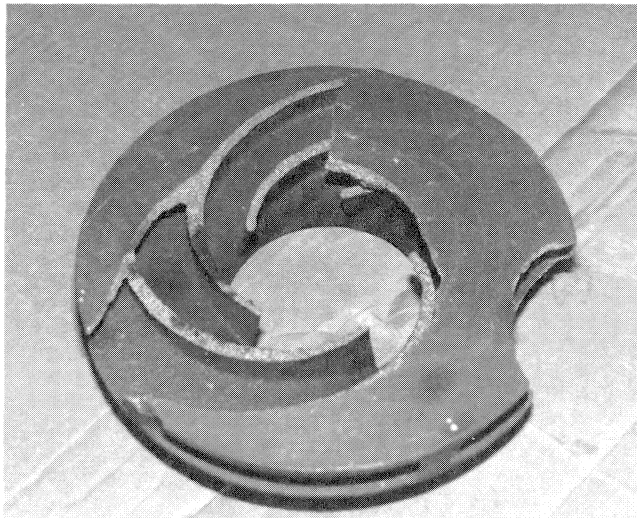
Figure 17. Impeller Destroyed at Disassembly.

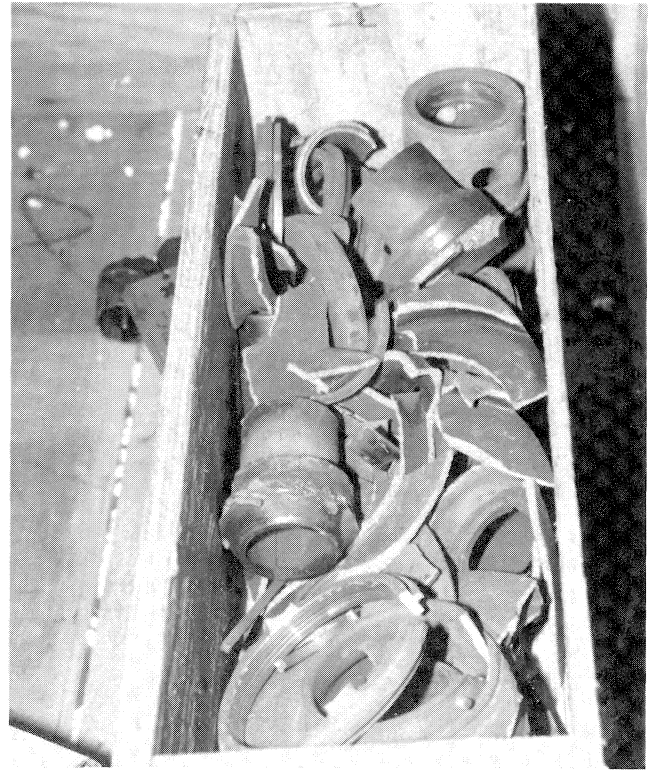
Figure 18. More Components Destroyed at Disassembly.

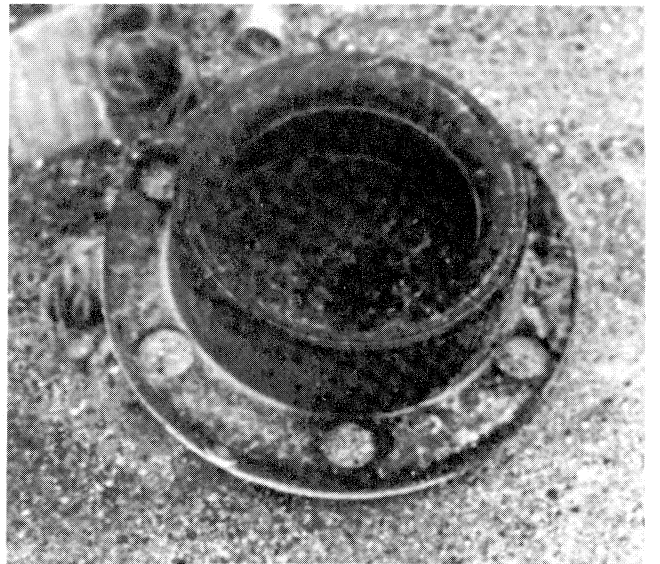
Points of evidence: severe ridges were visible in the softer of the two mating gears; no traces of lubricant were found in the drive-side coupling on the failed pump set; also, no traces were found of lubricant in the couplings of both adjacent identical pump sets.

Figure 19. Worn Gear Coupling.

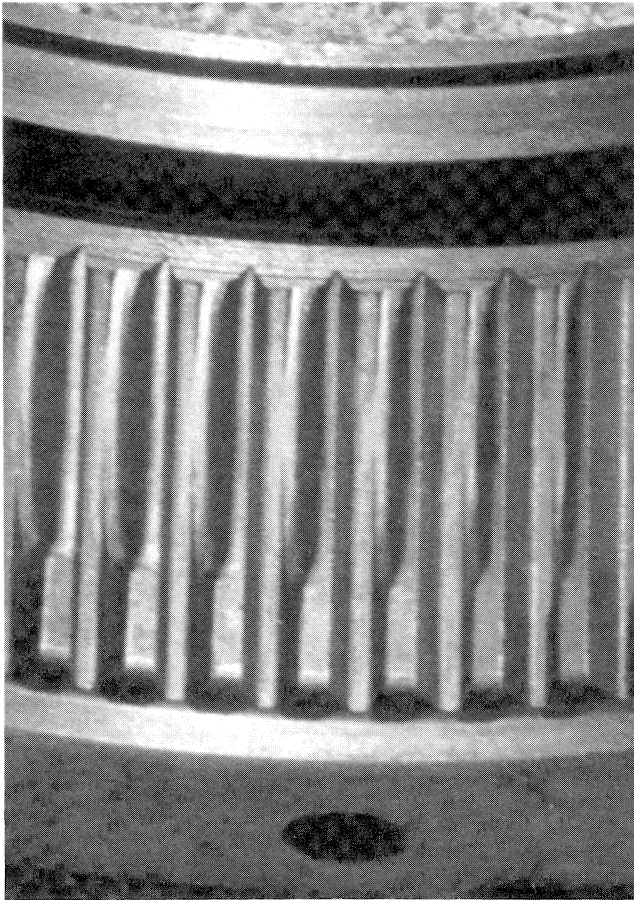
Figure 20. Closeup of Worn Gear Coupling.
