46<sup>TH</sup> TURBOMACHINERY & 33<sup>RD</sup> PUMP SYMPOSIA  
HOUSTON, TEXAS | DECEMBER 11-14, 2017  
GEORGE R. BROWN CONVENTION CENTER

# Vertical Seawater Lift Pump Reversible Performance Deterioration

# Problem

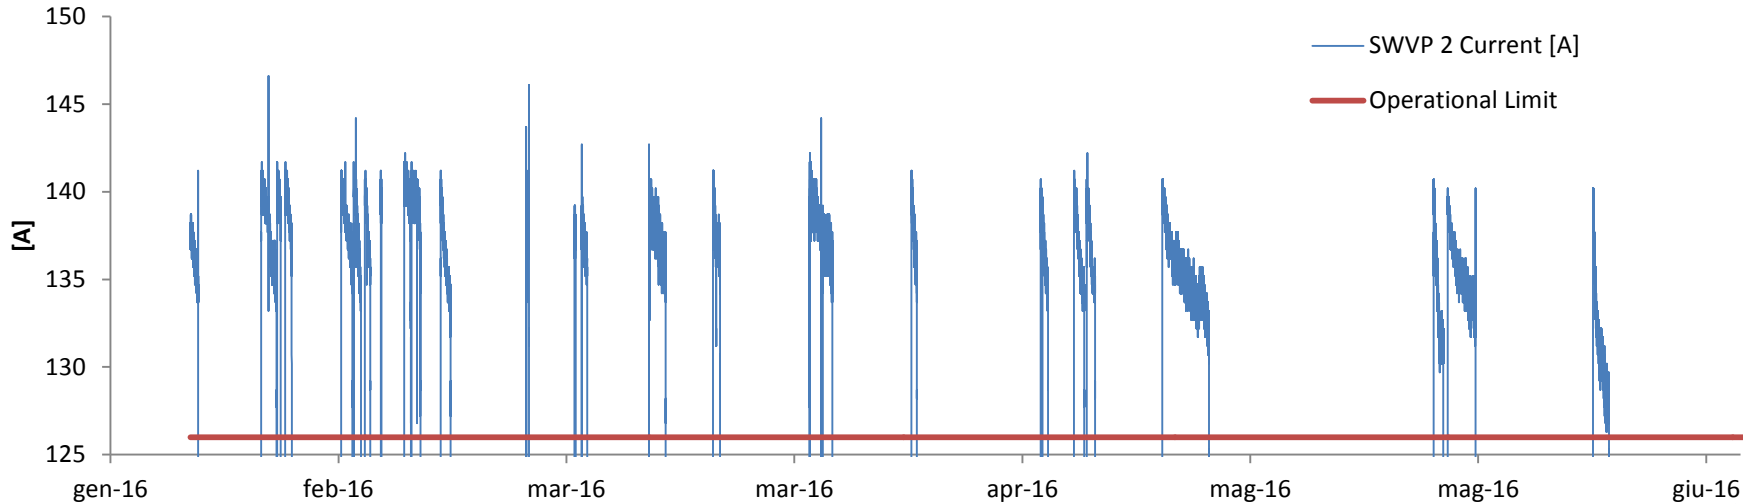
- Motor current is the available performance measure
- Behavior limited to #2 pump
- SW header following same trend

Rate of performance degradation increase over time

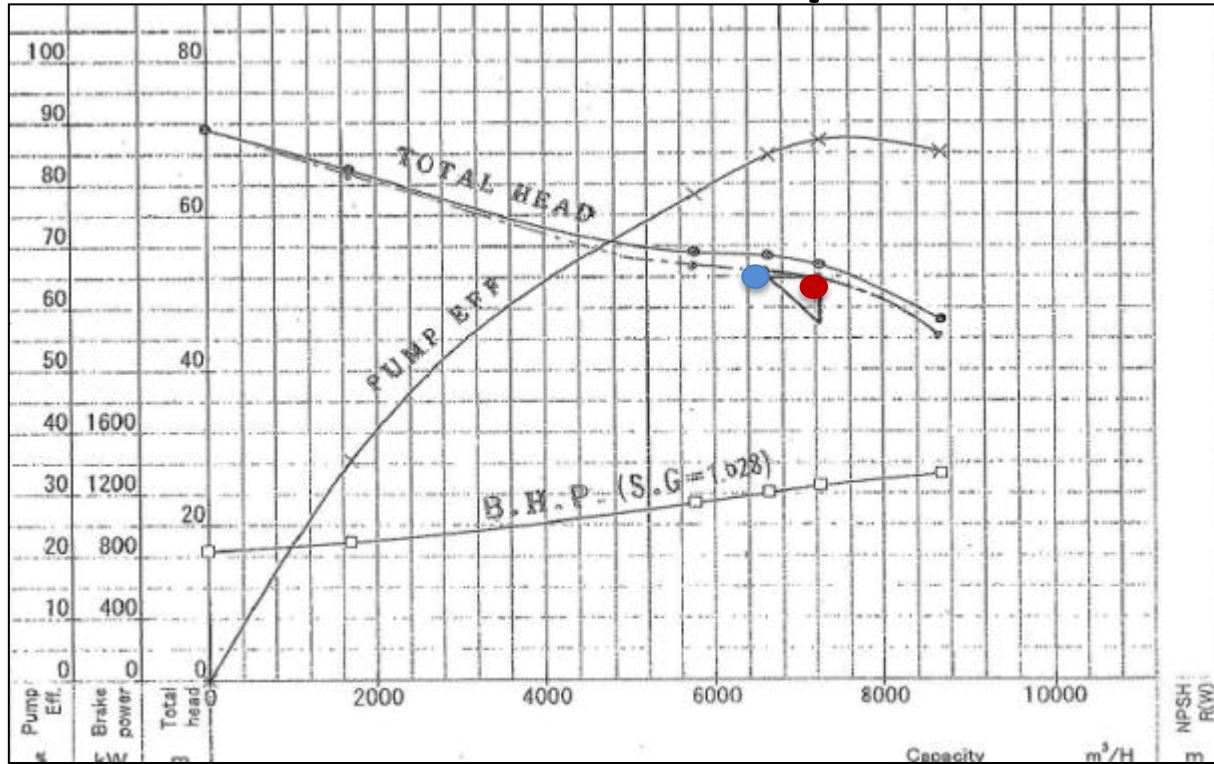
0.05 bar (0.7 psi) increase in either discharge pressure or DP across suction strainer  
→ 5800 m³/h (13% drop)

Performance calculation can not identify the problem

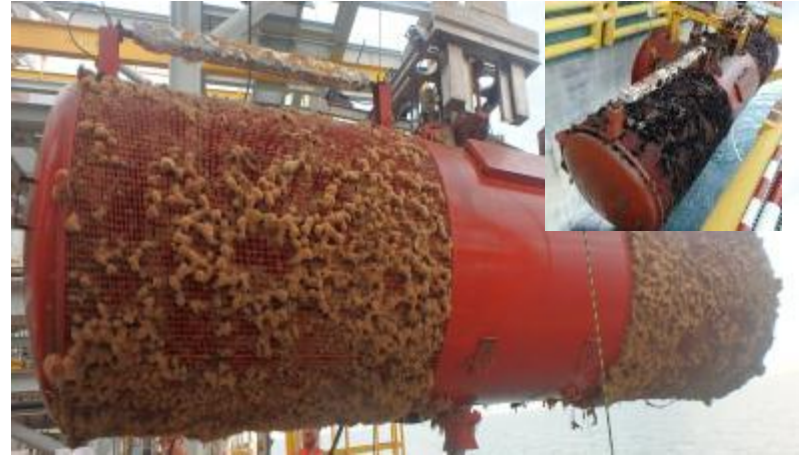
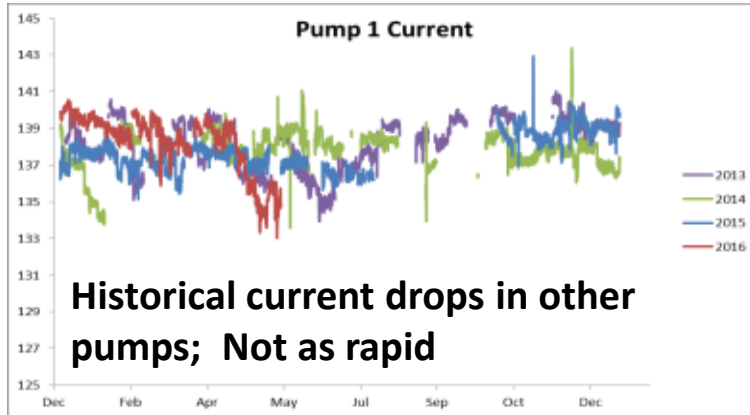
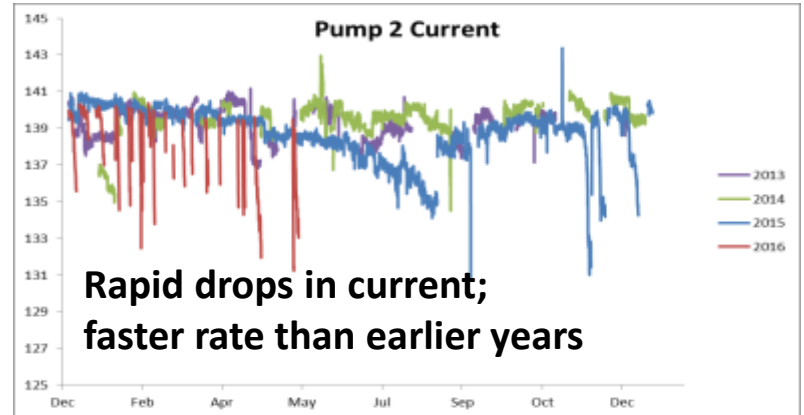
- Historic seasonality effect across all pumps
- Change in behaviour related on pump 2
- Basin strainer gets plugged, but no performance effect

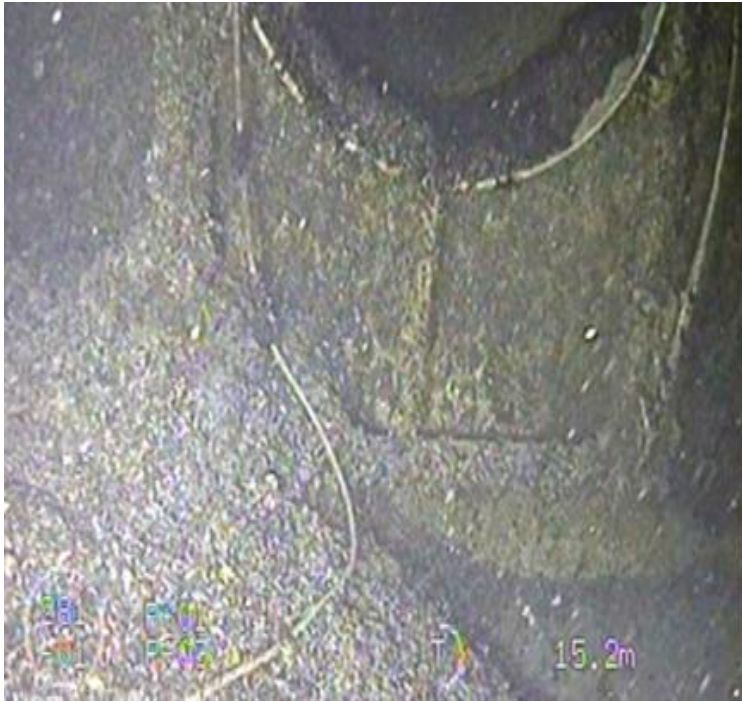
Significant marine fouling

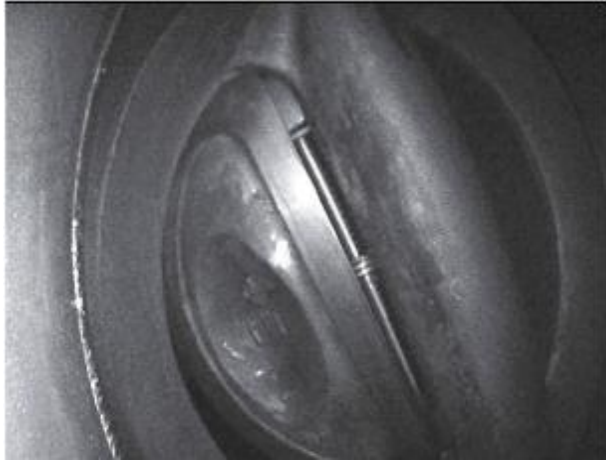
Partially stuck check valve

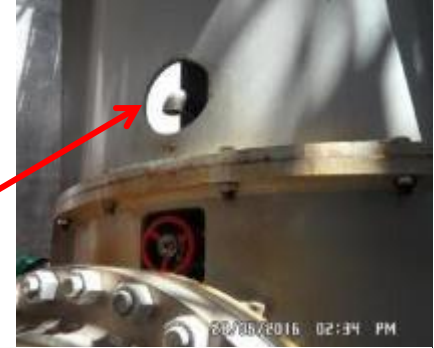
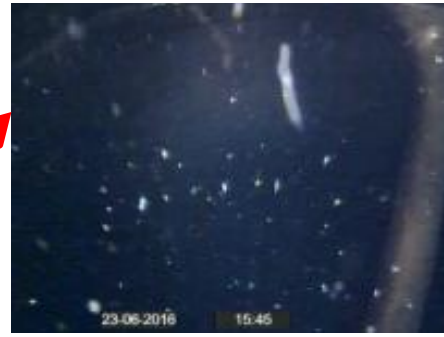
Camera inspection inside pump

No attached growth on pump internals

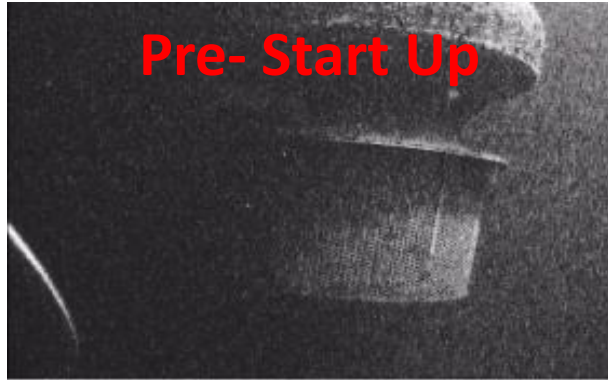
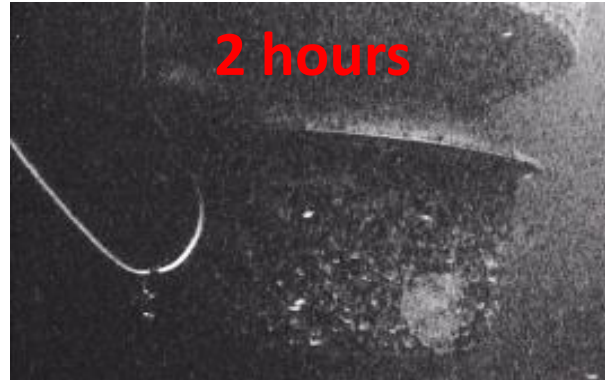
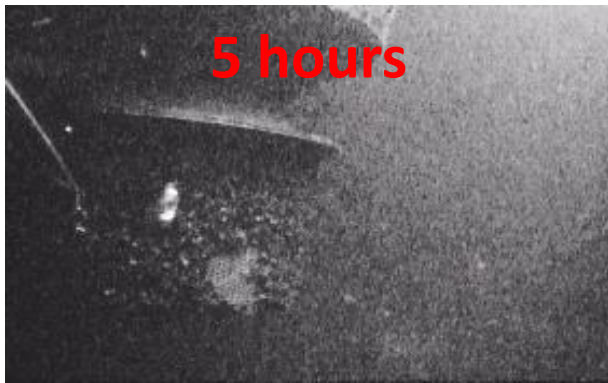
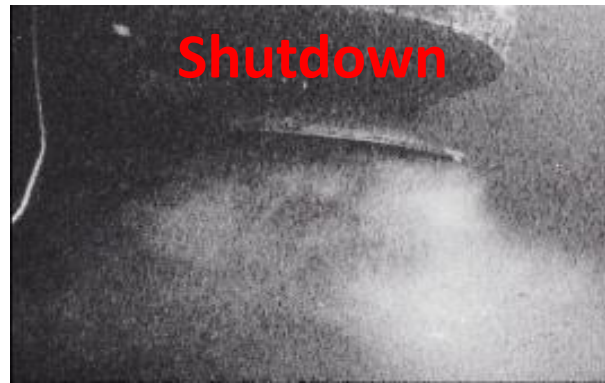
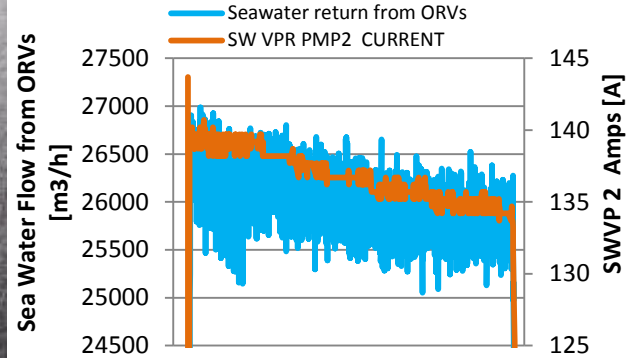
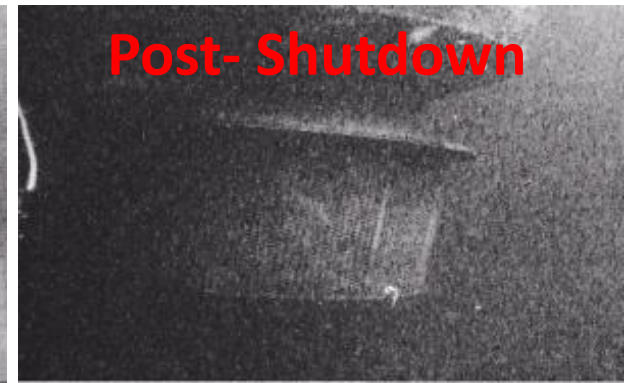
5 hours to block strainer at  $>6000$  m<sup>3</sup>/hr water flow...Why?

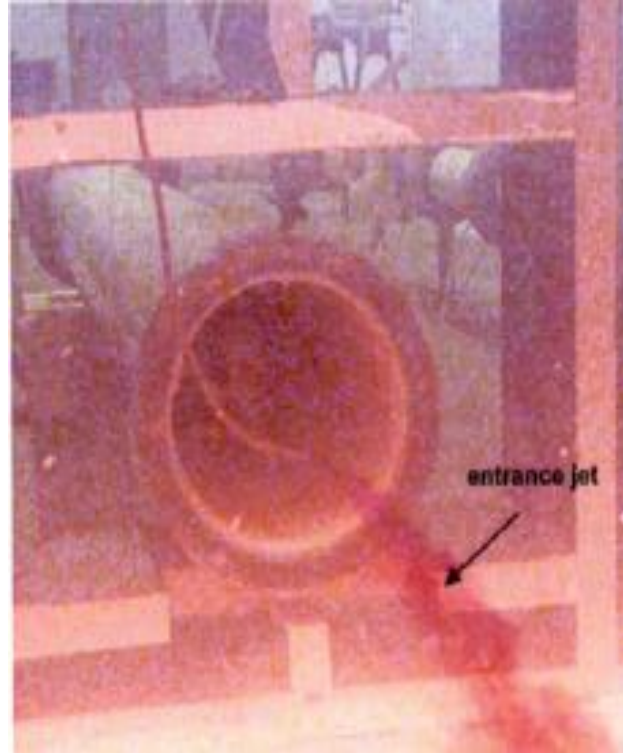
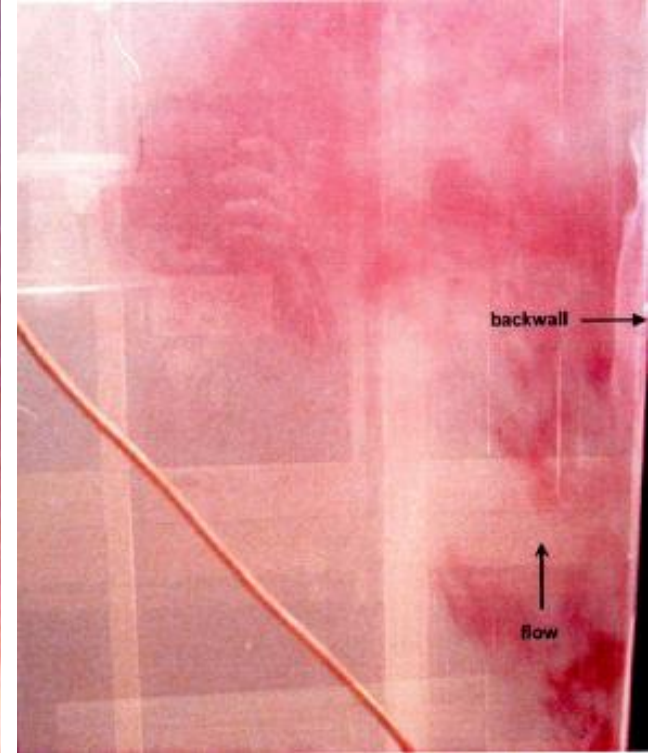
Jet flow through basin entrance

Flow distribution in basin affects rate of suction strainer blockage
