46TH TURBOMACHINERY & 33RD PUMP SYMPOSIA
HOUSTON, TEXAS | DECEMBER 11-14, 2017
GEORGE R. BROWN CONVENTION CENTER

STRATEGIES TO PREVENT SUDDEN CATASTROPHIC COMPRESSOR FAILURES DURING TRANSIENT OPERATING CONDITIONS

CASE STUDY 1: COMPRESSOR FAILURE DURING START-UP

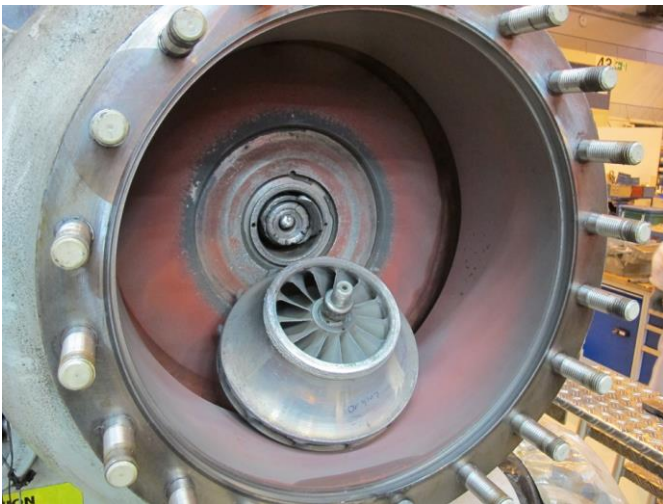
Figure 2: Damage Impeller

The damage to the compressor was extensive. The pinion shafts were all snapped off behind the impellers due to hard rubs, apart from the stage two impeller which had not rubbed. One of the damaged impellers is shown in Figure 2.

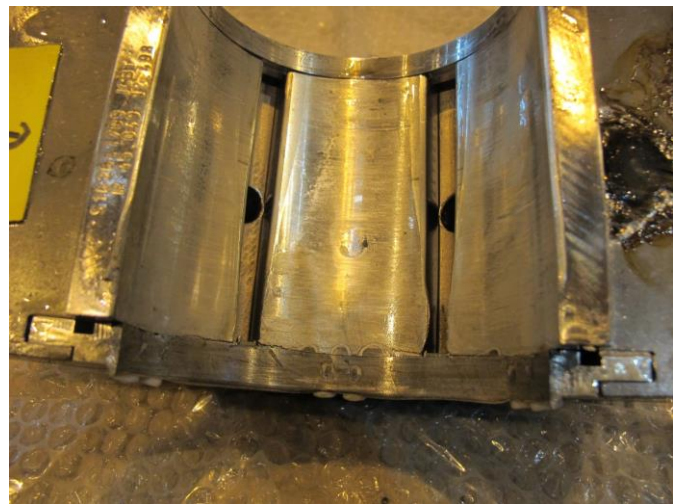
Figure 3: Damaged Pinion Bearing

The stage one/two tilting pad pinion bearings are a higher rated design than the other pinion bearings and showed little to no damage. The stage three/four and stage five/six pinion bearings were heavily damaged. An example of the damage is shown in Figure 3. These bearings consist of five pads. The pads are made from steel with a thin Babbitt layer on the inside diameter. It can be seen that the Babbitt was displaced due to very high loads and not wiped due to high temperatures.

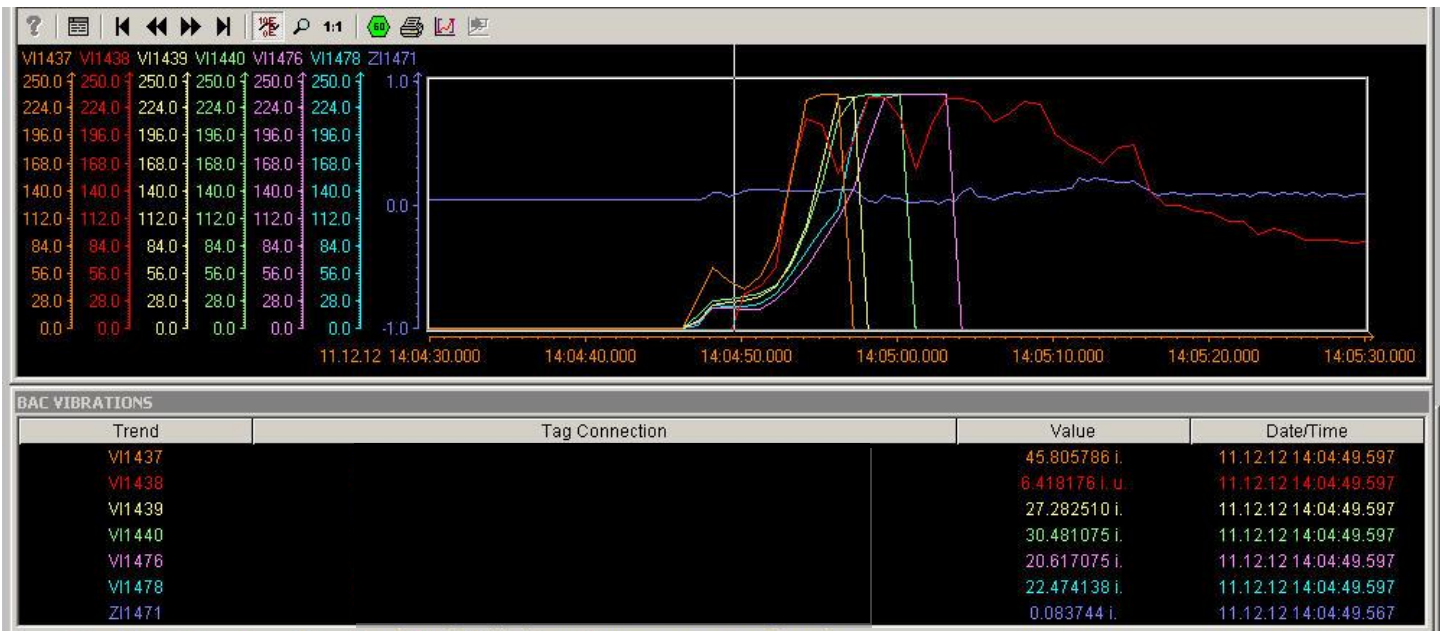
Figure 5: Start-Up Vibration Trends During Failure

Figure 4 shows the vibration trends during the start-up prior to the failure. Figure 5 shows the vibration trends during the start-up when the failure occurred. Comparing the trends, the vibration levels for the start-up when the failure occurred were higher from the moment the compressor was started. And, about five seconds into the start, the vibration levels for stages one and two increased exponentially to 250 microns p-p, which is the full range of the transmitters. The vibration levels for stages three and four also increased exponentially to 250 microns p-p, but lagged behind the stage one and two vibration increase by approximately two seconds. The vibration levels for stages five and six showed the same trend, but lagged two seconds behind the stage three and four increase. Note that some of the vibration readings drop sharply before the machine trip. This is because these vibration signals went to bad quality. The compressor did not trip on high vibration because the vibration shutdowns were bypassed for 30 seconds during start-up.

Based on prior starts, the compressor reaches full speed in about 17 to 18 seconds. As shown in Figure 4, on the start-up prior to the failure, the vibration of all the stages spikes just before reaching full speed. It was determined that this was due to excitation from the train torsional natural frequency (TNF). The calculated TNF is 1250 CPM, which is 83% of the operating speed of 1500 RPM. A

To prevent unnecessary high vibration alarms and trips on start-up and still provide high vibration protection, another option is to temporarily elevate the high vibration alarm and trip set points. This method is recommended by API and is described in API-670, "Machinery Protection Systems." The elevated vibration alarm and trip set points need to be set higher than the rotor's characteristic response at any resonances during the start-up, but the levels should be set as low as possible in order to maximize the machinery protection. In some machines, the alarm and trip points do not need to be elevated at all. In other machines, the alarm and trip set points may need to be elevated by as much as two or even three times the normal set points. However, if the set points need to be elevated more than this, there may be a problem and this requires further review.

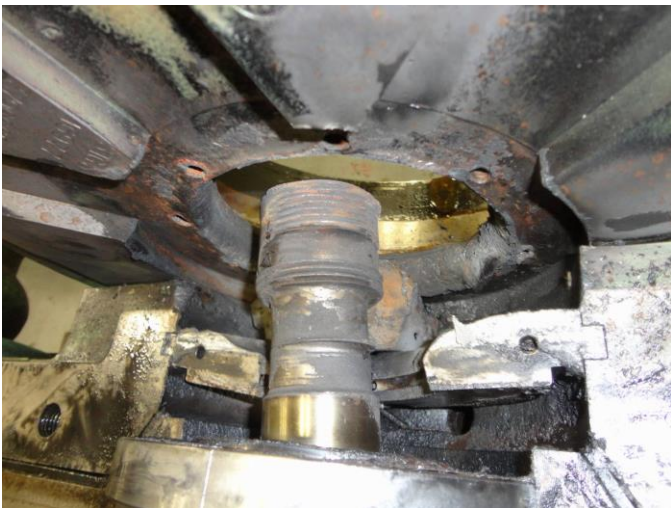
Figure 7: Damaged Pinion

Figure 7 shows a damaged pinion where it can be seen that the shaft end that drives the impeller was snapped off. Figure 8 shows damage to the normally unloaded bullgear thrust bearing. This will be discussed in more detail below.

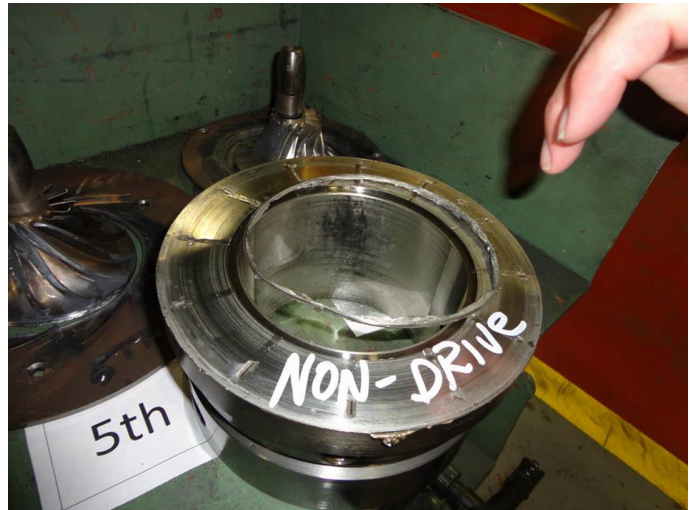
Figure 8: Normally Unloaded Bullgear Thrust Bearing

term vibration trends or thermodynamic performance. However, the bullgear thrust bearing damage was predominately on the non-drive end, which is opposite the calculated direction of thrust at the design operating conditions. Thus, it is likely this damage occurred during a transient event, such as a compressor shutdown, and not during normal steady state operation. Since there were limited shutdowns, this damage could have gone undetected. In this scenario, progressive damage could have occurred during each shutdown until there was sufficient wear/damage to allow for contact between rotating and stationary parts. The bullgear shaft is not fitted with an axial position probe and so it is not possible to determine exactly when the damage occurred.

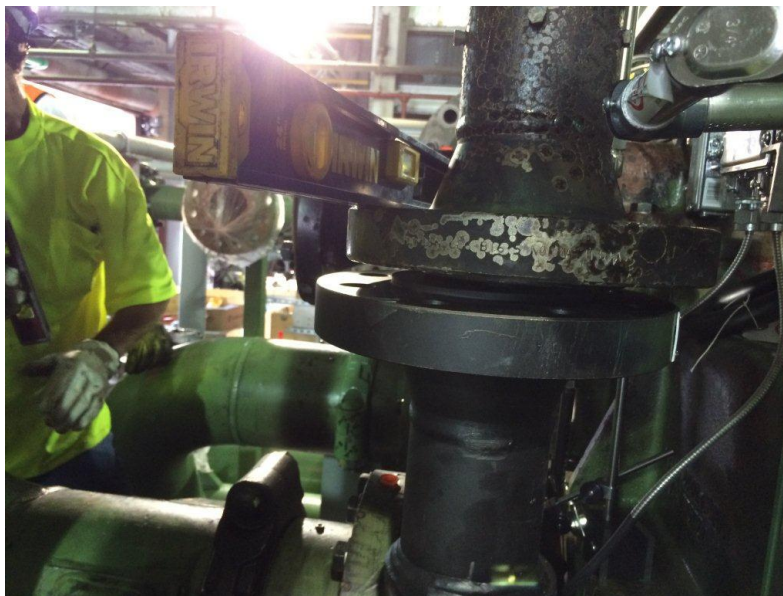
Figure 9: Piping Misalignment

The millwrights that removed the compressor after the failure reported a difficult time removing some of the piping due to excessive misalignment. During reassembly at site after the repair, numerous interstage pipes had to be modified in order to correct this piping misalignment. A picture showing some of the gross piping misalignment is shown in Figure 9. It was concluded that gearbox distortion resulting from excessive piping misalignment could have contributed to the failure by resulting in reduced impeller to shroud running clearances and/or bearing and seal misalignment.

- Ensured there was minimal gearbox distortion due to excessive piping misalignment. During re-assembly several pipes had

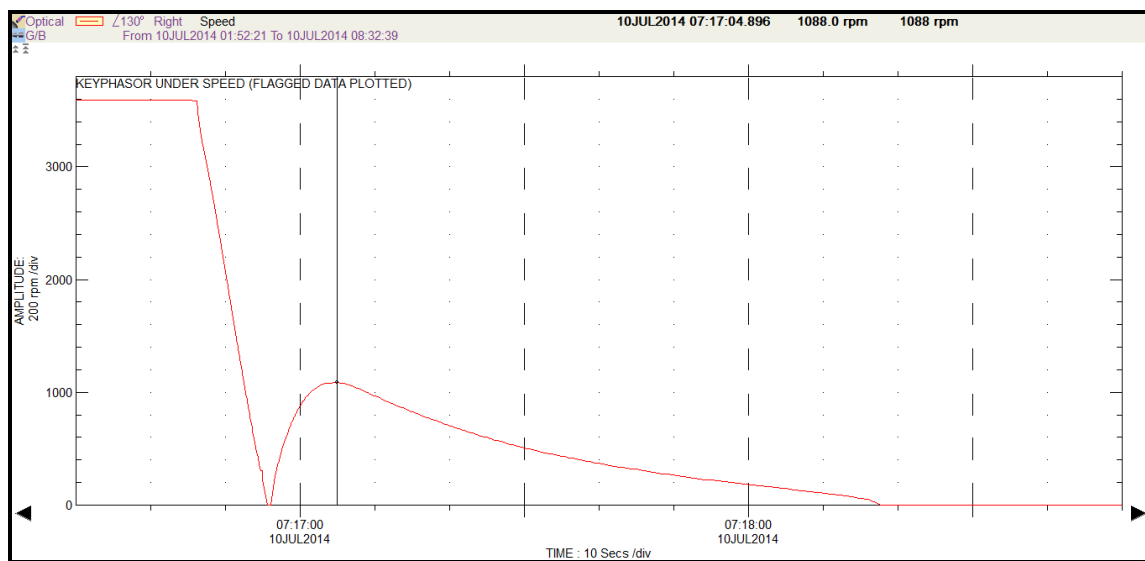
Figure 10: Speed and Verses Time Shutdown Trend

A review of the data at the time of the failure did not show any evidence of reverse rotation on the compressor shutdown. After the repair, the compressor went through extensive testing at site. Following the first full load shutdown test it was observed that the compressor stopped rotating about 10 seconds after being tripped and then spun backwards for about one and a half minutes, reaching a reverse speed of about 1000 RPM. This was seen by a GE-BN vibration analyzer that was being used for detailed vibration testing following the repair. See Figure 10. Operating in reverse is something that should be prevented because of potential for damage/wear due to lubrication problems, possible over pressure of oil pump suction piping, damage to oil pump foot valves and possible damage to bearings. The bullgear tapered land thrust bearings in this machine are a unidirectional design and have significantly reduced load carrying capability when operating in the reverse direction. If the normally unloaded bullgear thrust bearing was damaged due to repeated reverse rotation incidents, this could have contributed to the compressor failure.

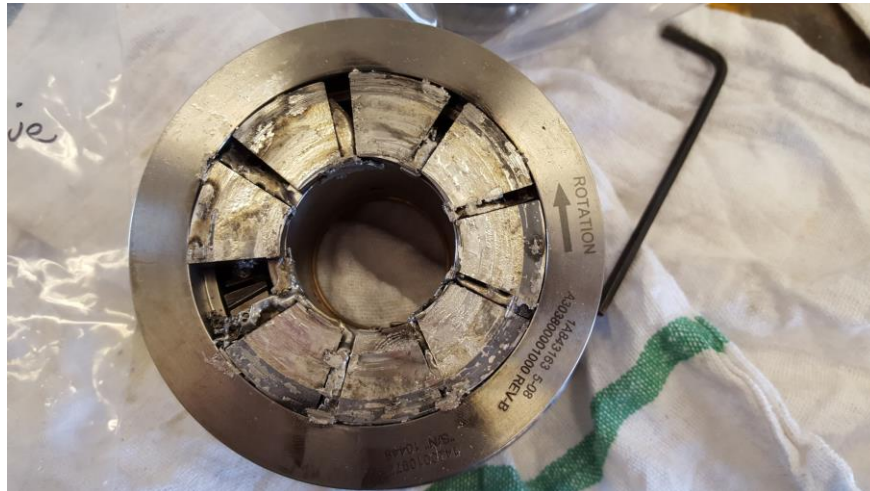
Figure 15: Pinion 2 Inactive Thrust Bearing Damage

Figure 15 shows a picture of the damaged first stage inactive thrust bearing.

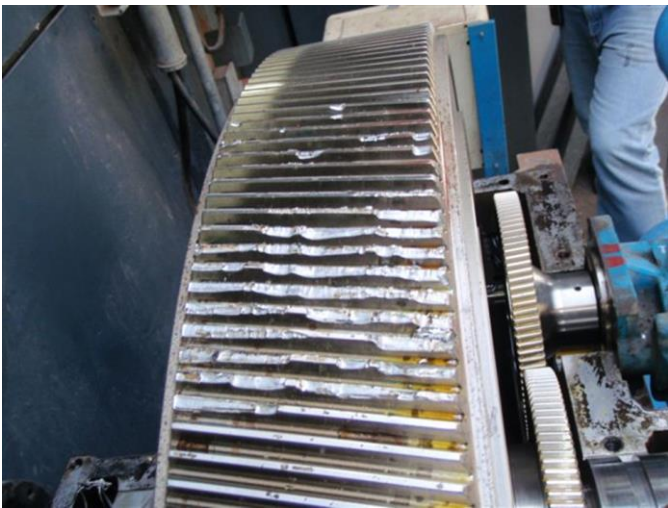
Figure 19: Gear Damage

The damage to the compressor and gearbox was extensive. The labyrinth seals and seal bushings in both compressors were badly rubbed and had to be replaced. The bullgear and pinion teeth had also failed. See Figure 19. And the couplings between the gearbox and high pressure compressor and between the high pressure compressor and low pressure compressor were twisted and bent. It was clear that this was a very violent failure.

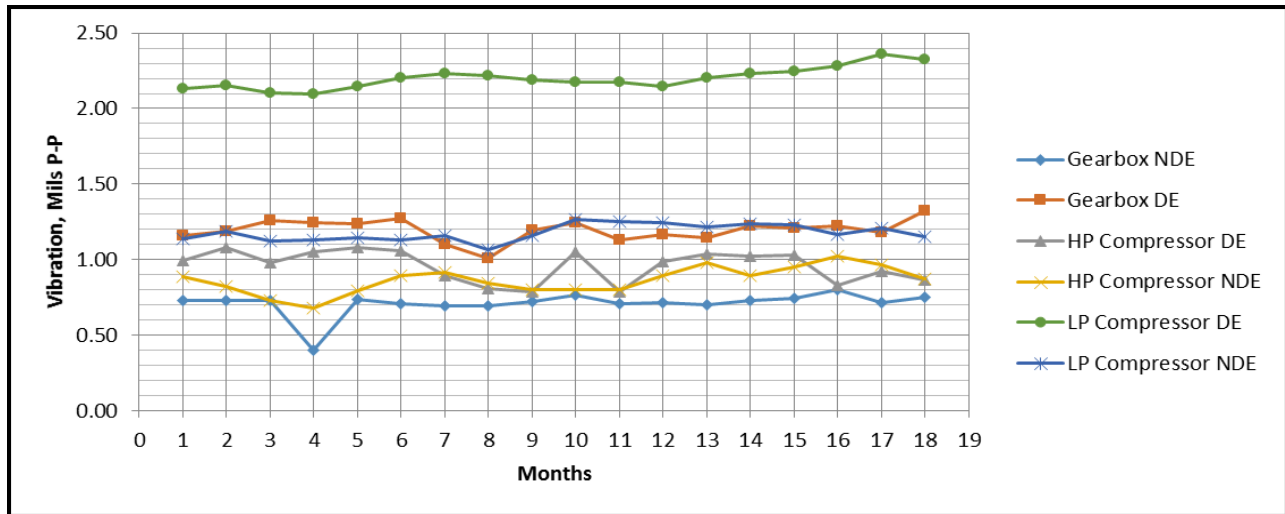
Figure 21: Vibration Trends

As mentioned previously, the compressor mechanical and thermodynamic performance was reviewed monthly and the efficiency, rotor vibrations and bearing temperatures were stable. A plot of 18 months of vibration data leading up to the failure is shown in Figure 21. The low pressure compressor DE vibration was somewhat high, but it appeared stable and was below the alarm point. A more detailed review showed that this vibration had slowly gone up almost one mil in vibration since commissioning (13 years later). And although the vibration appeared stable, it had been approaching the alarm limit. Other than this vibration point, all other compressor and gearbox vibrations were significantly lower than the alarm set points.

After the repair the steady state vibration levels and start-up vibration peaks were much lower than the values before the failure. A couple of changes could be made to improve the probability of identifying the degraded bearing condition in the future and should be
