46TH TURBOMACHINERY & 33RD PUMP SYMPOSIA
HOUSTON, TEXAS | DECEMBER 11-14, 2017
GEORGE R. BROWN CONVENTION CENTER

“Severe corrosion on rotor blades of back pressure type Steam Turbine due to unique reason”. What Went Wrong ?

H MEL, Guru Gobind Singh Refinery , INDIA

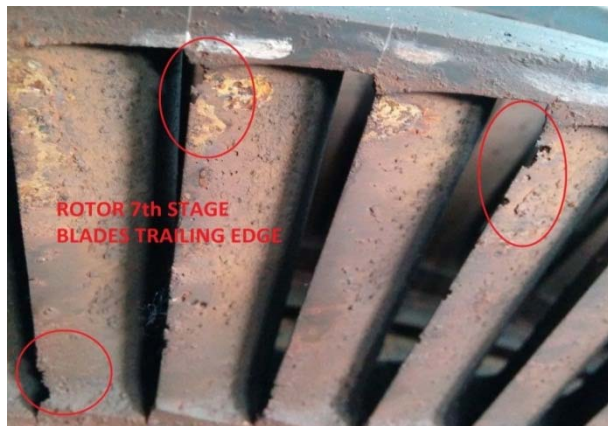
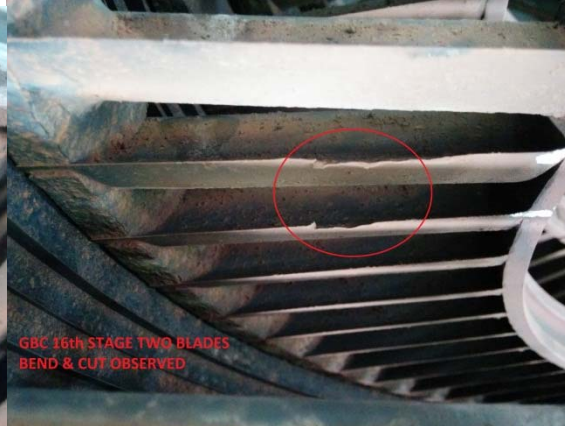
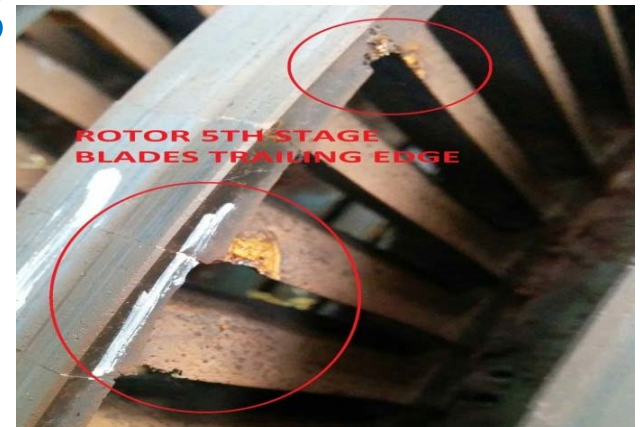
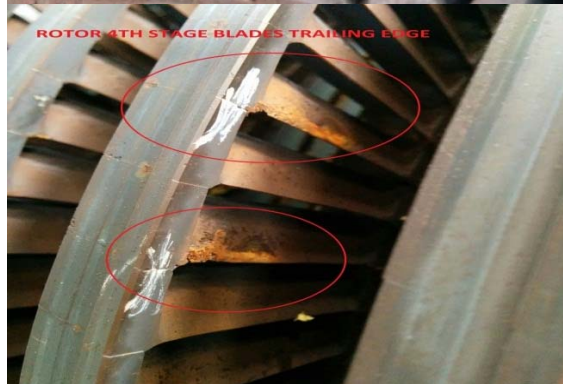
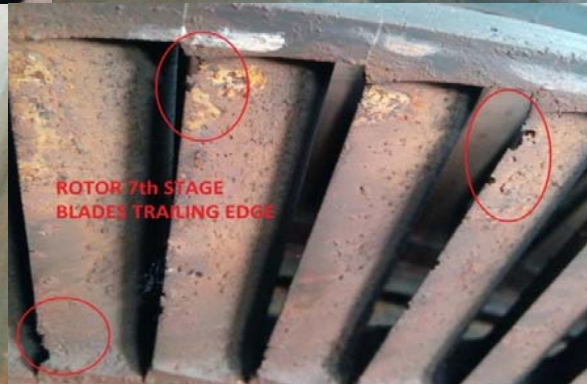
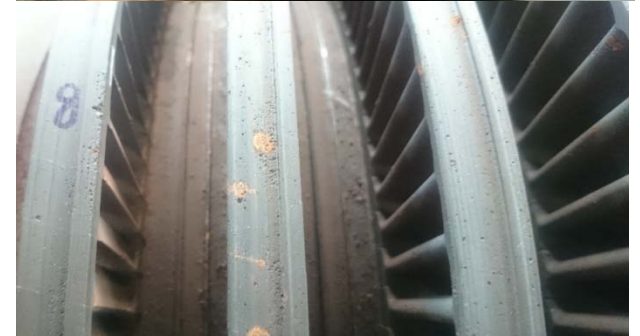
Observations on steam path

Based on the observations collected during overhauling and analysis thereafter, it was concluded that reason for the corrosion on turbine blading was wet ambience inside the turbine casing during machine idle condition.

Steam Turbine major overhauling revealed deterioration to steam path components in the form of corrosion, erosion, pitting and other components in lube oil circuit like bearings.

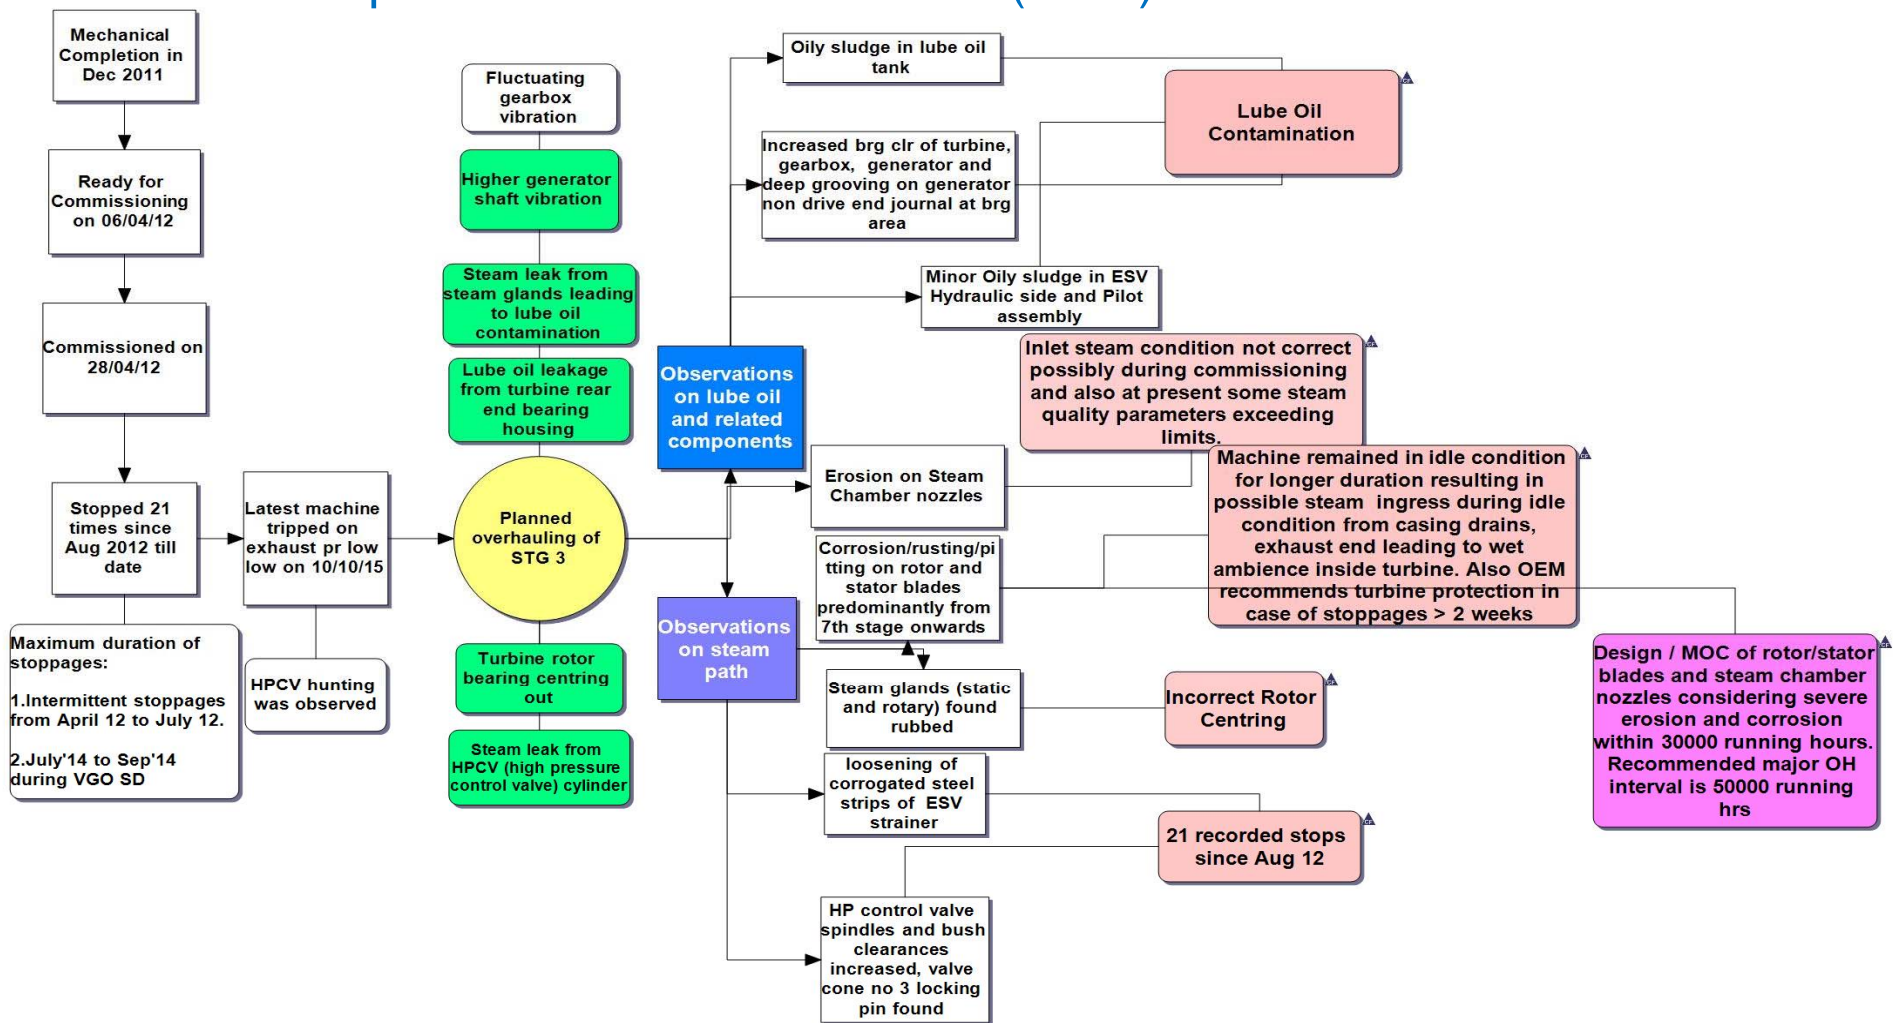
Snap Chart and Causal Factor (RCA)

Wet Ambience In turbine during rotor standstill condition for longer duration

- Machine commissioned in April 2012.
- May'12 to July'12 - in intermittent start stop condition. Same time, the steam lines were charged and possibility of steam ingress inside turbine casing existed.
- July'14 to Sep'14 – machine stopped due to plant shutdown.
- More than 21 stoppages since Aug 12.
- BPSTG (Back Pressure Steam Turbine) flash tank -12 nos. drain lines : 9 no. intermittent (including 3 turbine casing drains) and 3 nos. continuous drains.
- Continuous drains are from VHP (Very High Pressure) header & remain in service during BPSTG trip condition too.

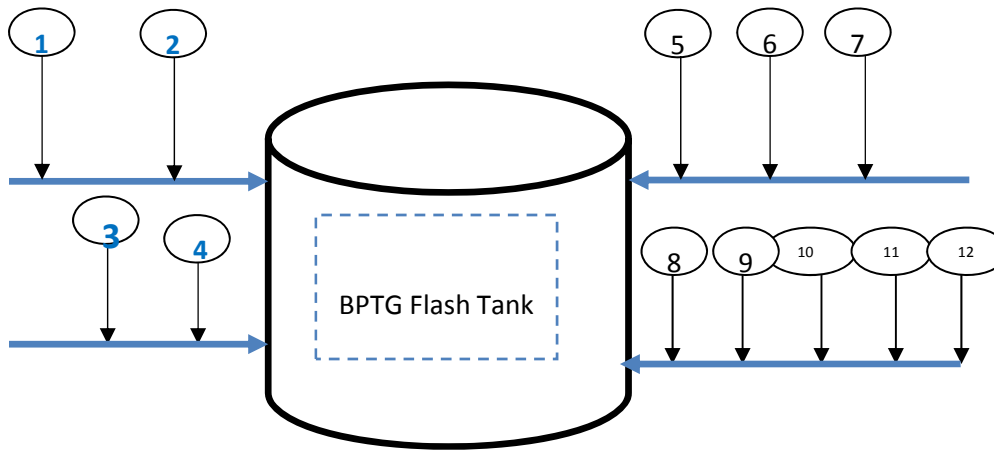
BPTG Flash Tank Drain Details

- Back flow of flash steam from these continuous drains can create wet ambience in turbine during rotor standstill condition.
- BPSTG drains from upstream and downstream of exhaust steam (LP)
- Motor operated valve (MOV) are connected to same drain header, which has potential to create wet ambience in turbine during rotor standstill condition. (Refer schematic)

Note: During site test as part of RCA, back flow of steam from flash tank to turbine casing noted from HP casing drain and back flow from LP exhaust line.

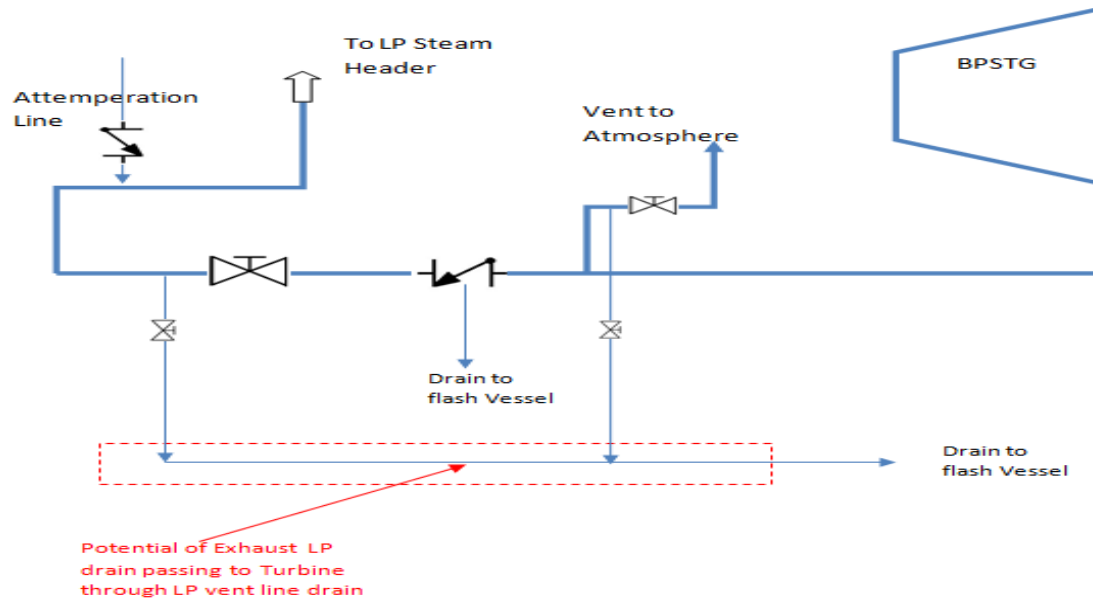
Exhaust Steam Line Drains

BPSTG drains from upstream and downstream of exhaust steam (LP) MOV connected to same drain header and has potential to create wet ambience in turbine during rotor standstill
