46<sup>TH</sup> TURBOMACHINERY & 33<sup>RD</sup> PUMP SYMPOSIA  
HOUSTON, TEXAS | DECEMBER 11-14, 2017  
GEORGE R. BROWN CONVENTION CENTER

# COMPANDER VIBRATION TROUBLESHOOTING

The “compander” is an integrally-gearred turbo machine with three warm compressor stages and one cryogenic expander stage. It’s used on LNG carrier to liquefy the boil off gas.(Brayton cycle)  
The factory acceptance test (FAT) troubleshooting concerns the last compander in a series of 8 identical machines.

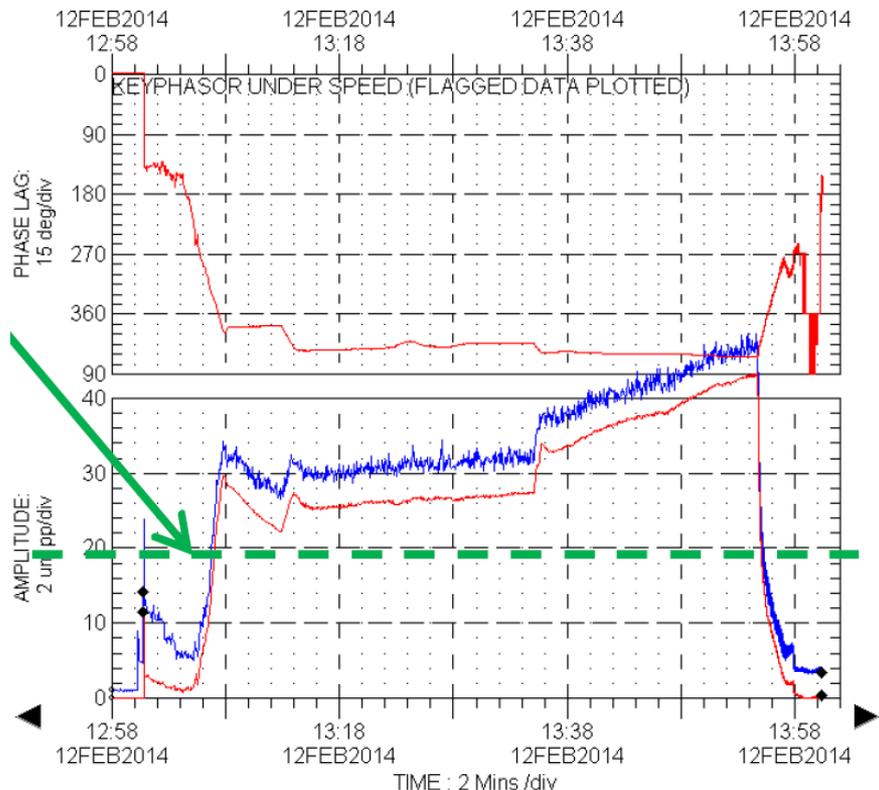
C3 vibration trend during 1<sup>st</sup> GBM MRT

During routine tests performed by the GBM, high level of vibrations were observed on high speed shaft 2.

Several tests were performed, in different configurations, in order to find the Root Cause of the vibration and reduced the amplitude from 31 to 16  $\mu\text{m pp}$ .

(API criteria @19  $\mu\text{m pp}$ )

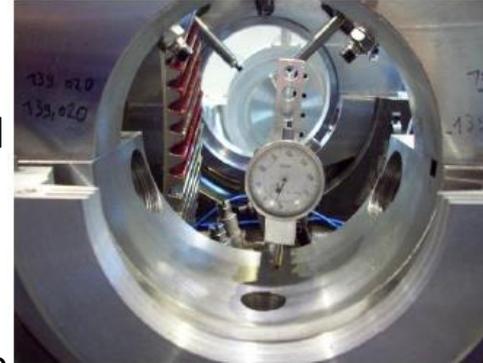
Bearing support geometry control

50  $\mu\text{m}$  clearance between casing and bearing support block has been found. Putting shims between the casing and the support block did not improve the dynamical behaviour of Pinion 2

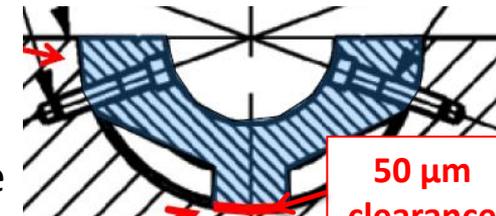
Bearing support potential cause

50  $\mu\text{m}$  clearance

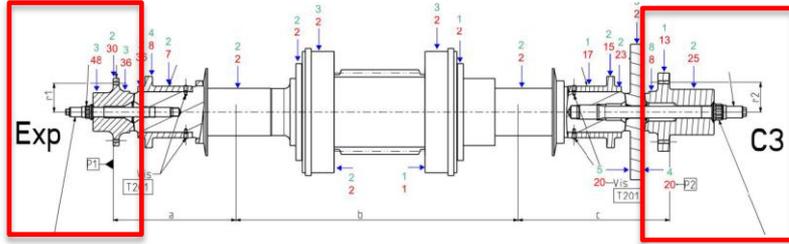
Pinion 2 Runout measurement

Too large lateral and radial runout of the dummy wheels (48  $\mu\text{m}$  on Expander, 25 on C3, reduced to 4 and 8  $\mu\text{m}$  respectively). After having re-tested the machine, it can be stated that:

This issue is the most likely root cause

**Lesson learned:** For low speed balancing, the rotor behaves as a rigid body. Balancing is done, applying corrective unbalance weights,  $U_c$ , at two planes I and II. If the rotor later bends at high speed then the corrective weights could be useless. Incremental balancing during the assembly of the rotor is necessary to reduce axial distance between unbalance  $U_n$  and correction  $U_c$ . When the rotor residual unbalance is found out of tolerance. It's necessary to check the residual unbalance of each rotor element to specifically update the relevant ones.

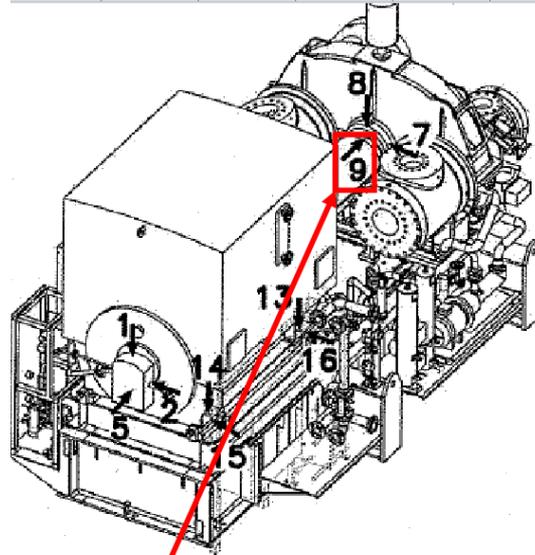
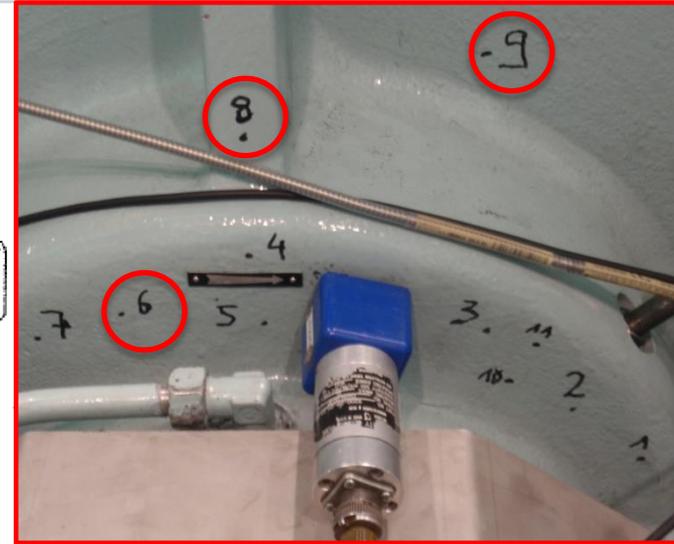
**Zoom on**  
Point 9 axial gear box  
low speed shaft  
velocity discrepancy

Over the 16 velocity measurement points around the machine, one (Point 9) highlighted higher values than the acceptance criteria of 4 mm/s rms [10-1000 Hz].

At this point, the magnitude varied a lot from 2.8 to 4.8 mm/s.

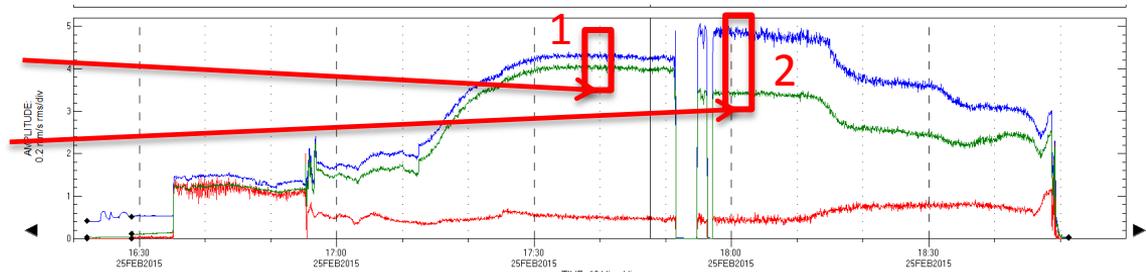
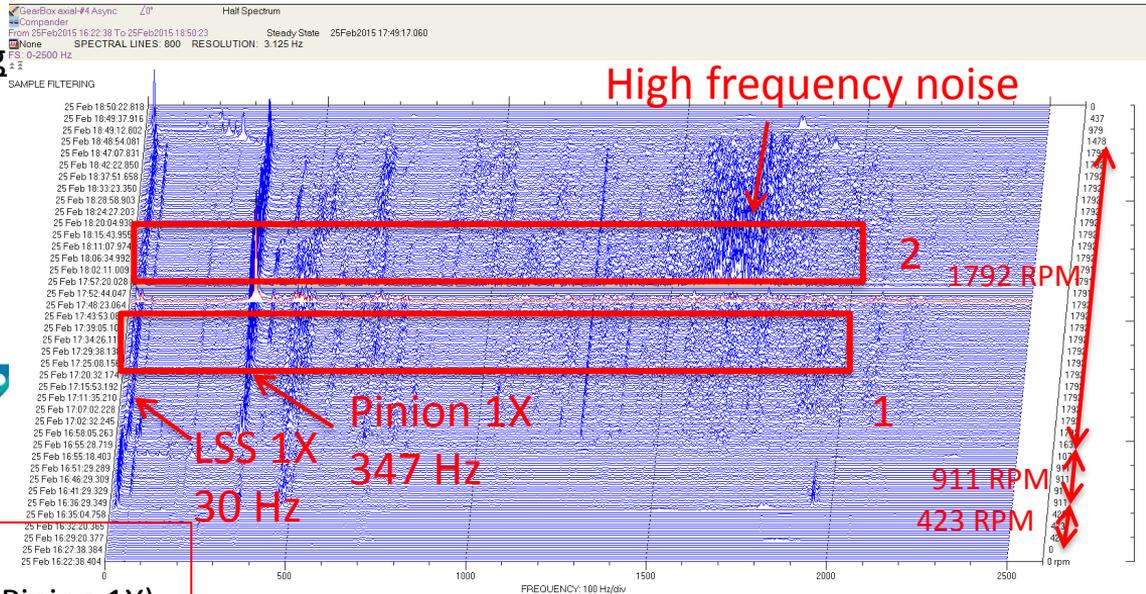
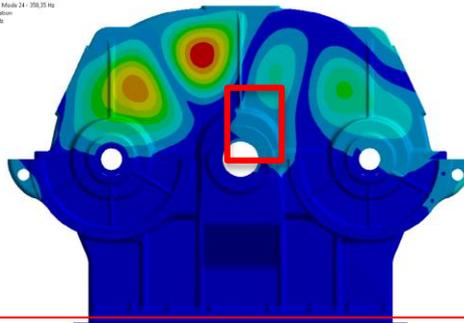
GB Casing-Modal analysis  
350 Hz Mode shape (close to Pinion 1X)

Measurement point location changed only from few millimeters, but level varied a lot.

It was due to GB casing mode.

Measurements should be done on the bearing not on the thin plate (according to ISO 10816) to avoid this issue.

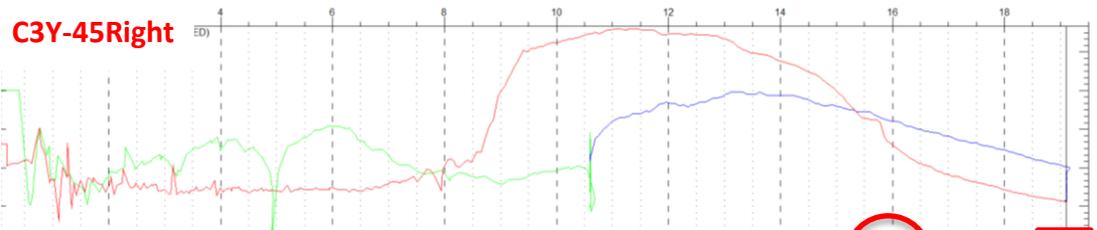
The vibration level increased to 75  $\mu\text{m}$  pp during shut down when crossing the pinion 2 critical speed at 15500 RPM.

Vibration level reduced, by contact?

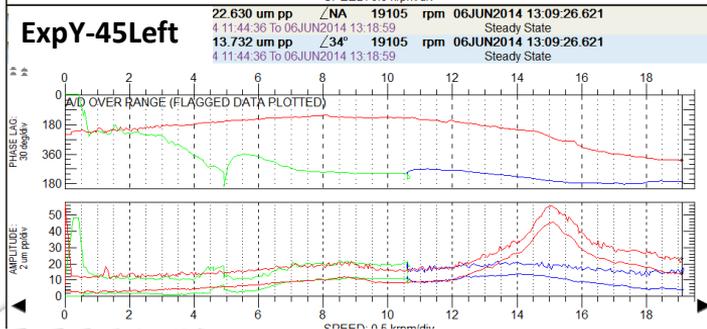
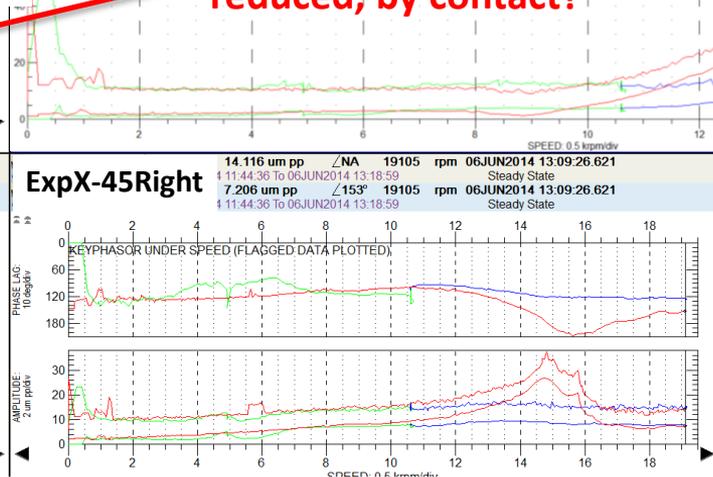
Pinion 2 Bode Diagram

Displacement Trip on HSS n°2  
Compressor 3-Right probe increased from 34 to 53  $\mu\text{m}$  pp, at 19105 RPM, during 1 min, just after ramp up

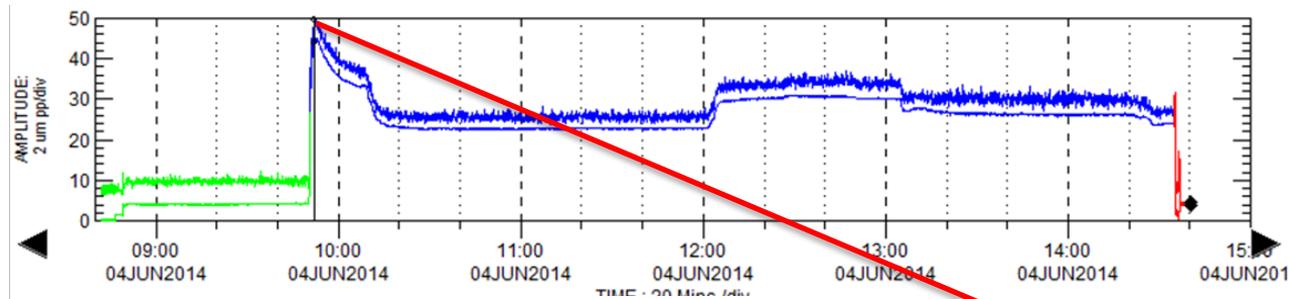
C3Y-45Right Trend

- The same phenomenon was present during previous tests but with a lower amplitude.
- Vibration reached 49  $\mu\text{m}$  pp just after speed ramp up from 10000 RPM to 19100 RPM.
- Not during critical speed crossing but 1 min after stabilisation at 19100 RPM.

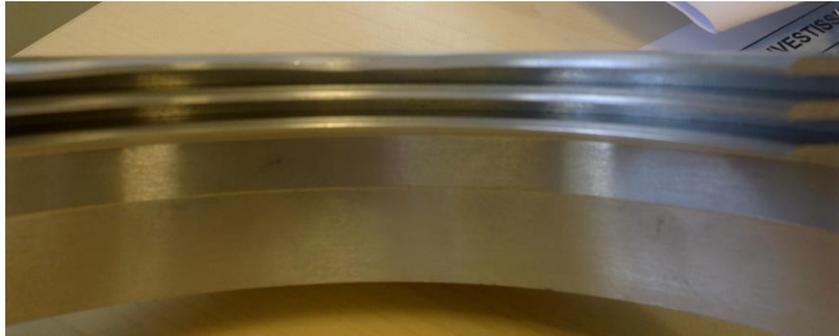
Machine inspection found an oil deflector strain and plastic parts in the oil filter (coming from oil pump caps – Oil pump trip during first start up)

Oil deflector strain

The 2 potential root causes creating a thermal bow during start up are:

- Pinion 2 rubs in oil deflector
- No sufficient lubrication of bearings (foreign body in oil pipe system)

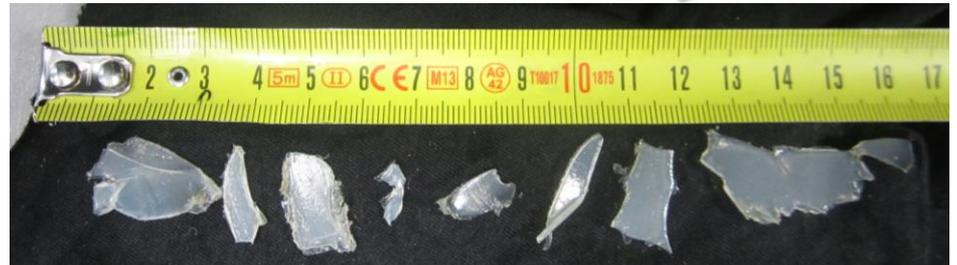
Plastic parts

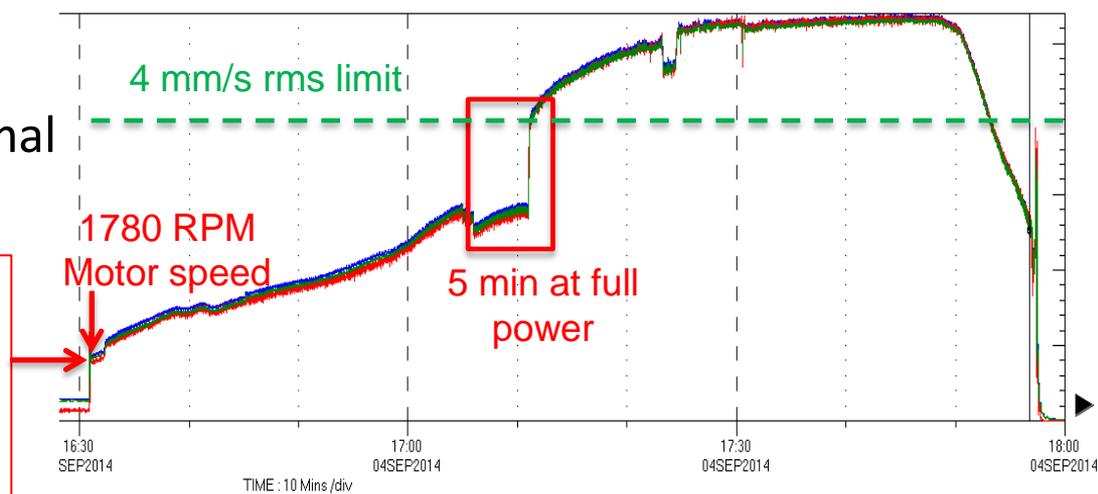
Motor velocity during EOM FAT

Last 5 mm/s > 4 mm/s criteria

A sudden increase of 1 X vibration at constant speed and constant power (after 5 min at 3.7 Mwatt)

-> Something moving on the rotor shaft. It could be related to a thermal phenomenon.

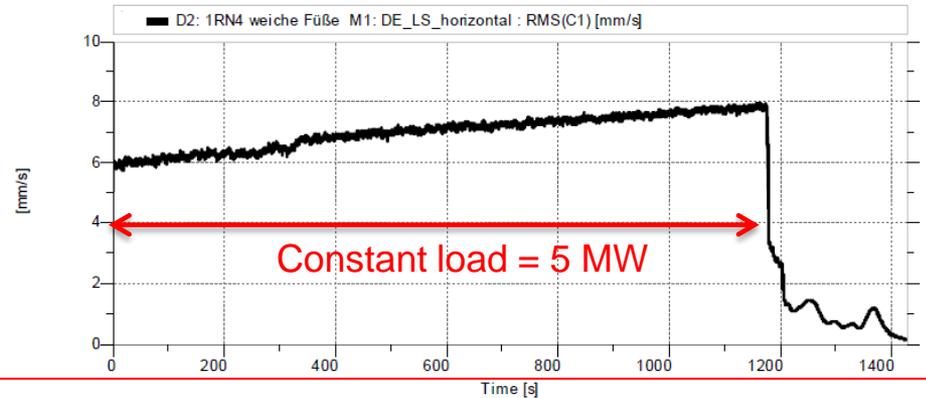
Motor manufacturer test loaded on soft support

A steady increase in bearings vibration velocity with time was present for both conditions. Recommendation to rebalance rotor to ensure low vibrations for operation under high load (warm) condition.
