ASIA TURBOMACHINERY & PUMP SYMPOSIUM
MARCH 2018 | SUNTEC SINGAPORE

Investigation of High Bearing Temperature in Centrifugal Compressor

ExxonMobil
Chemical

**MITSUBISHI HEAVY INDUSTRIES
COMPRESSOR CORPORATION**

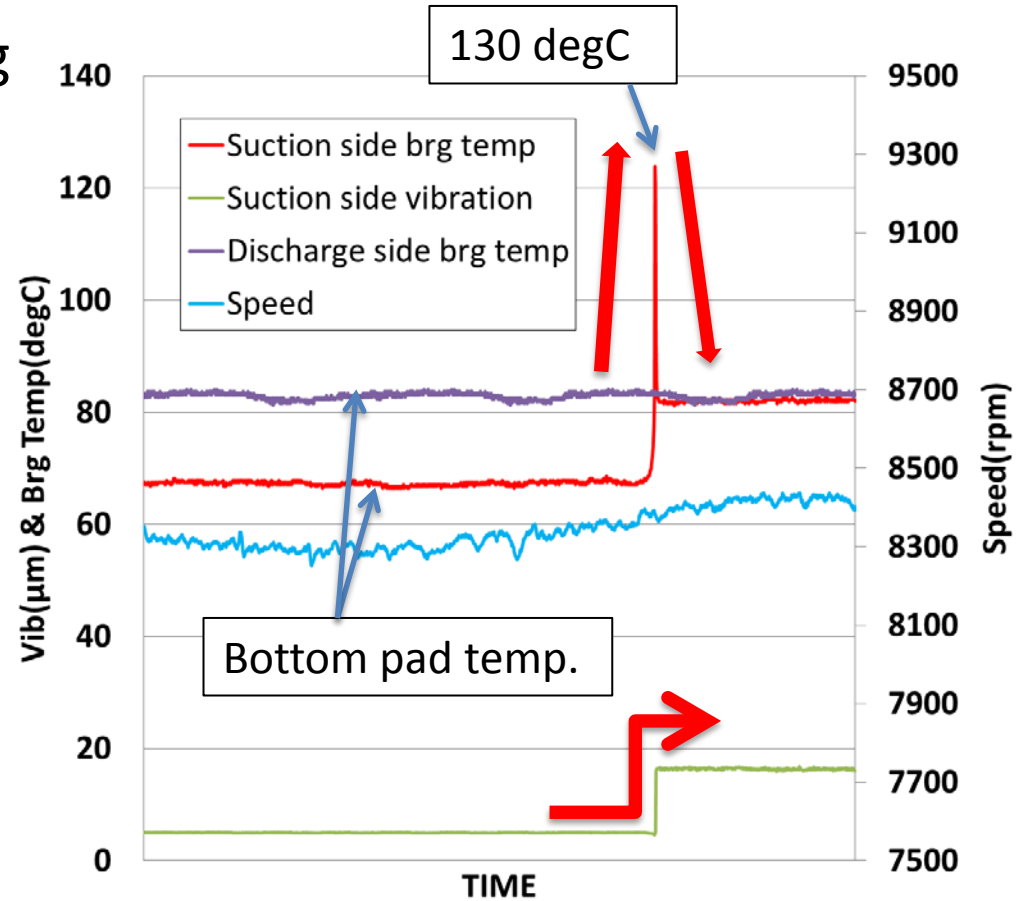
- Suction side journal bearing temp. was increased instantaneously and reduced suddenly. (65 => 130 => 80 degC)
- Bottom pad temp. was too low before it spikes.
- Shaft vibration was increased stepwise. (5 => 15 μm p-p)

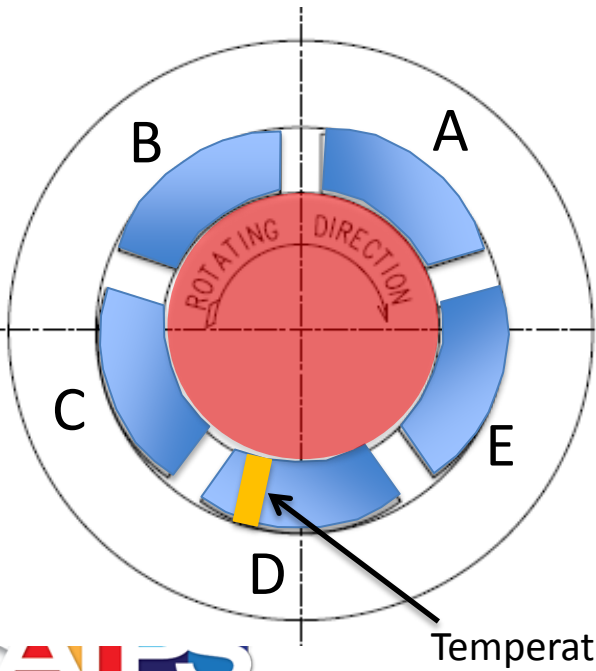
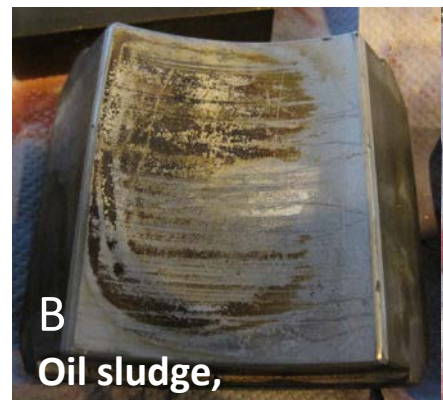
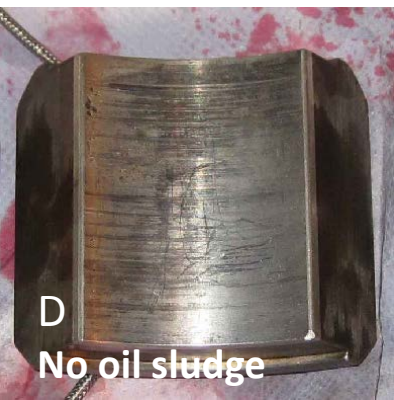
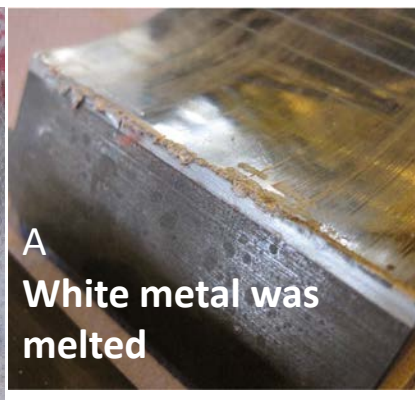
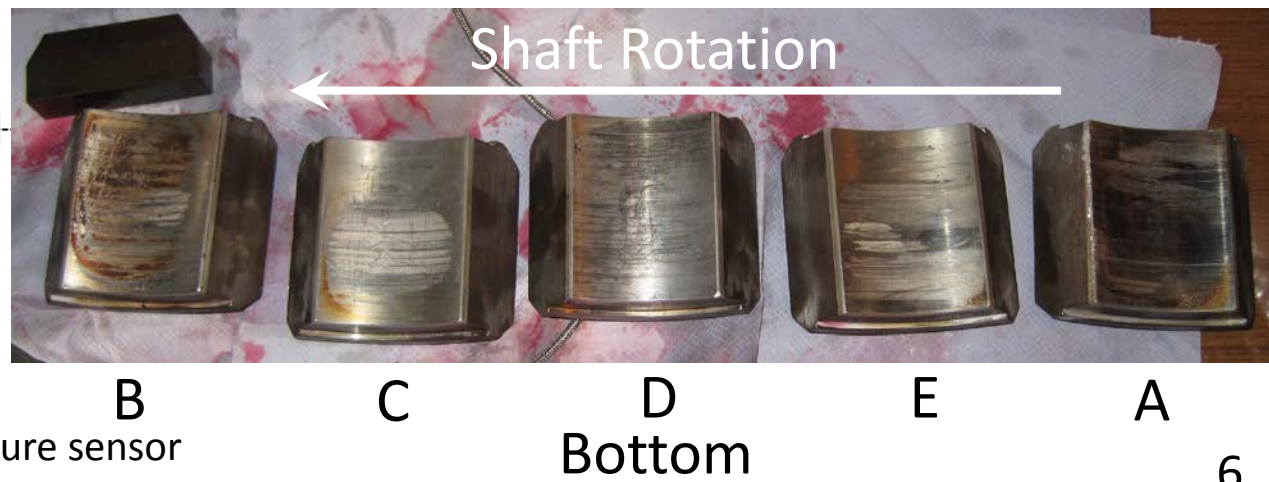
Observation at overhaul inspection

- Damage was identified on suction side journal bearing pad except for bottom pad.

- Suction side bottom journal temp. was too low indicating abnormal condition.
- Based upon the disassembly inspection, pads were found to be in damaged condition.

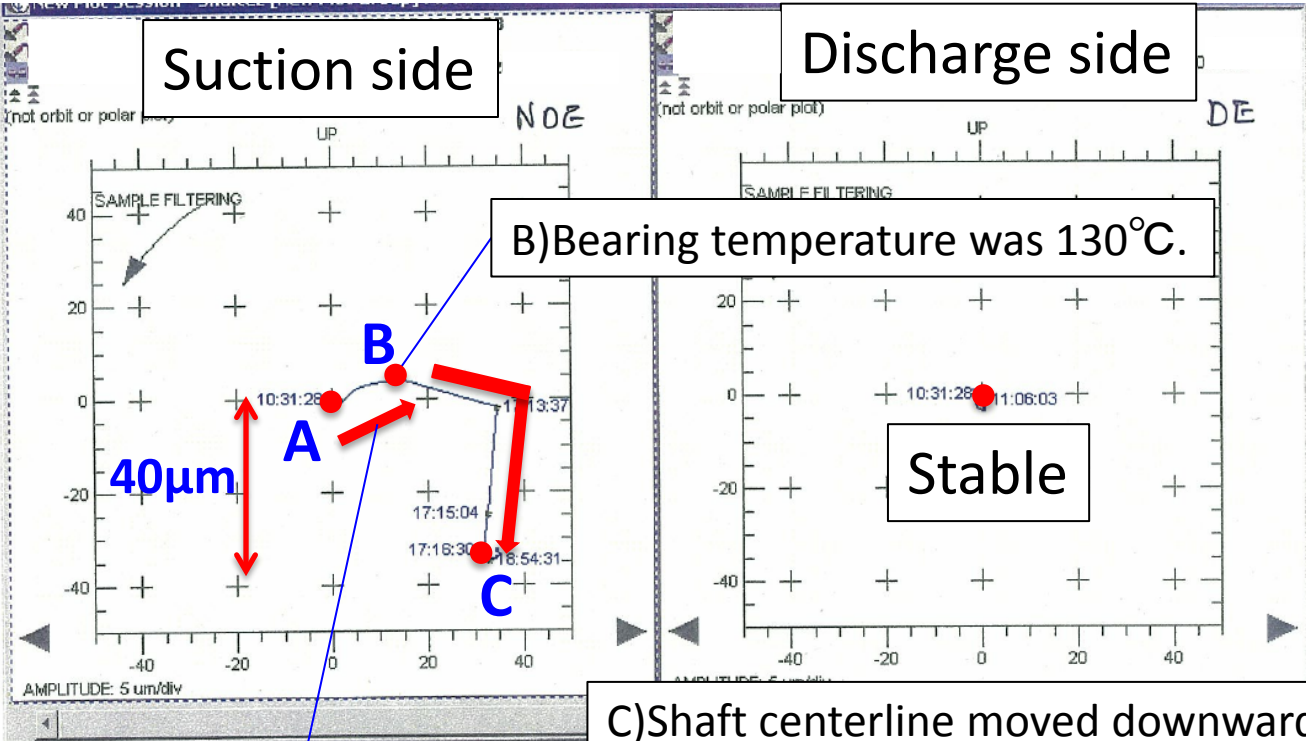
Observation at shaft vibration data

Shaft position moved only at suction side, discharge side was stable.

B) Bearing temperature was 130°C.

A) Shaft position moved 15µm during temperature rise.

C) Shaft centerline moved downward 40µm during temperature decrease. This would be caused by bearing damage (reduce white metal thickness).

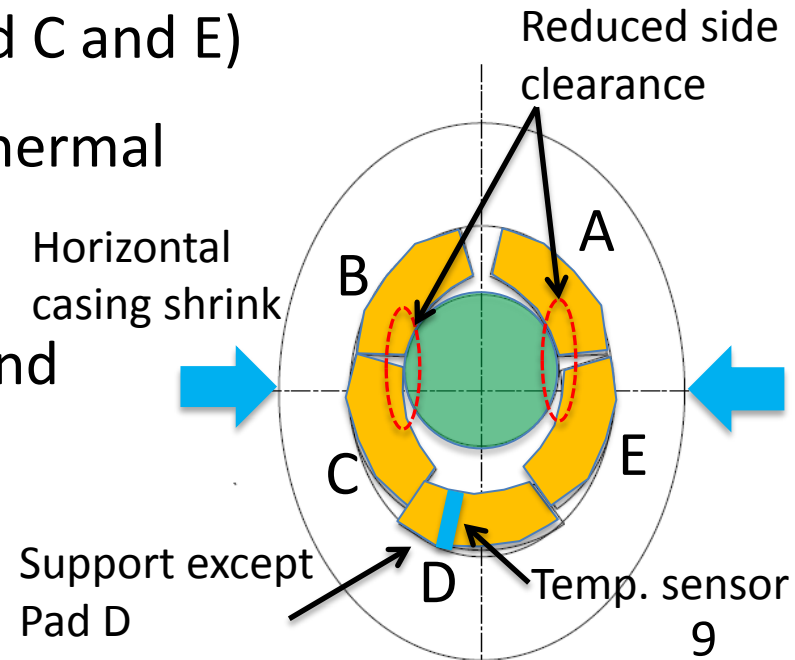
1. Casing shrinkage by low temp. suction gas.
2. Bearing clearance was decreased in horizontal direction.
(Bearing housing was compressed in horizontal direction.)
3. Rotor was supported by side pads. (pad C and E)
4. It made the clearance smaller due to thermal expansion of bearing pads and shaft.
Then, it generated much higher heat and finally damaged.

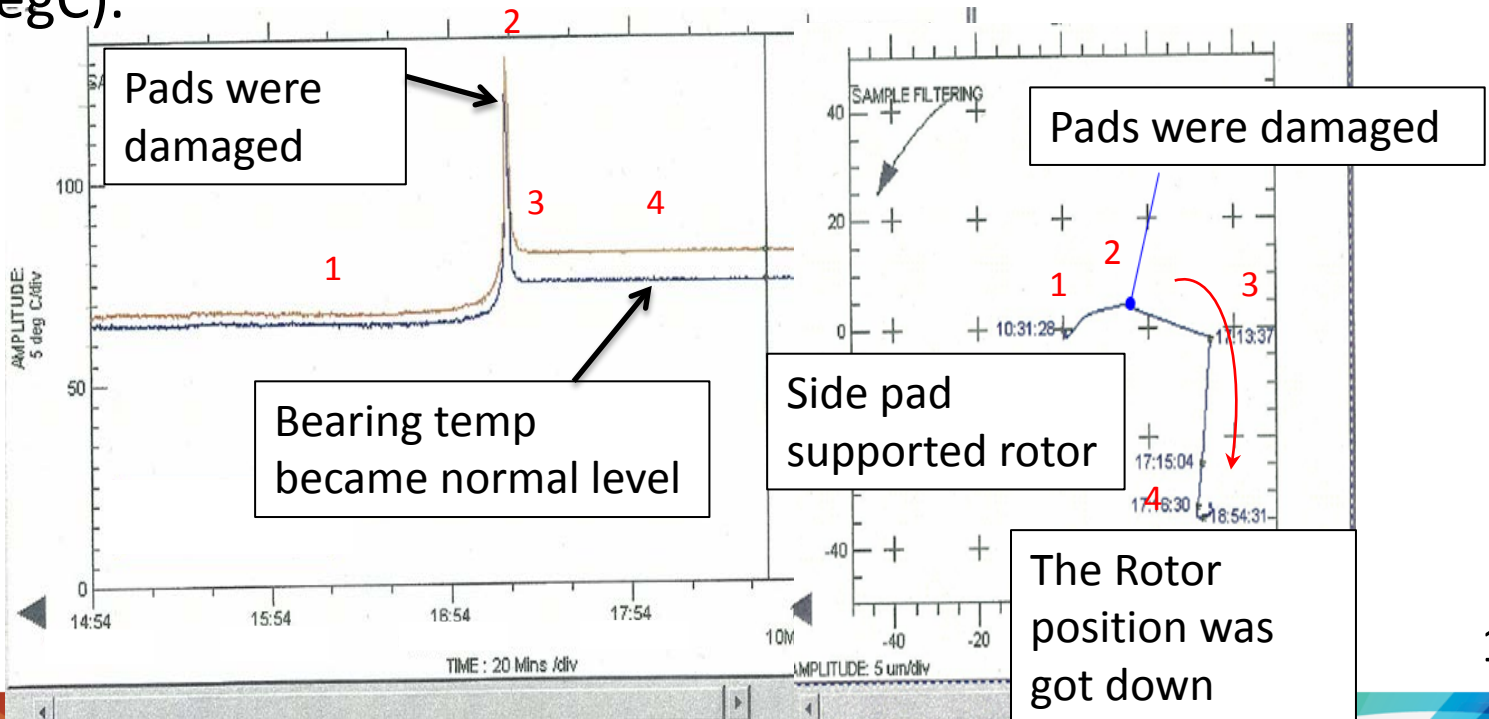
- 5. Bearing clearance was increased by melting of babbitt metal.
- 6. The rotor position was got down.
- 7. After that, bottom pad temperature became to normal level (75-82 degC).

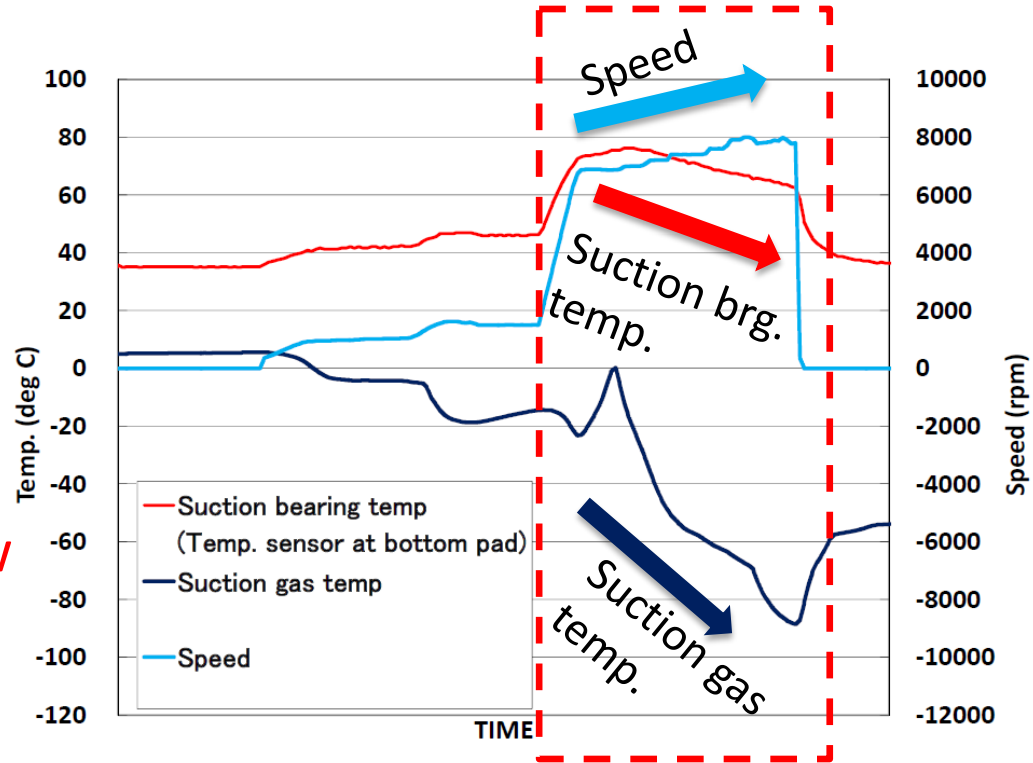
- When suction gas temperature was decreased, bearing temperature also decreased, though the operating speed was increased.
- This also affirms the below possible scenario.
- Bearing clearance in horizontal direction was decreased by low temp. gas.
- Rotor was supported by side pads, and the load on bottom pad was decreased.

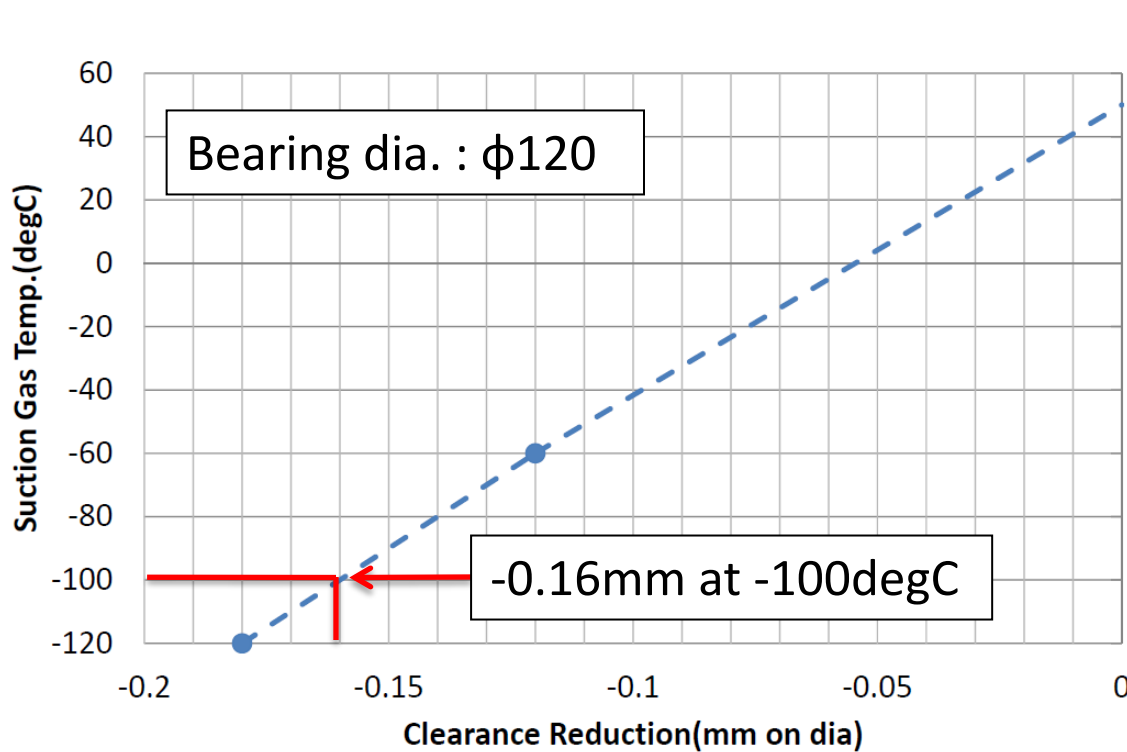
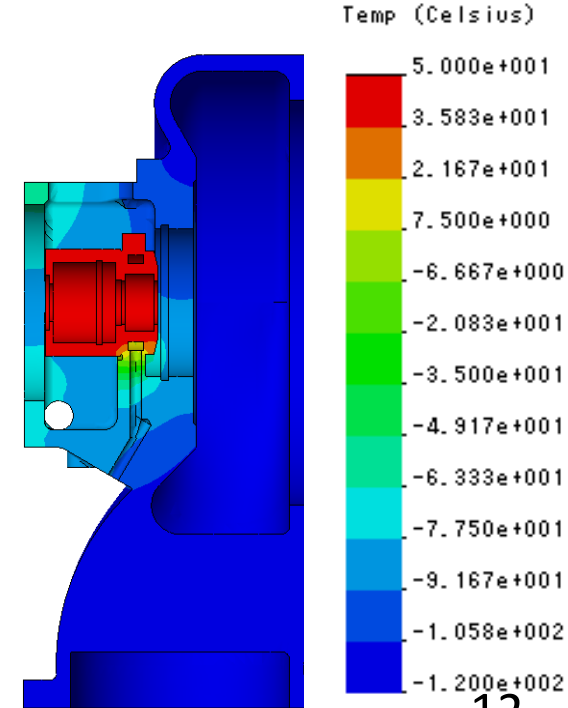
FEM Analysis Result

Suction gas temperature and bearing heat by the rotation were considered into the analytical model.

Reduction amount is 75% at -100deg C of normal bearing clearance.
