ASIA TURBOMACHINERY & PUMP SYMPOSIUM
MARCH 2018 | SUNTEC SINGAPORE

Steam Turbine Steam control valve failure
By
Vasanth Bhat & Thangavel Suthan
Singapore Refining Company Pte. Ltd.

Wet Gas Compressor Steam Turbine Governor Valve Failure

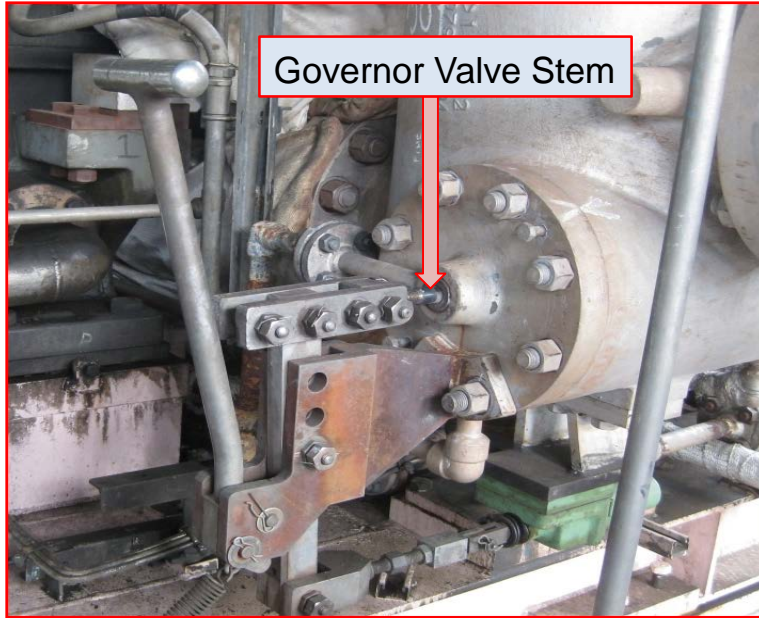
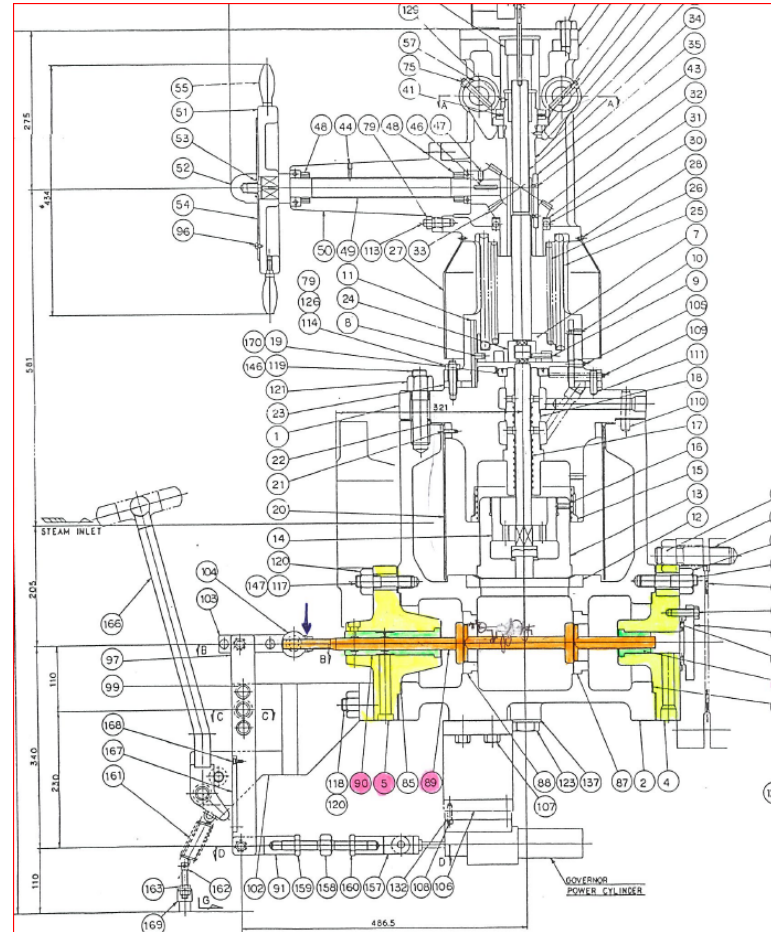
Governor Valve Stem Details

- The Wet Gas compressor in the FCC unit is driven by a four stage back pressure turbine.
- The turbine is controlled by a dual port single stem slide valve using a Hydraulic governor.
- The turbine, after commissioning in 1993, was rerated in 2006 to take additional load from the compressor at end of run conditions.
- Prior to 2012 there were issues of abnormal wear observed in the governor valve stem bushing.

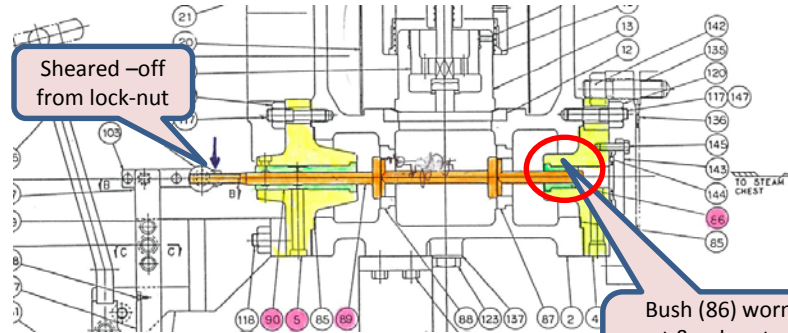
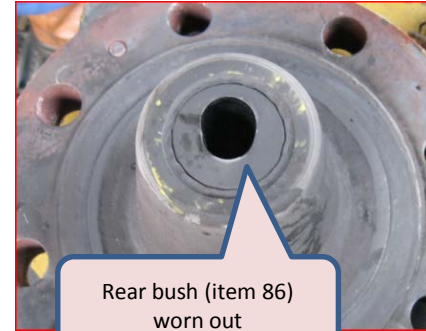
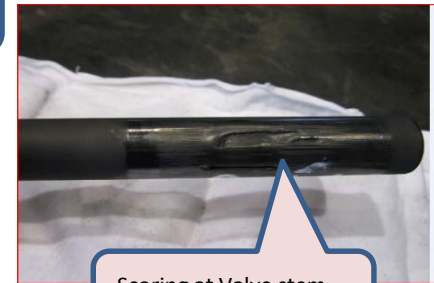
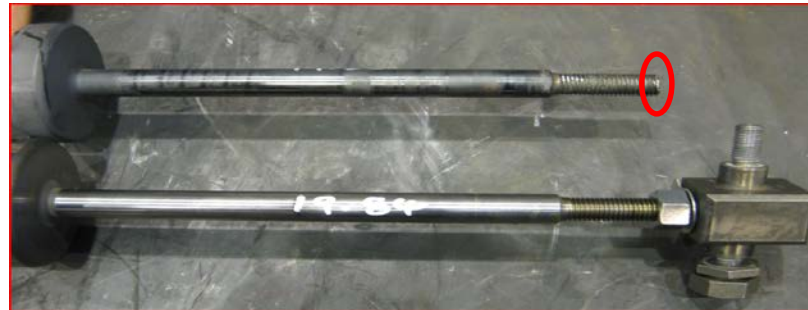
Governor Valve Stem Failure – Oct'12

1. Valve stem found broken at threaded section. Rear support bush was badly worn out. Front bush had relatively less wear compared to rear.
2. Stem surface found to have high wear at rear bush area.

- Broken valve stem was sent for metallurgical analysis by OEM. It was concluded that the stem broke due to fatigue. (not due to metallurgical defects)

1. Replaced stem and bush in kind
2. Carry out vibration monitoring of valve stem. Found on the higher side (25 to 30mm/sec pk).
3. Dominant peak around 200 Hz.
4. Impact test done and found the resonant frequency was 212 Hz.
5. OEM recommended Improvements to the threaded area and rear bush area for the spare stem.

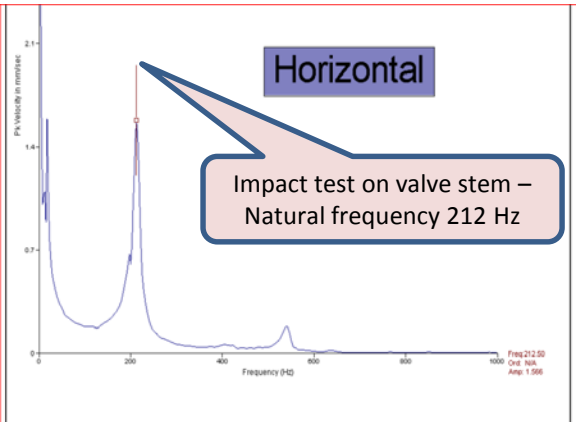
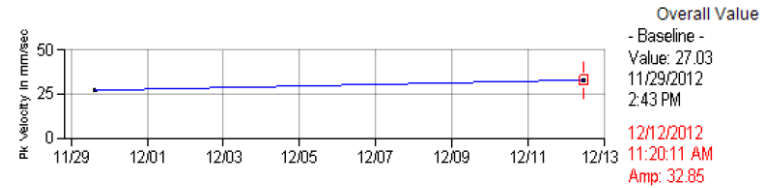
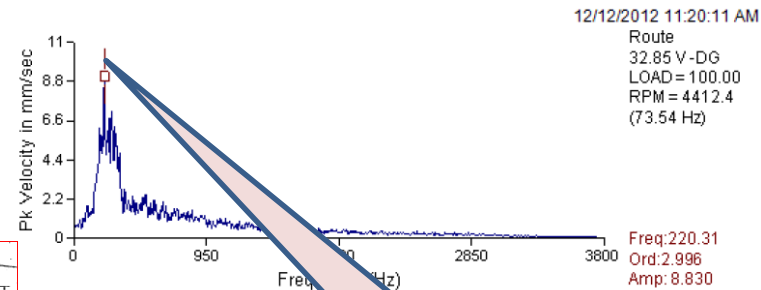
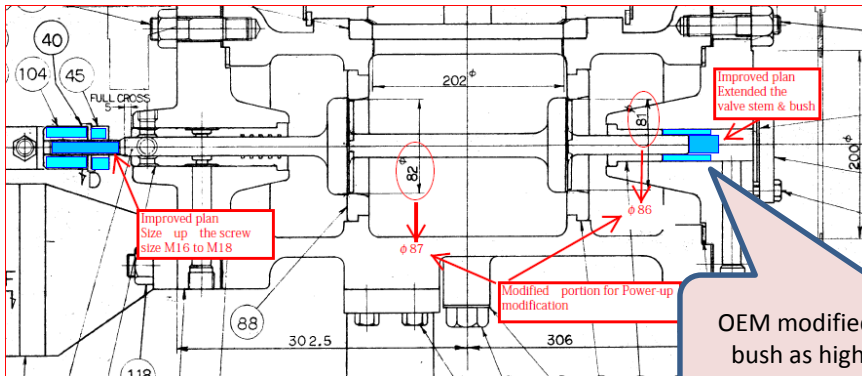
Governor Valve Stem Failure – Oct'12

OEM modified valve stem and rear bush as highlighted in blue color

Vibration monitoring on routine basis – Overall vibration around 25 ~ 31 mm/sec pk
Dominant vibration frequency around 220 Hz

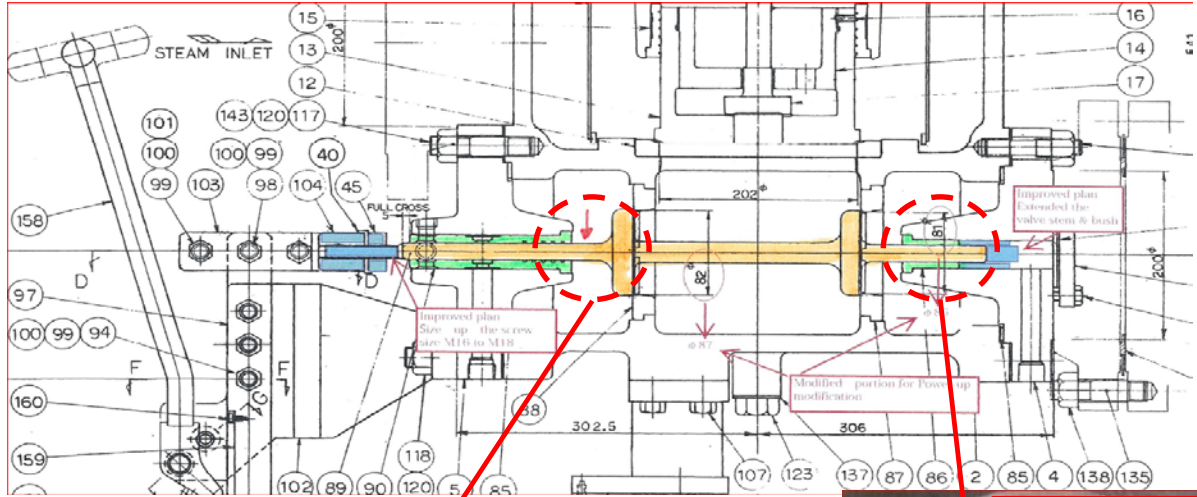
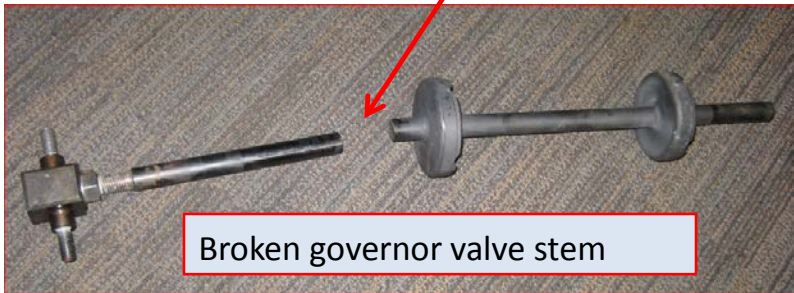
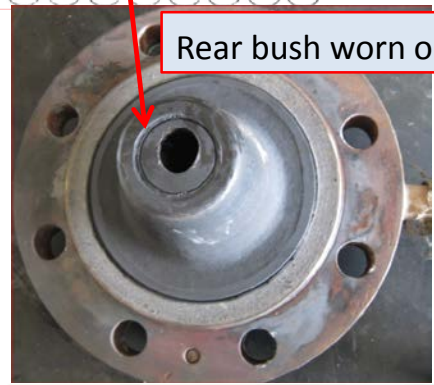
Governor Valve Stem Failure – June 2014

1. On dismantling, governor valve stem was found broken from inside.
2. Valve stem rear bush found worn out excessively.
3. Hydraulic oil was leaking from valve actuator (power cylinder). Oil leak could be due to excessive vibration of valve stem.
4. These findings are similar to the failure occurred in Oct'12 except that the stem was broken from inside.

1. Replaced damaged governor valve stem with modified new valve stem & bush.
2. The vibrations on the stem did not show any significant reduction with the dominant spectrum in the peak remaining around the 200Hz.
3. OEM asked to carry out detailed analysis on the cause and recommend modifications to eliminate the issue

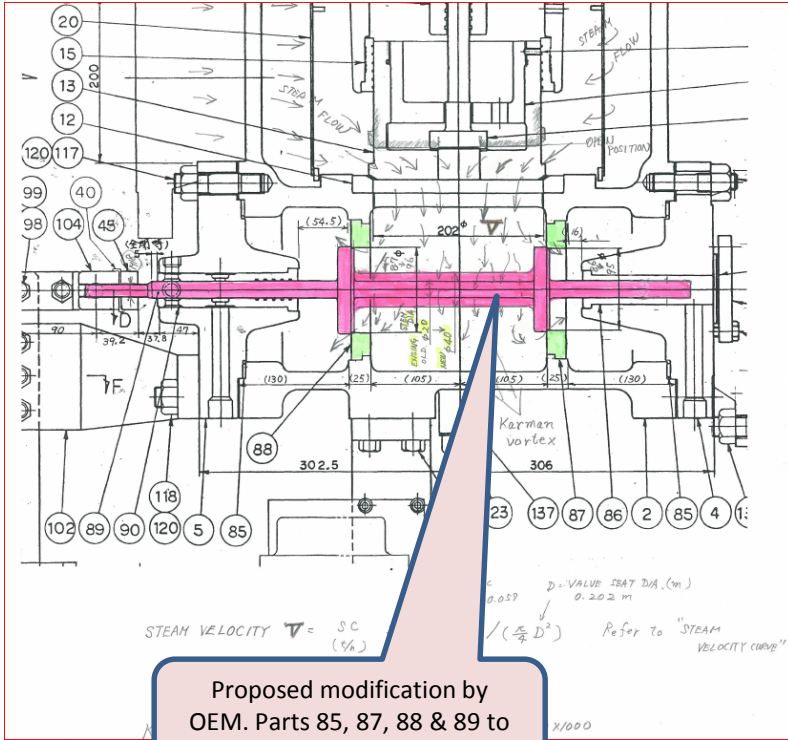
Proposed Modification

Provision valve stem (Free)	(fixation of bolt part)	(fixation of bolt part, fixation of interlevel bush cylinder, fixation of cylinder, fixation of end to side bush cylinder)
fixation condition

1. Modified stem and related parts installed during turbine overhaul in 2015.
2. The overall vibrations did not show a distinct reduction but there is no dominant peak at 200Hz.
3. Unit is under monitoring and no abnormalities observed.
