ASIA TURBOMACHINERY & PUMP SYMPOSIUM
MARCH 2018 | SUNTEC SINGAPORE

Resolving Structural Vibration Issues On a Multi Stage Pump

Nicolas Peton
Sankar Ganesh

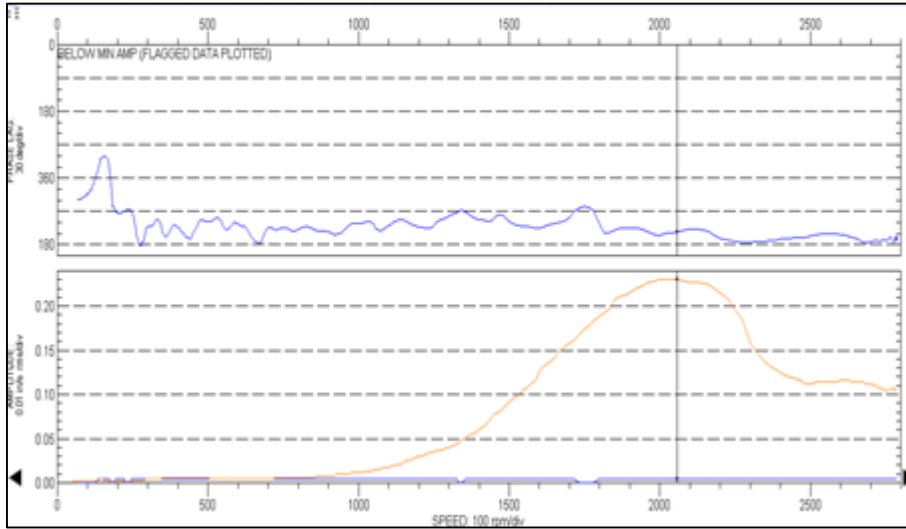
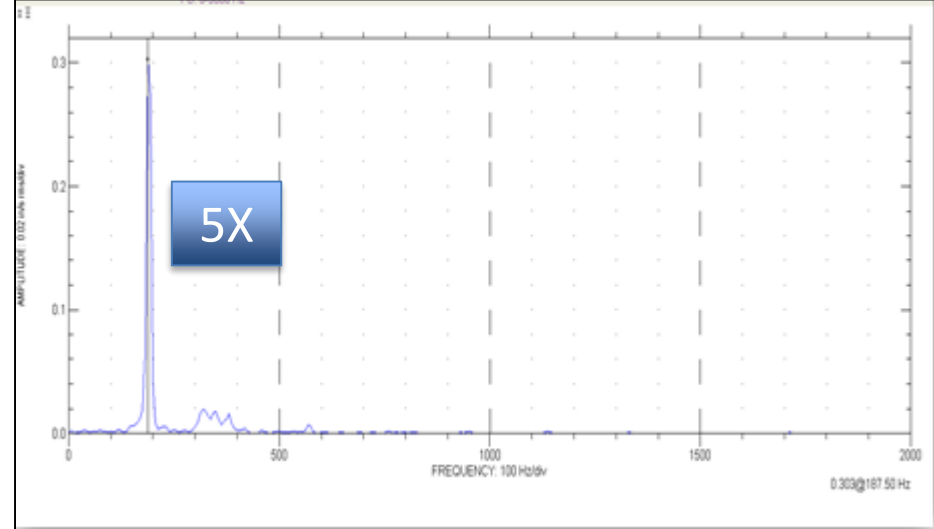
Data Analysis-Online Software

The online casing probe at Pump NDE Vertical showed high vibration (above 0.2 in/s rms) while crossing the speed range from 1850 to 2300 rpm.

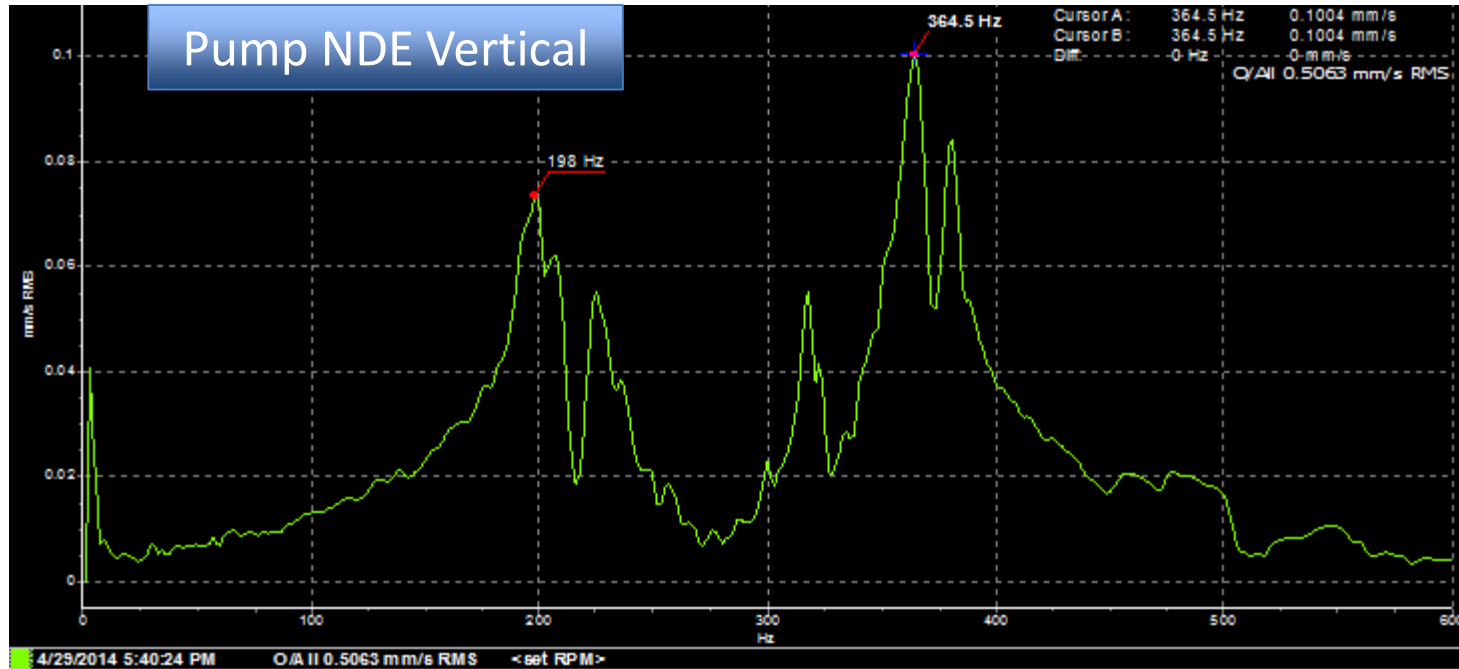
Data Analysis-Bump Test “Vertical”

Pump NDE Vertical showed natural frequency at 198 Hz which is 5 times the running speed of 39.6 Hz

- The pedestal of the pump support structure appears to be the weak point in the vertical and horizontal direction.
- The Non Drive End Bearing appears to move much more in the vertical direction than the Drive end bearing.
- Recommendation would be to modify the support pedestals of the pumps and to check the integrity of non drive end bearing housing mountings.

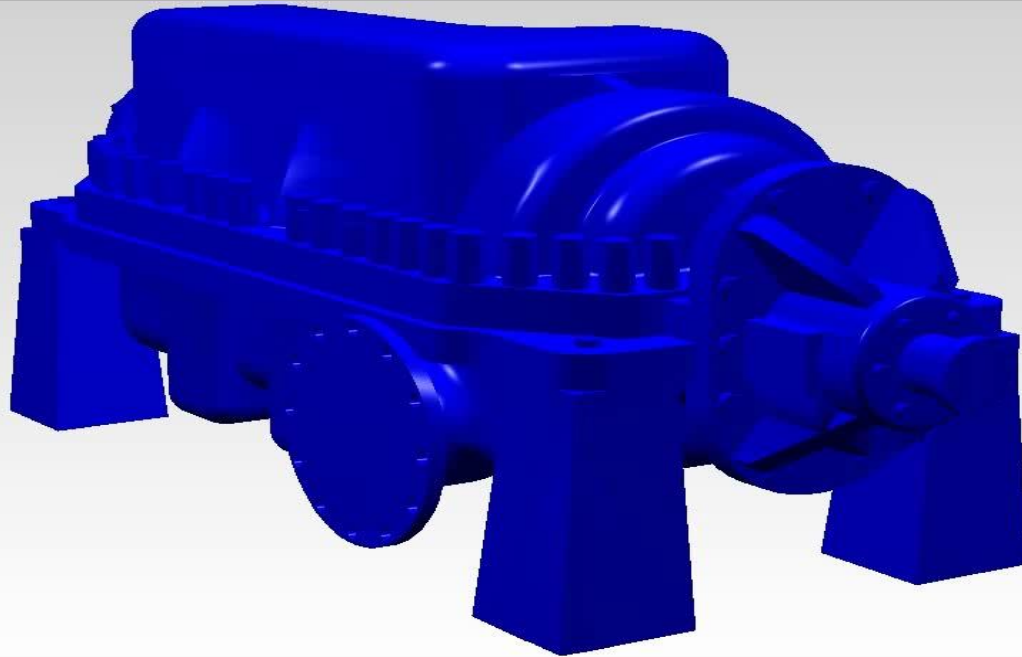
Data Analysis-ODS (At 39.8Hz “1X”)

- The Operating Deflection Shape (cross spectrum) performed at 2388 rpm shows the motion of vibration at the rotating speed at 39.8 Hz and 199 Hz (5X).
- Both ODS from cross spectrum & ODS Frequency Response Function (FRF) shows a horizontal deflection at 1X.
- Both ODS from cross spectrum & ODS Frequency Response Function (FRF) shows a horizontal deflection at 5X.

Horizontal deflections at 1X (39.8 Hz)

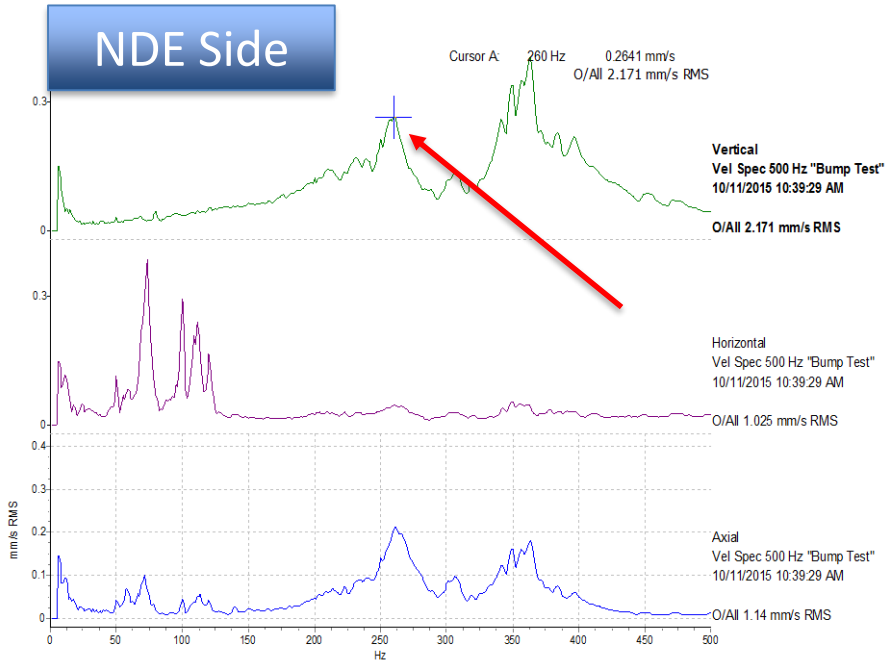
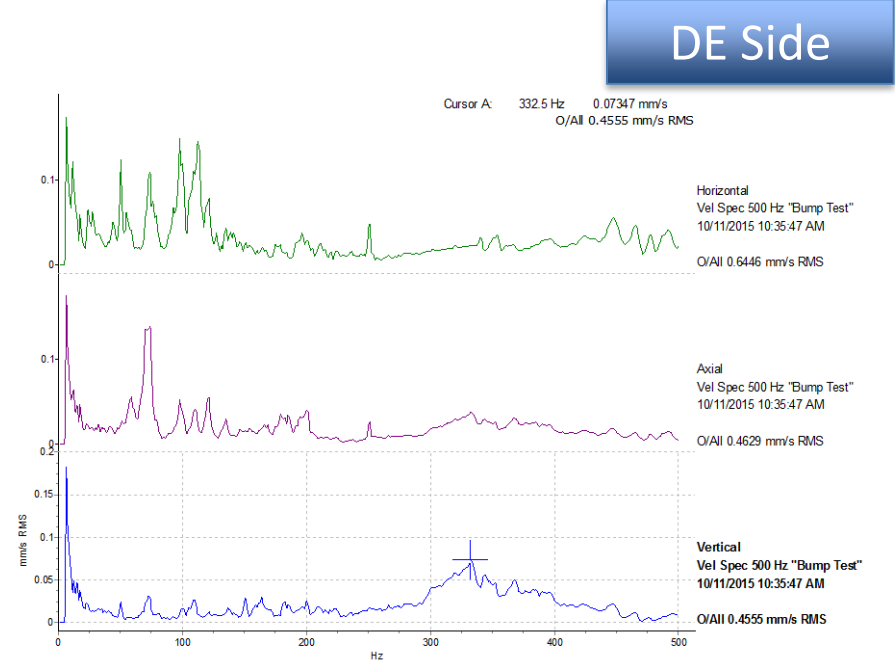
Post Analysis-Impact Test

Pump NDE Vertical showed new natural frequency at 260 Hz after the modifications

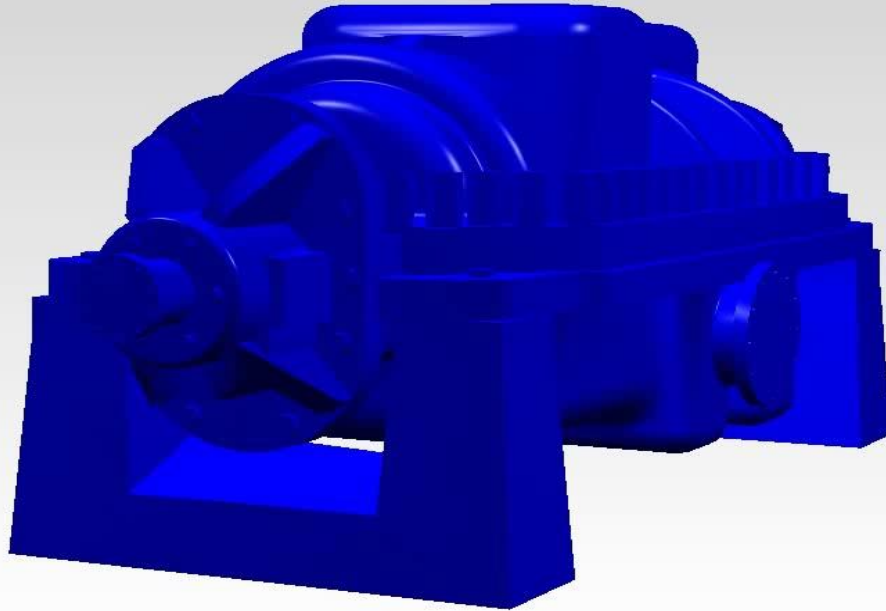
Post Analysis-ODS At 253Hz “5X”

Vertical deflections at 5X (253 Hz)
