ASIA TURBOMACHINERY & PUMP SYMPOSIUM  
MARCH 2018 | SUNTEC SINGAPORE

# UNEXPECTED VIBRATIONS IN GEARBOX CAUSED BY SYSTEM INTEGRATION ISSUES

This case study deals with a 24MW turbo-compressor unit composed of a gas turbine, a speed reduction gearbox with a lube oil pump mounted on its low speed shaft and two compressors in series. The unit was subject to high radial vibrations at the gearbox low speed shaft during initial running phase.

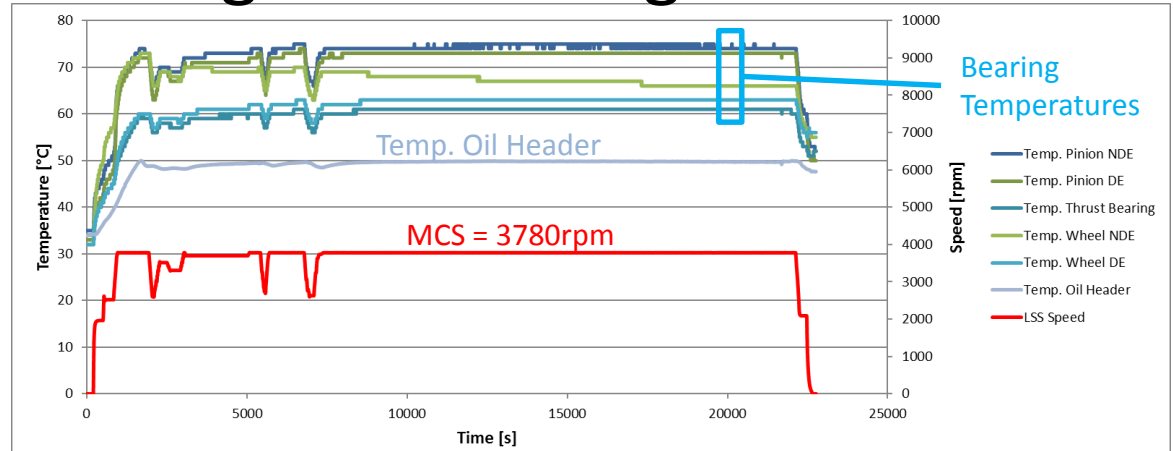
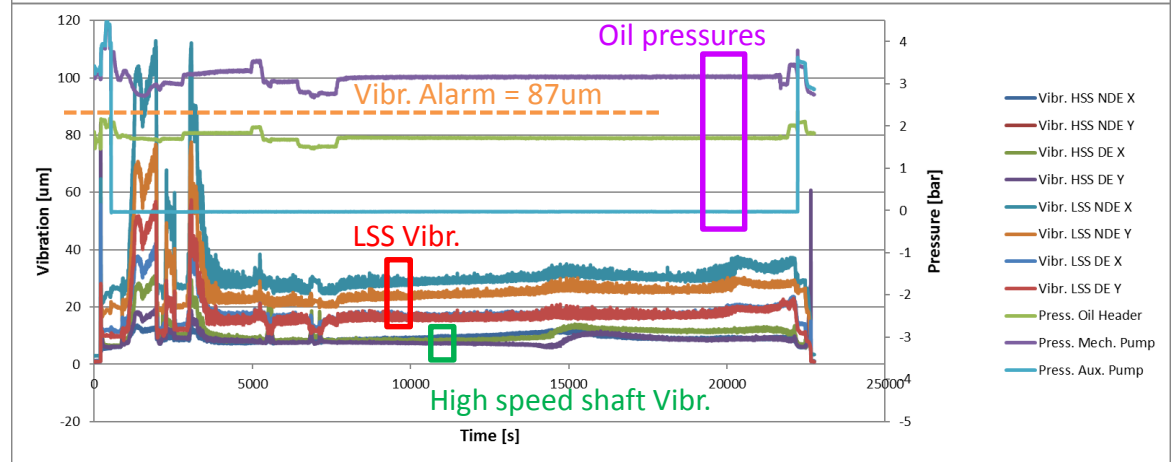
- LSS vibration above Alarm limit @ Max Continuous Speed (MCS)
- Event extinguished approx. 75min. after train start-up
- Bearing temperatures: no issues, as expected
- Lube oil supply: no issues, as expected
- Lube Oil Pump on Gearbox reported to work in a noisy way

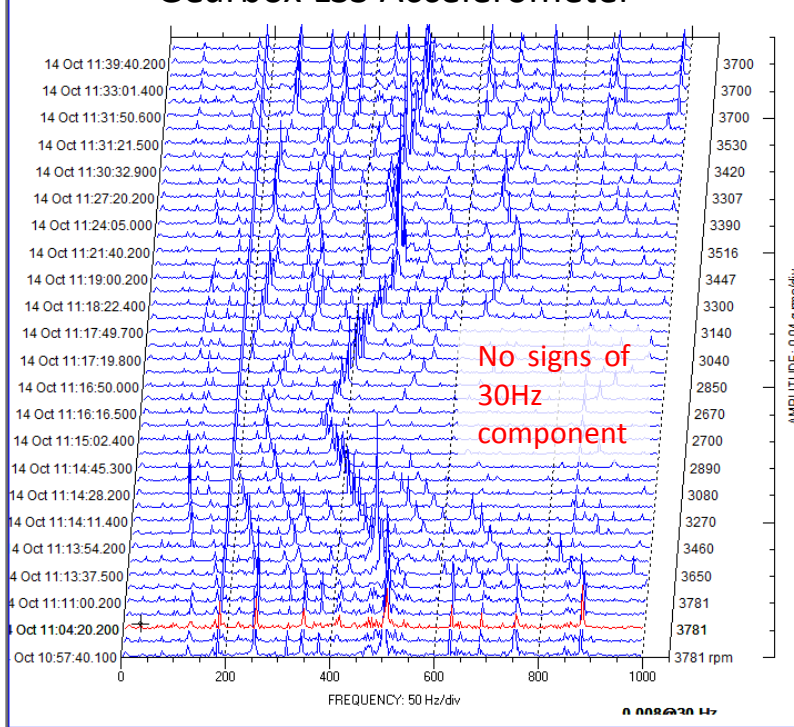
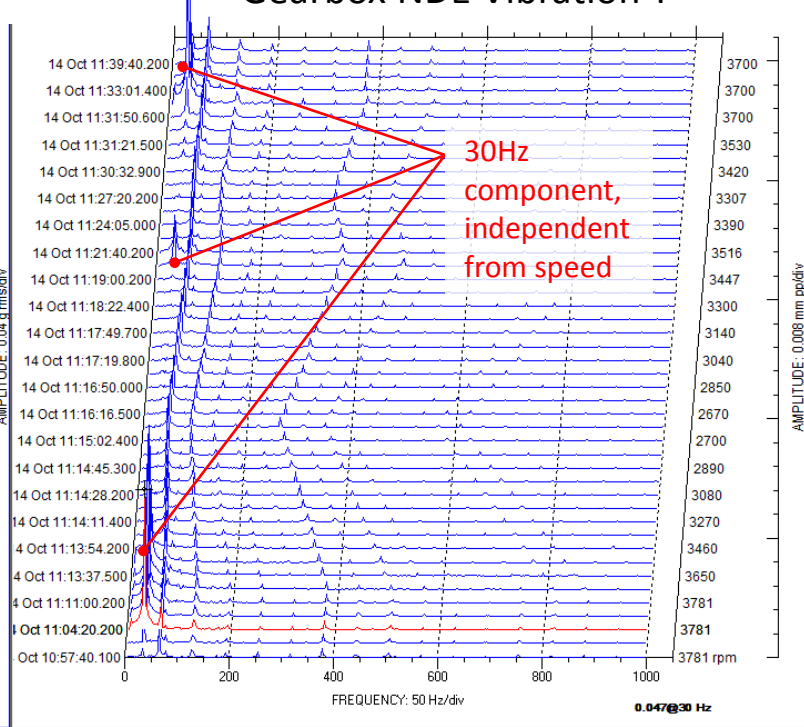
~30Hz component on LSS vibr. probe, independent from speed, not detected by GB casing accelerometer: disturbance of torsional nature

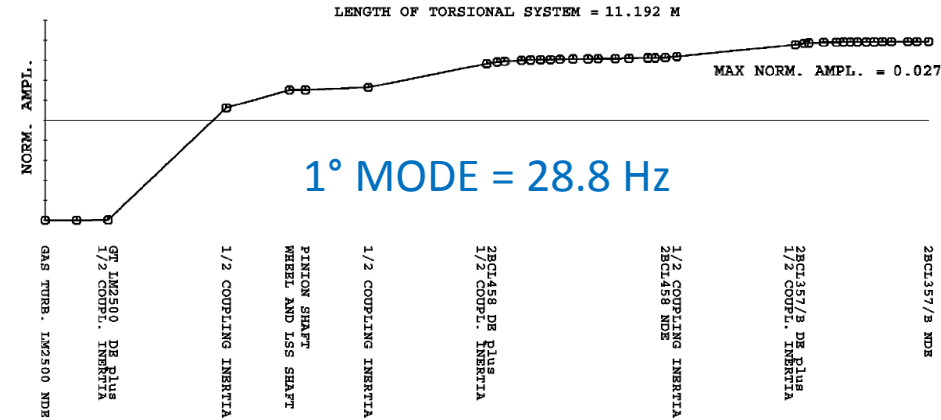
Gearbox radial vibration response at 1st Torsional Natural Frequency (TNF) was induced by torsional-lateral cross coupled effect, due to the kinematics of the geared system

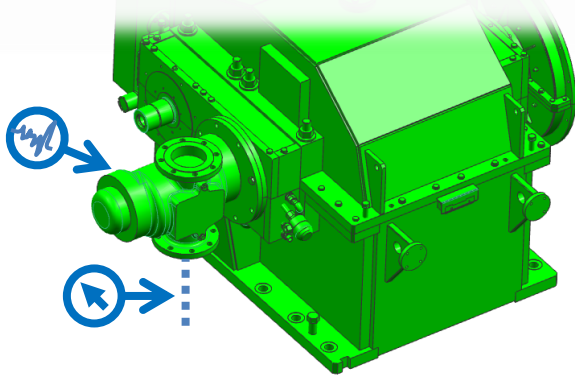
Outlet pressure (~3.5 bar) much lower than pump design pressure (6.5 bar)

High pressure drop at pump suction

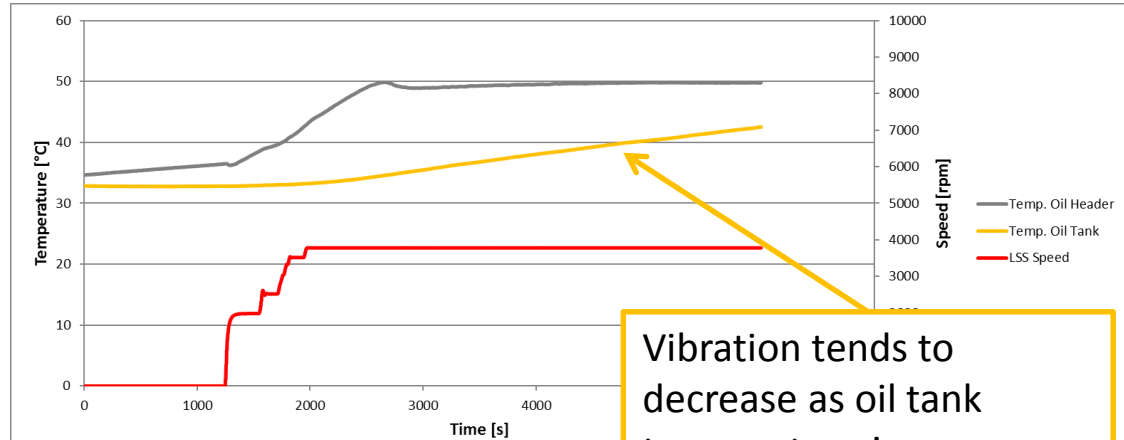
Vibration tends to decrease as oil tank temperature increases

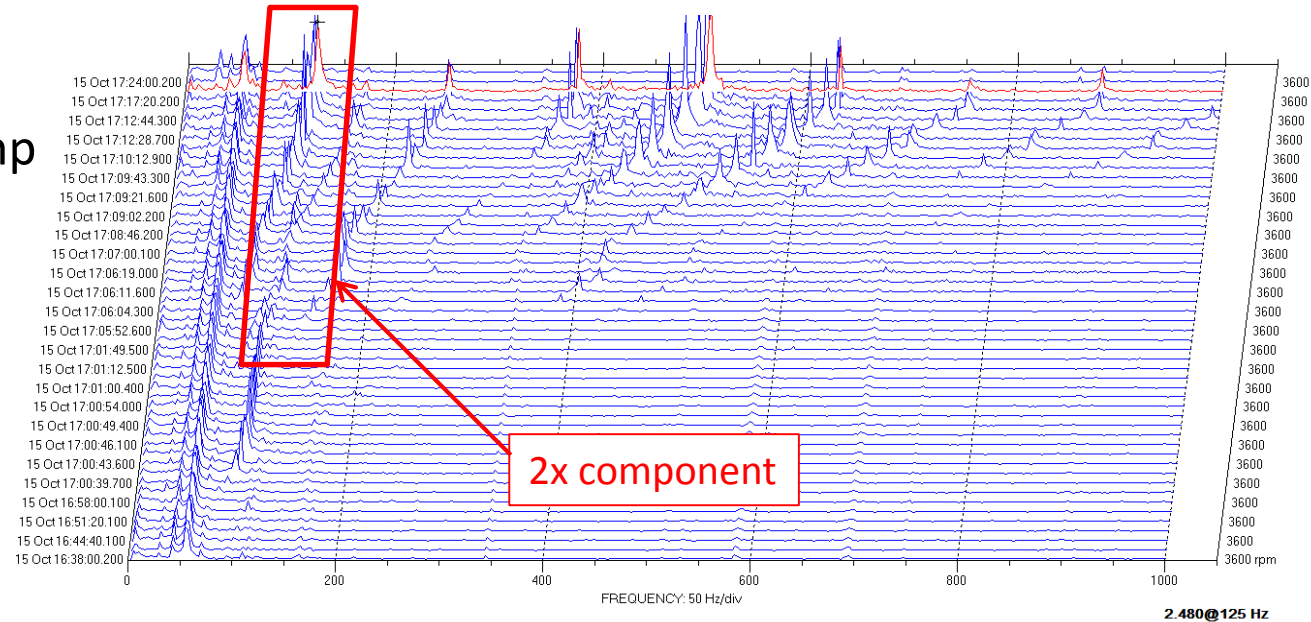
- Strong 2X component detected by accelerometer on pump casing
- Noisy functioning
- Low suction pressure
- Outlet pressure set below pump design pressure
- Dependence on oil temperature

Pump working in Aeration

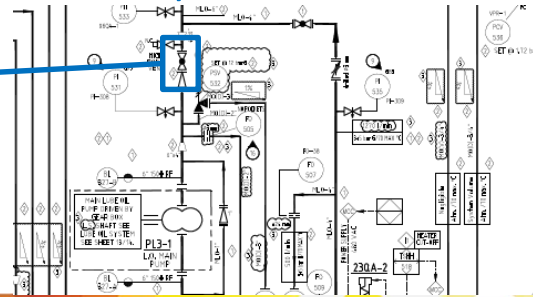
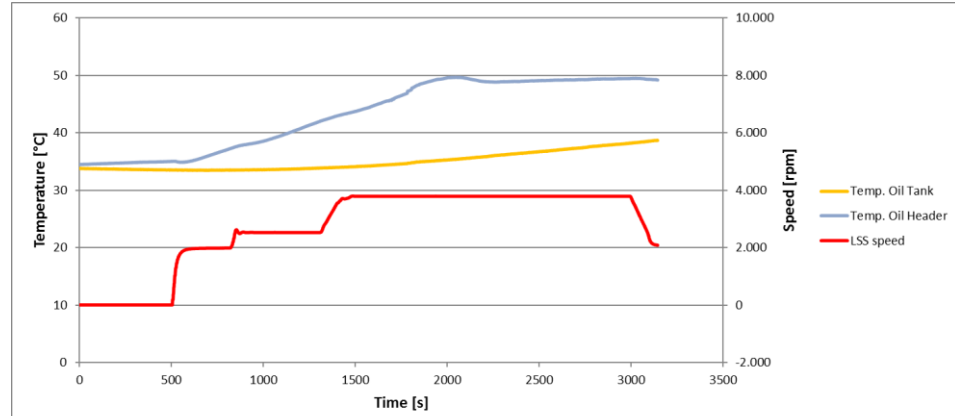
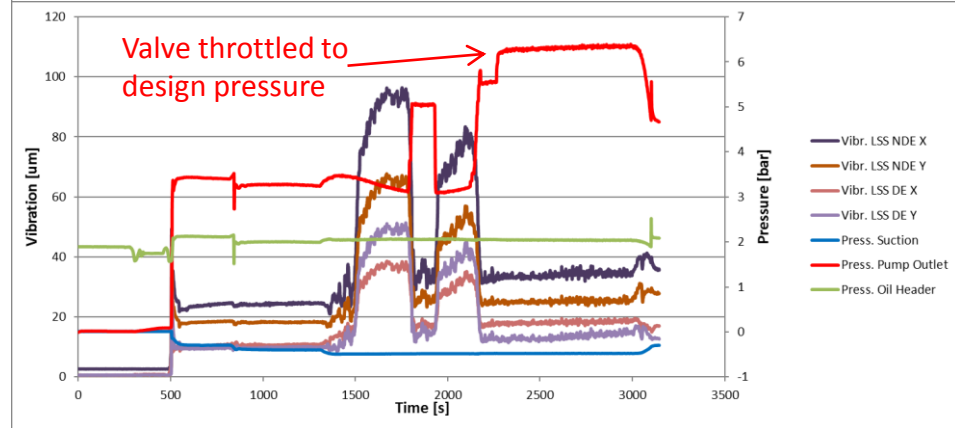
**Root cause:** Pump designed/optimized for discharge nominal pressure of 6.5 bar, as required at the beginning of the project. Lube oil system pressure set-point was then reduced to 3.5 bar afterwards, without reviewing pump design ( $6.5 < 3.5$ )

**Solution:** Mitigate aeration by increasing outlet pressure set-point (other actions not feasible at site, as they needed major reworking of materials)

Manual valve throttled

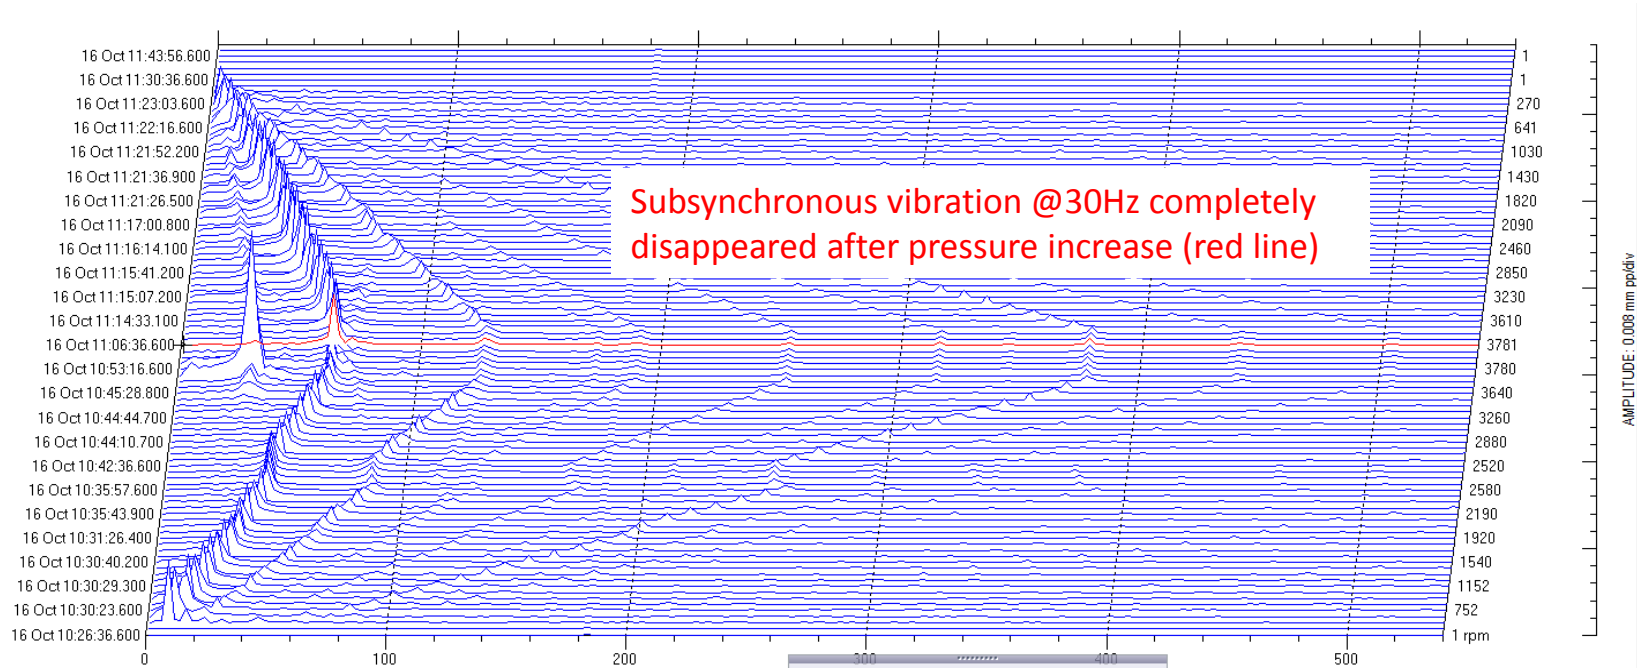
- Aeration phenomenon was extinguished
- Train torsional vibration completely disappeared

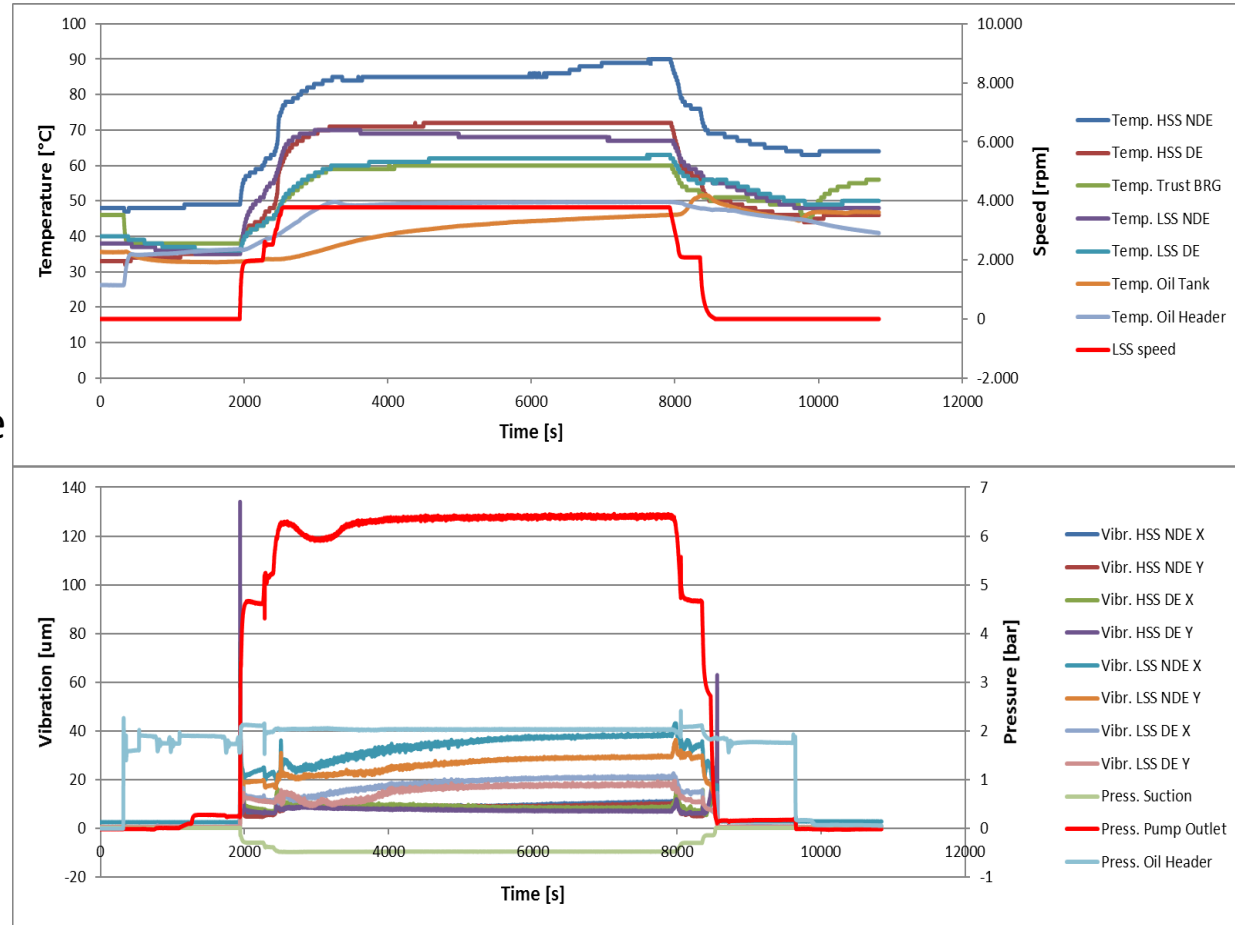
Final Full Speed – No Load test to validate corrective action: **no high vibration, corrective action is effective**

- Corrective action: orifice installed downstream of pump discharge to increase pressure set-point.
- Orifice selected to guarantee correct discharge pressure in all operating cases (different speed and different pressure drops in the system)
